AQUADENE ROAD UPGRADE RICHARDS BAY

Ecological Review of the proposed upgrades to the R619, uMhlatuze Municipal area

January 2016

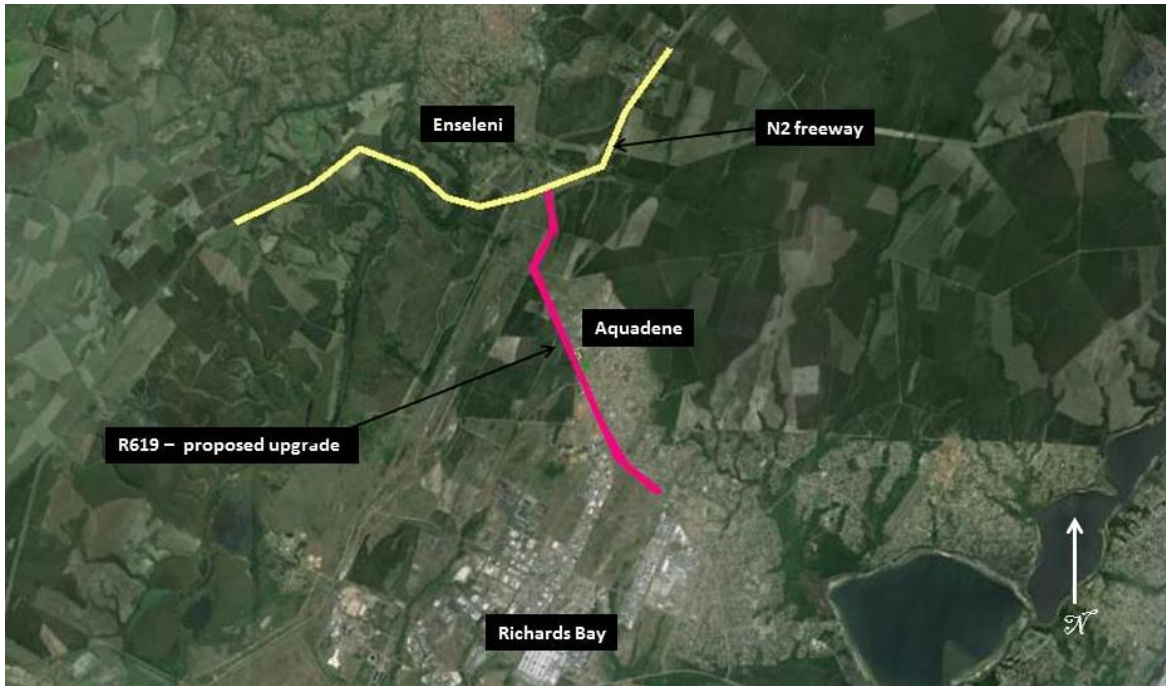
Fig. 2 Aerial image indicating R619 in regional context. (Source Google Earth)

The subject area extends from 28°41.41S 32°01' 44E, in the vicinity of the N2 interchange, to the south at 28°44' 29S , 32°02' 58'E. (See Fig. 1 and Fig. 2).

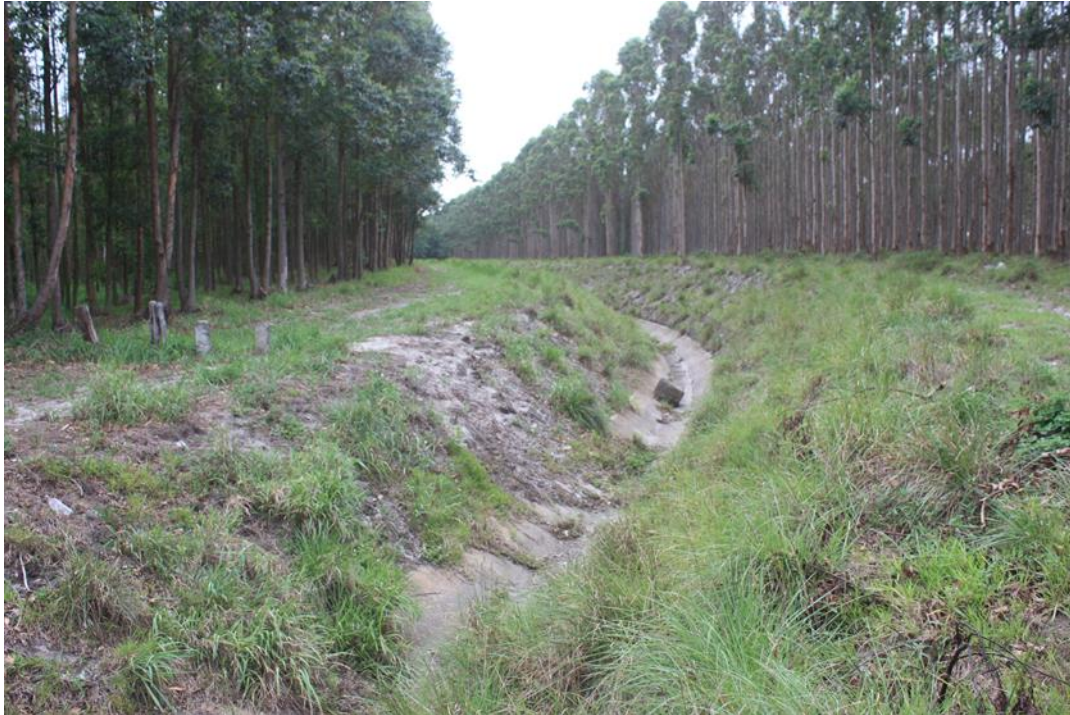
Wetland system 1. This wetland system identified in the NFEPA data base, is now a highly transformed drainage system that comprises of an excavated and concrete lined sluice drain that serves both the roadway and adjacent plantation. (Fig. 7)

Fig.7. Sluice drain on Wetland 1.

Given such transformation, it is evident that the sluice drains adjacent lands and directs run off in a southerly direction. No hygrophilous vegetation is noted around the drainage sluice, while geohydromorphic soils are absent from the area on account of infilling and other earthworks. It is anticipated that the former wetland system that was identified by the NFEPA evaluation was a shallow endoreic system that became inundated during high precipitation events. The high level of transformation in the region, including plantation establishment, roadworks and general infilling of the area through earthworks has served to change the structural nature of this wetland to a lined sluice, effectively removing all wetland function.

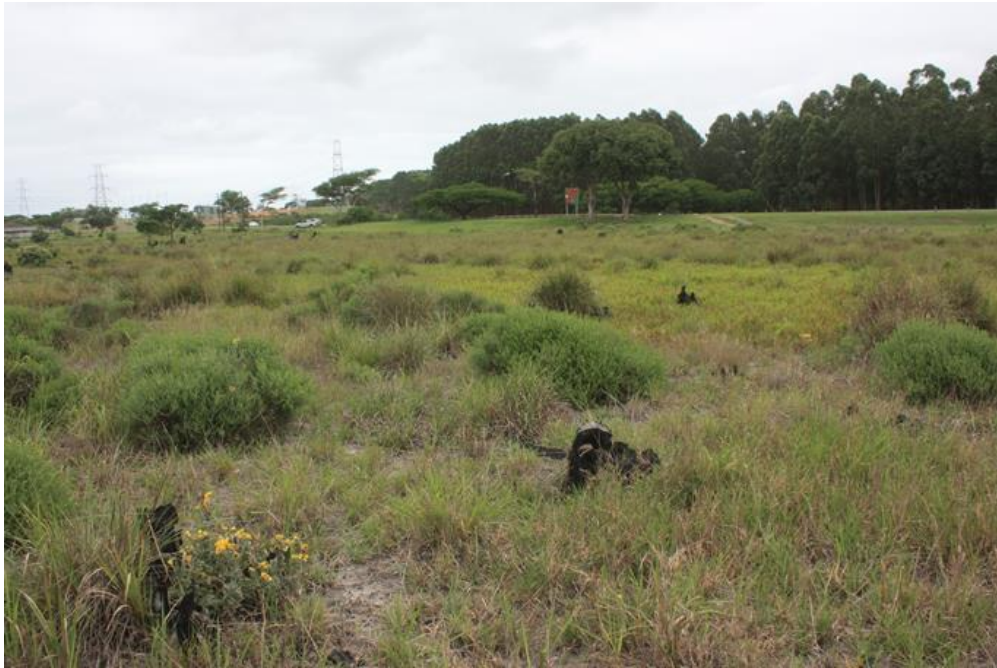
Wetland system 2. This wetland system lies just to the south of wetland 1. This area is a seasonal, closed endoreic system which has effectively been subject to some transformation on account of the construction of the R169, as well as, until recently the establishment of plantation, which served to lower the water table at this point (Fig. 8)

Fig.8. Image of wetland system 2. Note stumps indicating presence of commercial timber on site.

This wetland system comprises primarily of mesic grasses (*Eragrostis curvula*, *Melinis repens* and *Digitaria eriantha*), as well as forbs which include *Helichrysum cymosum*, *Crotalaria lanceolata*, and *Argyrolobium* sp. The presence of *Centella asiatica* and *Cyperus rupestris*, as well as the general morphology of the area, is indicative of the fact that this shallow depression is subject to minor inundation during high rainfall events. As indicated above, and evident from Fig. 8, the former plantation on this site has significantly altered wetland function at this point.

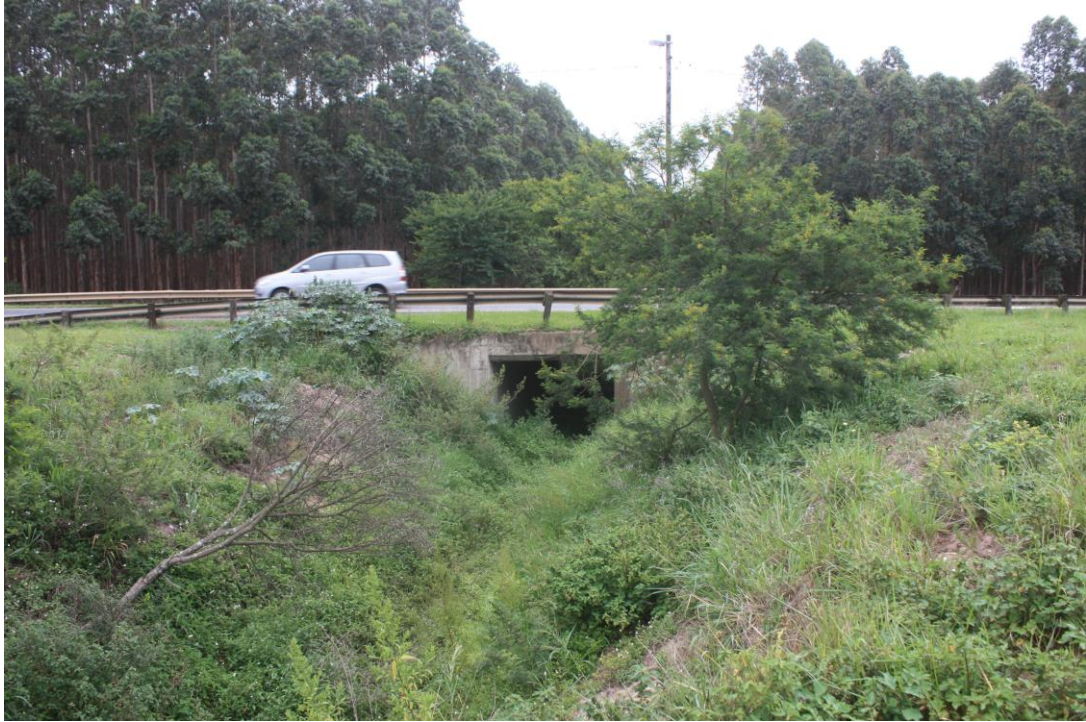
Wetland system 3. Approximately 150m south of wetland 2 lies a transformed endoreic system that has been subject to excavation and the establishment of a drainage channel. This drainage channel, unlike wetland system 1, has not been lined and effectively reflects a deeply incised seasonal stream that is driven by the excavation and exposure of the deeper clay soils associated with the water table. Hygrophilous species common to site include, *Persicaria senegalensis*, *Fimbristylis complanata*, *Mariscus solidus* and the exotic *Colocasia esculenta*. The most dominant herb within the drainage system is *Commelina erecta*, a facultative wetland liane. The area is tended to a “park like” state, with larger woody species including *Acacia karoo*, *Acacia xanthophloea* and *Acacia sieberiana*.

Surface water was evident in the drainage system at the time of inspection, however no flow was evident. It is likely that this particular drainage system was a low lying endoreic pan that has been subject to excavation in order to facilitate drainage away from the nearby Aquadene housing development. Much of the drainage system lies between the road and the housing development and is testimony to the poor drainage that is inherent within this area.

Fig. 9. Image of wetland system 2 near road culvert.

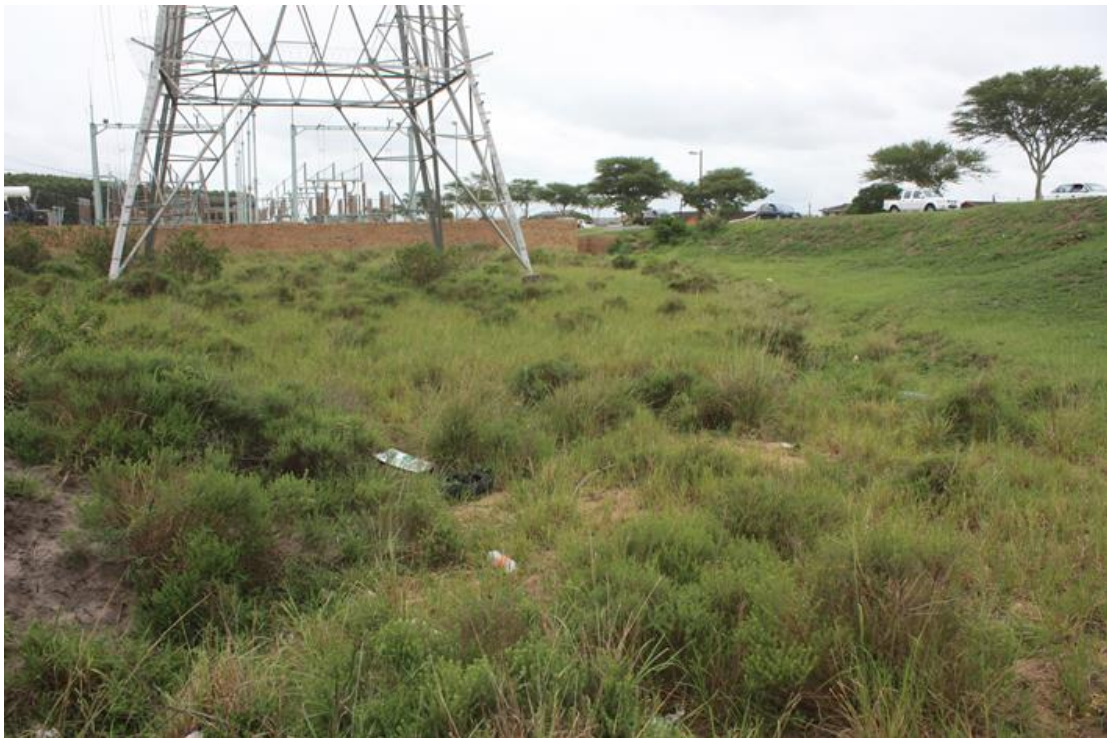
Wetland system 4. This wetland lies on the western side of the R619, opposite Via Fibrosa interchange. This particular wetland system has been subject to extensive transformation, including the establishment of a large electrical substation complex as well as apparent ongoing excavation and disturbance. (Fig 10).

Fig. 10. Image of wetland system 4, with substation in background.

This wetland system was, prior to the construction of the R619 and the urban settlement of Aquadene, part of the upper catchment of the Nkoninkha River, which feeds into the Mzingazi lake. Urban development has however severed surface linkage between these two systems.

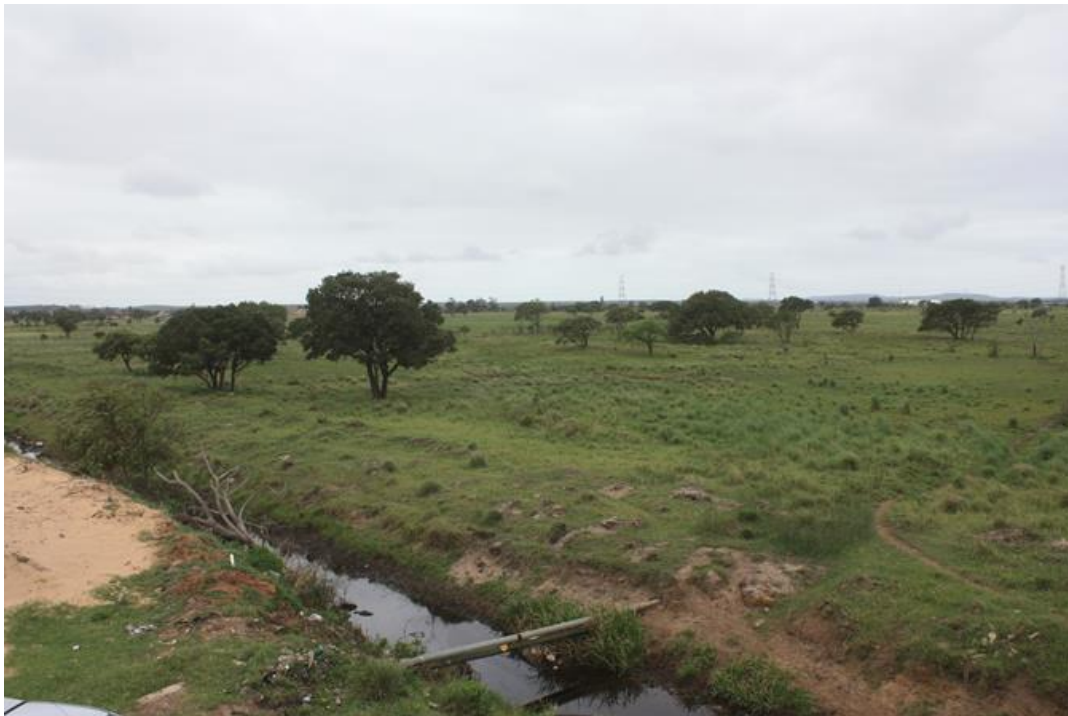
Wetland system 5. This wetland system comprises of a wide, level expanse of graminoid dominated endoreic depression which has been subject to extensive drainage in order to establish commercial / industrial development and prevent possible inundation of waters during high rainfall periods. (Fig. 11).

Fig. 11. View across wetland system 5. Note excavated drain in foreground.

The wetland system drainage pattern is in a westerly direction with the main excavated channel lying in or proximal, to the subsurface water table. The wetland is generally seasonal in nature, with only occasional facultative wetland species being present, however larger woody species, comprising primarily of *Syzigium cordatum* and *Acacia karoo* dominate across the system.

This system lies some 250m south west of the subject area and as such, is unlikely to be affected by the expansion of the R619.

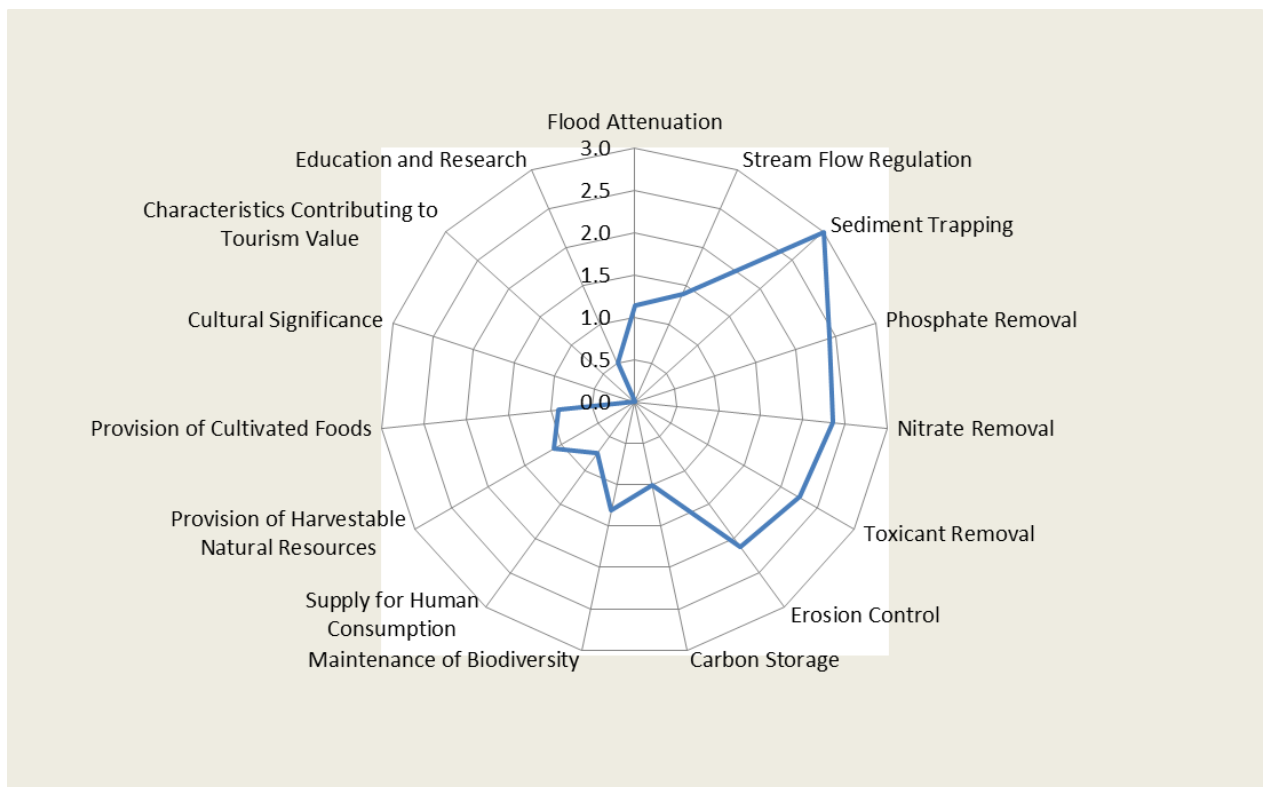
This system was considered to show the highest level of ecological services, this being related primarily to sediment trapping and nitrate - toxicant removal, however most other identified services are limited (Fig. 12). The highly transformed nature of the system and the generally low score of 1.35 identifies this system as having an intermediate level of function of the three systems evaluated.

Fig. 12. Graph indicating functional score across eco-service suite for Wetland 1

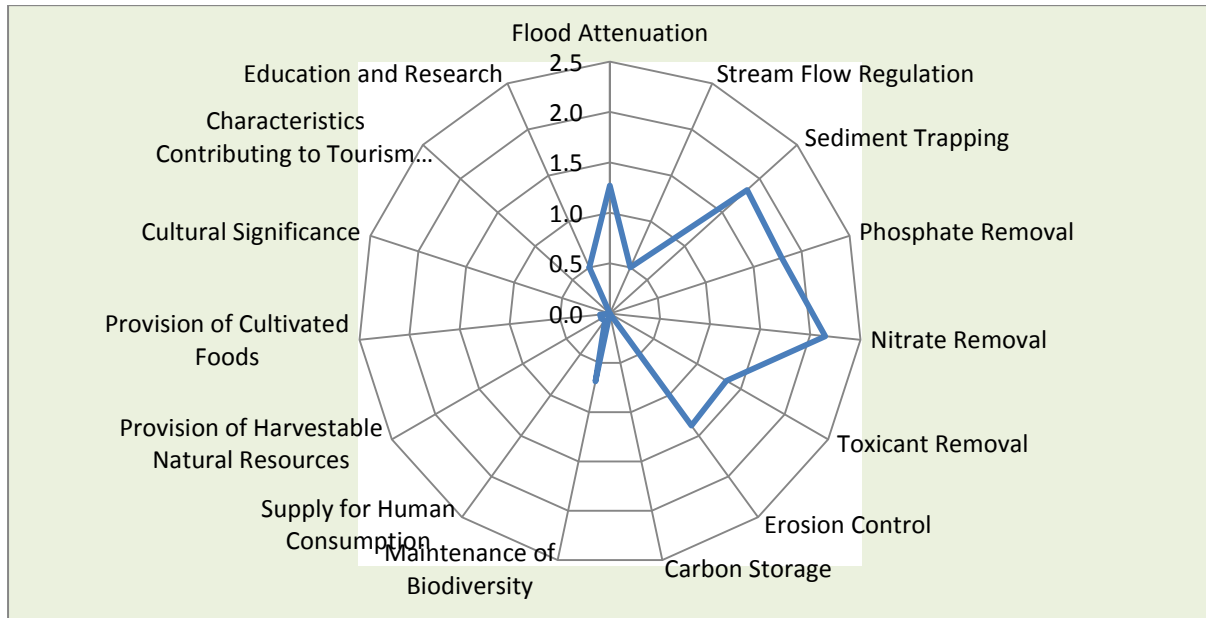
This highly disturbed system, which is tenuously linked with wetland 4 through the establishment of a stormwater drain shows a “moderately low” functional state. As per wetland 2, the removal of

nitrates and other chemical species from inundating waters is the primary driver of this increased state of function. Some flood attenuation function, on account of the engineered aspects applied to this system, are also offered by this wetland. It is suggested that this score is higher than should be applied to such system, particularly if the ongoing management of the drainage system is considered.

Fig 13 Graph indicating functional score across eco-service suite for Wetland 3.

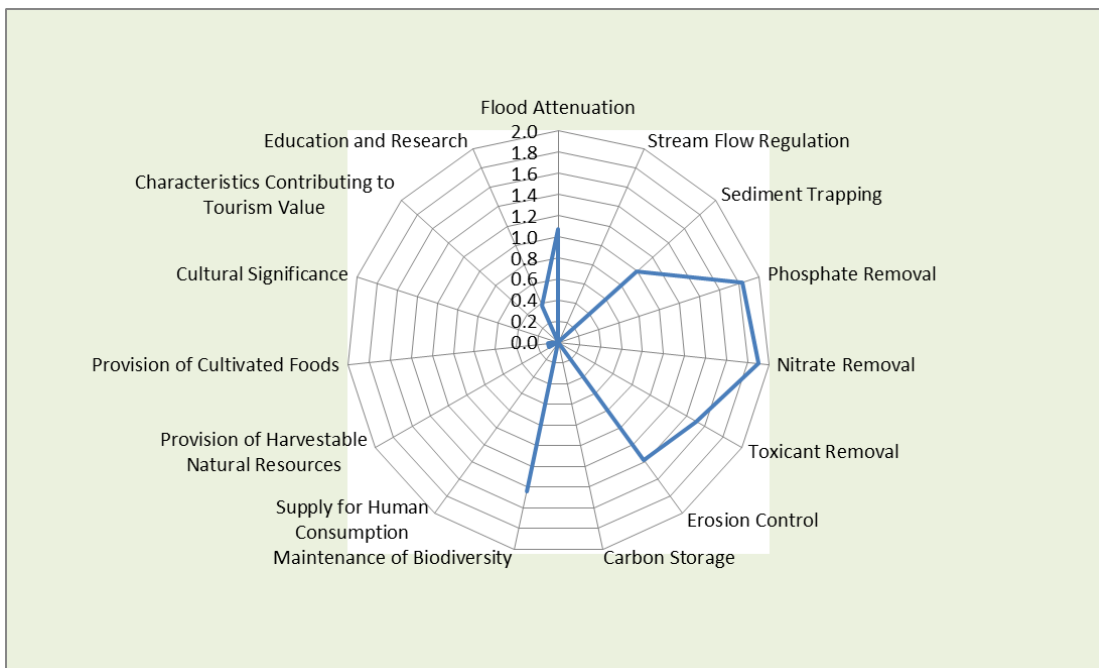
The wetland functionality status of wetland 4 identifies a *moderately low* functional system, with toxicant removal and erosion control being considered the highest scoring service categories in this wetland. The wetland is however, subject to ongoing disturbance, on account of the continued infilling and dumping of material. In addition the establishment of infrastructure and services in this area, have served to reduce the extent of the wetland system. It is suggested that the ecological and environmental services offered by this wetland are over-emphasised in this evaluation method

Fig. 15. Graph indicating functional score across eco-service suite for Wetland 3
