## **WORKING FOR WETLANDS REHABILITATION PROGRAMME, KWAZULU-NATAL**

### **REHABILITATION PLAN PROJECT: ISIMANGALISO**

**W32H**

**REHABILITATION PLAN FOR THE ISIMANGALISO PROJECT,  
KWAZULU-NATAL PLANNING YEAR 2018/2019  
AS PART OF  
THE WORKING FOR WETLANDS PROGRAMME  
FOR THE  
DEPARTMENT OF ENVIRONMENTAL AFFAIRS  
DIRECTORATE: WORKING FOR WETLANDS**

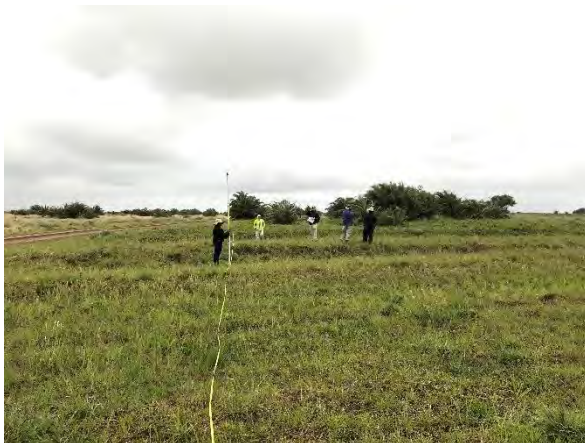
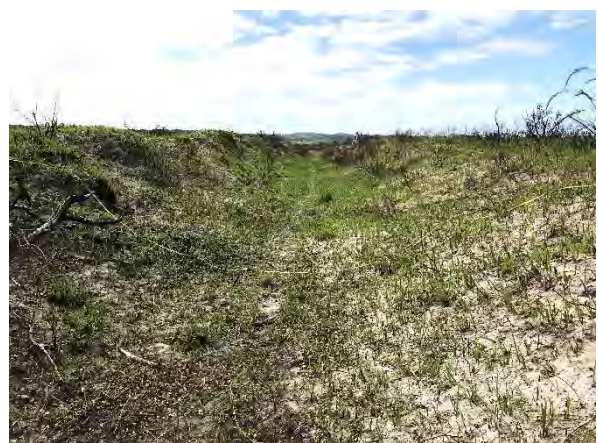
**Plate 7 and Plate 8: Drains and associated fill-berms on either side of forestry road embankments, exacerbating the interception of natural flow and disruption of wetland functioning caused by the roads.**

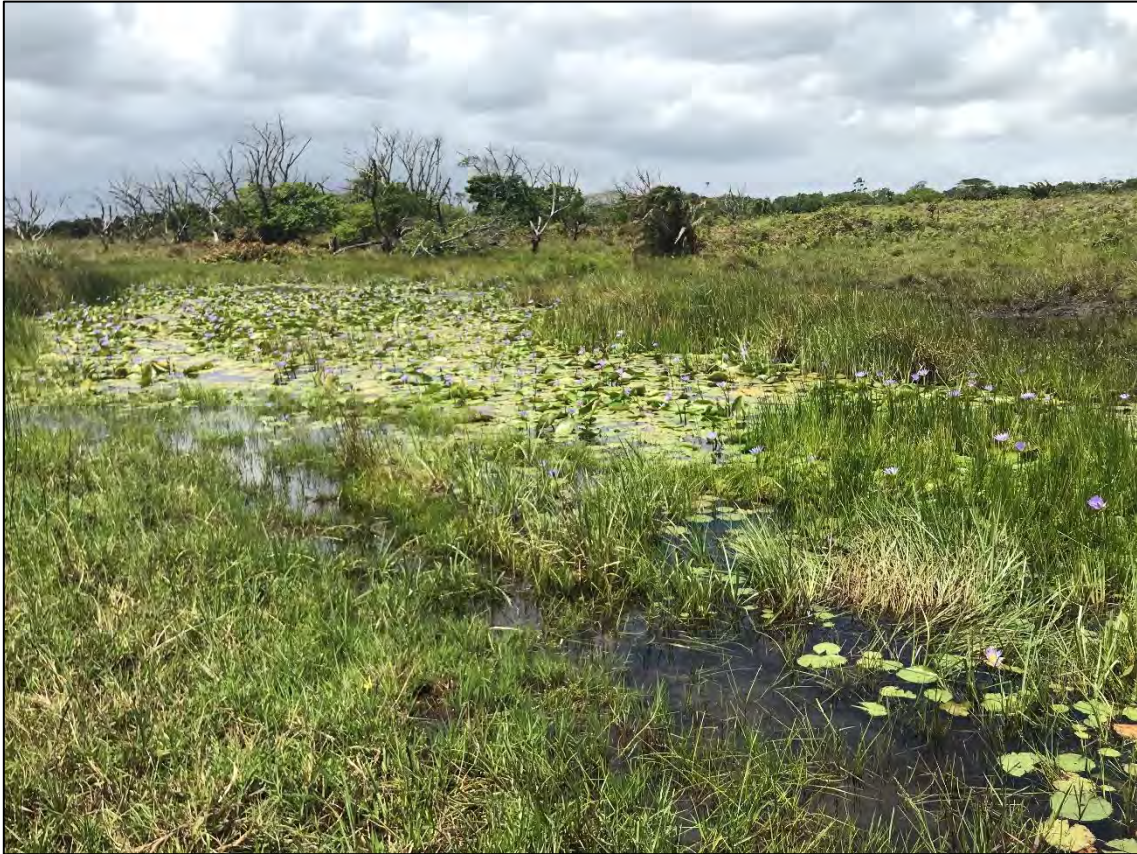
**Figure 4.8** Photographic evidence of damming on the upstream side of old forestry road

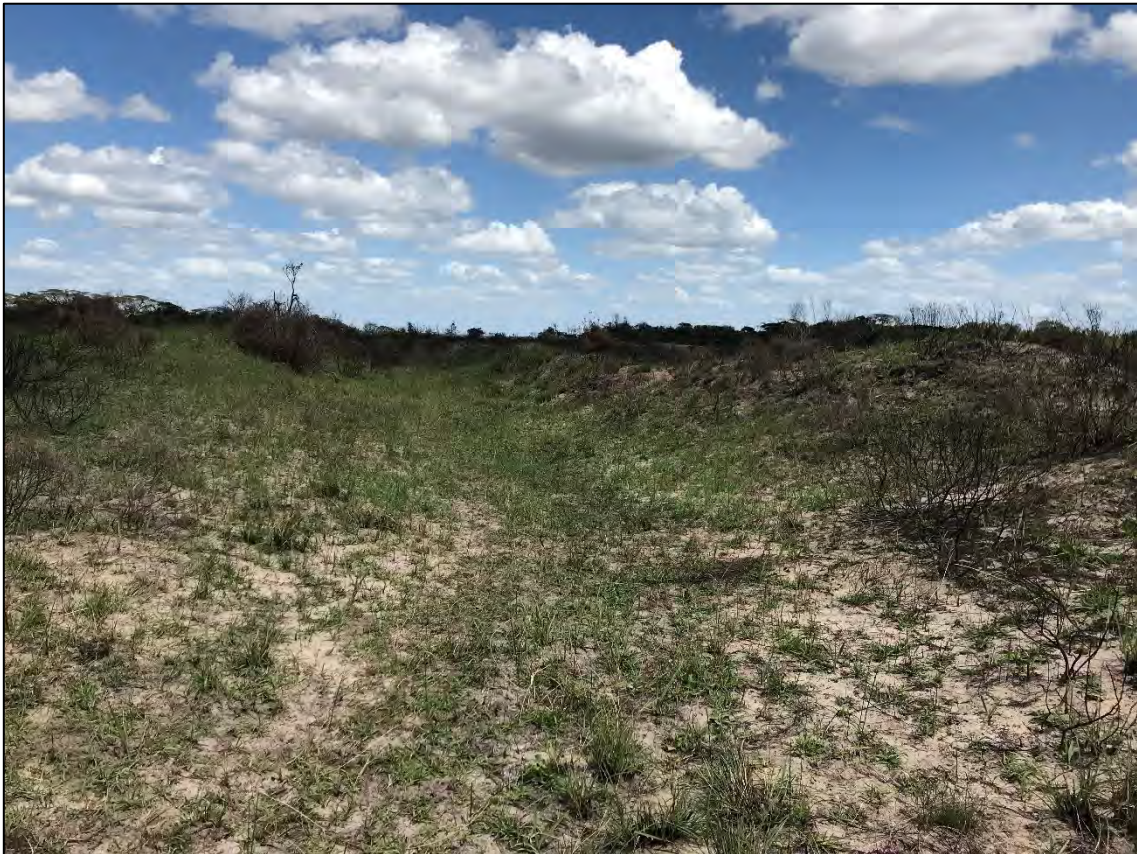
**Figure 4.15** Photographic evidence of the excavated drain and the spoil deposits running along either side of the drain.

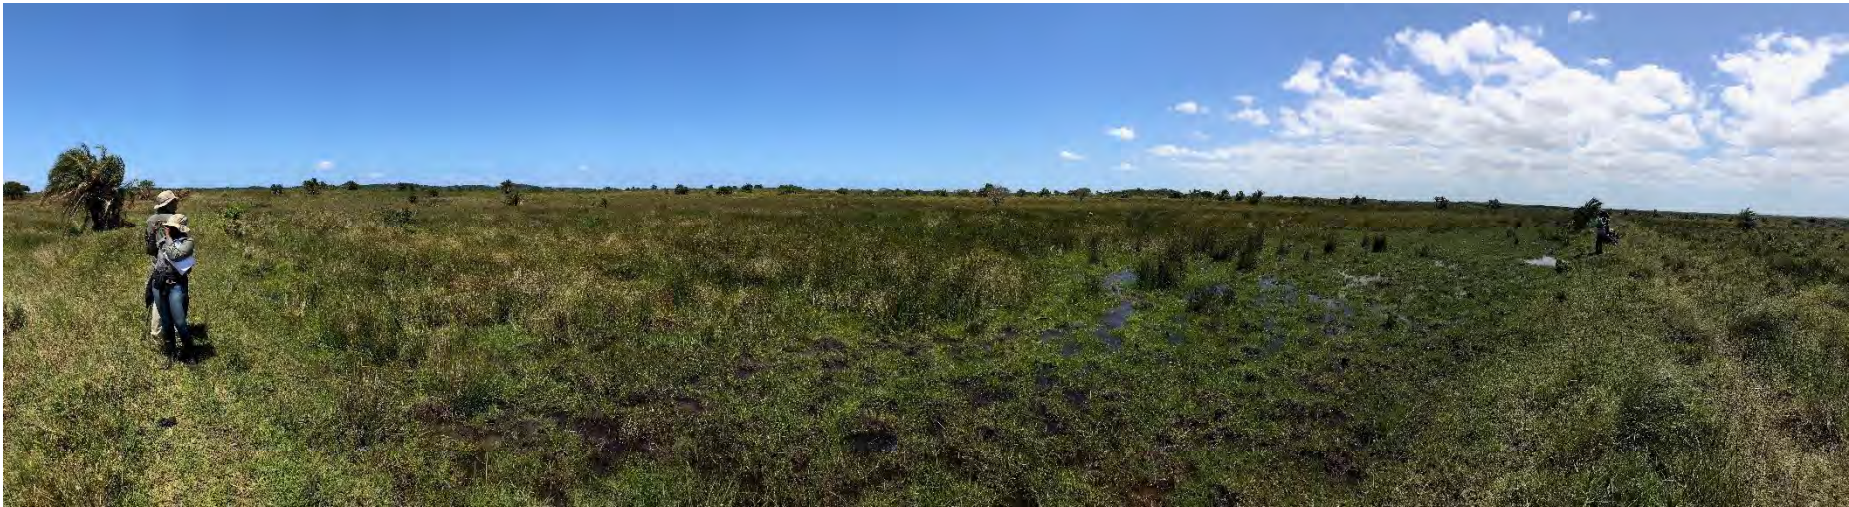
**Figure 4.17 Photographic evidence of the extent of damming that occurs behind roads within Wetland 13 (W32H-13)**

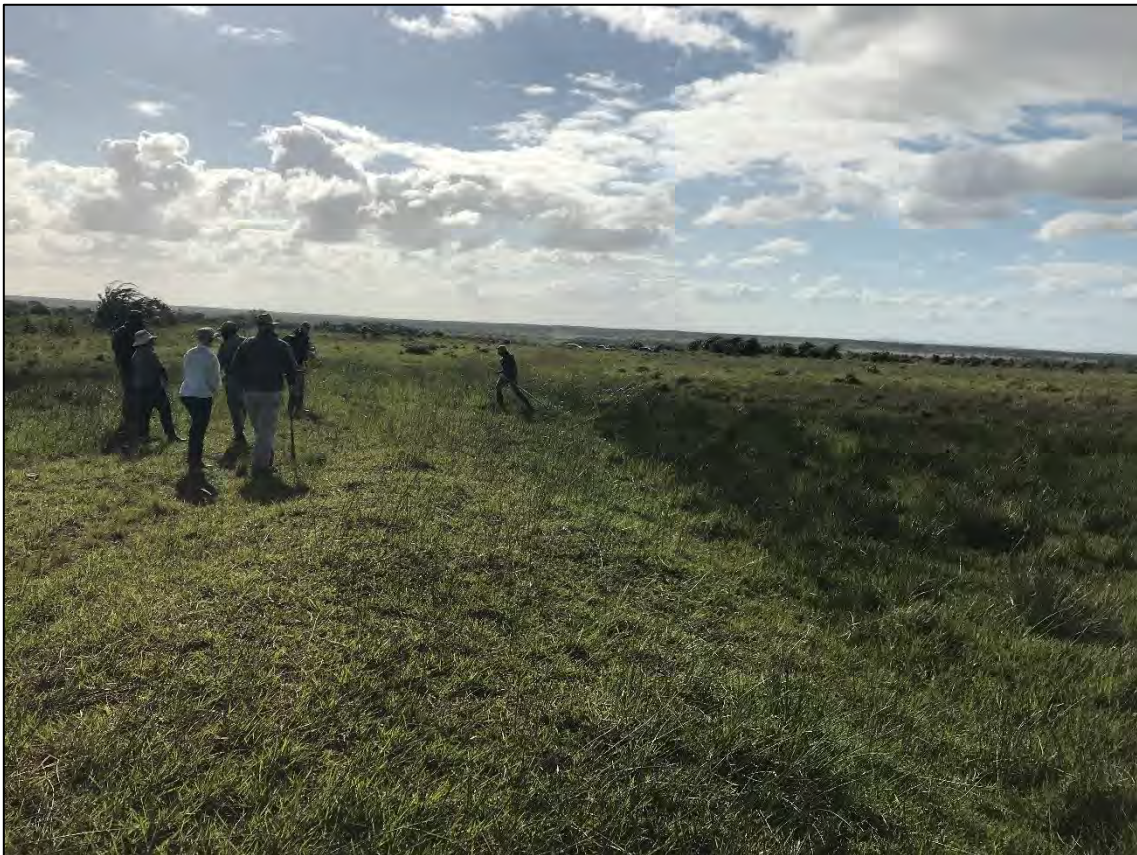
**Figure 1.3** Photographic evidence of road interrupting natural flows in wetland. Area to the right of the road is the hillslope seep and area to the left (outside frame) is the bowl shaped wetland area.

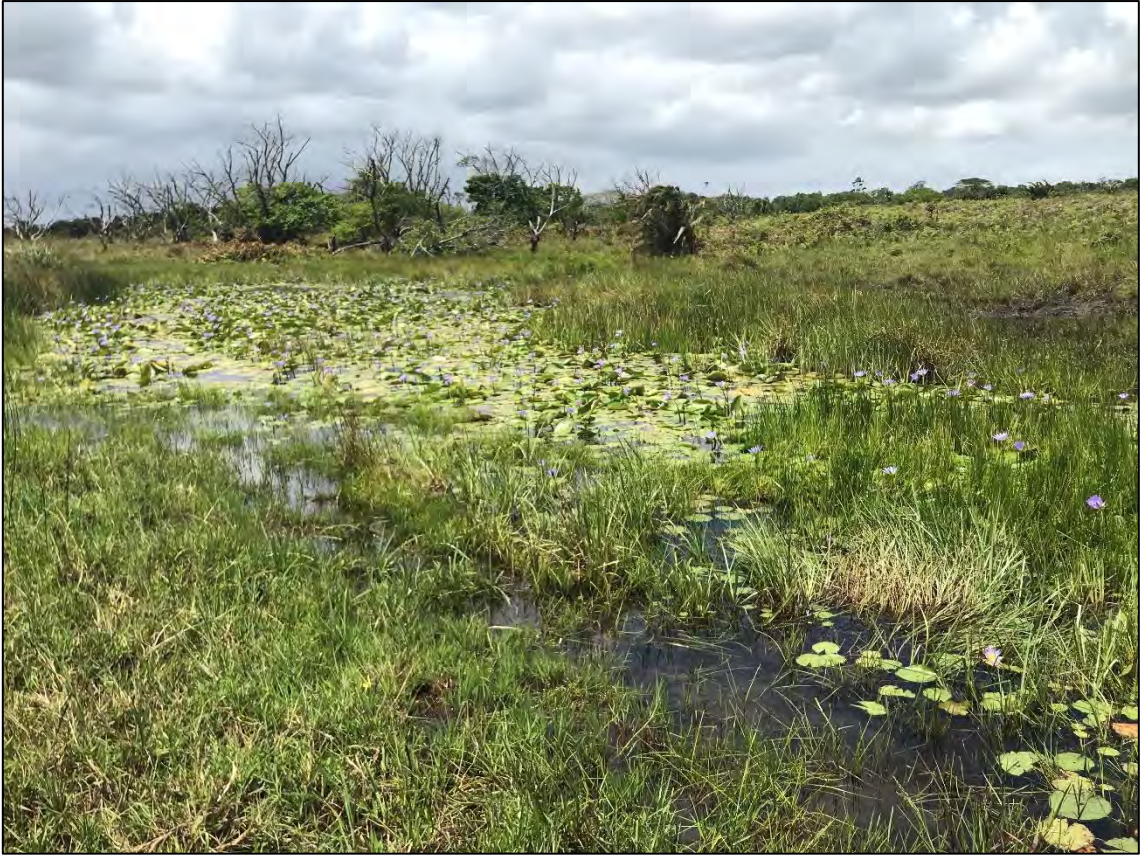
**Figure 1.8 Photographic evidence of damming on upstream side of old forestry road**

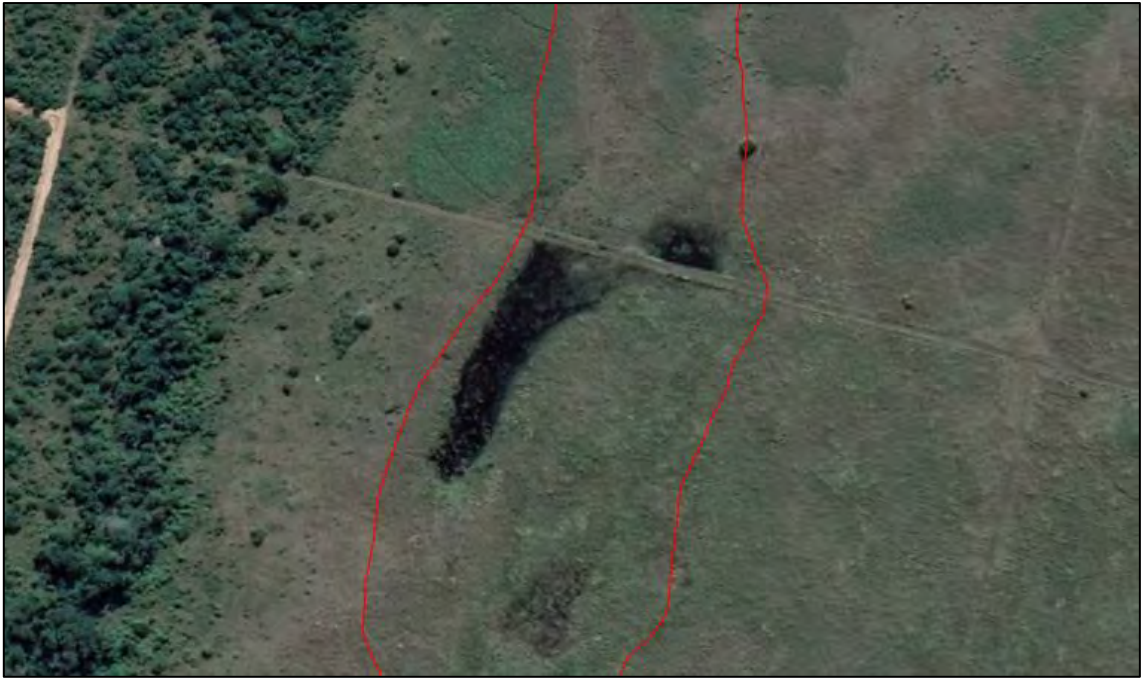
**Figure 1.12 - 2017 Google Earth satellite imagery showing disruptions to hydrological flows in wetland during wet season.**

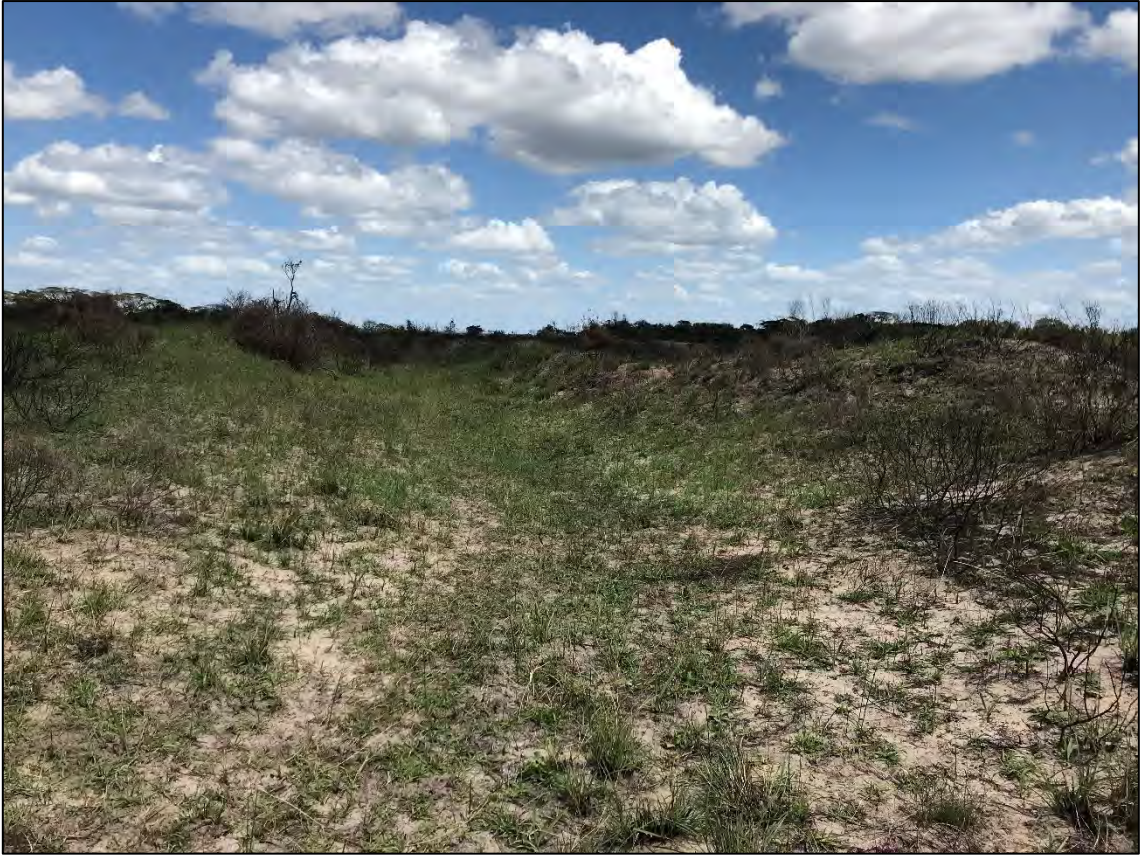
**Figure 1.17 Photographic evidence of the excavated drain and the spoil deposits running along either side of the drain.**
