**GINGINDLOVU: SOUTH AFRICAN POLICE SERVICES: PROJECT FIVE STAR: UPGRADING OF POLICE CELLS AND COMPLETE REPAIRS AND RENOVATIONS TO STATION: APPLICATION FOR THE DEMOLITION OF STATE OWNED BUILDINGS: UPDATED FROM 2012**

**DEPARTMENT OF PUBLIC WORKS  
PROPERTY DEVELOPMENT  
DEMOLITION OF STATE OWNED BUILDINGS**

**PROJECT: GINGINDLOVU: SOUTH AFRICAN POLICE SERVICES: PROJECT FIVE STAR:  
UPGRADING OF POLICE AND COMPLETE REPAIRS AND RENOVATIONS TO  
STATION**

Please find enclosed the application for the demolition of the Buildings # 1 - # 13

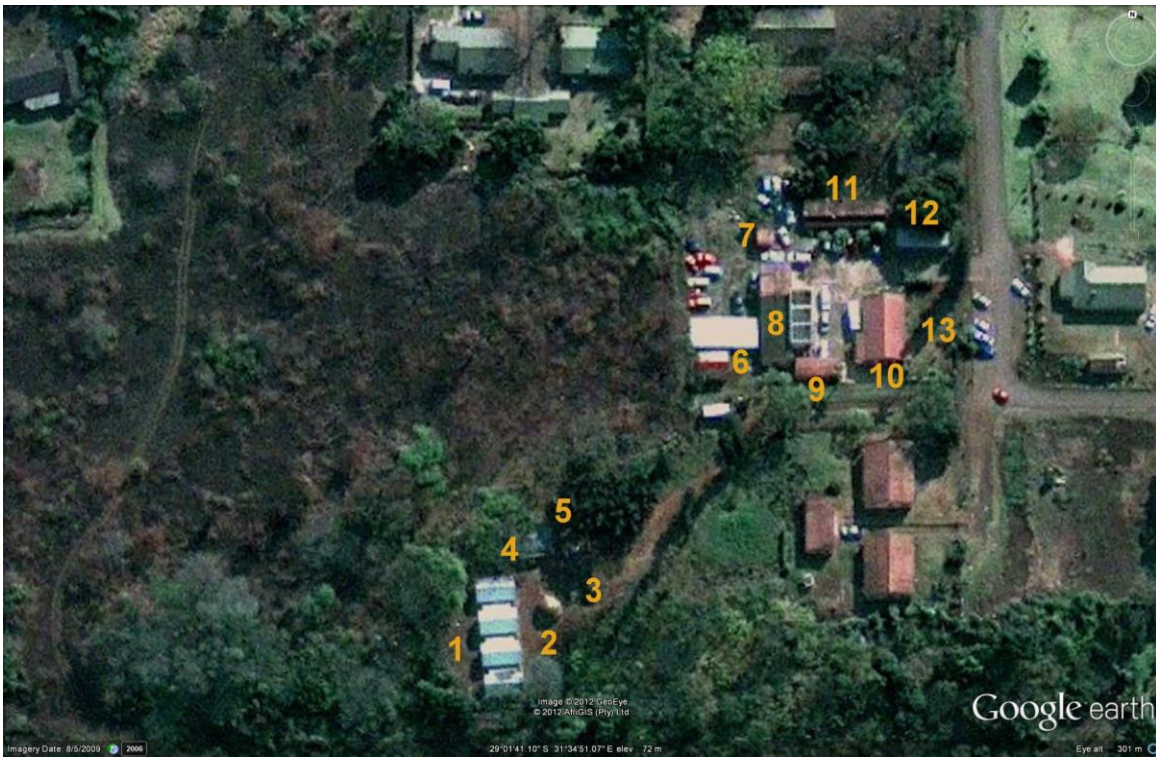
Google Earth Imagery (buildings to be demolished indicated)

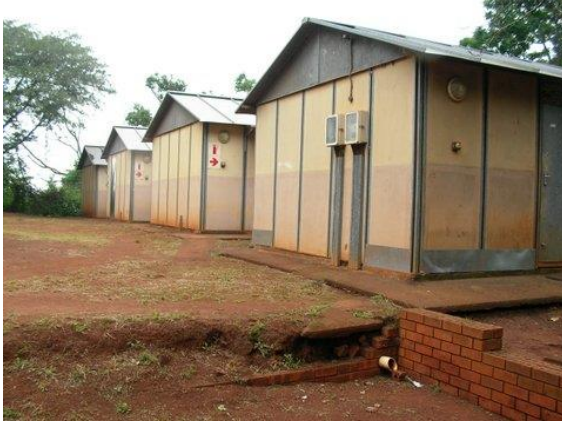
**BUILDING(S) # 1**

**Details:** Type: 4 Prefabricated structures  
 Address: Foxon Street, Gingindlovu  
 No. of floors: Single storey  
 Total area of building(s): 4 units x 39.31m<sup>2</sup> = 157.24m<sup>2</sup>  
 Total area of land: 3,7108 ha  
 Utilization: Single staff quarters  
 Current status: Occupied

Reasons for demolition	Earmarked for demolition as per SAPS Needs Assessment document. These units are to be replaced with 20 new single staff quarters as per SAPS requirements.
Present value of building(s)	R268 789
Present market value of building(s)	R67 196
Present market value of land:	N/A – Government Land
Present replacement value of building(s)	R1 415 160
Estimated cost of repair of building(s)	Irreparable
Present value of material to be recovered	R10 000
Manner in which recovered material will be disposed	By contractor appropriately
Can land and building(s) be sold by auction	N/A – Government Land
Is land needed for other purposes	Yes - New SAPS Facility to be provided
Will some other building(s) be erected on land	Yes
Can building(s) perhaps be utilised for some purposes	No
Estimated age	Less than 60 years
Confirmation that funds are available for demolition	WCS 035880
Who will carry out demolition work	Recommended contractor by tender process

Estimated cost of demolition	R40 000.00
Demolition by implosion / use of explosives	No
Implosion / explosive guidelines to be complied with.	N/A

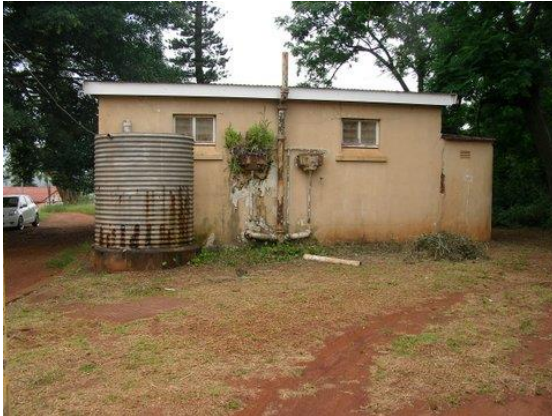
**BUILDING(S) # 3**

**Details:** Type: Brick with asbestos roof sheeting  
 Address: Foxon Street, Gingindlovu  
 No. of floors: Single storey  
 Total area of building(s): 27.09m<sup>2</sup>  
 Total area of land: 3,7108 ha  
 Utilization: Ablution  
 Current status: Unoccupied

Reasons for demolition	Earmarked for demolition as per SAPS Needs Assessment document. Building not in use.
Present value of building(s)	R101 271
Present market value of building(s)	R88 612
Present market value of land:	N/A – Government Land
Present replacement value of building(s)	R190 000
Estimated cost of repair of building(s)	R108 360
Present value of material to be recovered	R10 000
Manner in which recovered material will be disposed	By contractor appropriately
Can land and building(s) be sold by auction	N/A – Government Land
Is land needed for other purposes	Yes - New SAPS Facility to be provided
Will some other building(s) be erected on land	Yes
Can building(s) perhaps be utilised for some purposes	No
Estimated age	Circa 40 years – not significant – under 60 years therefore exempt from heritage application.
Confirmation that funds are available for demolition	WCS 035880
Who will carry out demolition work	Recommended contractor by tender process

Estimated cost of demolition	R25 000 (including asbestos removal)
Demolition by implosion / use of explosives	No
Implosion / explosive guidelines to be complied with.	N/A

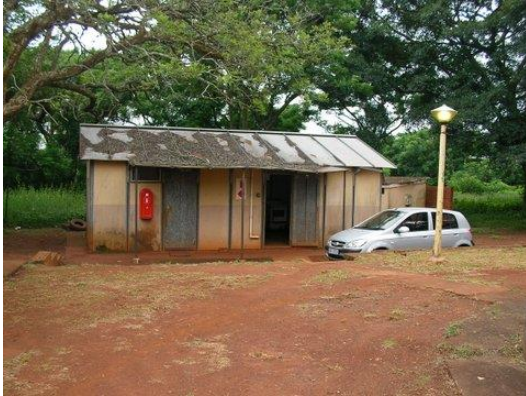
**BUILDING(S) # 4**

**Details:** Type: Prefabricated structure  
 Address: Foxon Street, Gingindlovu  
 No. of floors: Single storey  
 Total area of building(s): 38.67m<sup>2</sup>  
 Total area of land: 3,7108 ha  
 Utilization: Ablution  
 Current status: Occupied

Reasons for demolition	Earmarked for demolition as per SAPS Needs Assessment document. New single staff quarters will include ablution facilities as per SAPS requirements.
Present value of building(s)	R72 280
Present market value of building(s)	R105 463
Present market value of land:	N/A – Government Land
Present replacement value of building(s)	R309 360
Estimated cost of repair of building(s)	Irreparable
Present value of material to be recovered	R5 000
Manner in which recovered material will be disposed	By contractor appropriately
Can land and building(s) be sold by auction	N/A – Government Land
Is land needed for other purposes	No
Will some other building(s) be erected on land	No
Can building(s) perhaps be utilised for some purposes	No
Estimated age	Less than 60 years
Confirmation that funds are available for demolition	WCS 035880
Who will carry out demolition work	Recommended contractor by tender process

Estimated cost of demolition	R10 000
Demolition by implosion / use of explosives	No
Implosion / explosive guidelines to be complied with.	N/A

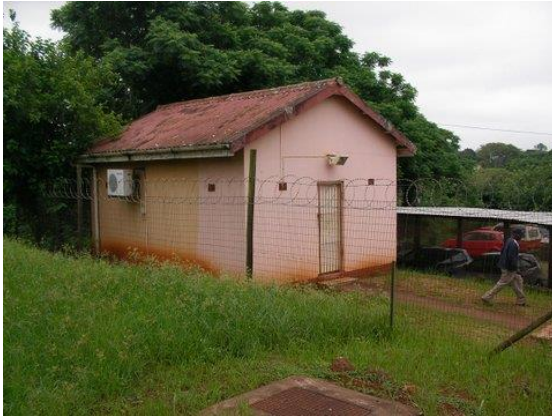
**BUILDING(S) # 6**

**Details:** Type: Brick with asbestos roof sheeting  
 Address: Foxon Street, Gingindlovu  
 No. of floors: Single storey  
 Total area of building(s): 33.14m<sup>2</sup>  
 Total area of land: 3,7108 ha  
 Utilization: Docket Filing Room  
 Current status: Occupied

Reasons for demolition	Earmarked for demolition as per SAPS Needs Assessment document. A new docket storing facility will be accommodated in the new CSC building as per SAPS requirements.
Present value of building(s)	R92 915
Present market value of building(s)	R77 429
Present market value of land:	N/A – Government Land
Present replacement value of building(s)	R265 120
Estimated cost of repair of building(s)	R132 560
Present value of material to be recovered	R5 000
Manner in which recovered material will be disposed	By contractor appropriately
Can land and building(s) be sold by auction	N/A – Government Land
Is land needed for other purposes	Yes - New SAPS Facility to be provided
Will some other building(s) be erected on land	Yes
Can building(s) perhaps be utilised for some purposes	No
Estimated age	Circa 40 years - not significant – under 60 years therefore exempt from heritage application.
Confirmation that funds are available for demolition	WCS 035880

Who will carry out demolition work	Recommended contractor by tender process
Estimated cost of demolition	R20 000
Demolition by implosion / use of explosives	No
Implosion / explosive guidelines to be complied with.	N/A

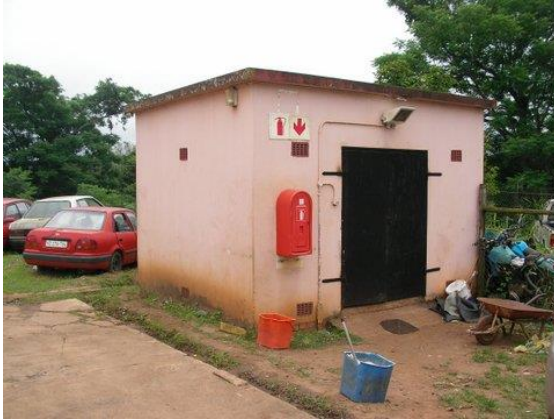
## BUILDING(S) # 7

<b>Details:</b>	Type:	Brick with concrete roof slab
	Address:	Foxon Street, Gingindlovu
	No. of floors:	Single storey
	Total area of building(s):	17.27m <sup>2</sup>
	Total area of land:	3,7108 ha
	Utilization:	Store
	Current status:	Occupied

Reasons for demolition	Earmarked for demolition as per SAPS Needs Assessment document. New and appropriate storing facilities will be accommodated in the new project as per SAPS requirements.
Present value of building(s)	R21 810
Present market value of building(s)	R15 000
Present market value of land:	N/A – Government Land
Present replacement value of building(s)	R60 445
Estimated cost of repair of building(s)	R29 080
Present value of material to be recovered	R2 000
Manner in which recovered material will be disposed	By contractor appropriately
Can land and building(s) be sold by auction	N/A – Government Land
Is land needed for other purposes	Yes - New SAPS Facility to be provided
Will some other building(s) be erected on land	Yes
Can building(s) perhaps be utilised for some purposes	No
Estimated age	Circa 40 years - not significant – under 60 years therefore exempt from heritage application. -
Confirmation that funds are available for demolition	WCS 035880

Who will carry out demolition work	Recommended contractor by tender process
Estimated cost of demolition	R10 000
Demolition by implosion / use of explosives	No
Implosion / explosive guidelines to be complied with.	N/A

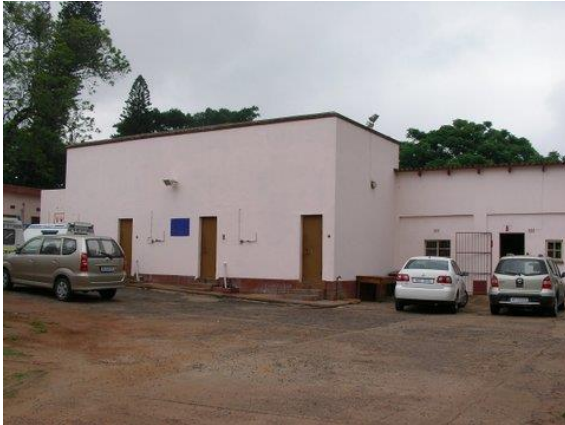
**BUILDING(S) # 8**

<b>Details:</b>	Type:	Brick, concrete roof slab and secured courtyards
	Address:	Foxon Street, Gingindlovu
	No. of floors:	Single storey
	Total area of building(s):	209.46m <sup>2</sup>
	Total area of land:	3,7108 ha
	Utilization:	Cell Block
	Current status:	Occupied

Reasons for demolition	Earmarked for demolition as per SAPS Needs Assessment document as it does not conform to Project 5 Star specifications. New Project 5 Star Cell Block to be erected.
Present value of building(s)	R783 028
Present market value of building(s)	R685 149
Present market value of land:	N/A – Government Land
Present replacement value of building(s)	R2 513 520
Estimated cost of repair of building(s)	R2 722 980
Present value of material to be recovered	R10 000
Manner in which recovered material will be disposed	By contractor appropriately
Can land and building(s) be sold by auction	N/A – Government Land
Is land needed for other purposes	Yes - New SAPS Facility to be provided
Will some other building(s) be erected on land	Yes
Can building(s) perhaps be utilised for some purposes	No
Estimated age	Circa 40 years - not significant – under 60 years therefore exempt from heritage application.
Confirmation that funds are available for demolition	WCS 035880

Who will carry out demolition work	Recommended contractor by tender process
Estimated cost of demolition	R55 000
Demolition by implosion / use of explosives	No
Implosion / explosive guidelines to be complied with.	N/A

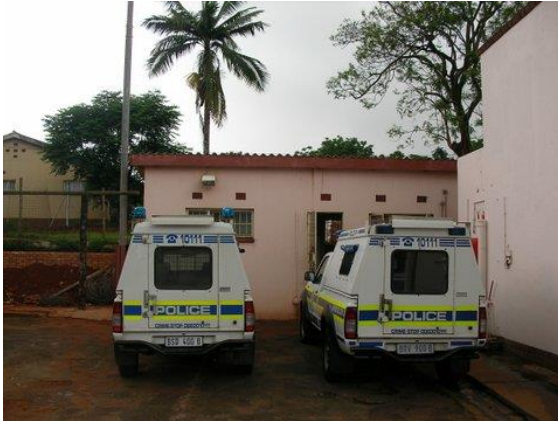
## BUILDING(S) # 9

<b>Details:</b>	Type:	Brick with asbestos roof sheeting
	Address:	Foxon Street, Gingindlovu
	No. of floors:	Single storey
	Total area of building(s):	35.33m <sup>2</sup>
	Total area of land:	3,7108 ha
	Utilization:	Kitchen serving Cell Block + Staff Toilets
	Current status:	Occupied

Reasons for demolition	Earmarked for demolition as per SAPS Needs Assessment document. A new kitchen facility servicing detainees will be accommodated in the new Project 5 Star Cell Block.
Present value of building(s)	R132 074
Present market value of building(s)	R123 655
Present market value of land:	N/A – Government Land
Present replacement value of building(s)	R335 635
Estimated cost of repair of building(s)	R247 310
Present value of material to be recovered	R5 000
Manner in which recovered material will be disposed	By contractor appropriately
Can land and building(s) be sold by auction	N/A – Government Land
Is land needed for other purposes	Yes - New SAPS Facility to be provided
Will some other building(s) be erected on land	Yes
Can building(s) perhaps be utilised for some purposes	No
Estimated age	Circa 40 years - not significant – under 60 years therefore exempt from heritage application.
Confirmation that funds are available for demolition	WCS 035880

Who will carry out demolition work	Recommended contractor by tender process
Estimated cost of demolition	R20 000
Demolition by implosion / use of explosives	No
Implosion / explosive guidelines to be complied with.	N/A

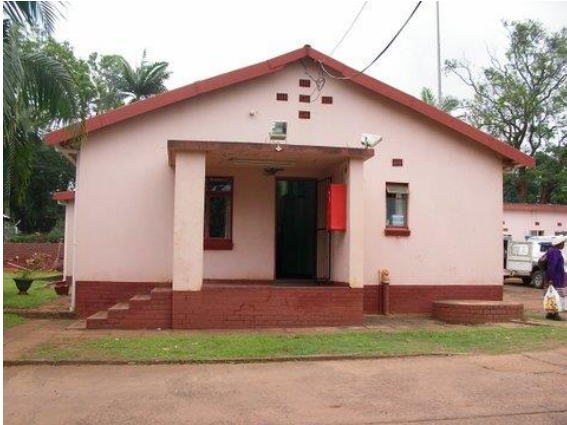
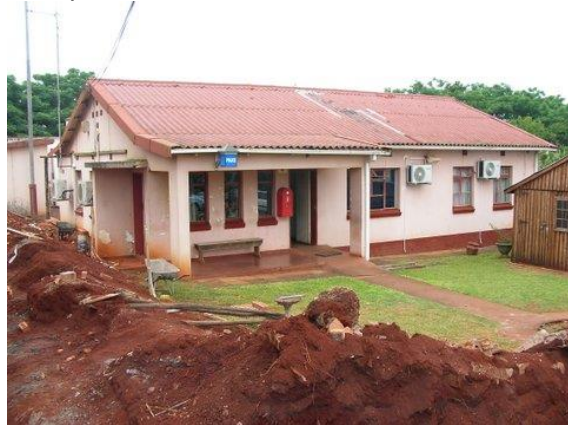
**BUILDING(S) # 10**

Type: Brick with asbestos roof sheeting  
Address: Foxon Street, Gingindlovu  
No. of floors: Single storey  
Total area of building(s): 133.33m<sup>2</sup>  
Total area of land: 3,7108 ha  
Utilization: Community Service Centre (CSC)  
Current status: Occupied

Reasons for demolition	<ul style="list-style-type: none"> <li>• Condition: Sub-standard and overcrowded</li> <li>• CSC is currently accommodated in a dwelling</li> <li>• Current layout cannot accommodate SAPS needs.</li> <li>• Conversion impractical due to the following reasons: <ul style="list-style-type: none"> <li>• all internal walls to be removed</li> <li>• windows positions altered</li> <li>• roof to be replaced</li> <li>• plastered external walls not fitting overall aesthetic value of project and proposed general facebrick finish</li> <li>• negative impact on planning and functional circulation</li> </ul> </li> </ul>
Present value of building(s)	R560 733
Present market value of building(s)	R733 315
Present market value of land:	N/A – Government Land
Present replacement value of building(s)	R1 199 970
Estimated cost of repair of building(s)	R399 990
Present value of material to be recovered	R15 000

Manner in which recovered material will be disposed	By contractor appropriately
Can land and building(s) be sold by auction	N/A – Government Land
Is land needed for other purposes	Yes - New SAPS Facility to be provided
Will some other building(s) be erected on land	Yes
Can building(s) perhaps be utilised for some purposes	No
Estimated age	Circa 40 years - not significant – under 60 years therefore exempt from heritage application.
Confirmation that funds are available for demolition	WCS 035880
Who will carry out demolition work	Recommended contractor by tender process
Estimated cost of demolition	R50 000
Demolition by implosion / use of explosives	No
Implosion / explosive guidelines to be complied with.	N/A

There are only two buildings which have not been earmarked for demolition as per SAPS Needs Assessment document ,namely; The CSC and Office Blocks (Above referred to as buildings # 10 & # 11). Their position, condition and planning relationships are not suitable or viable for their incorporation or retention in the new project design.

- The new CSC and Administration block is a double storey structure over the current Building # 10.
- The position of the new Cell Block and the planning/flow relationship to the new CSC, Administration Block and adjacent property's Magistrates Court is critical thus making Building # 11 unsuitable to retain.
- The site slopes towards the west away from the proposed new facility therefore positioning of new buildings elsewhere on the site would not be cost effective and appropriate for the smooth functioning of the police station.

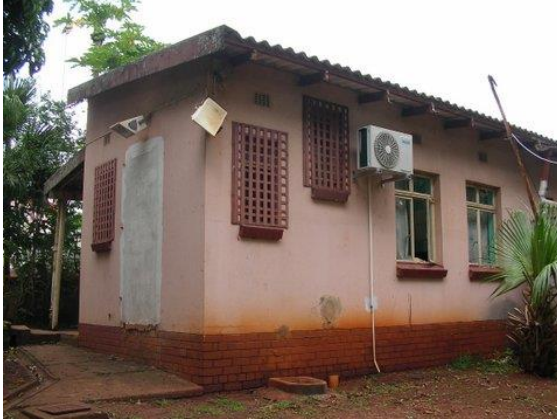
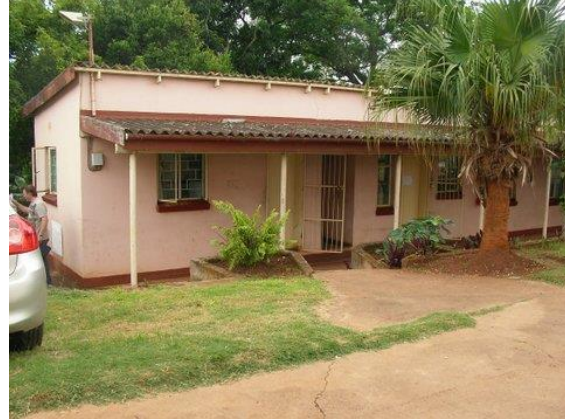
**BUILDING(S) # 11**

Type: Brick with asbestos roof sheeting  
Address: Foxon Street, Gingindlovu  
No. of floors: Single storey  
Total area of building(s): 66.66m<sup>2</sup>  
Total area of land: 3,7108 ha  
Utilization: Office Block  
Current status: Partially occupied

Reasons for demolition	<ul style="list-style-type: none"> <li>• Condition: sub-standard</li> <li>• Office block currently accommodated in an outbuilding</li> <li>• Current layout cannot accommodate SAPS needs both in size and planning</li> <li>• Existing position on site impacts negatively with accommodation and circulation planning of other facilities as per SAPS requirements</li> </ul>
Present value of building(s)	R280 345
Present market value of building(s)	R399 960
Present market value of land:	N/A – Government Land
Present replacement value of building(s)	R599 940
Estimated cost of repair of building(s)	R199 980
Present value of material to be recovered	R5 000
Manner in which recovered material will be disposed	By contractor appropriately
Can land and building(s) be sold by auction	N/A – Government Land
Is land needed for other purposes	Yes - New SAPS Facility to be provided
Will some other building(s) be erected on land	Yes

Can building(s) perhaps be utilised for some purposes	No
Estimated age	Circa 40 years - not significant – under 60 years therefore exempt from heritage application.
Confirmation that funds are available for demolition	WCS 035880
Who will carry out demolition work	Recommended contractor by tender process
Estimated cost of demolition	R20 000
Demolition by implosion / use of explosives	No
Implosion / explosive guidelines to be complied with.	N/A

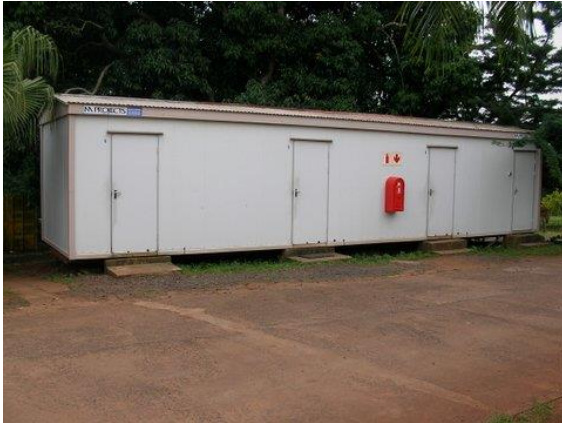
## BUILDING(S) # 12

<b>Details:</b>	Type:	Prefabricated mobile structure
	Address:	Foxon Street, Gingindlovu
	No. of floors:	Single storey
	Total area of building(s):	37.48m <sup>2</sup>
	Total area of land:	3,7108 ha
	Utilization:	Offices for Investigators
	Current status:	Occupied

Reasons for demolition	Earmarked for removal/demolition as per SAPS requirements
Present value of building(s)	R72 076
Present market value of building(s)	R18 740
Present market value of land:	N/A – Government Land
Present replacement value of building(s)	R262 360
Estimated cost of repair of building(s)	Irreparable
Present value of material to be recovered	R5 000
Manner in which recovered material will be disposed	By contractor appropriately
Can land and building(s) be sold by auction	N/A – Government Land
Is land needed for other purposes	Yes - New SAPS Facility to be provided
Will some other building(s) be erected on land	Yes
Can building(s) perhaps be utilised for some purposes	No
Estimated age	Recent
Confirmation that funds are available for demolition	WCS 035880
Who will carry out demolition work	Recommended contractor by tender process
Estimated cost of demolition	R10 000
Demolition by implosion / use of explosives	No
