91 BEREA PARK

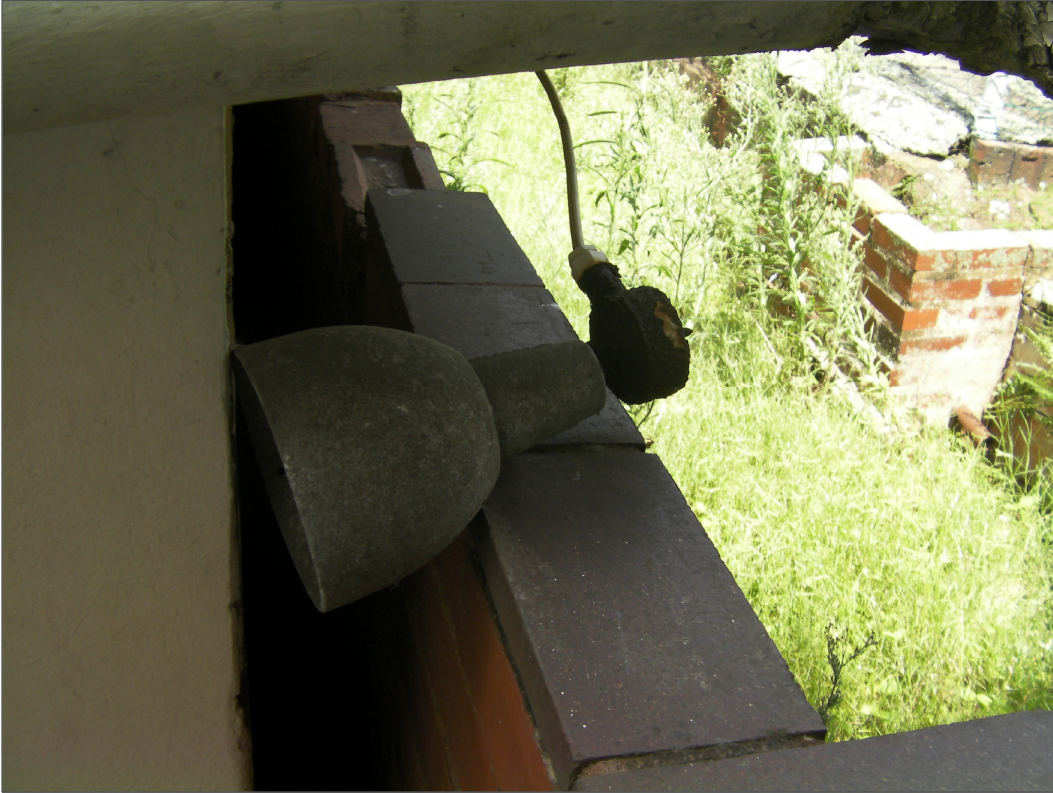
PHOTOGRAPH 19 -----VIEW OF LIGHT FITTING - HOUSING TO ELECTRICAL CONNECTION IS ALSO RUSTING AWAY - FITTING IS LYING LOOSE WITH SUB STANDARD CONNECTION (DANGEROUS)

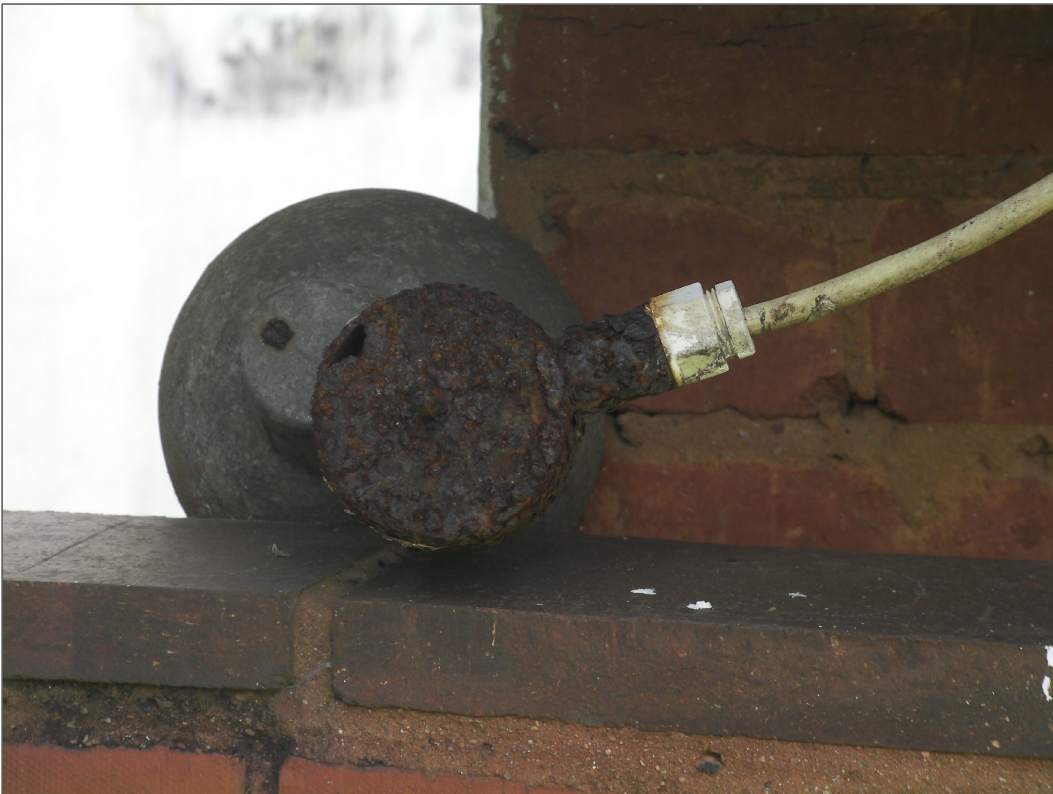
PHOTOGRAPH 20 -----VIEW OF LIGHT FITTING - HOUSING TO ELECTRICAL CONNECTION IS ALSO RUSTING AWAY - FITTING IS LYING LOOSE WITH SUB STANDARD CONNECTION (DANGEROUS)
