SIGNATURE
architectural studio

91 BEREA PARK

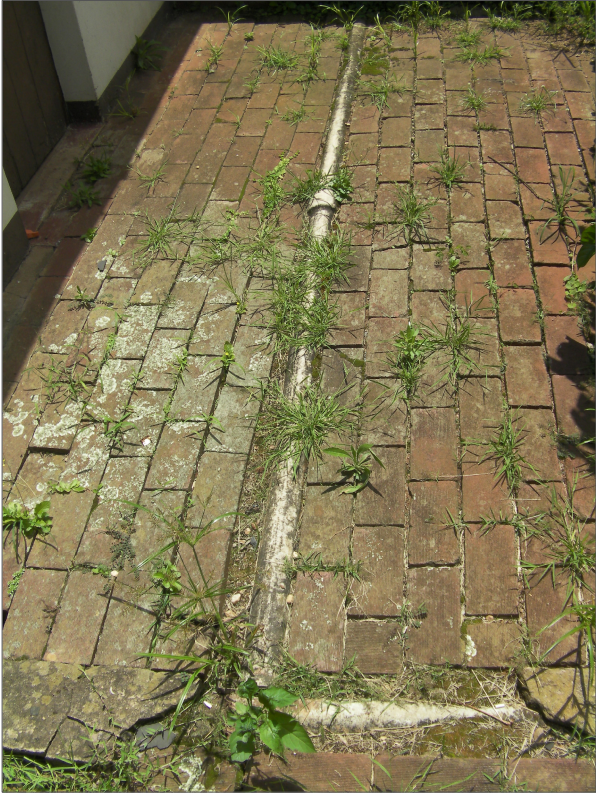
PHOTOGRAPH 21 ---- SEWER PIPE IS EXPOSED - LAID AT PAVING LEVEL WITH PIPE FALLING IN TWO DIFFERANT DIRECTIONS

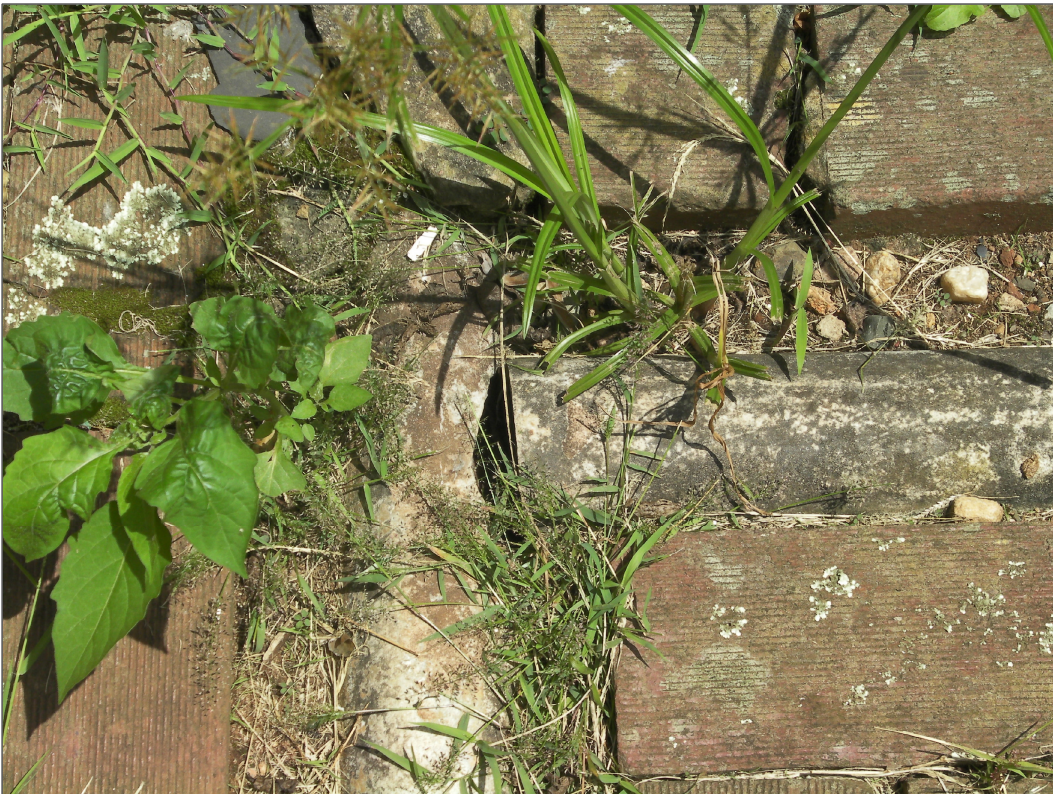
PHOTOGRAPH 22 ---- SEWER PIPE IS EXPOSED - CONNECTION BETWEEN TWO PIPES INCORRECT
THERE IS A HUG GAP THAT WILL ALLOW FOR THE SEWER TO LEAK ONTO THE PAVING
