**SIGNATURE**  
architectural studio

91 BEREA PARK

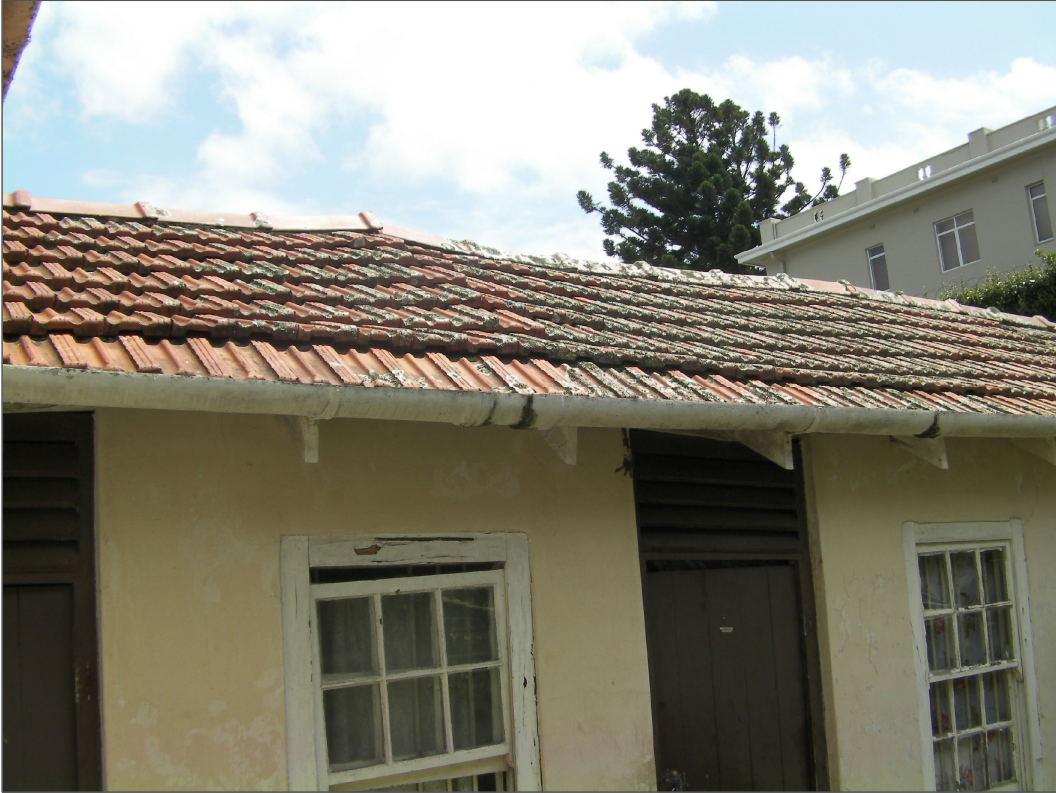
PHOTOGRAPH 23 ---- VIEW OF EXISTING MAIDS QUARTERS - ROOF STRUCTURE IS BORER INFESTED (ROOF TILES ARE BOWING)

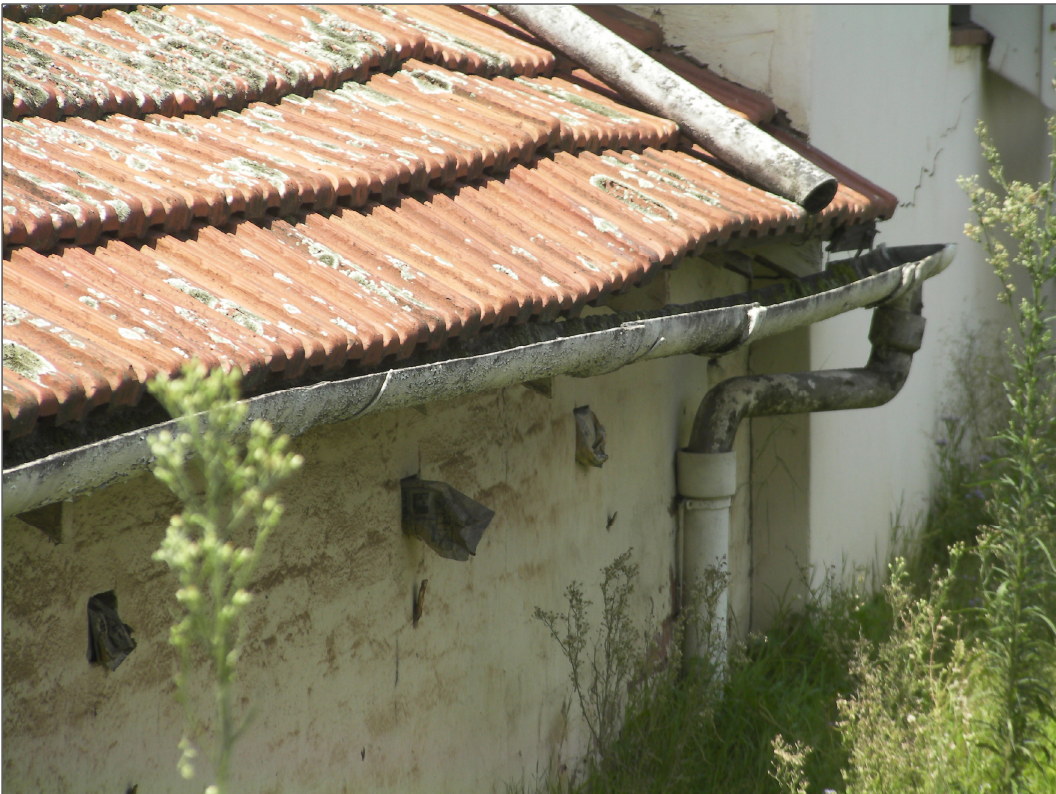
PHOTOGRAPH 24 ---- VIEW OF EXISTING MAIDS QUARTERS - ROOF STRUCTURE IS BORER INFESTED (ROOF TILES ARE BOWING & GUTTERS ARE FALLING OFF)
