91 BEREAS PARK

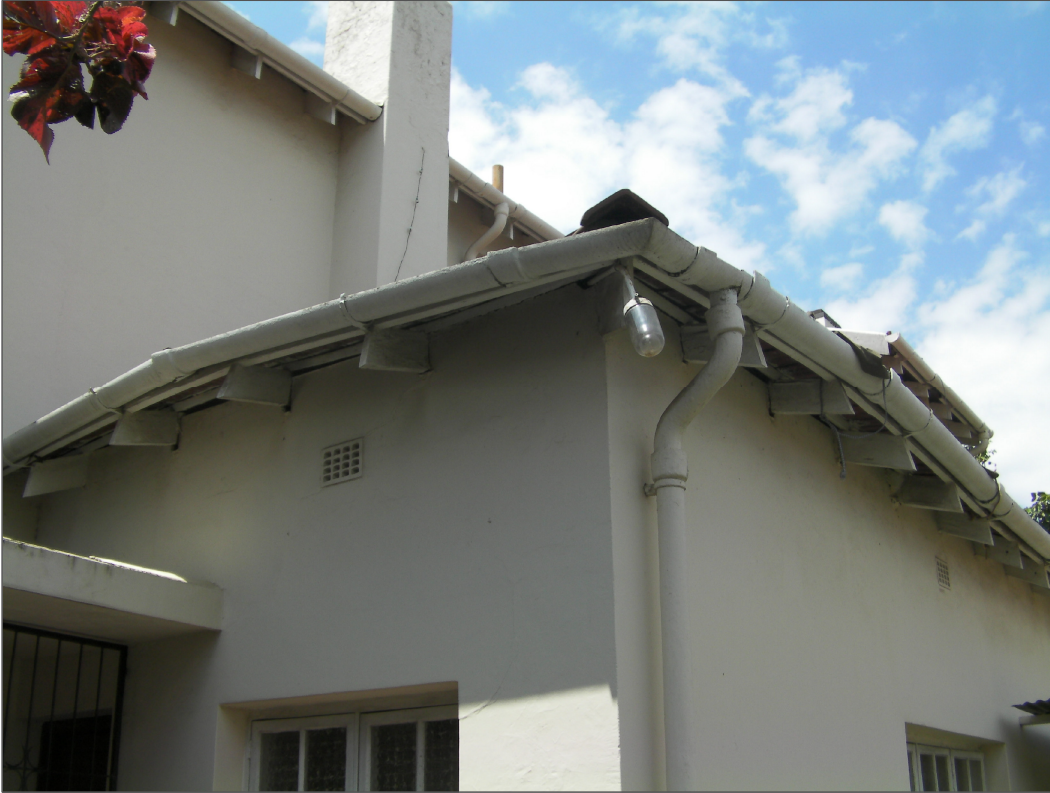
PHOTOGRAPH 15 ----- VIEW OF EXISTING ROOF THAT HAS FALLEN IN
(REFER TO PHOTO BELOW FOR TOP VIEW)

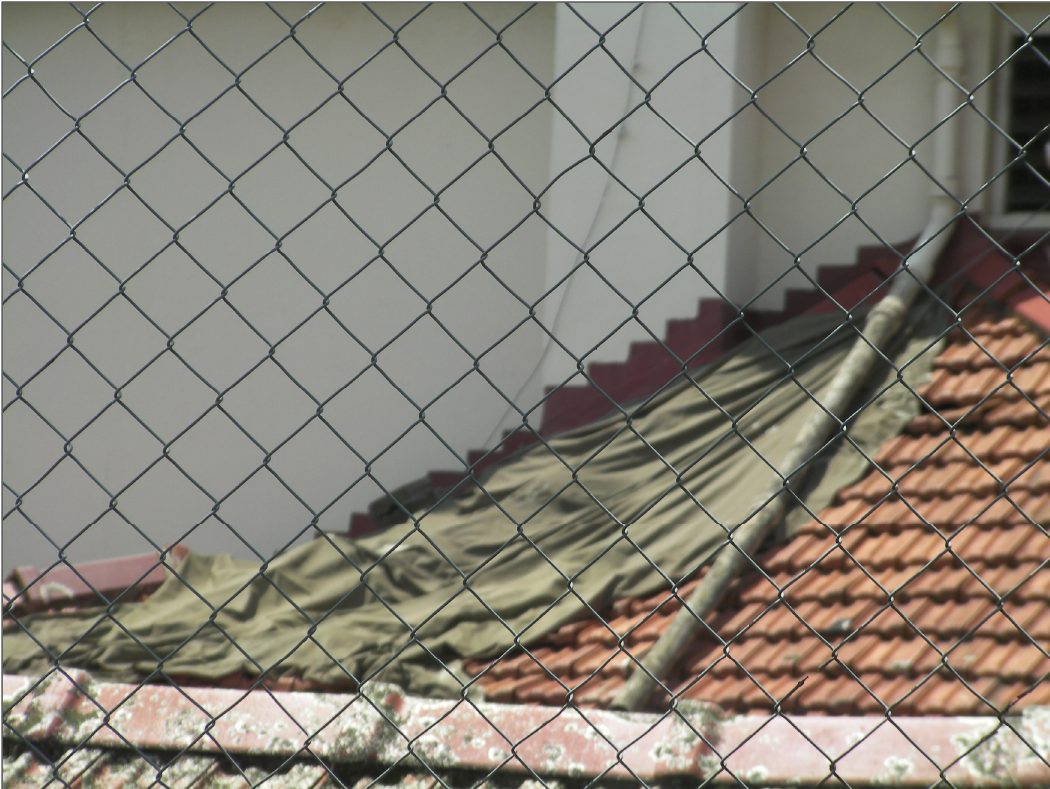
PHOTOGRAPH 16 ----- VIEW OF PART OF THE ROOF THAT HAS COLLAPSED - AREA IS COVERED WITH
SOME SORT OF MATERIAL - ENTIRE ROOF IS BORER INFESTED
