ARCHAEOLOGICAL Survey Portion of Rem of ERF

1 Ladysmith

For: Swahina Investments (Pty) Limited

Date: 9 February 2008

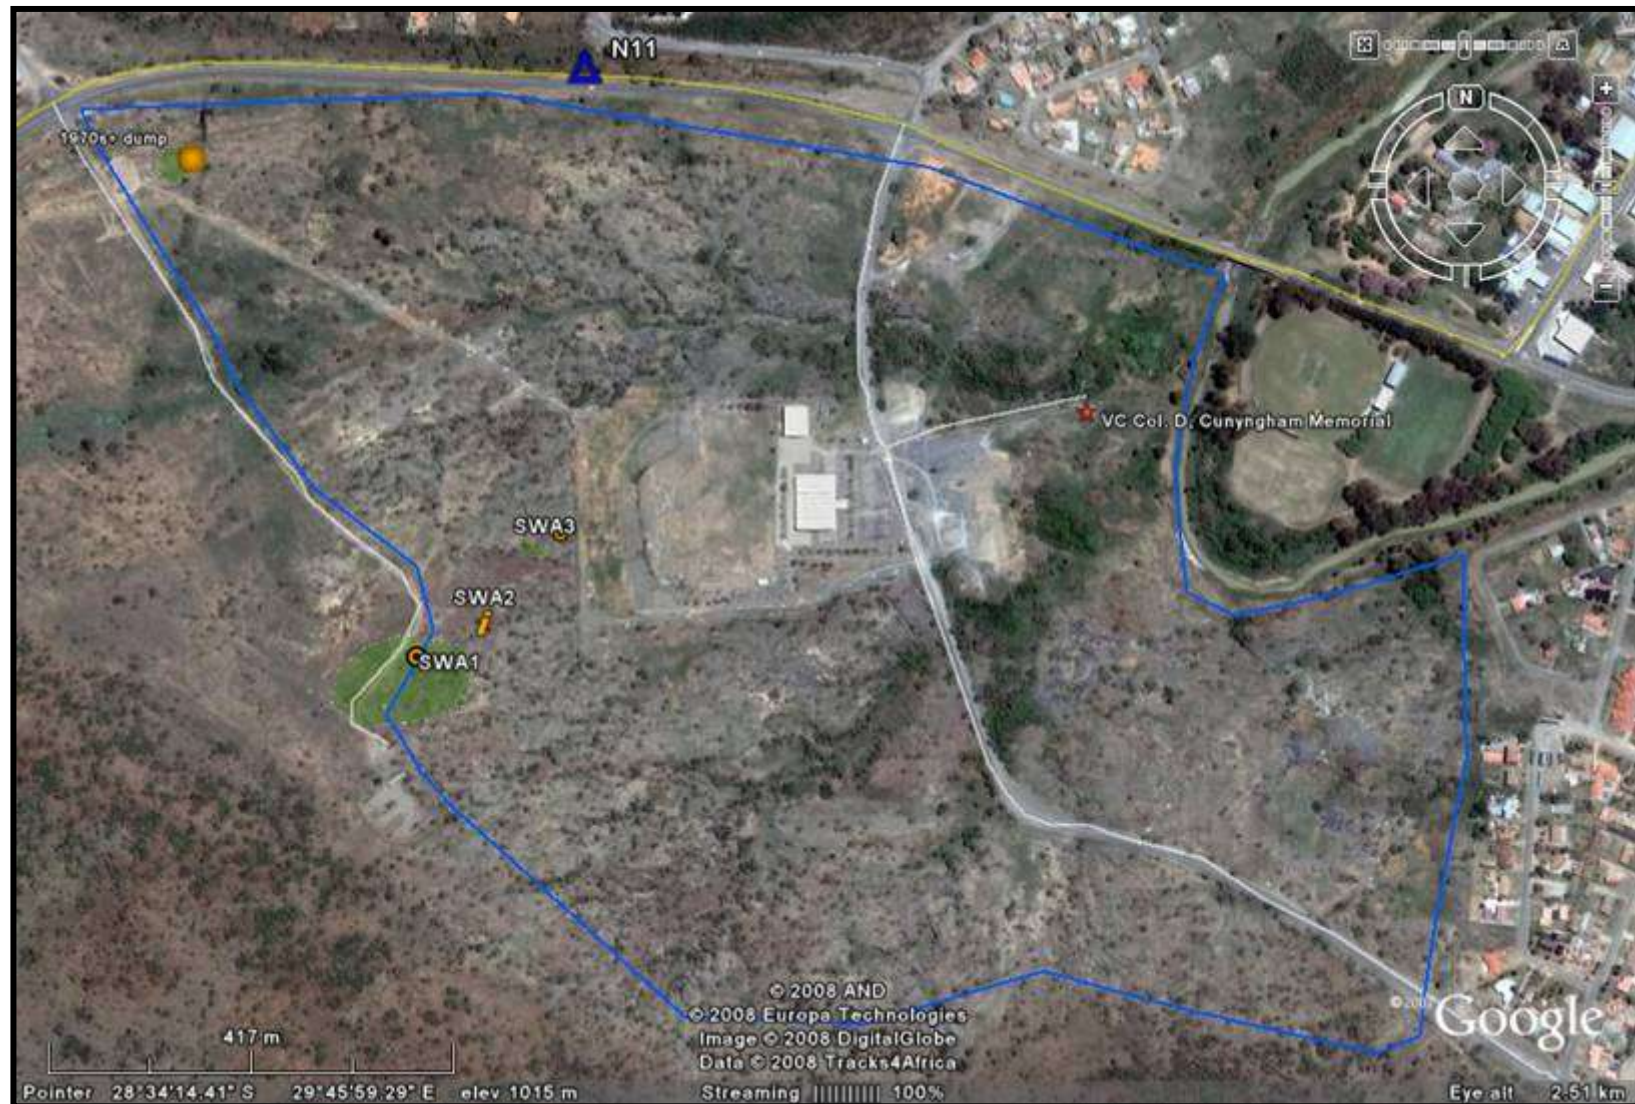
FIGURE 2: LOCATION OF SITES AND SENSITIVE AREAS MENTIONED IN THE REPORT

Figure 1 indicates the location of various sites and sensitive areas mentioned in the text.

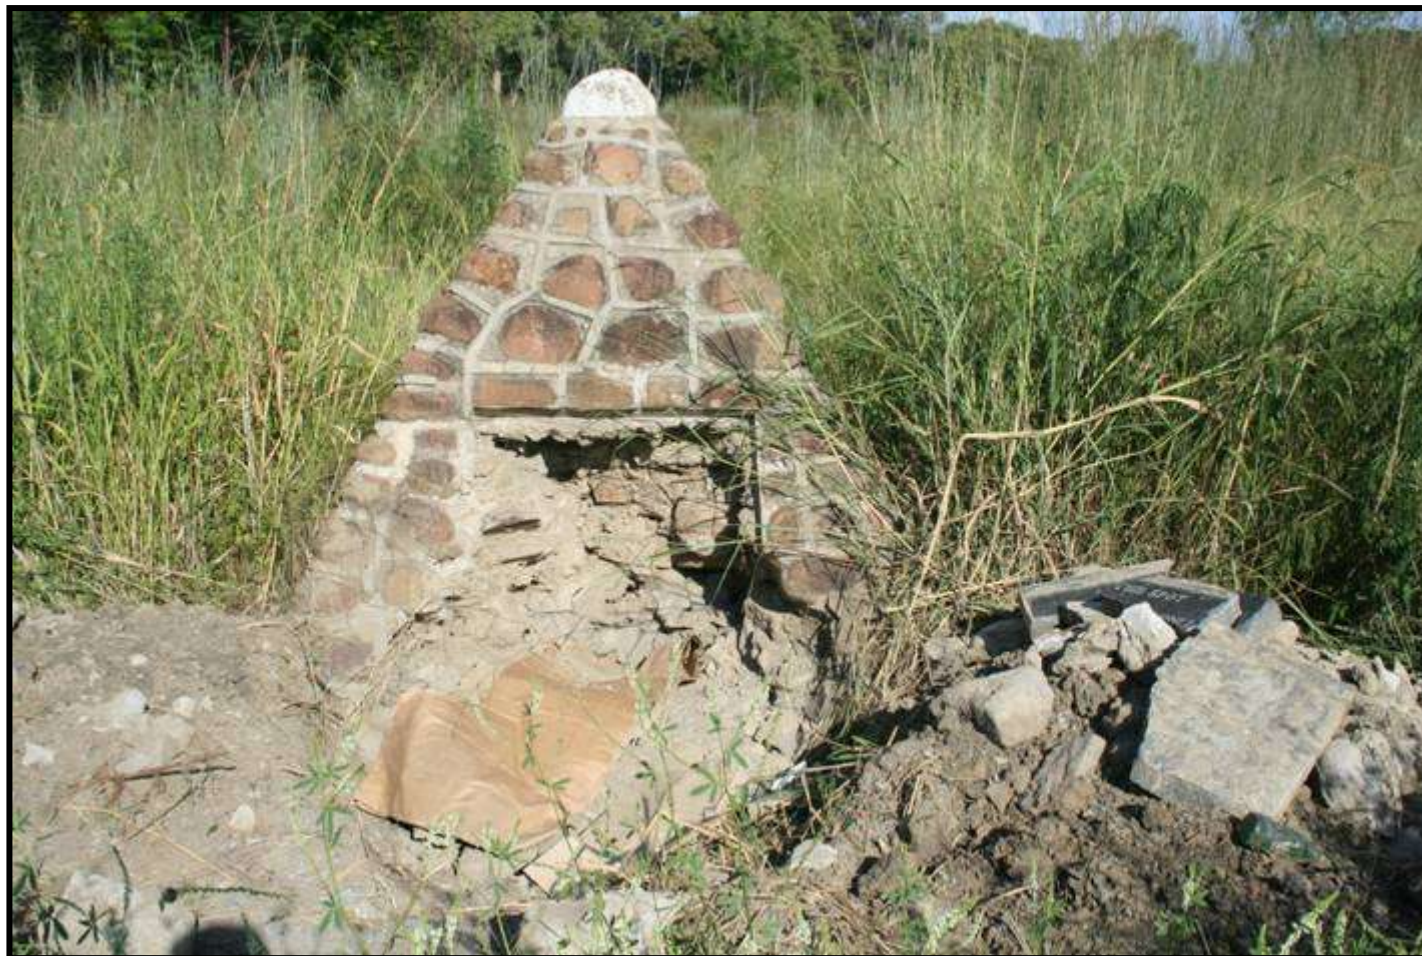
FIGURE 2: CURRENT CONDITION OF THE V.C. LT-COL. W.H. DICK CUNYNGHAM MEMORIAL

The memorial is currently surrounded by various types of litter (illegal dumping) and it has been seriously vandalised (see fig. 2). The marble plaque has been broken and left to one side, and there is a hole at the base of the memorial. I believe that there was an (unsuccessful) attempt to obtain human remains.

Mitigation: The damaging of the memorial is illegal and unfortunate and it needs to be rebuilt. Furthermore, the illegal dumping in the area should be removed by the relevant municipality. One cannot have an international tourist attraction that is an eyesore, and that has been vandalised. I have reported the above to KZN Heritage, however I suggest that Swahina Investments takes a proactive stance, and offers to rebuild the memorial and include it in the development. The plans will need to be approved by KZN Heritage.
