**Heritage Impact Assessment in accordance to
Section 38 of NHRA 25 of 1999 for submission
to SAHRA**

**with
Special Focus on Lifts upgrade on
Portions of the Farm Elandspoort 357- JR,
Pretoria, Tshwane, Gauteng
05th of August 2019**

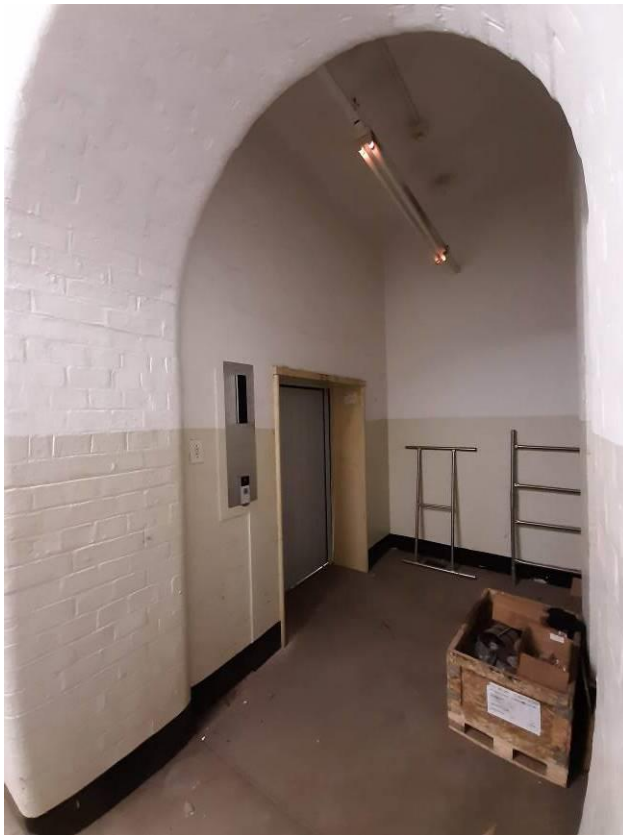
- **Goods Delivery Lift - PE 2751
 (West Wing)**

Fig. 22_Goods Delivery Lift replaced with new Lift
 (Source: tsica heritage consultants, 09.07.2019)

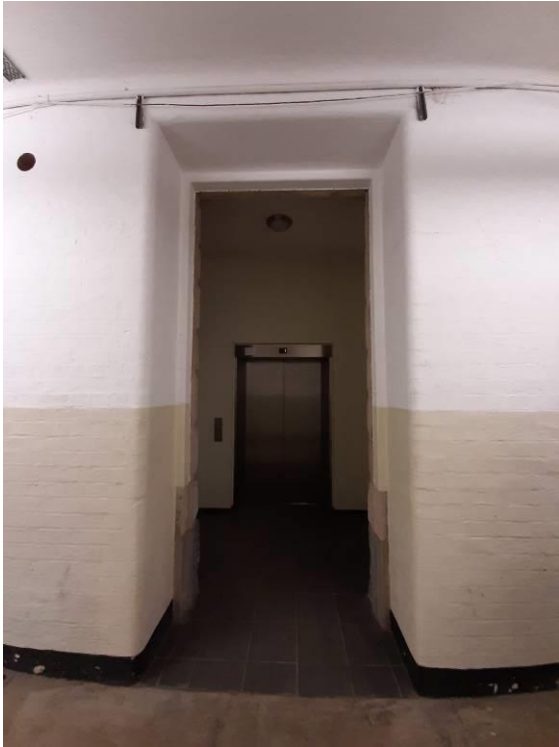
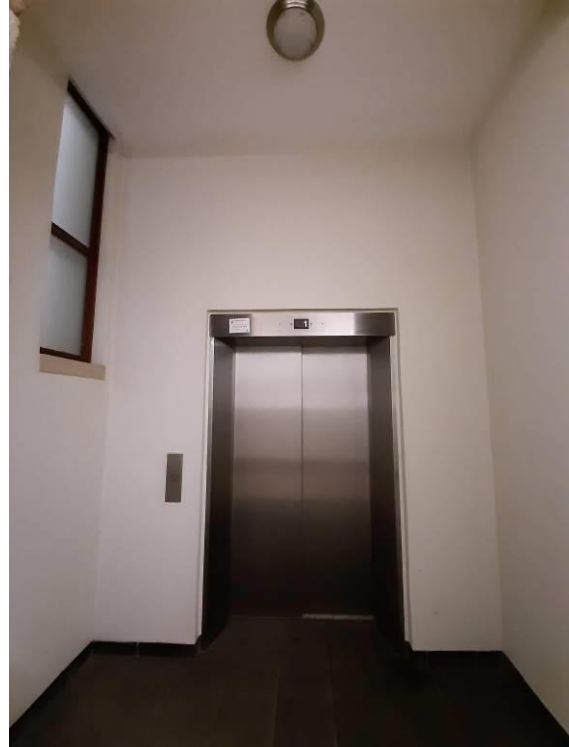
Fig. 23_Presidential Lift_Upgrade and refurbishment of Lift is completed
(Source: tsica heritage consultants, 09.07.2019)

Fig. 24_Presidential Lift_original façade along the western elevation is untouched
(Source: tsica heritage consultants, 09.07.2019)

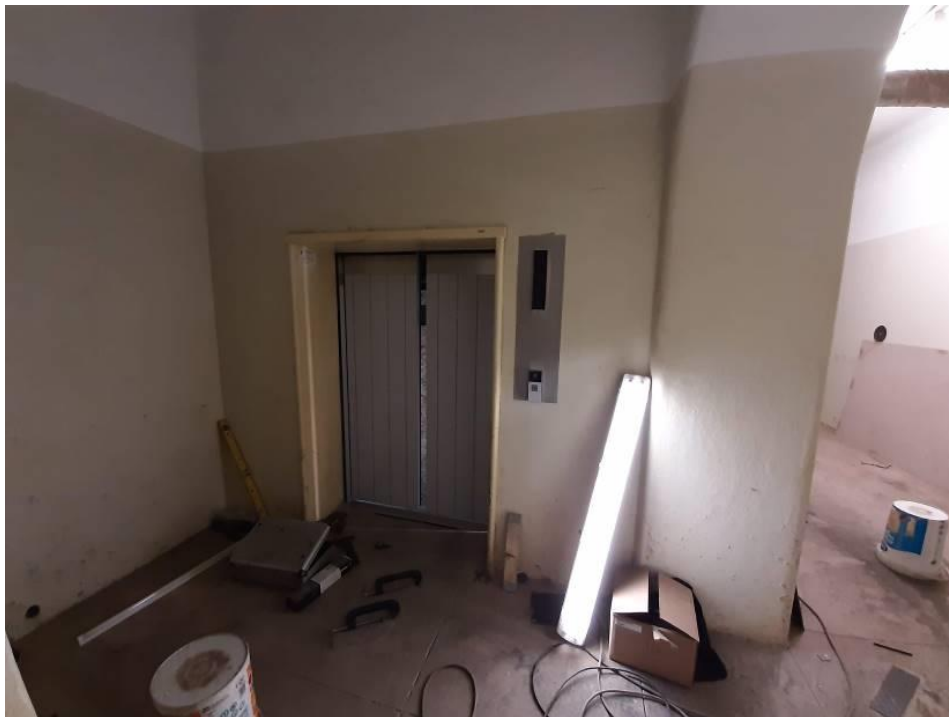
Fig. 26_Goods Delivery Lift replaced and work still in progress
 (Source: tsica heritage consultants, 09.07.2019)

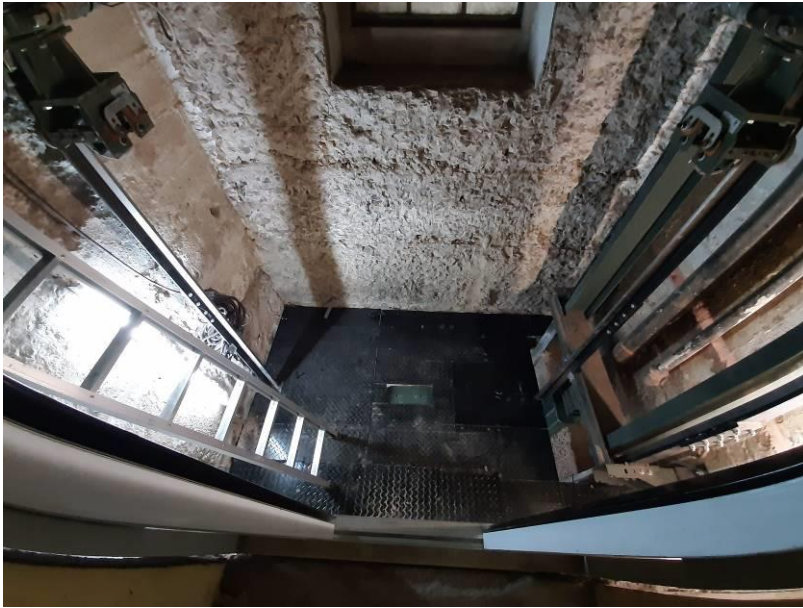
Fig. 27_ Goods Delivery Lift replaced and water issue resolved
(Source: tsica heritage consultants, 09.07.2019)

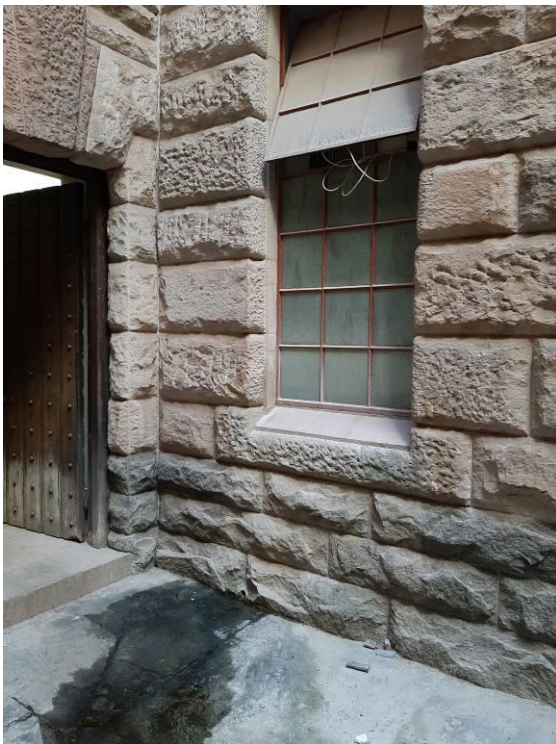
Fig. 28 & 29_Window from Lift shaft towards the courtyard with water outlet moved to the bottom of the façade to stop water penetrating the sandstone window sill and façade
(Source: tsica heritage consultants, 09.07.2019)

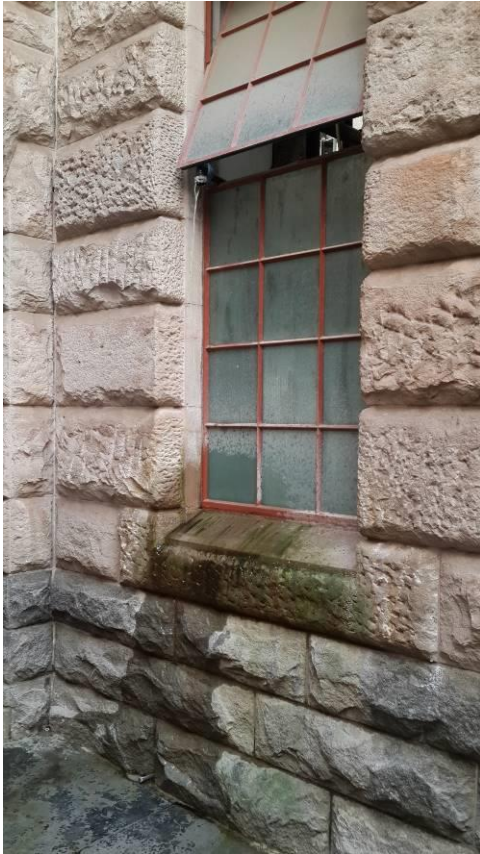
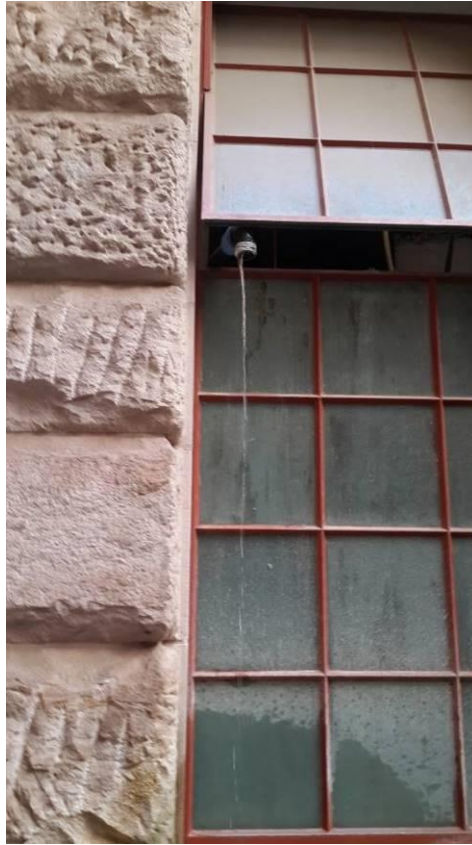
Fig. 30 & 31_Detected water outlet which damaged the sandstone façade; heritage consultant recommended to move outlet to the bottom of the façade to protect façade from water damage

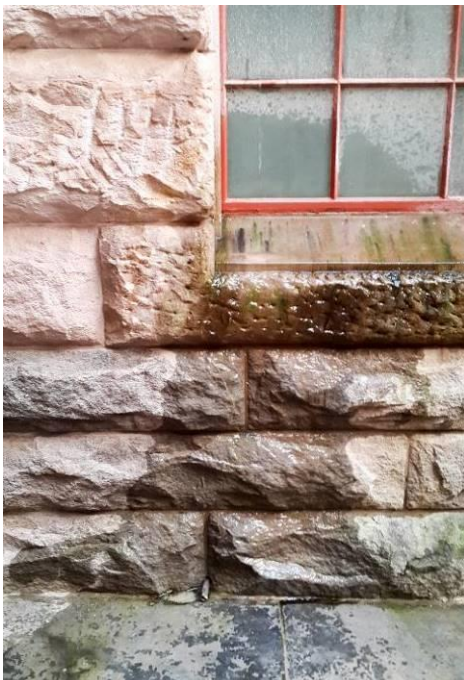
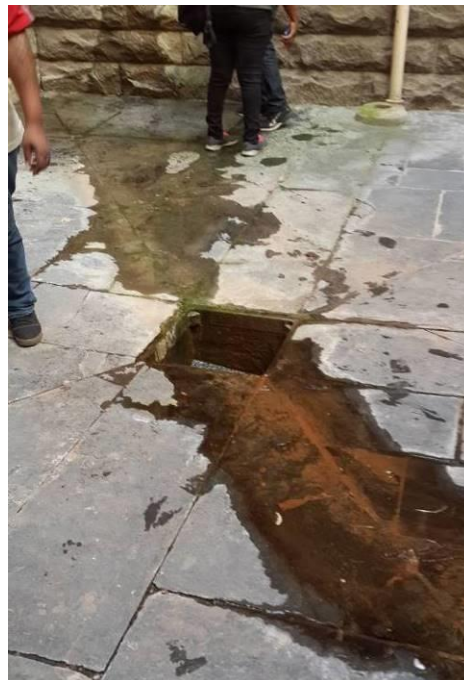
Fig. 32 & 33_Water was dripping on window sill and façade towards the gully inside the courtyard

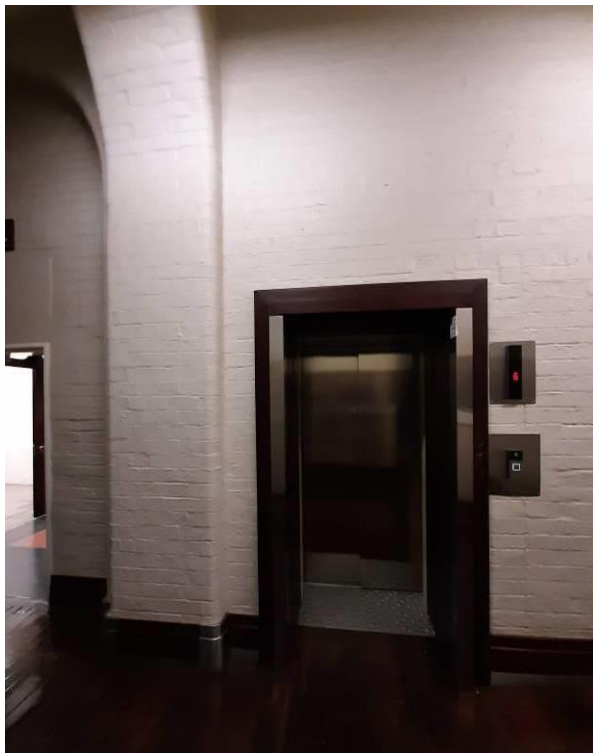
- **Passenger Lift - PE 2747
 (West Wing – North from
 Staircase indicated in green)**

Fig. 36_Passengers Lift replaced
 (Source: tsica heritage consultants, 09.07.2019)

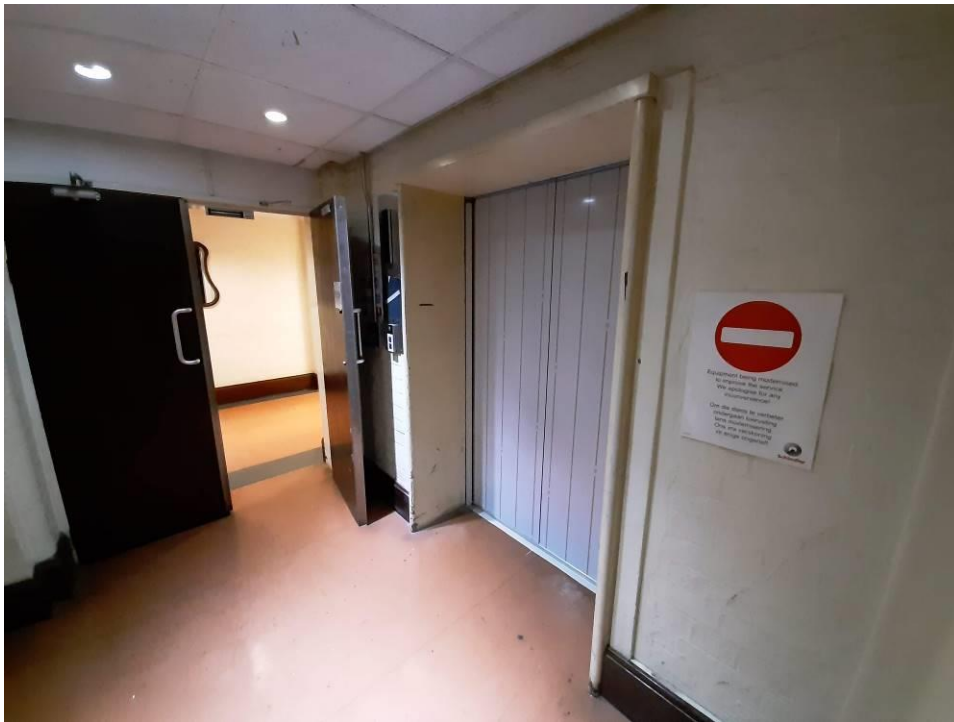
Fig. 37_Goods Delivery Lift replaced
(Source: tsica heritage consultants, 09.07.2019)

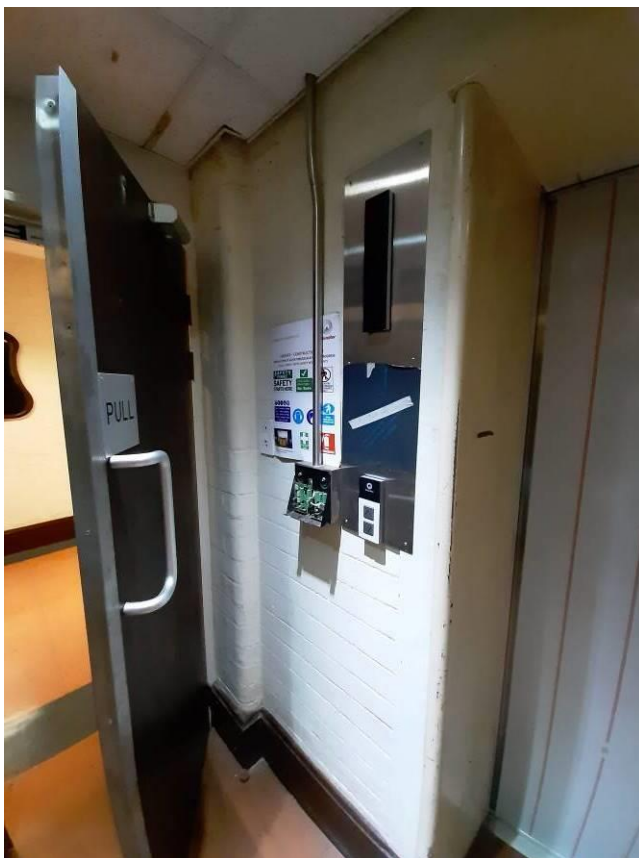
Fig. 38_Detail of replaced Goods Delivery Lift, added metal ducts with cabling and new control panel
(Source: tsica heritage consultants, 09.07.2019)

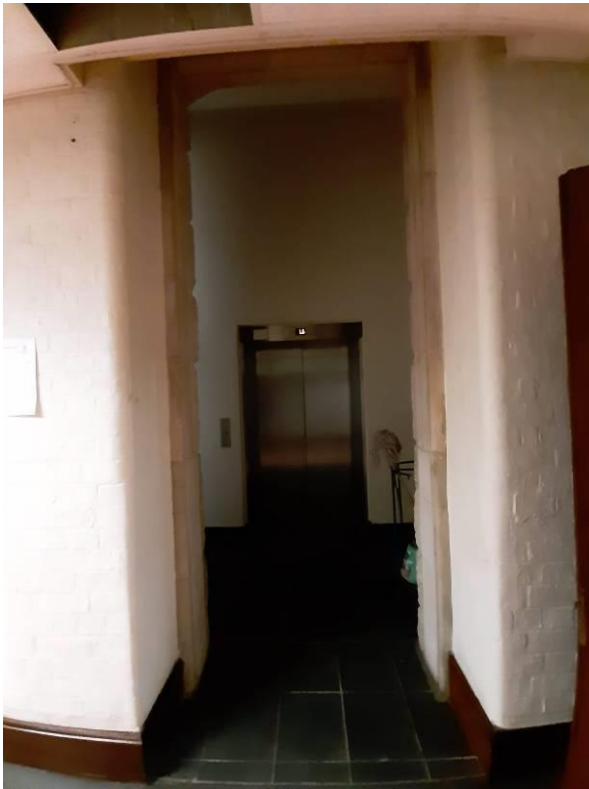
- Passenger Lift – 02L240 (West Wing – Presidential Lift indicated in red)

Fig. 39 & 40_Passengers Lift, upgraded and refurbished
(Source: tsica heritage consultants, 09.07.2019)

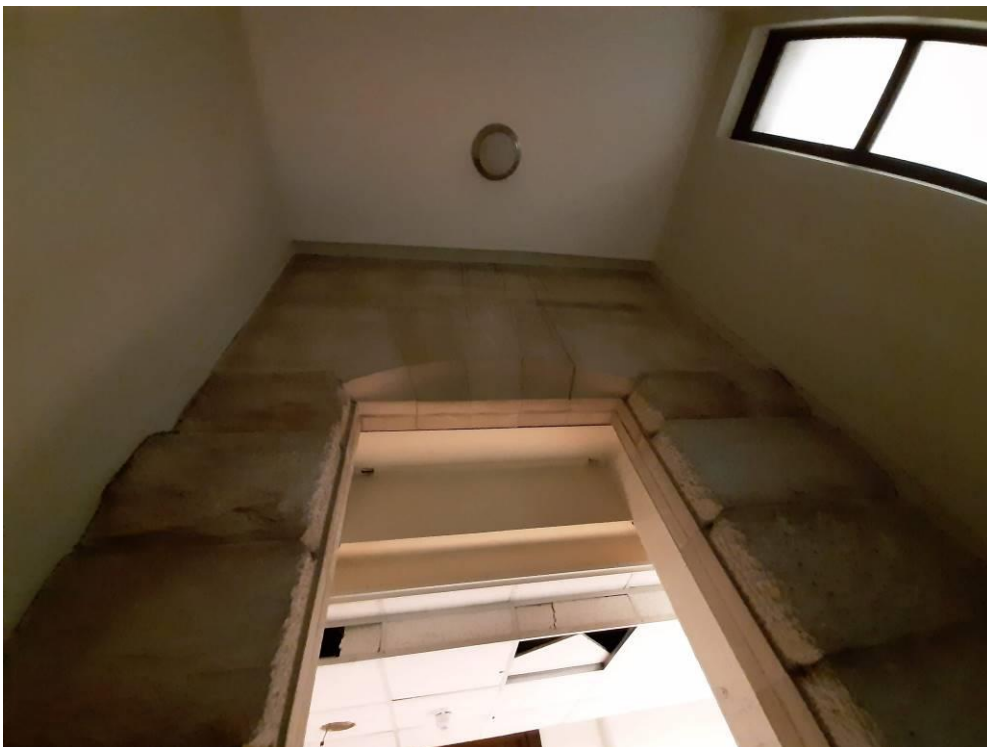
Fig. 41_Presidential Lift_original façade along the western elevation is untouched
(Source: tsica heritage consultants, 09.07.2019)

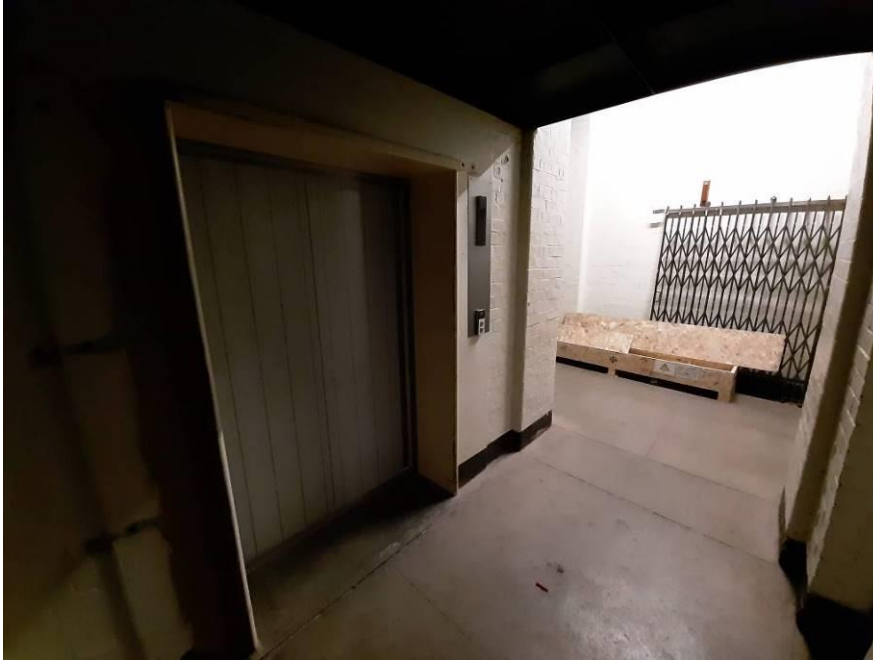
Fig. 44_Goods lift replaced
(Source: tsica heritage consultants, 09.07.2019)

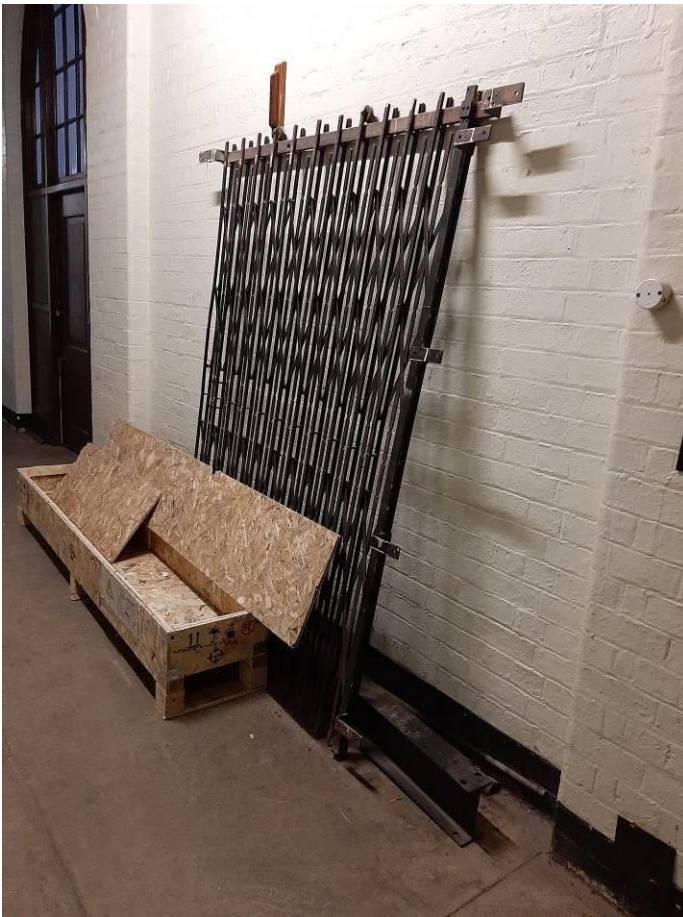
Fig. 45_Original sliding metal gate
with railings for Goods lift
(Source: tsica heritage consultants,
09.07.2019)

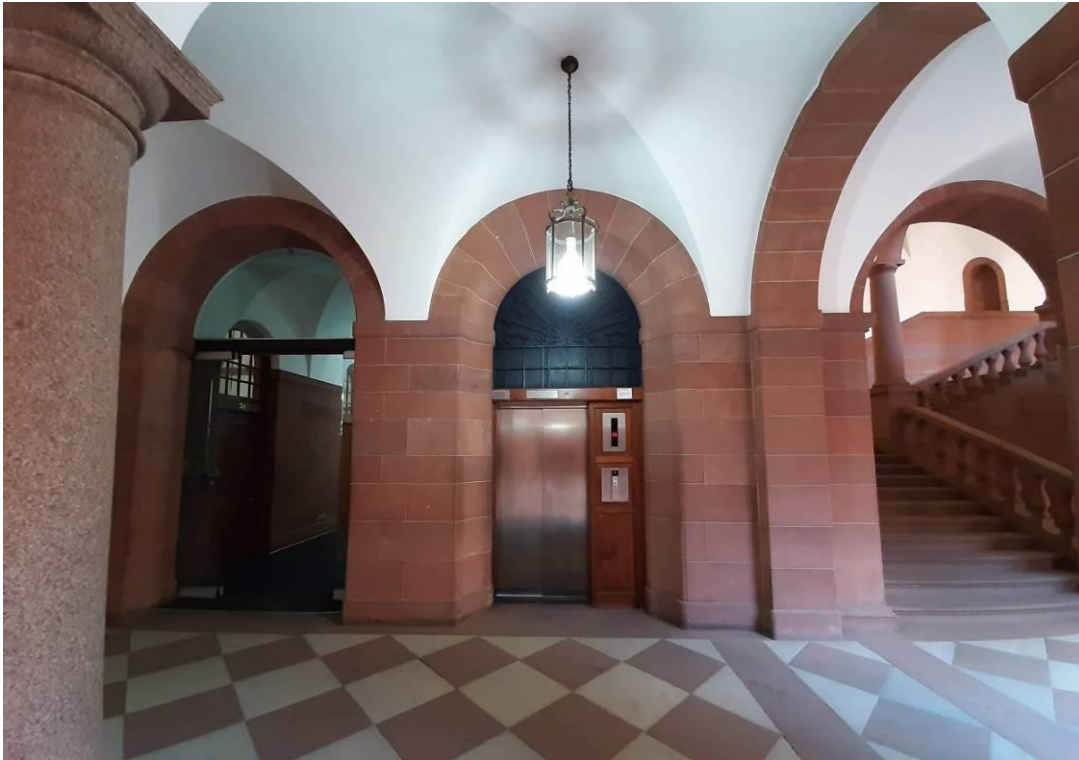
- **Passenger Lift - PE 2747 (West Wing – North from Staircase indicated in green); Ground Floor Level**

Fig. 48_Passenger lift for the public along the northern side of the main staircase
(Source: tsica heritage consultants, 09.07.2019)

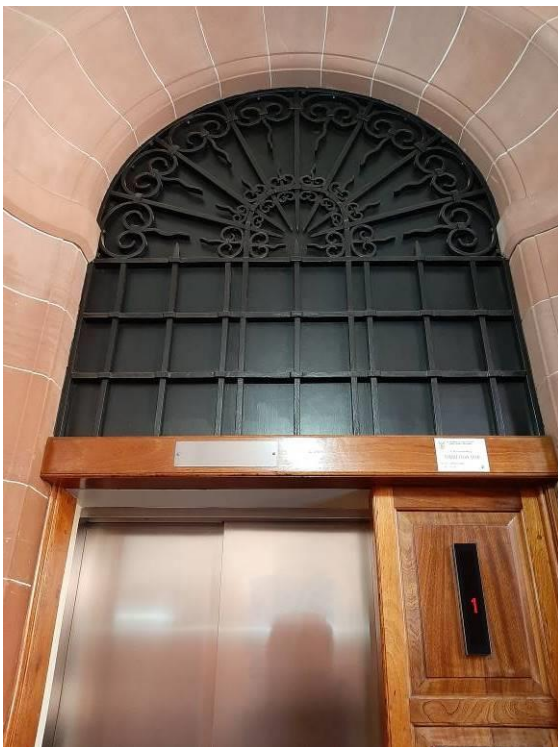
Fig. 49_Detail of wrought iron decoration above Passenger lift for the public along the northern side of the main staircase, wooden cladding was put back in place and not damaged after lift was replaced
(Source: tsica heritage consultants, 09.07.2019)

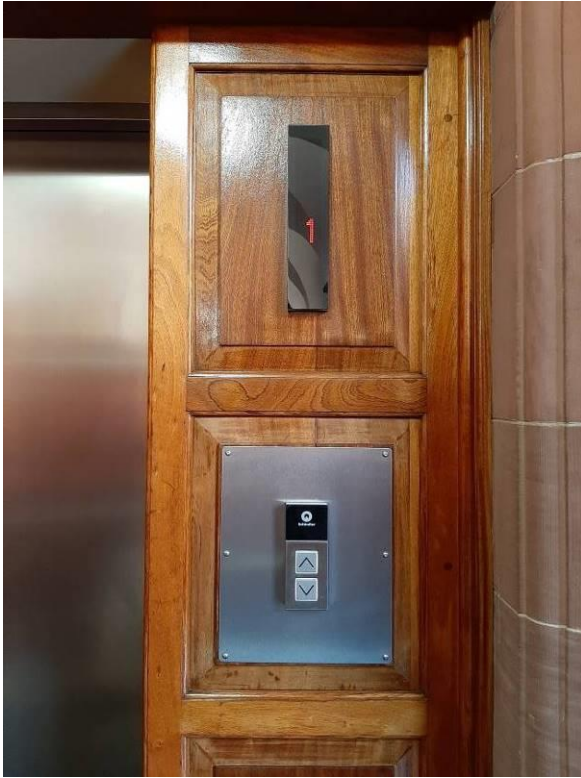
Fig. 50 & 51_Detail of wooden cladding with new control panel for Passenger lift, wooden cladding was put back in place and not damaged after lift was replaced (Source: tsica heritage consultants, 09.07.2019)

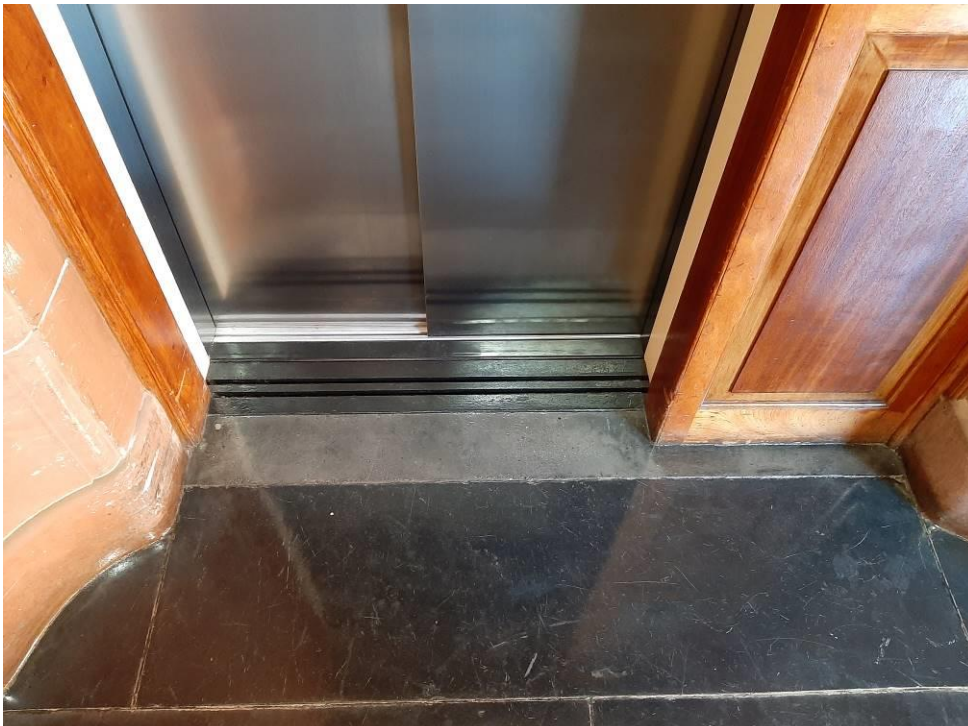
Fig. 52_Detail of floor landing interface of Passenger lift, all stone work and wooden cladding was put back in place and not damaged after lift was replaced (Source: tsica heritage consultants, 09.07.2019)

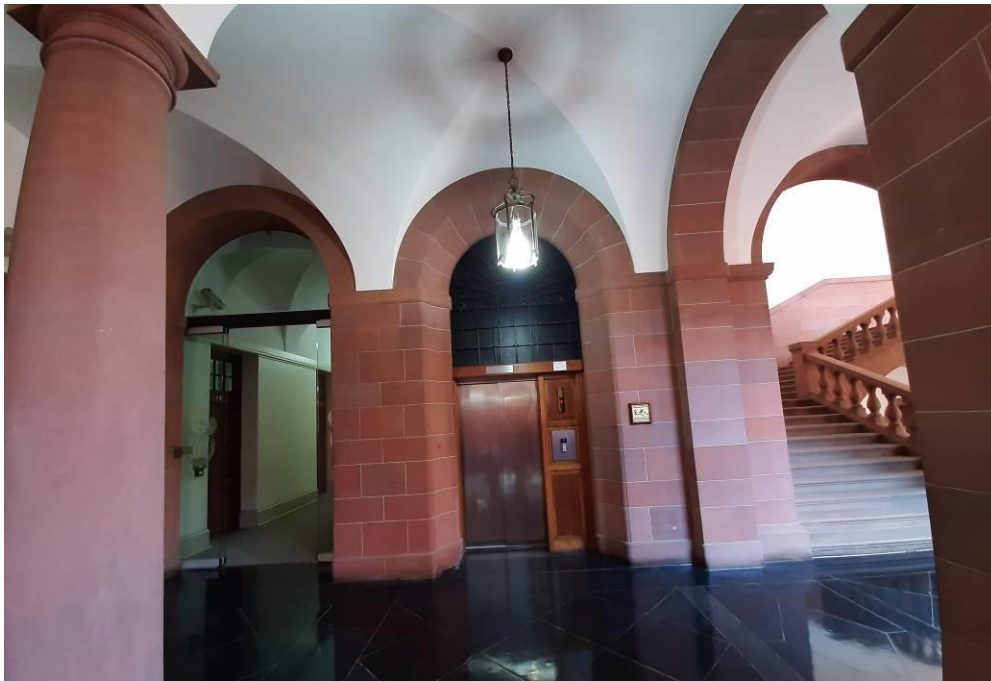
Fig. 53_Passenger lift replaced on first floor level and wooden cladding put back in place without any damage
(Source: tsica heritage consultants, 09.07.2019)

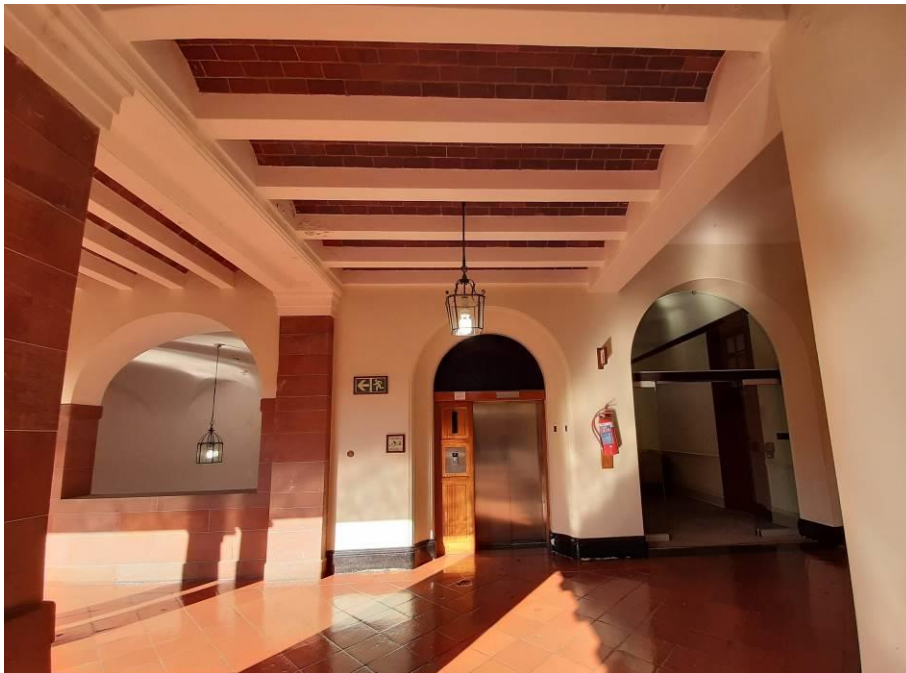
- Passenger Lift - PE 2747 (West Wing – North from Staircase)
Second Floor Level

Fig. 54_Passenger Lift replaced on second floor level
(Source: tsica heritage consultants, 09.07.2019)

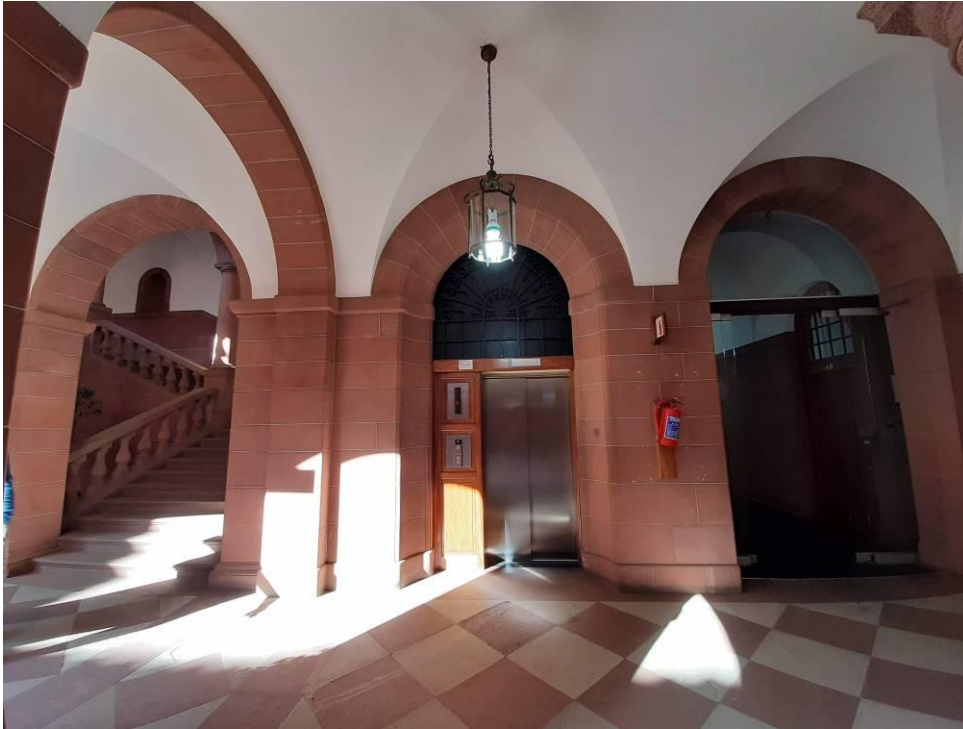
- **Passenger Lift - PE 2748 (West Wing – South from Staircase indicated in green); Ground Floor Level**

Fig. 55_Passenger lift for the public along the southern side of the main staircase
(Source: tsica heritage consultants, 09.07.2019)

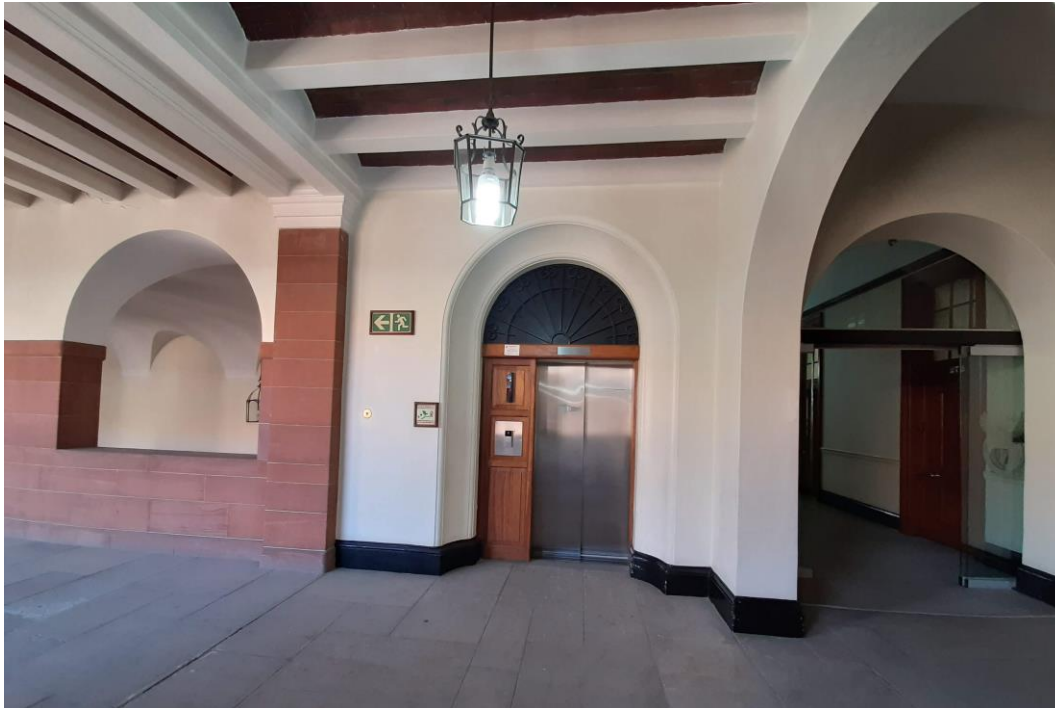
- Passenger Lift - PE 2748 (West Wing – South from Staircase)
Second Floor Level

Fig. 57_Passenger Lift replaced on second floor level
(Source: tsica heritage consultants, 09.07.2019)

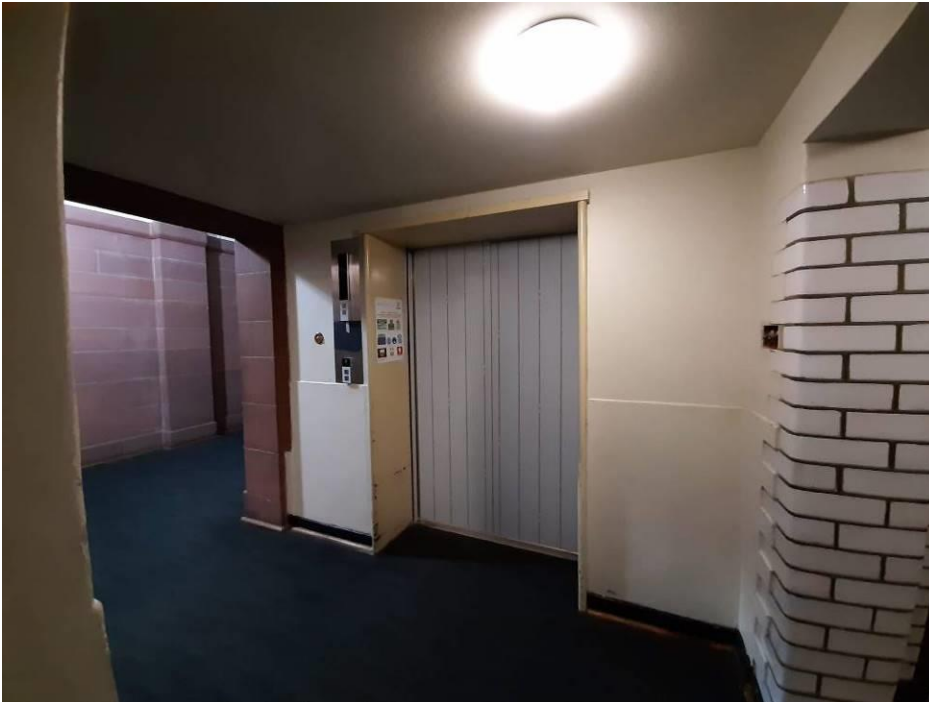
- **Goods Delivery Lift - PE 2751 (West Wing indicated in blue)**
Ground Floor Plan

Fig. 58_Goods Delivery Lift replaced on ground floor level
(Source: tsica heritage consultants, 09.07.2019)

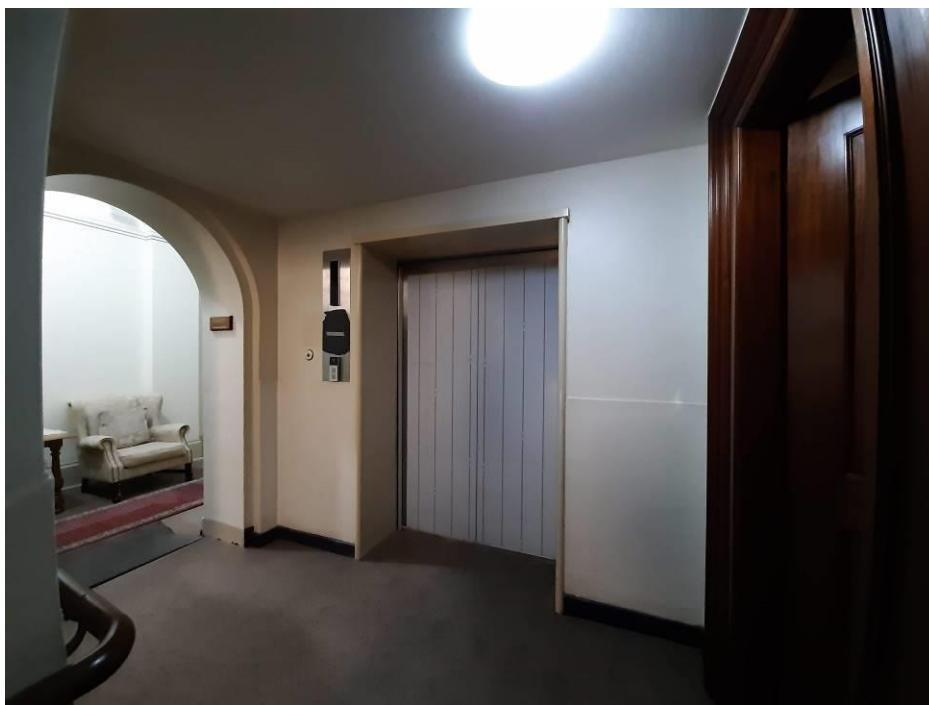
- **Goods Delivery Lift - PE 2751 (West Wing)**
First Floor Plan

Fig. 59_Goods Delivery Lift replaced on first floor level
(Source: tsica heritage consultants, 09.07.2019)

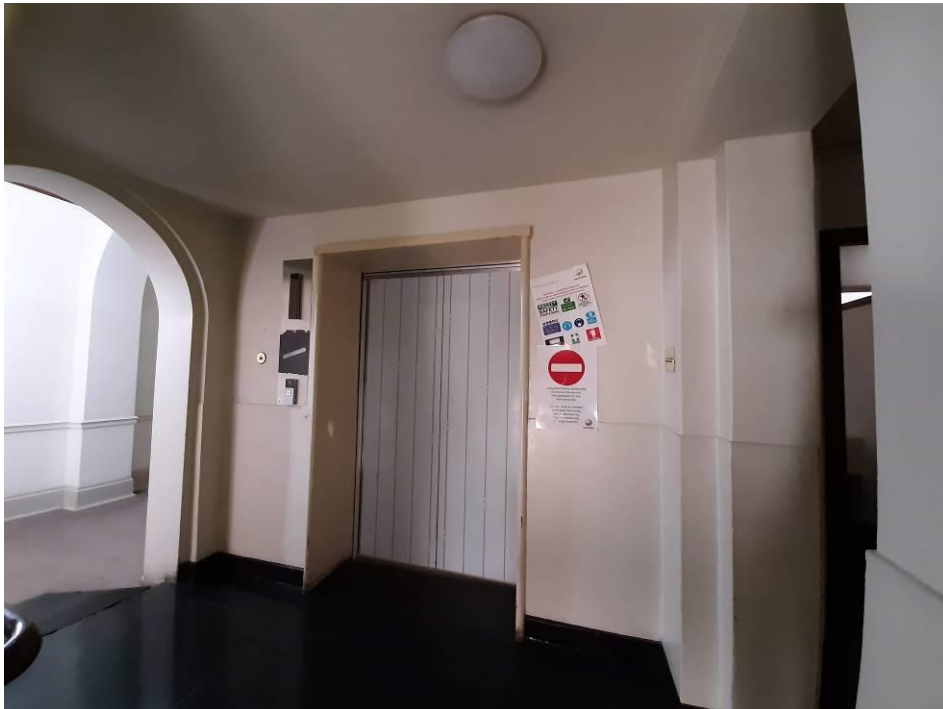
- Goods Delivery Lift - PE 2751 (West Wing)
Second Floor Plan

Fig. 60_Goods Delivery Lift replaced on second floor level
(Source: tsica heritage consultants, 09.07.2019)

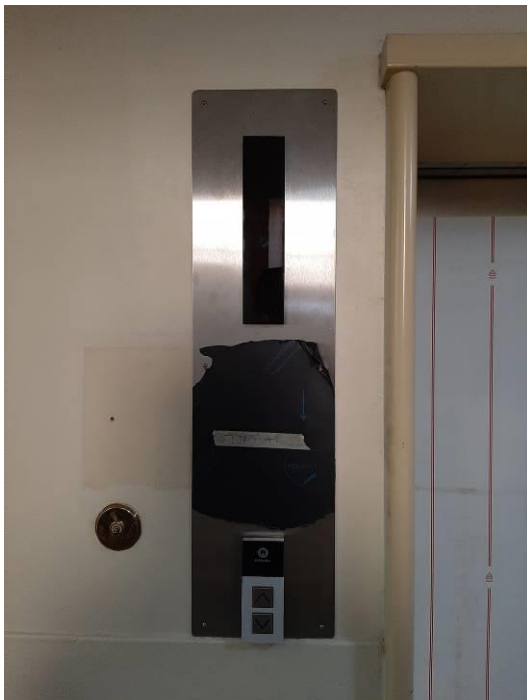
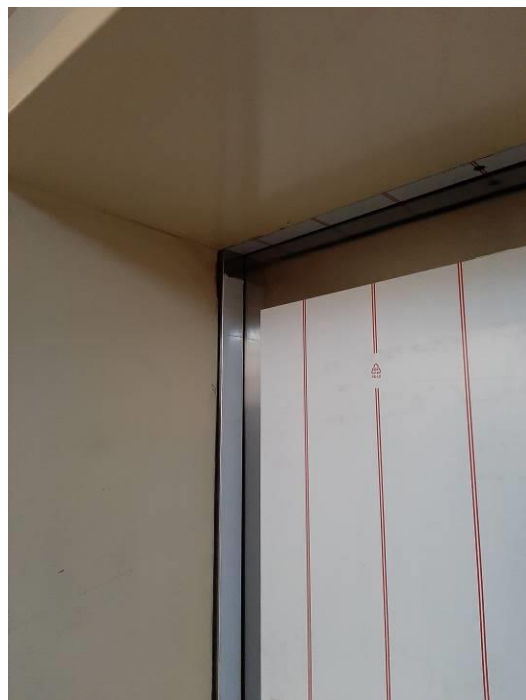
Fig. 61 & 62_Detail of Goods Delivery Lift, control panel (left) and metal cover strip between original steel door frame and new lift (right)
(Source: tsica heritage consultants, 09.07.2019)

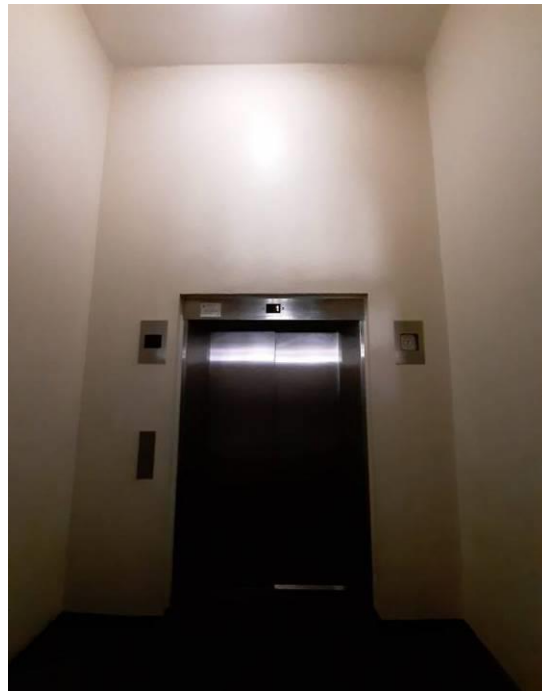
- **Passenger Lift – 02L240 (West Wing – Presidential Lift indicated in red)**
Ground Floor Level

Fig. 63 & 64_Passenger Lift within the Presidential Suite upgraded and maintained
(Source: tsica heritage consultants, 09.07.2019)

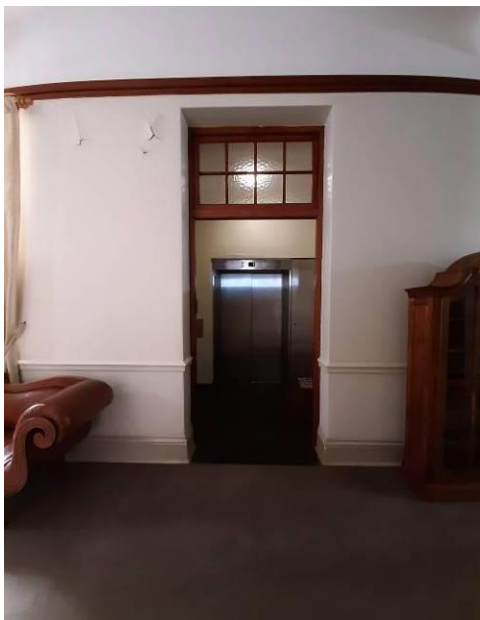
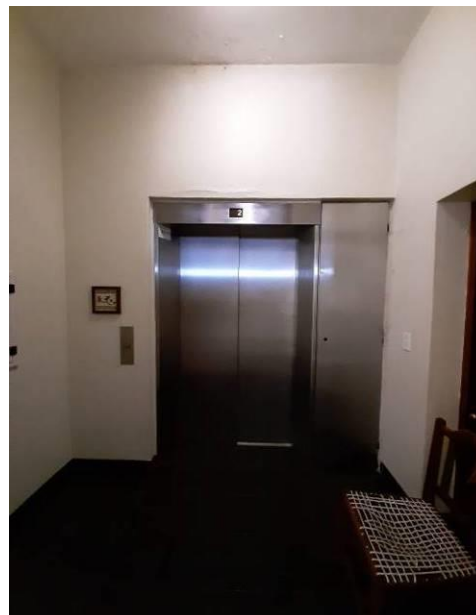
- **Passenger Lift – 02L240 (West Wing – Presidential Lift)**
Second Floor Level

Fig. 65 & 66_Passenger Lift within the Presidential Suite upgraded and maintained
(Source: tsica heritage consultants, 09.07.2019)

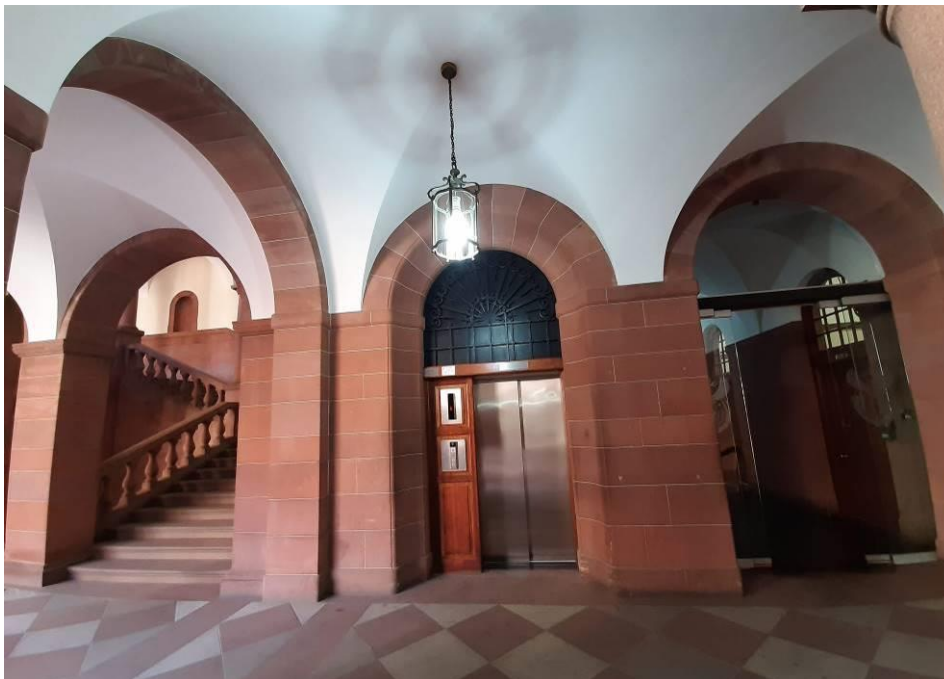
- **Passenger Lift - PE 2749 (East Wing – North from Staircase indicated in green); Ground Floor Level**

Fig. 68_Passenger lift for the public replaced along the northern side of the main staircase
(Source: tsica heritage consultants, 09.07.2019)

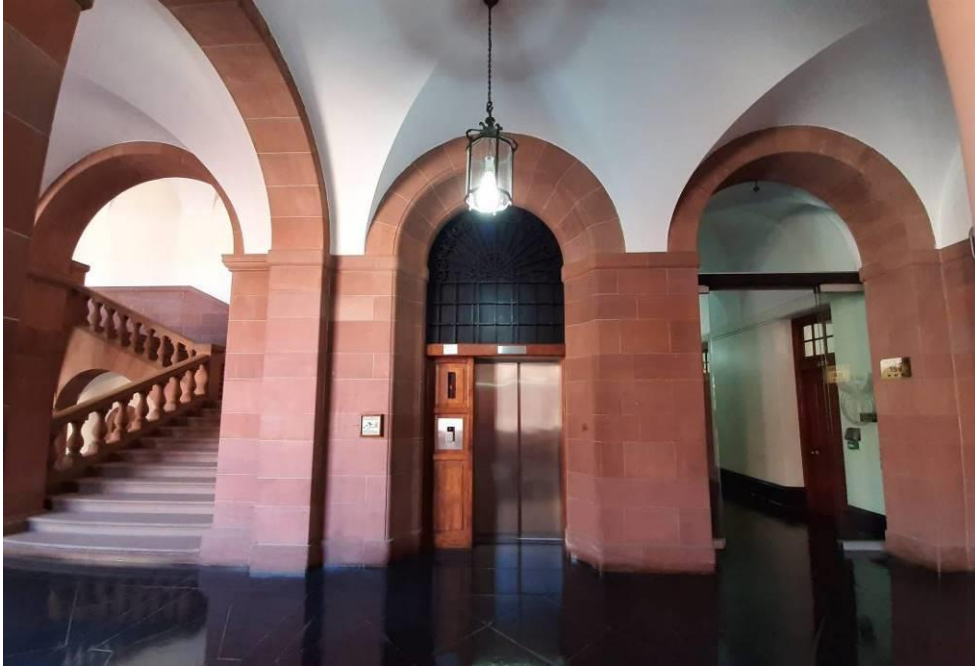
- Passenger Lift - PE 2749 (East Wing – North from Staircase)
First Floor Level

Fig. 69_Passenger lift for the public replaced along the northern side of the main staircase
(Source: tsica heritage consultants, 09.07.2019)

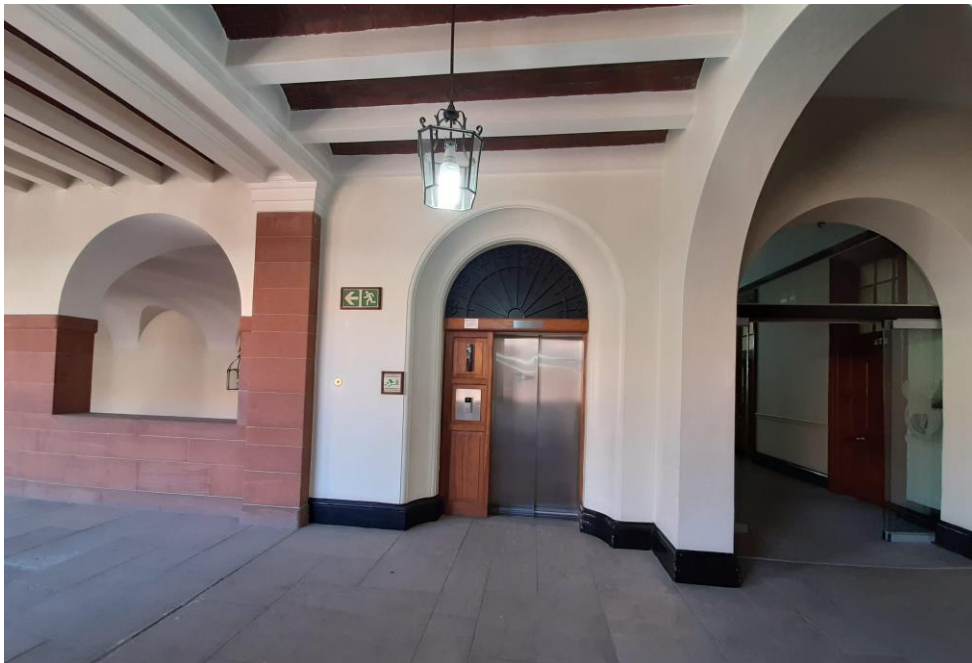
- Passenger Lift - PE 2749 (East Wing – North from Staircase)
Second Floor Level

Fig. 70_Passenger lift for the public replaced along the northern side of the main staircase
(Source: tsica heritage consultants, 09.07.2019)

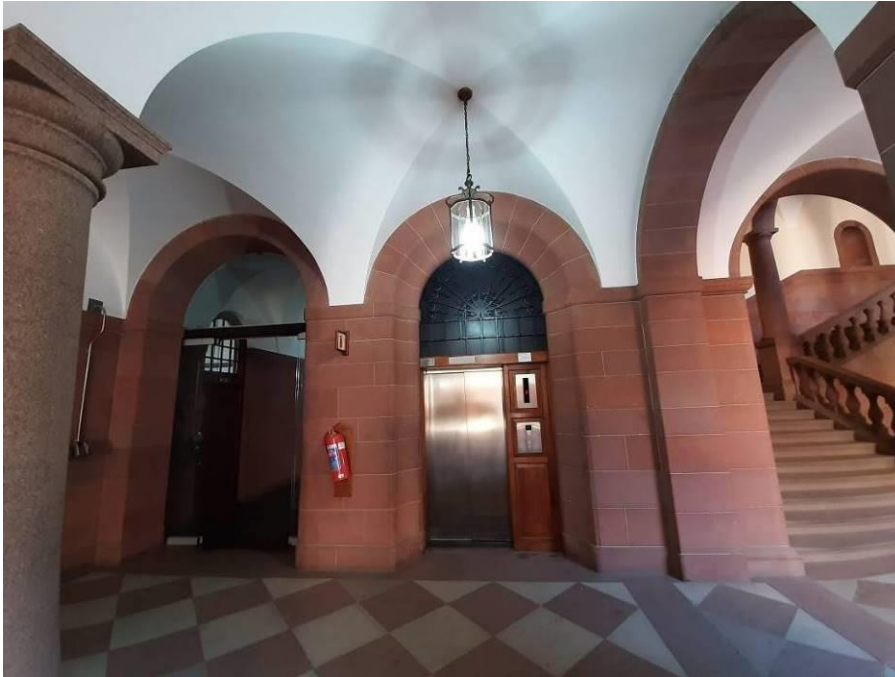
- **Passenger Lift - PE 2750 (East Wing – South from Staircase indicated in green); Ground Floor Level**

Fig. 71_Passenger lift for the public replaced along the southern side of the main staircase
(Source: tsica heritage consultants, 09.07.2019)

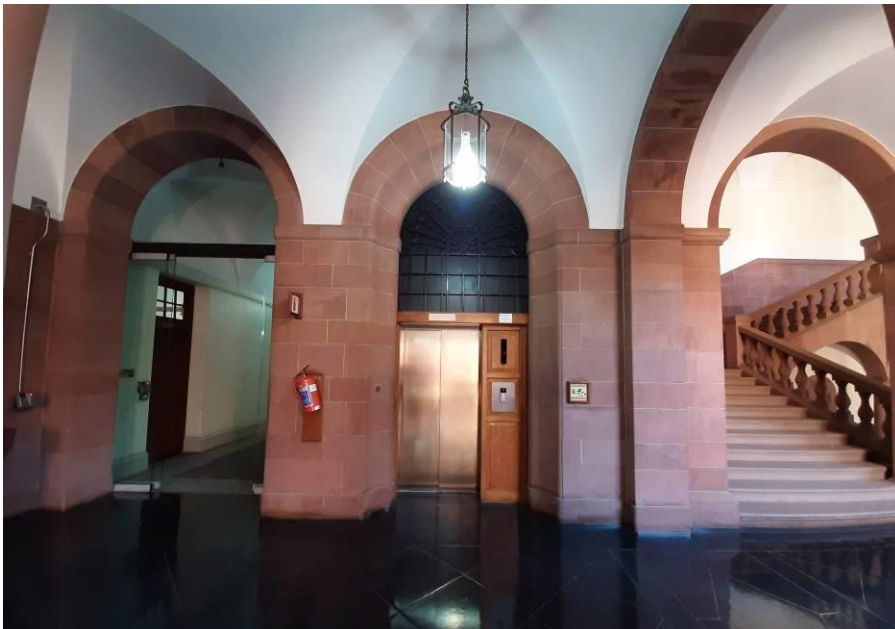
- **Passenger Lift - PE 2750 (East Wing – South from Staircase)
First Floor Level**

Fig. 72_Passenger lift for the public replaced along the southern side of the main staircase
(Source: tsica heritage consultants, 09.07.2019)

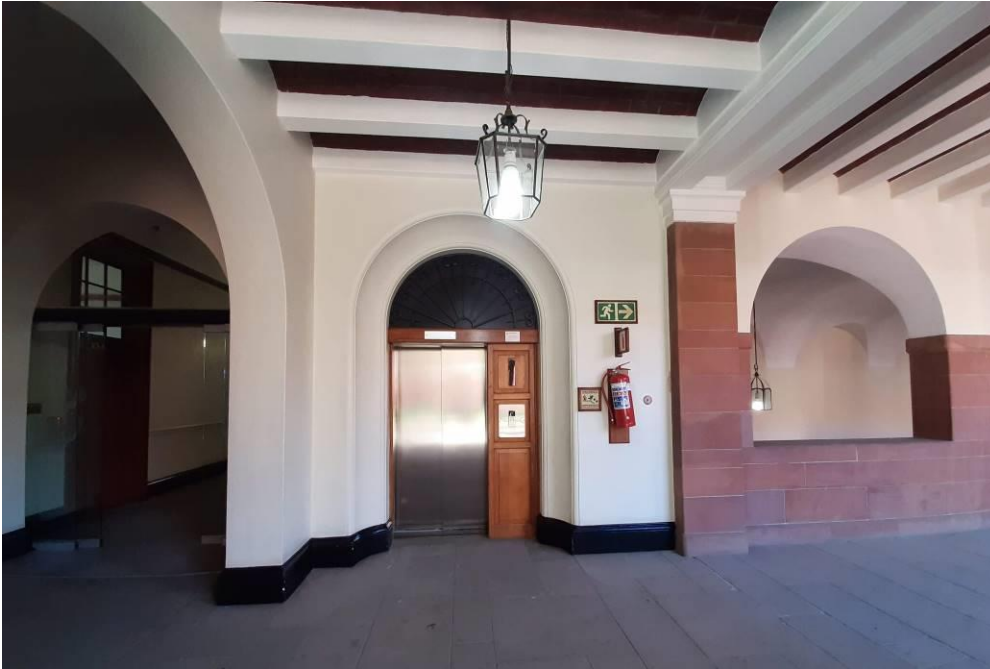
- Passenger Lift - PE 2750 (East Wing – South from Staircase)
Second Floor Level

Fig. 73_Passenger lift for the public replaced along the southern side of the main staircase
(Source: tsica heritage consultants, 09.07.2019)
