**Heritage Impact Assessment in accordance to
Section 38 of NHRA 25 of 1999 for submission
to SAHRA**

**with
Special Focus on Lifts upgrade on
Portions of the Farm Elandspoort 357- JR,
Pretoria, Tshwane, Gauteng
05th of August 2019**

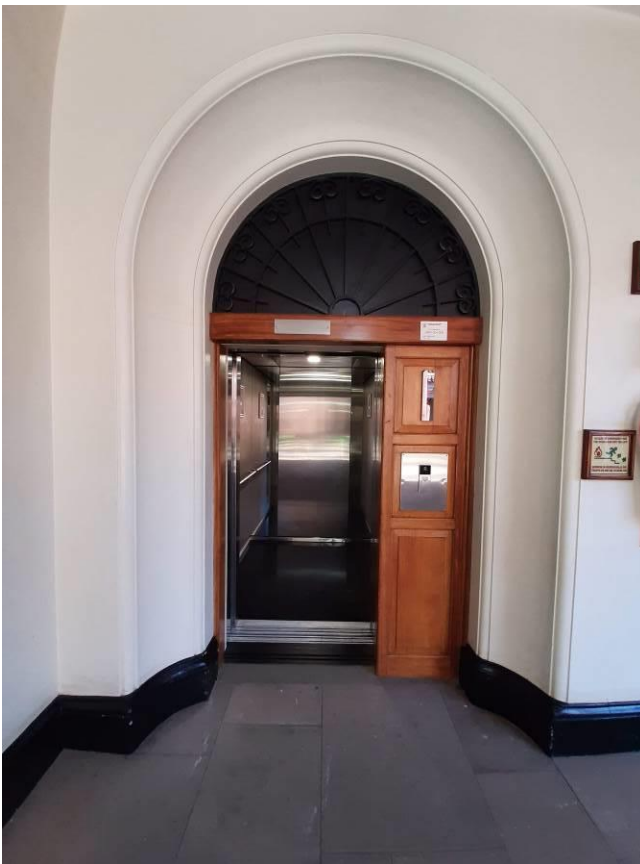
Fig. 74_Passenger lift for the public replaced along the southern side of the main staircase, all wooden cladding was removed and put back without damage
(Source: tsica heritage consultants, 09.07.2019)

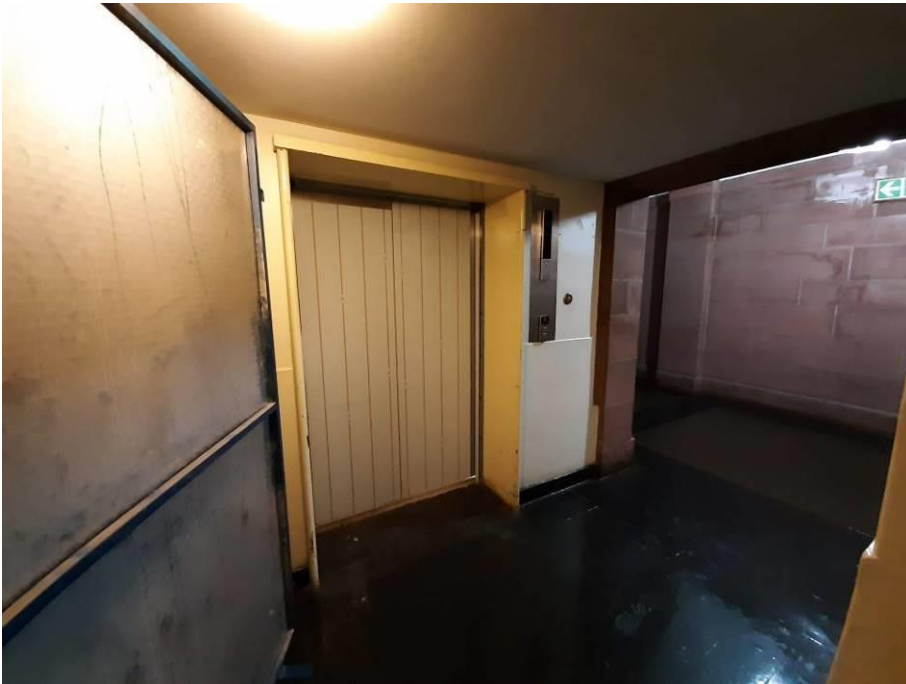
- **Goods Delivery Lift - PE 2752 (East Wing indicated in blue)**
Ground Floor Level

Fig. 75_Goods Delivery Lift replaced on ground floor level
(Source: tsica heritage consultants, 09.07.2019)

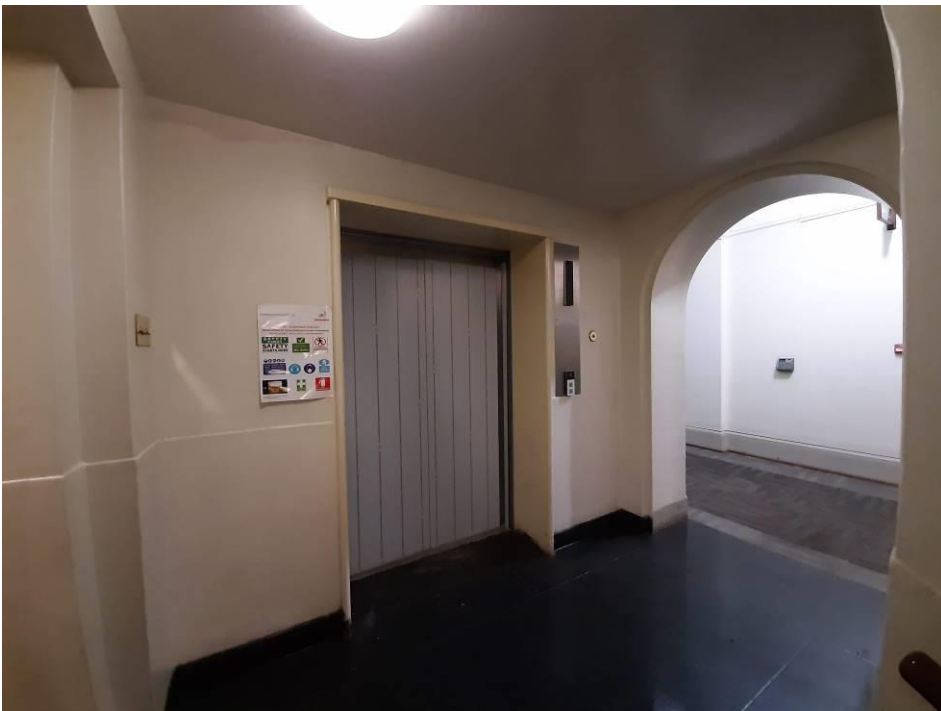
- **Goods Delivery Lift - PE 2752 (East Wing)**
First Floor Level

Fig. 76_Goods Delivery Lift replaced on first floor level
(Source: tsica heritage consultants, 09.07.2019)

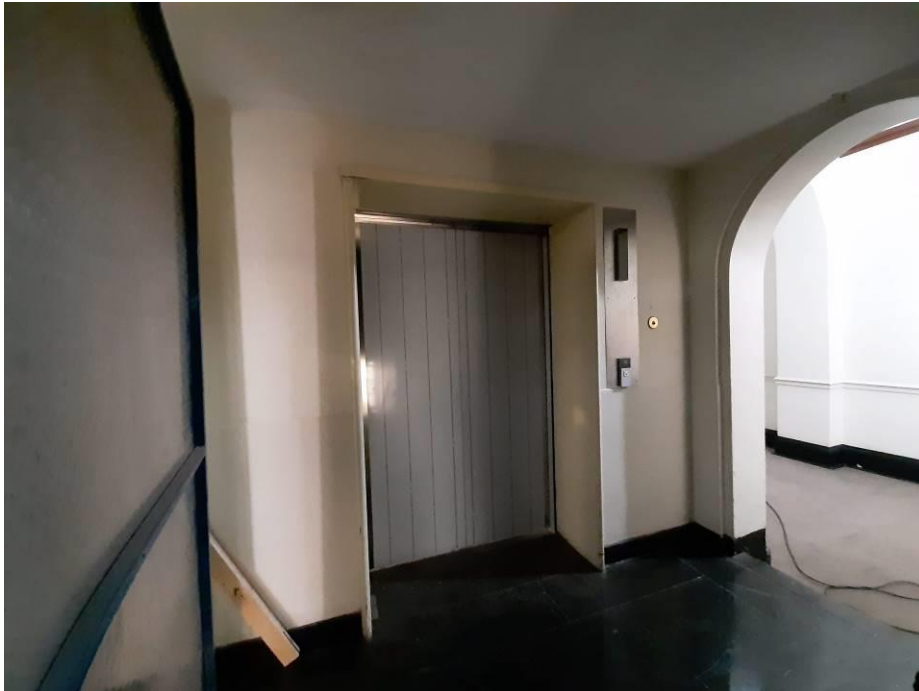
- Goods Delivery Lift - PE 2752 (East Wing)
Second Floor Level

Fig. 77_Goods Delivery Lift replaced on second floor level
(Source: tsica heritage consultants, 09.07.2019)

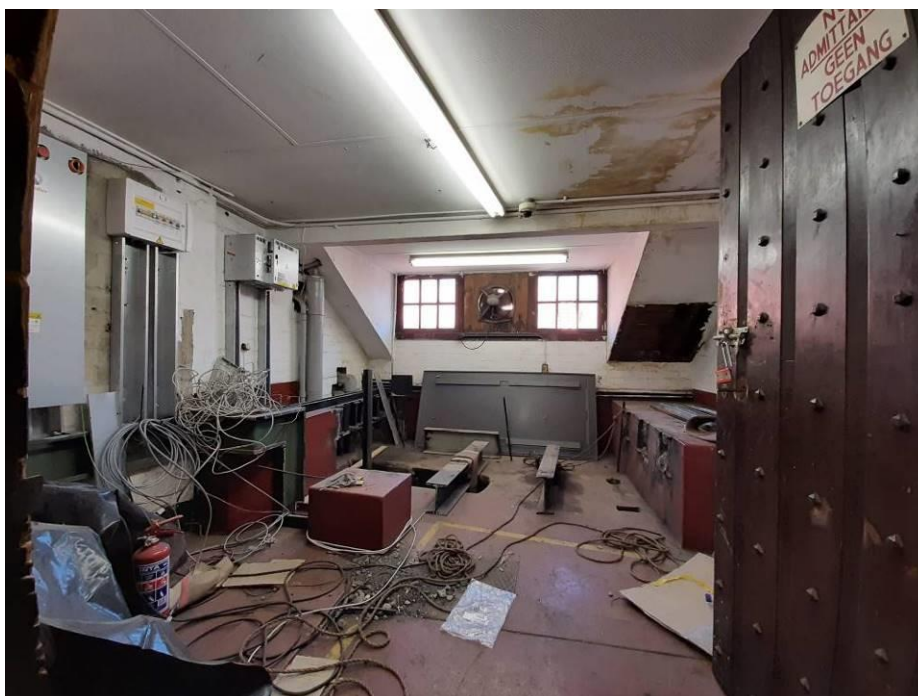
Fig. 81_Lift room located in the West wing above the Goods Lift shaft
 (Source: tsica heritage consultants, 09.07.2019)

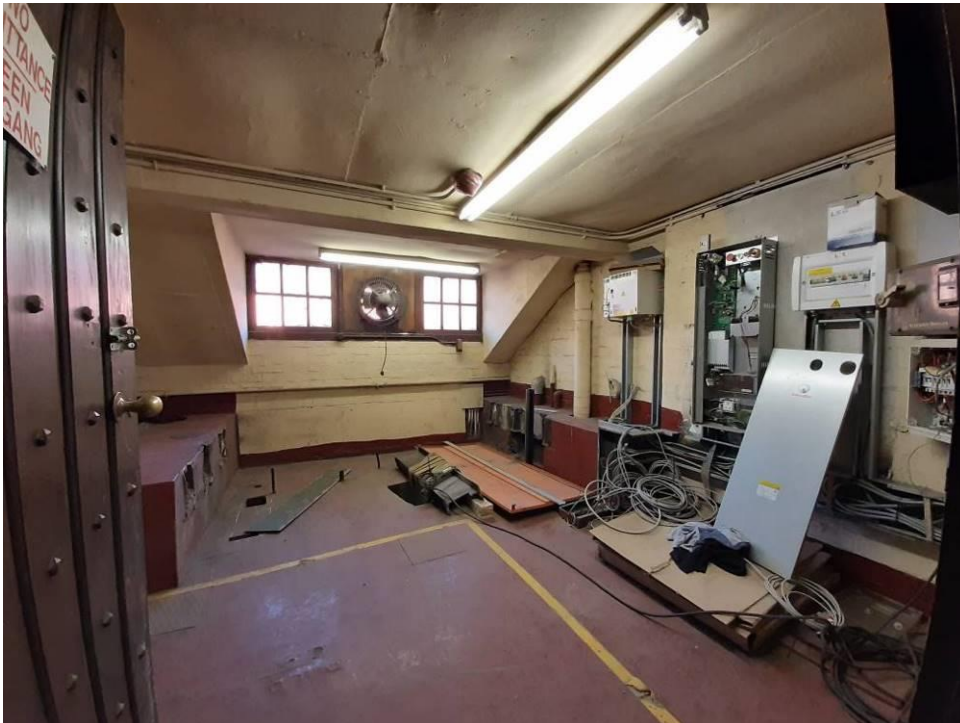
Fig. 83_Lift room located in the East wing above the Goods Lift shaft
(Source: tsica heritage consultants, 09.07.2019)

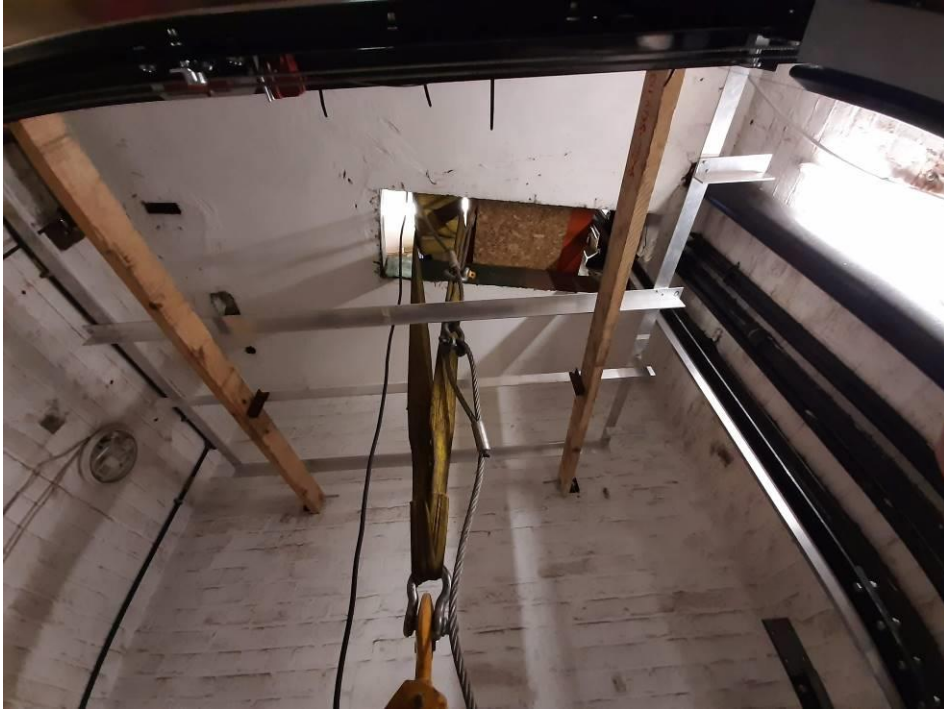
Fig. 84_Lift shaft located in the East wing
(Source: tsica heritage consultants, 09.07.2019)

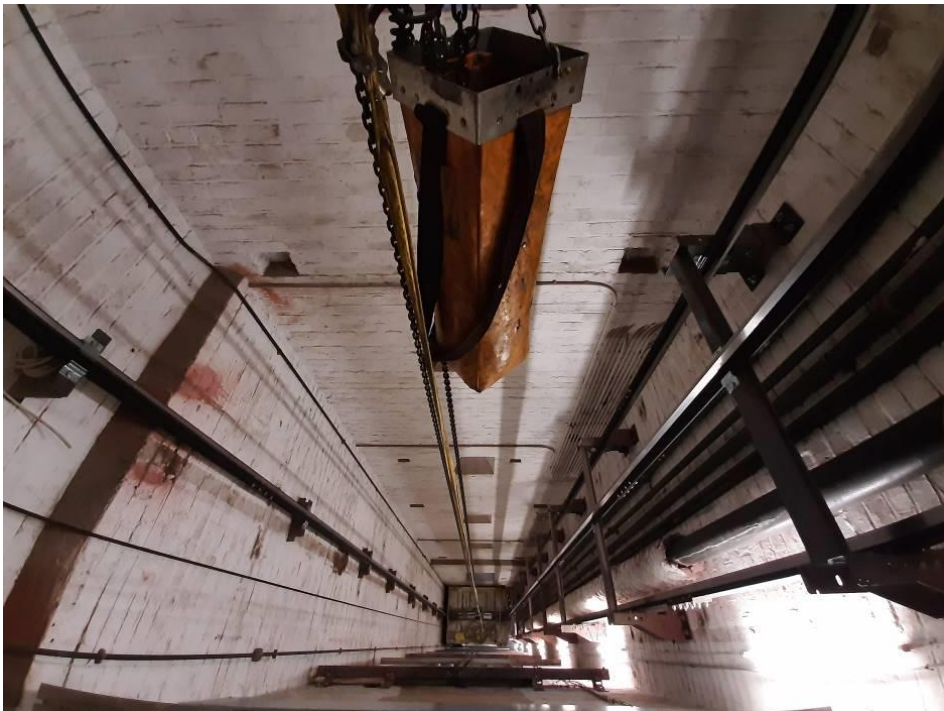
Fig. 85_Lift shaft located in the East wing
(Source: tsica heritage consultants, 09.07.2019)

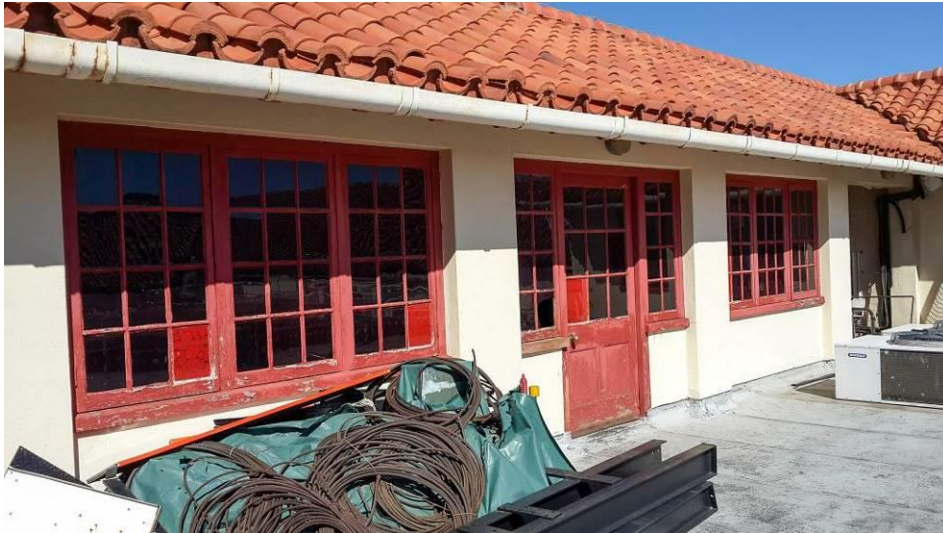
Fig. 86_ Sourced material of old lifts on top of the roof
(Source: tsica heritage consultants, 09.07.2019)

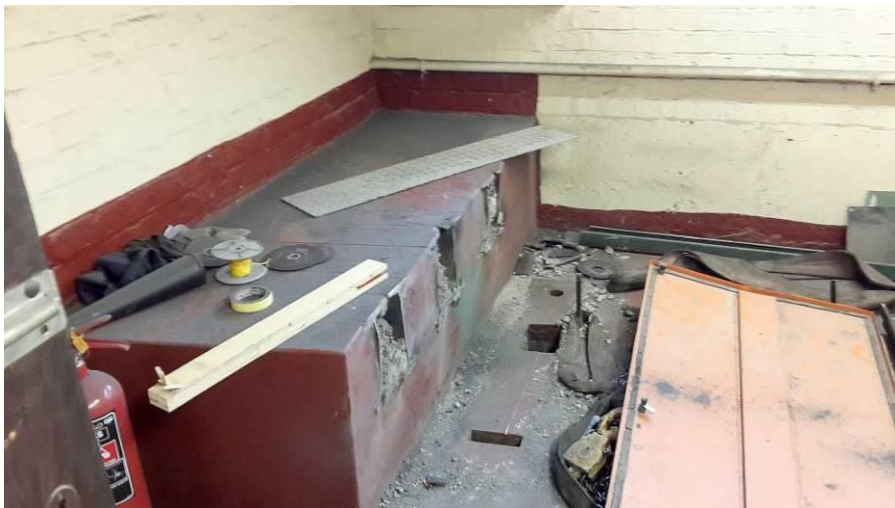
Fig. 87_ Lift room located in the East wing during the construction phase
(Source: tsica heritage consultants, 09.07.2019)

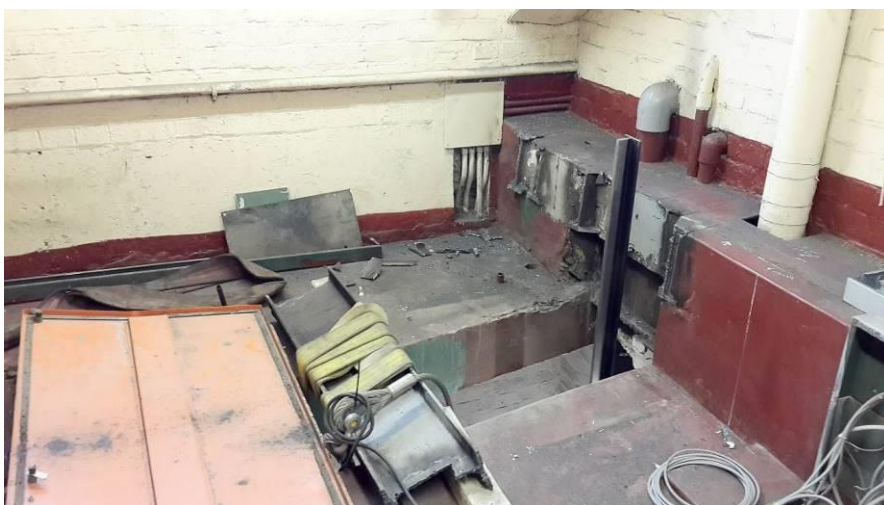
Fig. 88_ Lift room located in the East wing during the construction phase
(Source: tsica heritage consultants, 09.07.2019)
