Proposed Alleen 2 Open Cast Extension at the Magdalena Colliery near Dundee, KwaZulu-Natal:

Desktop Ecological Assessment Report

Version - 2
15 April 2014

GCS Project Number: 13-727

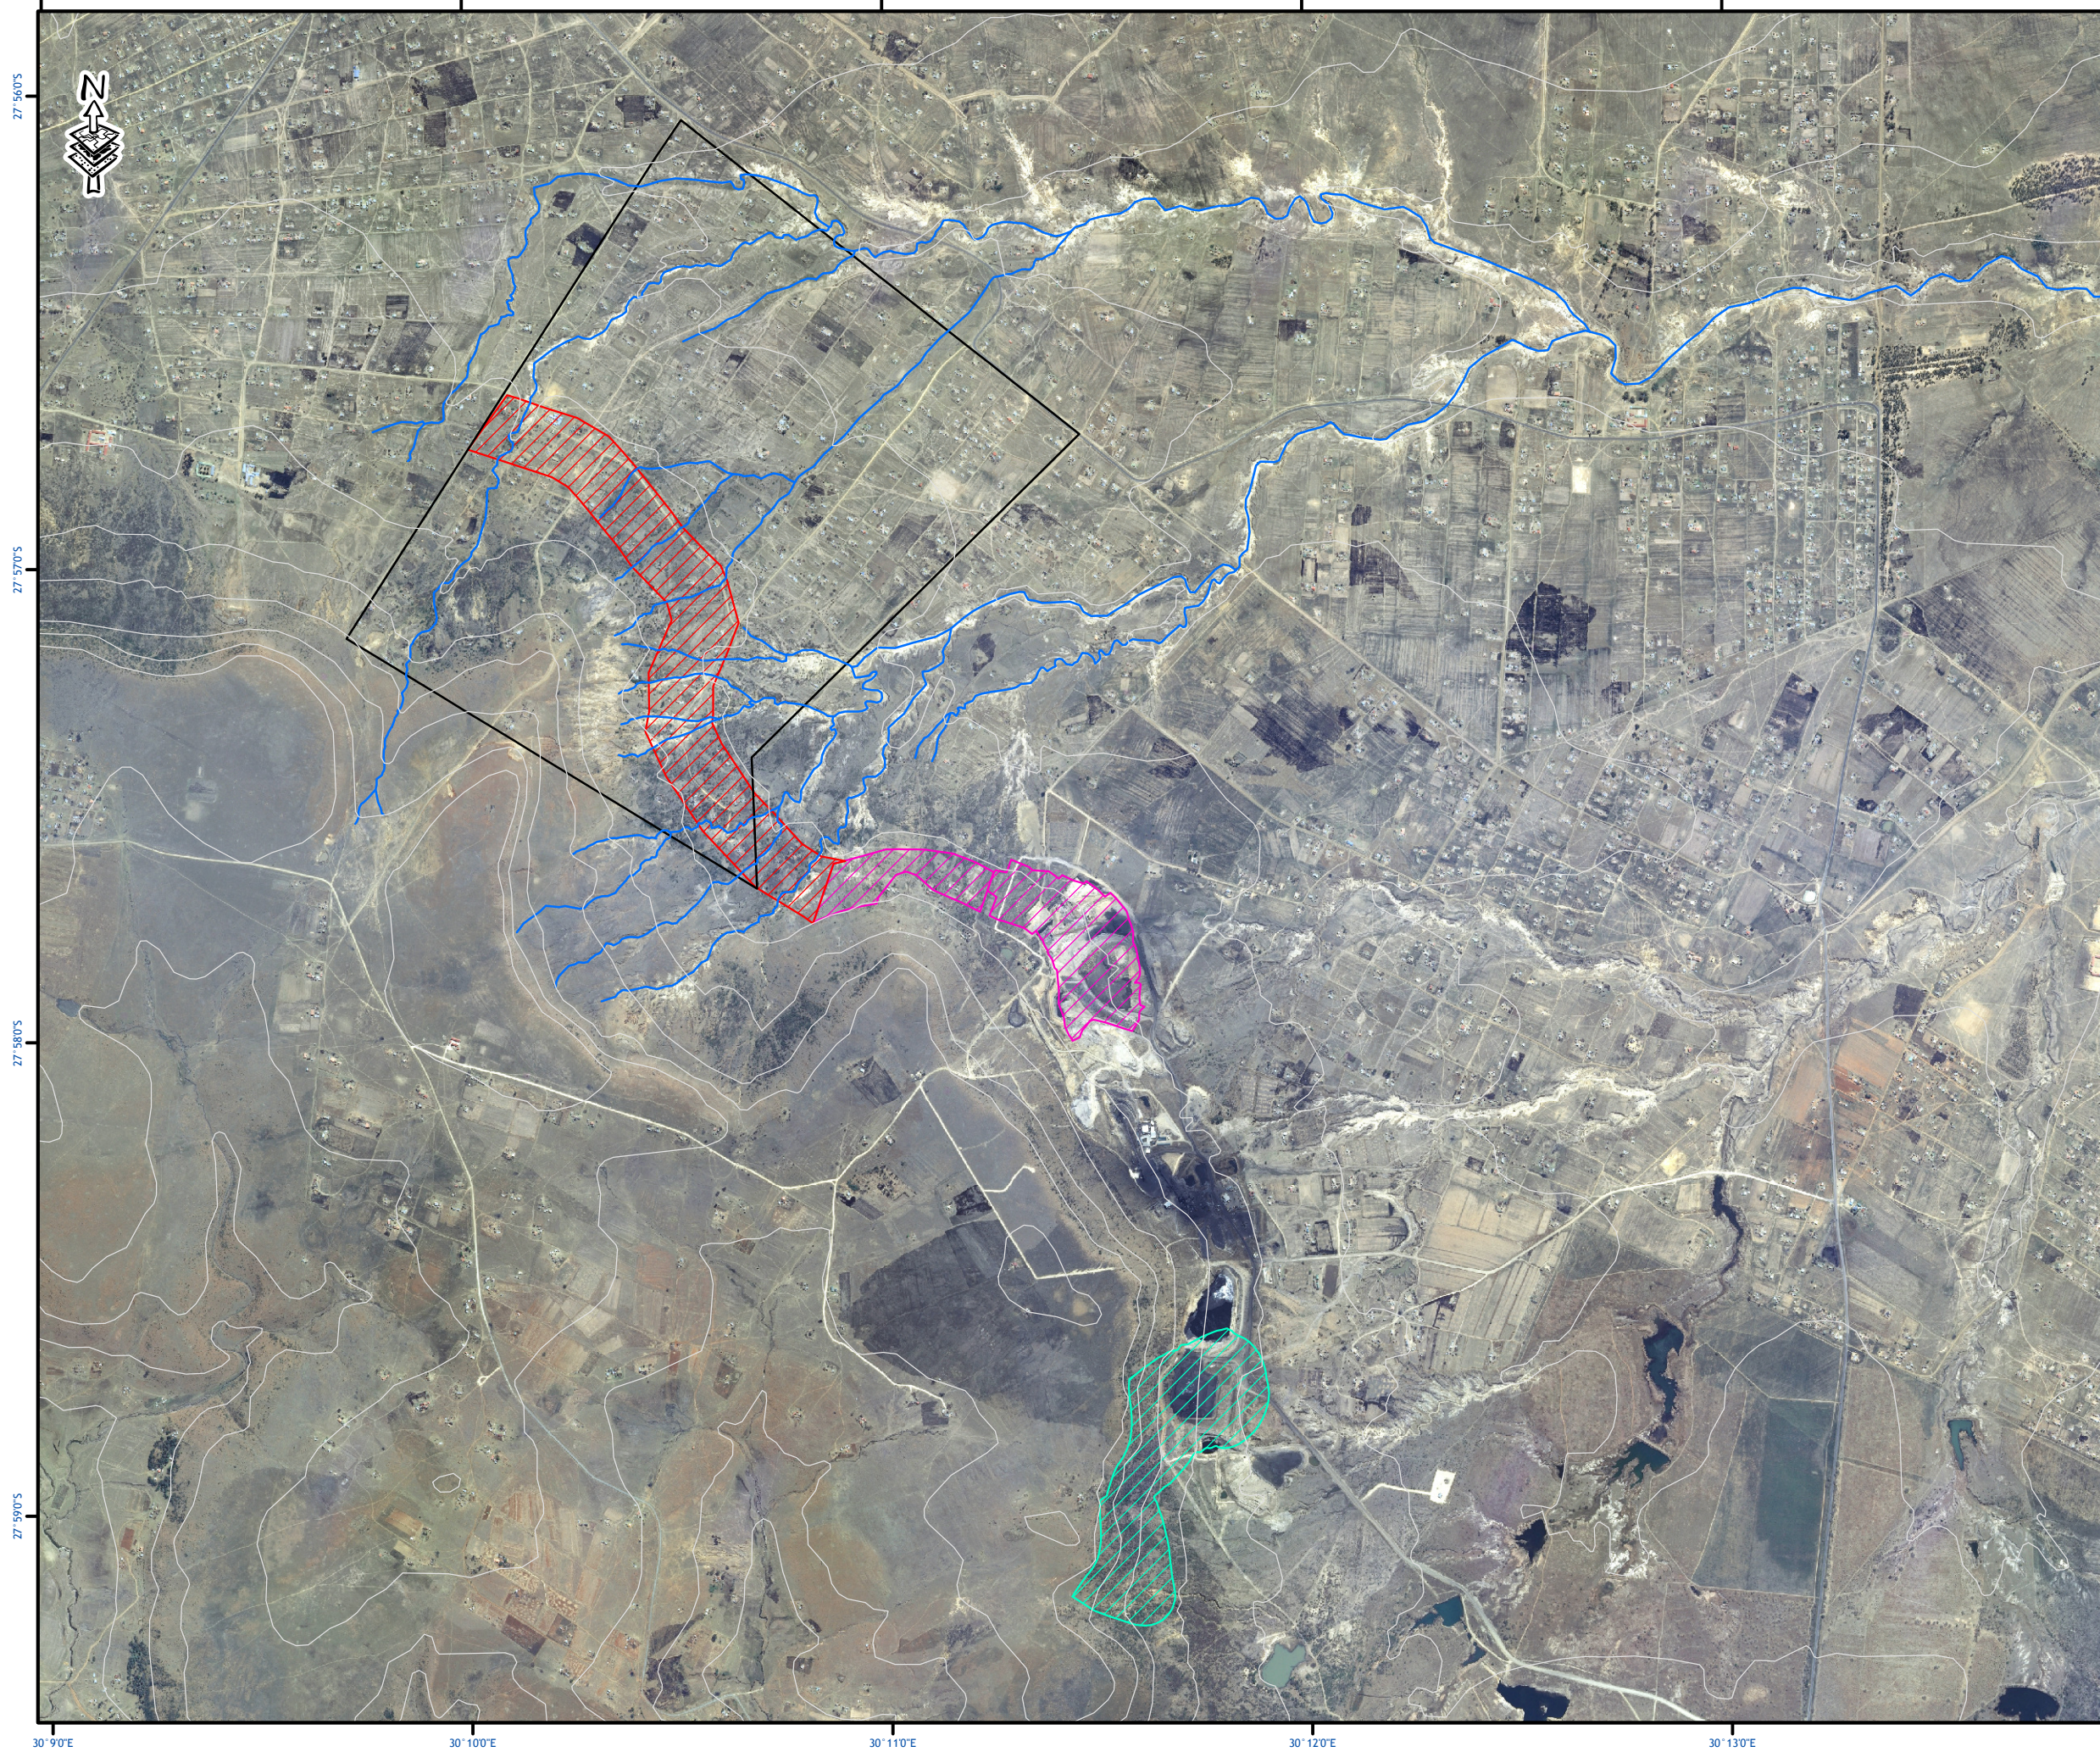
Figure 1: Study Area & Environmental Features

FIGURE 1: STUDY AREA & ENVIRONMENTAL FEATURES

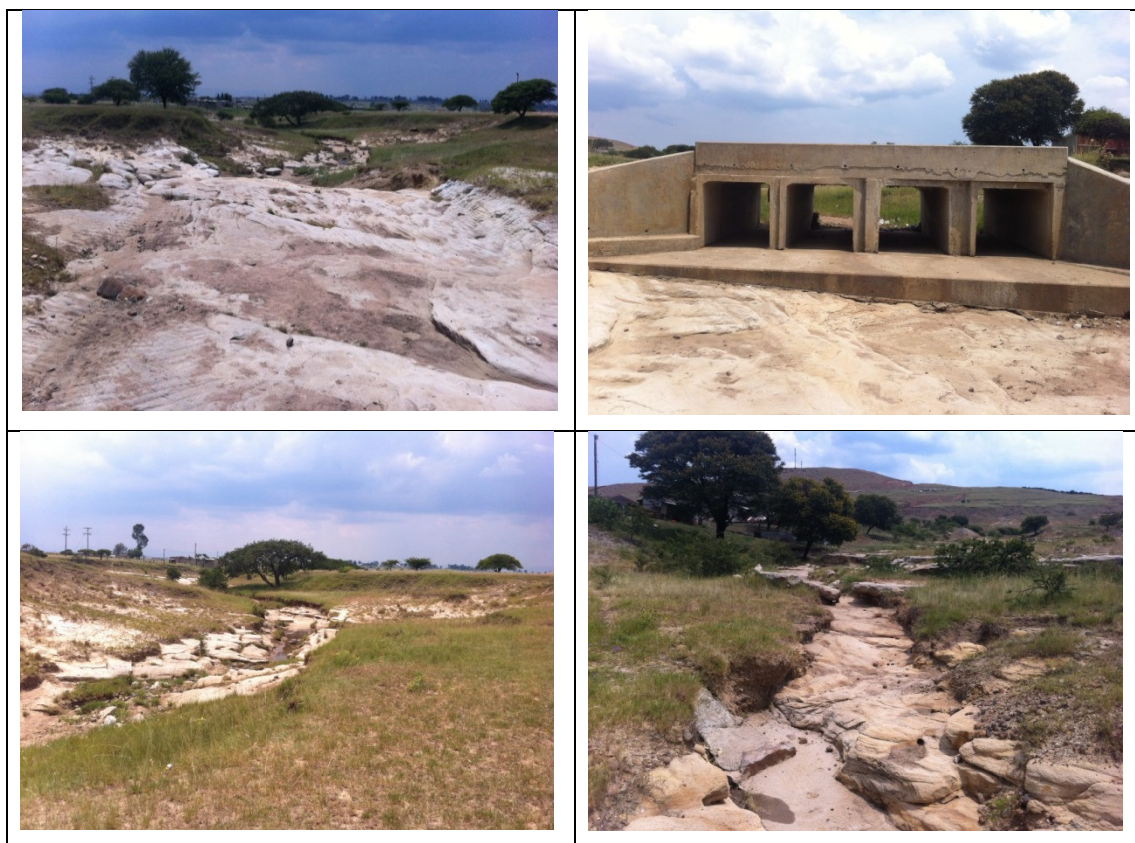
Following a raid site walkover, all of the watercourses observed were incised and had eroded down to bedrock. Plates of the impacted watercourses are shown below.

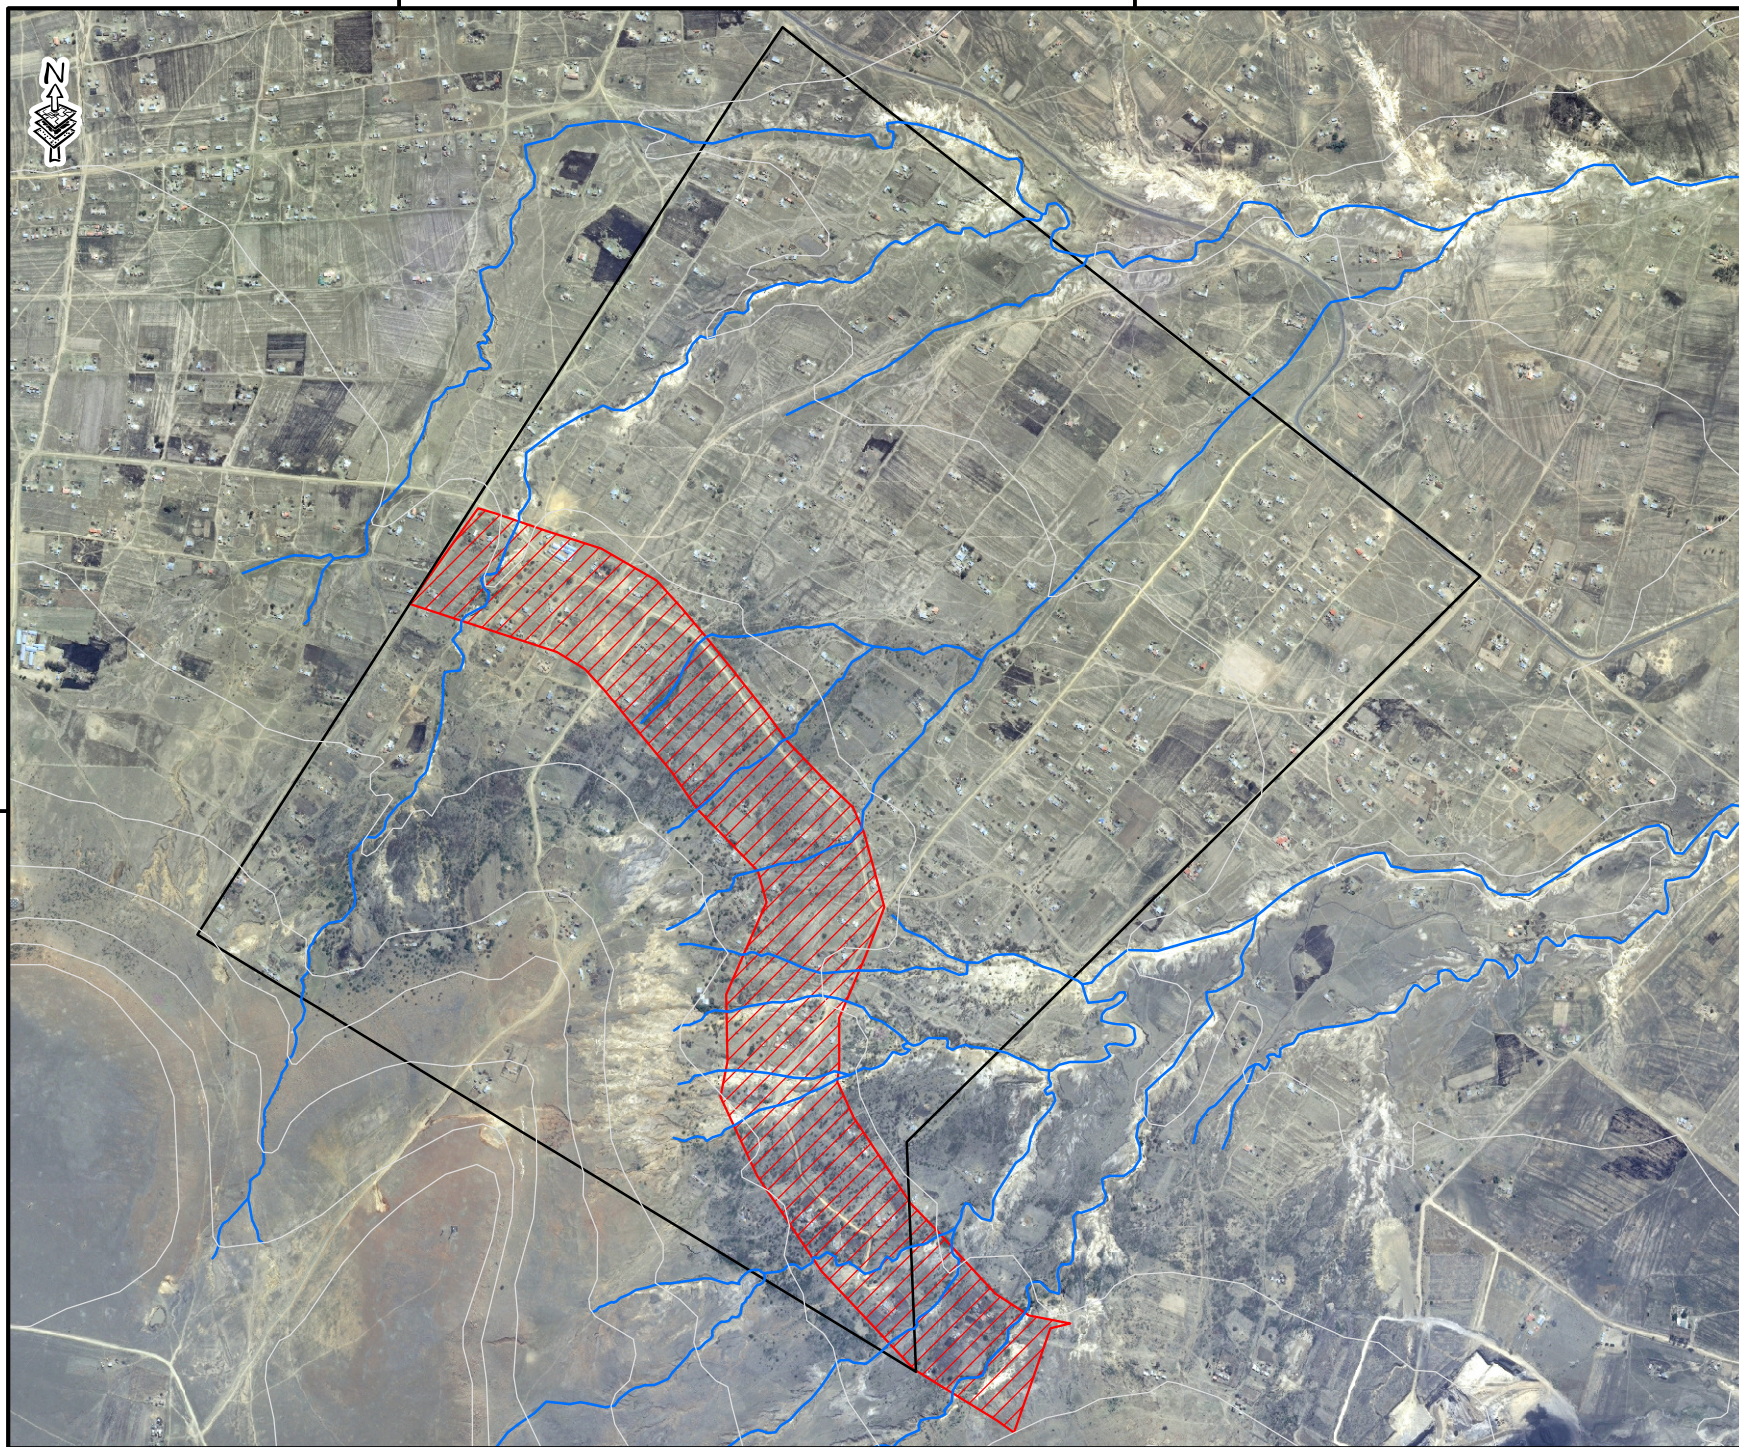
Figure 3: Drainage Lines Delineated from Aerial Photography

FIGURE 3: DRAINAGE LINES DELINEATED FROM AERIAL PHOTOGRAPHY

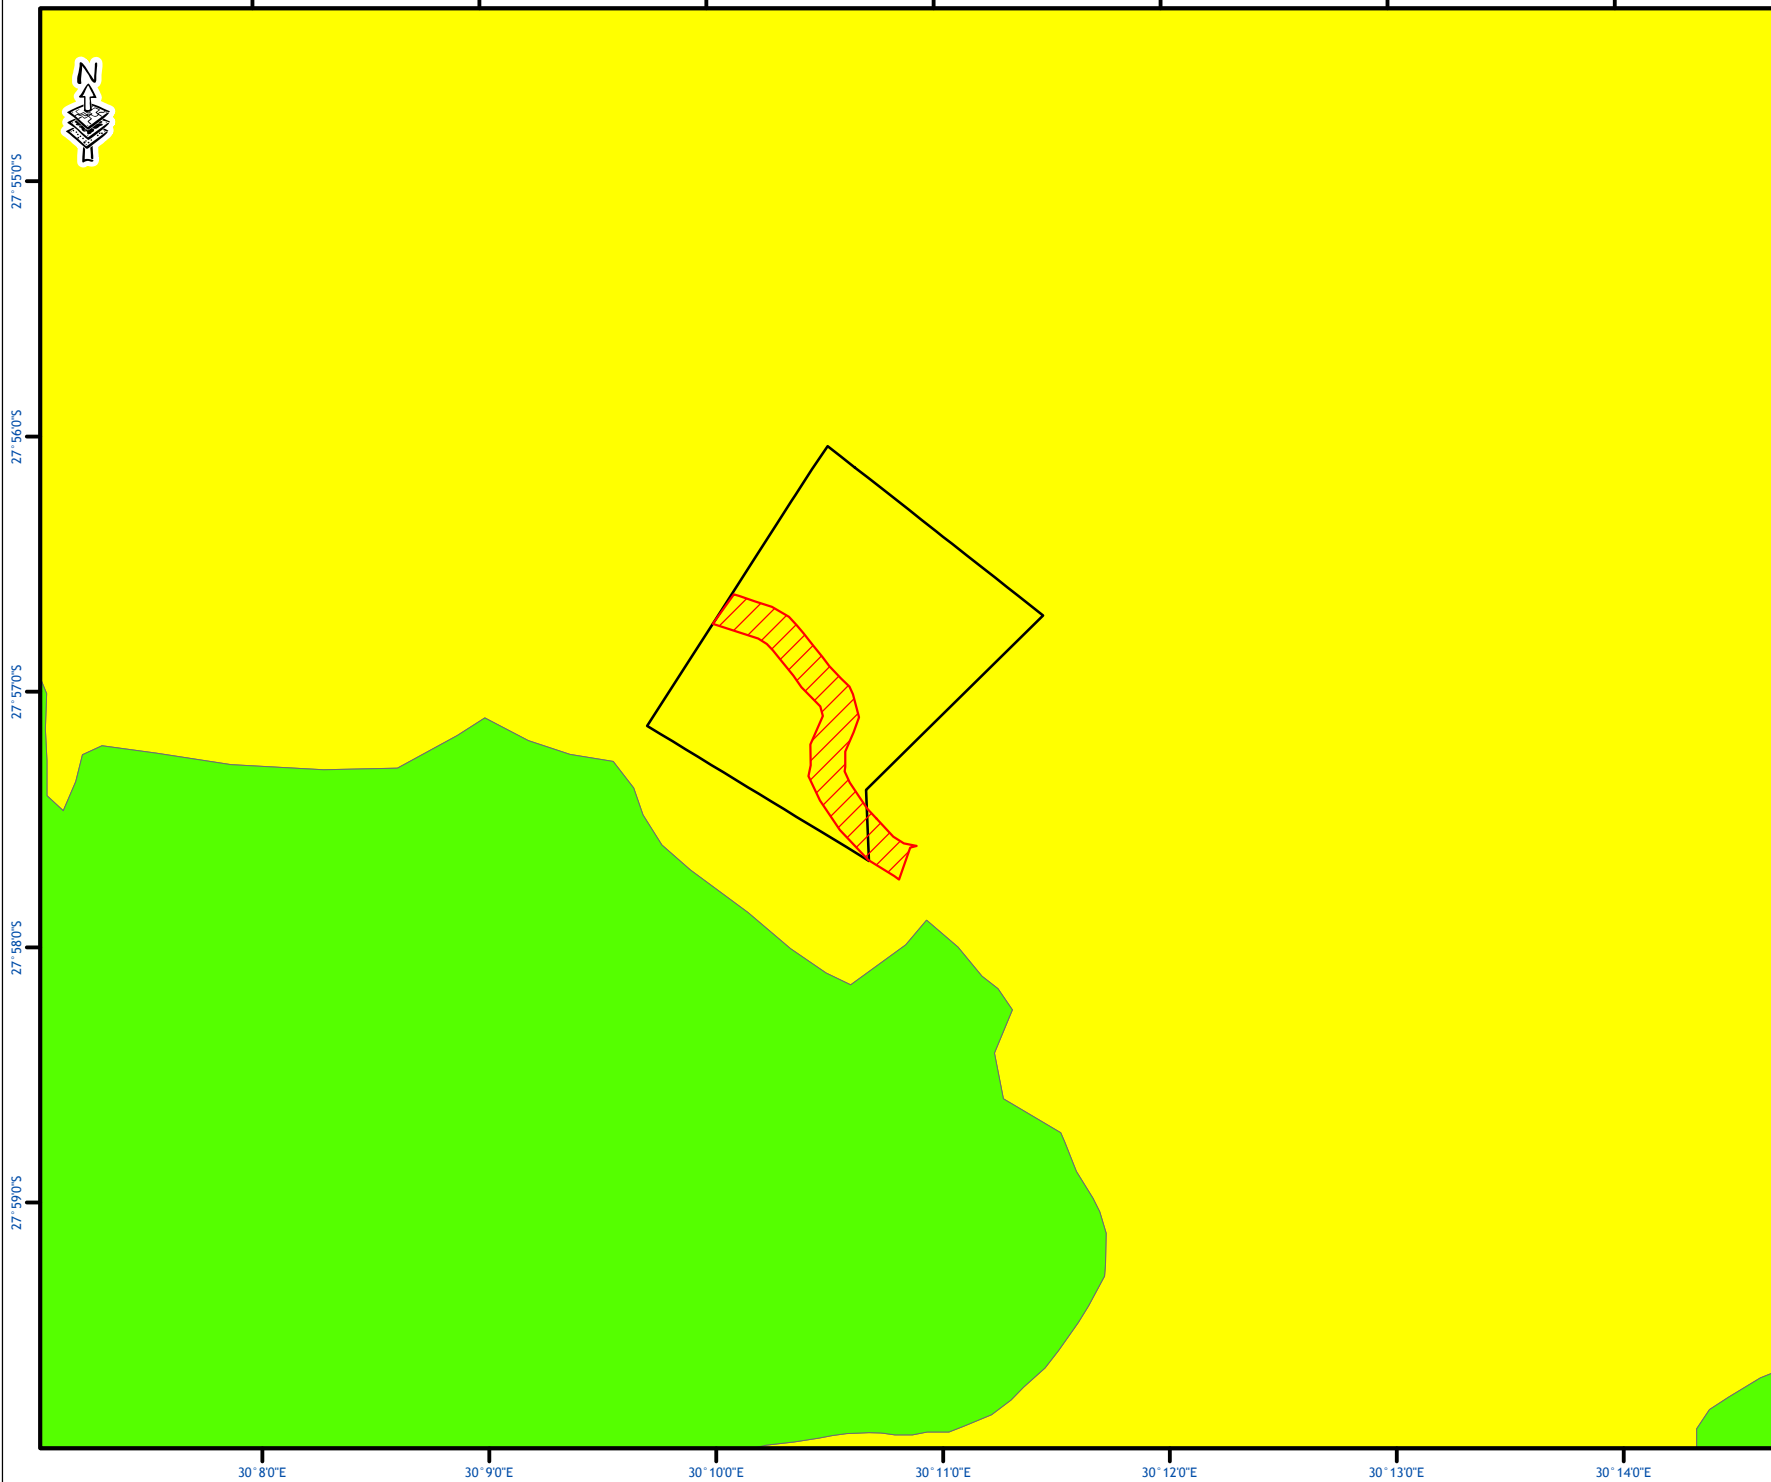
Figure 5: National Vegetation Types

FIGURE 5: NATIONAL VEGETATION TYPES

The project site is located within the Income Sandy Grassland vegetation unit as defined by Mucina & Rutherford (2006). The majority of the natural grassland has been cleared and/or transformed by rural development and overgrazing and associated erosion, and only small degraded/secondary patches remain in the steeper slopes.

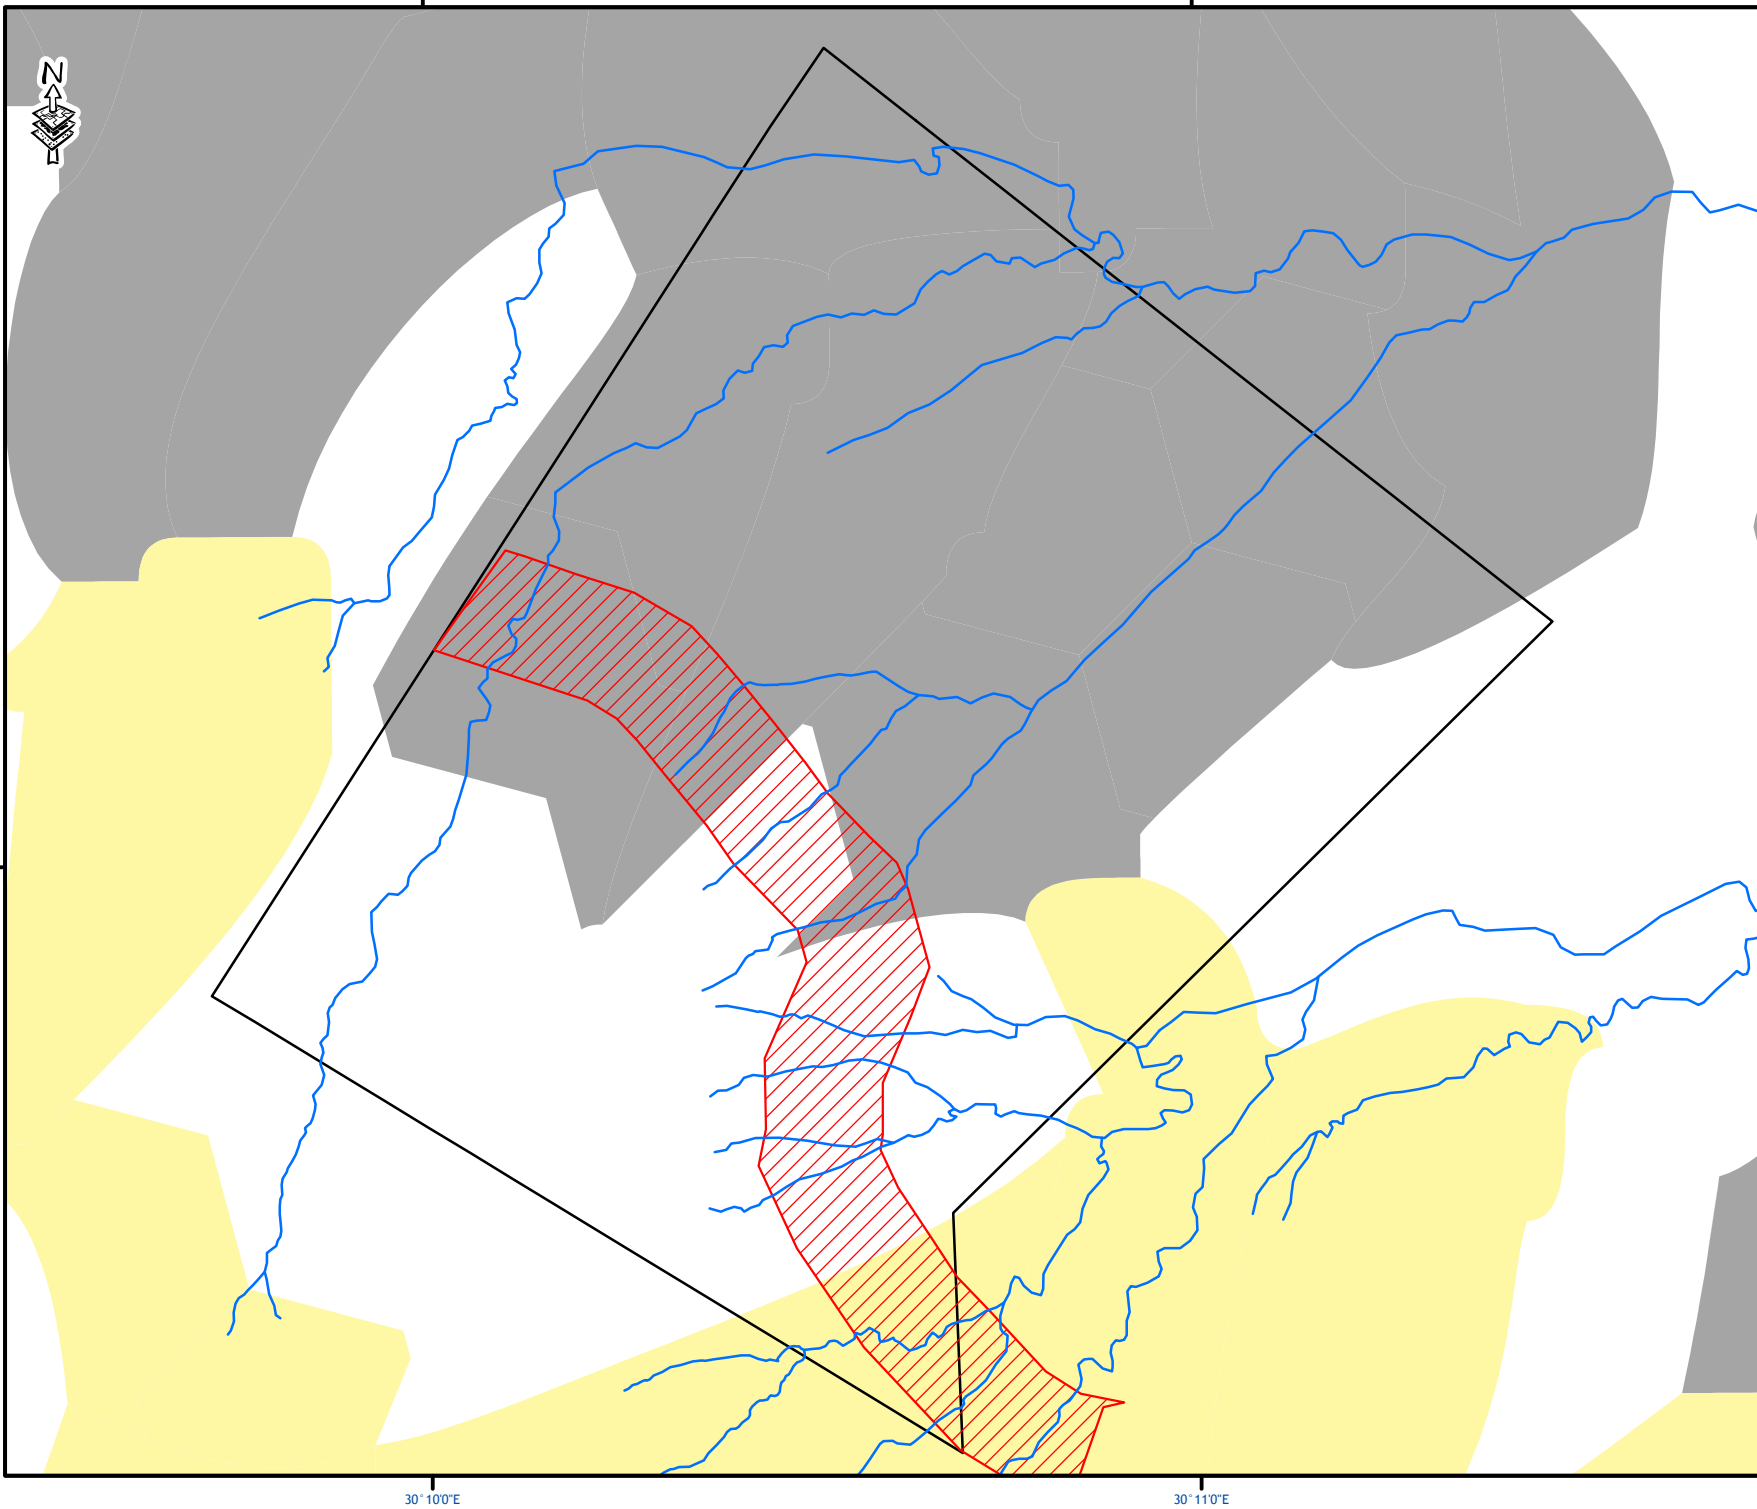
Figure 9: KZN Terrestrial Systematic Conservation Plan

FIGURE 9: KZN TERRESTRIAL SYSTEMATIC CONSERVATION PLAN (C-PLAN)

The central-eastern patch is classified as the possible remnants of Income Sandy Grassland and Glencoe Moist Grassland that could potentially host populations of *Doratogonus minor* and *Cochlitoma simplex*. However, a review of the aerial photography indicates that this patch has been transformed by rural development and is of limited conservation importance from a floral and faunal perspective.

The south-eastern patch is classified as the possible remnants of Income Sandy Grassland, Glencoe Moist Grassland and Midland Floodplain Grassland that could potentially host populations of *Doratogonus minor* and *Cochlitoma simplex*. However, a review of the aerial photography indicates that this patch has been disturbed by rural settlement and gully erosion and that the secondary grassland vegetation that remains has undergone woody bush encroachment. Intact secondary grassland is present in the vicinity of CBA3 zone, referred to as 'Intact Secondary Grassland' in sections above.
