PRECONSTRUCTION ARCHAEOLOGICAL SURVEY OF THE MAINSTREAM SUTHERLAND 2 WIND ENERGY FACILITY, NORTHERN CAPE

Required as a condition of authorisation.

Sutherland 2 WEF SAHRIS Case IDs: 9622, 10500, 14521
Sutherland Grid & MTS SAHRIS Case IDs: 10493, 14379, 16771, 17529, 17531

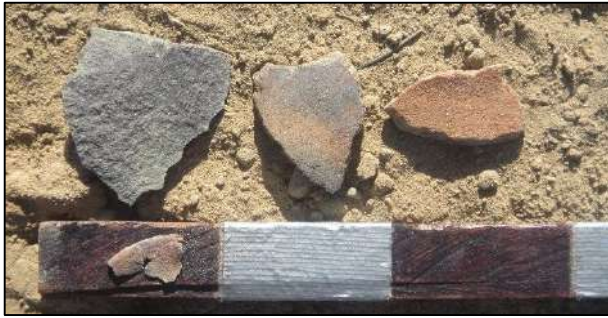
Figure 13: Quartzite flake and potsherds from the LSA and historical scatter at waypoint 1291. Scale = 15 cm.

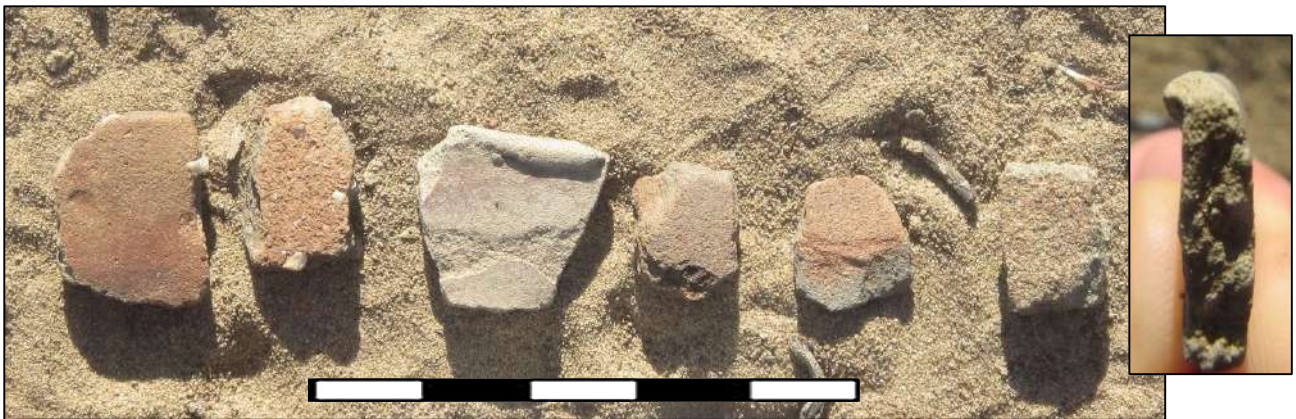
Figure 15: Pot sherds from the scatter with little other than pottery at waypoint 1294. The inset shows the cross-section through the rim sherd with everted lip. Scale = 6 cm.

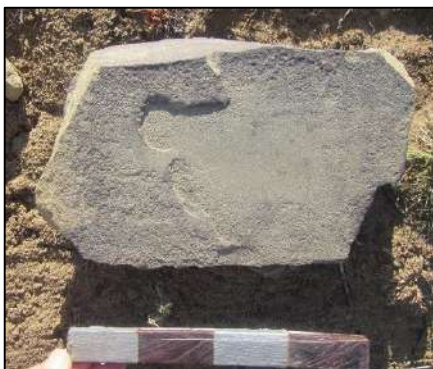
Figure 16: A lower grindstone found on the scatter at waypoint 1295. Scale = 20 cm.

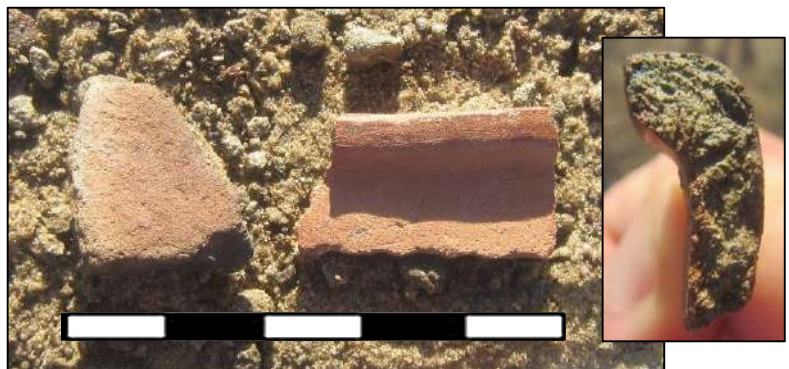
Figure 17: Pot sherds from the scatter at waypoint 1295. The inset shows the cross-section through the rim sherd with everted lip. Scale = 6 cm.

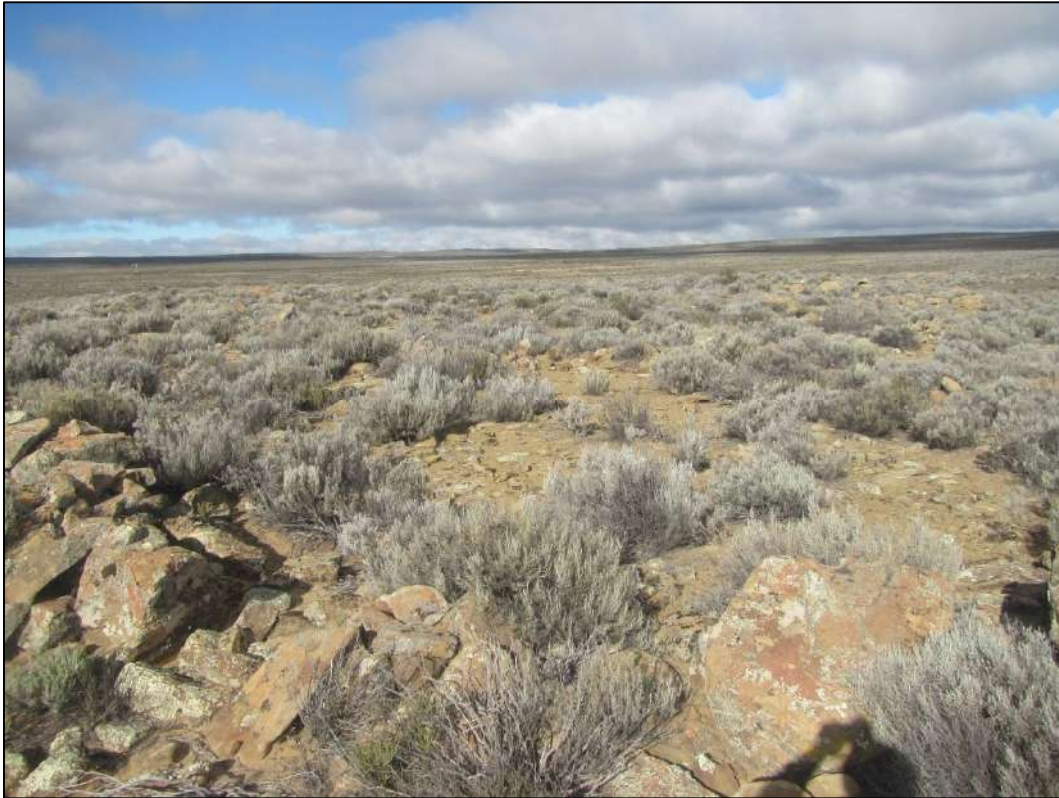
Figure 18: An example of one of the stone-walled enclosures in the LSA kraal complex at waypoints 1301 to 1309. This is at waypoint 1301.

- Wherever project infrastructure comes within 30 m of heritage resources the infrastructure should be micro-sited to get the distance between the resource and infrastructure as close to 30 m as possible. This applies to waypoints 1176, 1184, 1194-1199 inclusive, 1301 and 1309;

- Any heritage sites located within 30 m of the final layout should be physically flagged on site as no-go areas. This applies to the waypoints listed above unless infrastructure is moved beyond 30 m;

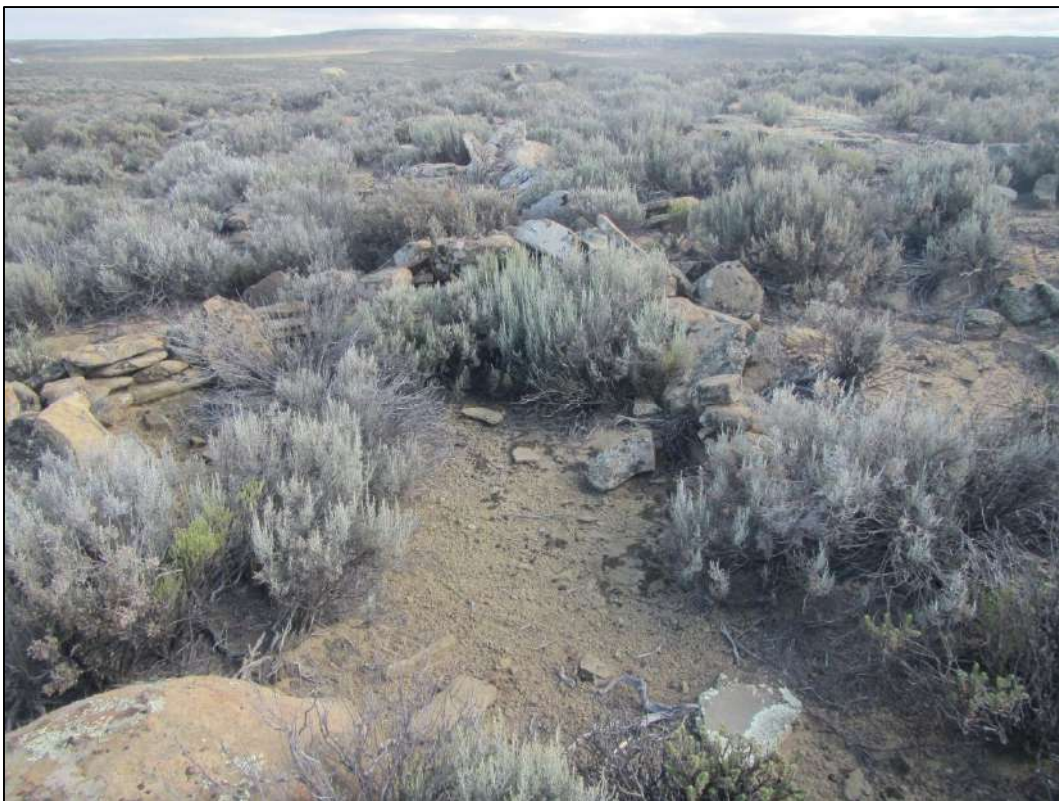
Figure 19: An example of one of the stone-walled enclosures in the LSA kraal complex at waypoints 1301 to 1309. This is at waypoint 1307.

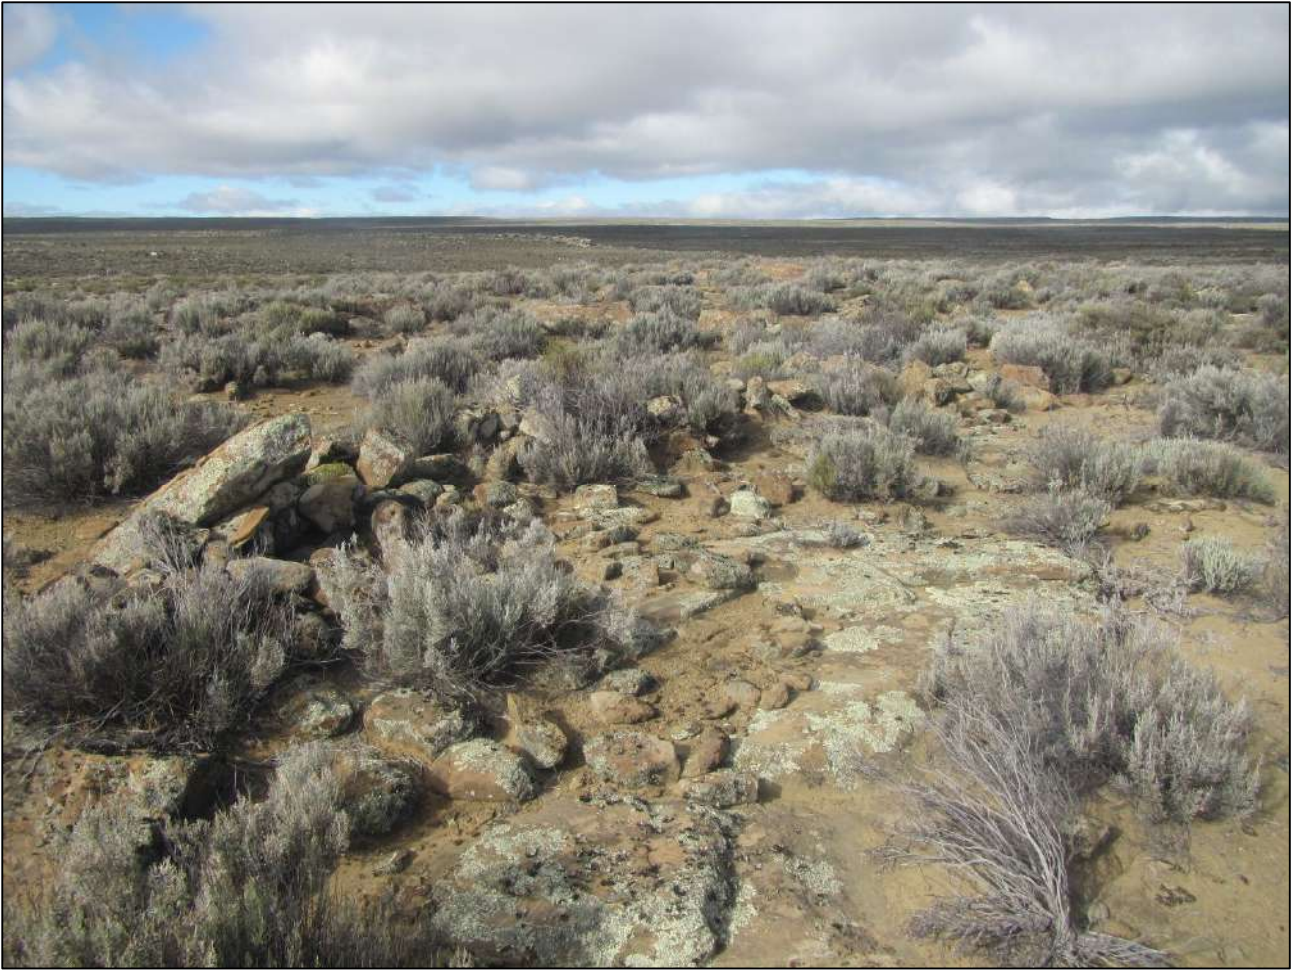
Figure 20: An example of one of the stone-walled enclosures in the LSA kraal complex at waypoints 1301 to 1309. This is at waypoint 1302.

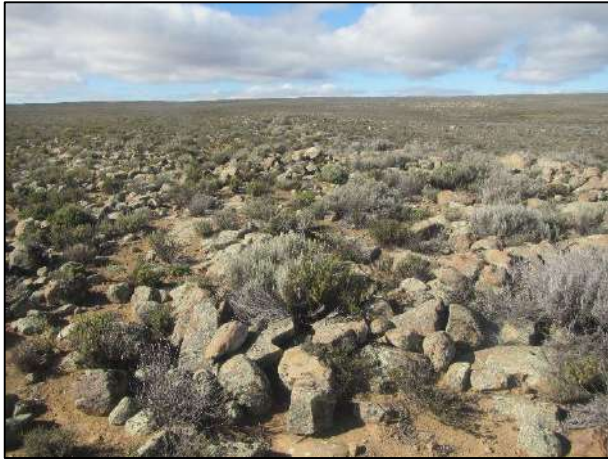
Figure 24: An example of one of the stone-walled enclosures in the LSA kraal complex at waypoints 1315 to 1318. This is at waypoint 1315.

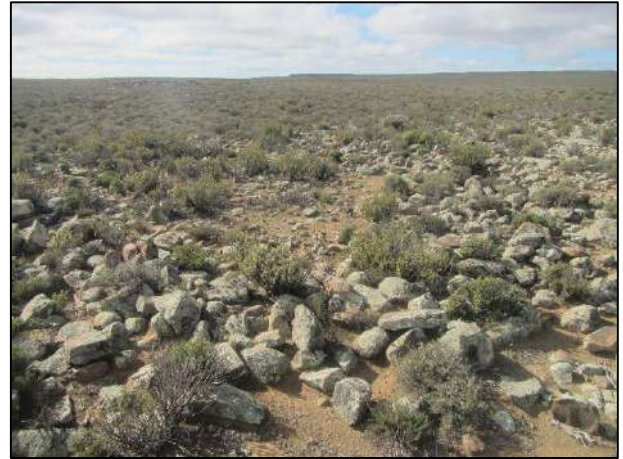
Figure 25: An example of one of the stone-walled enclosures in the LSA kraal complex at waypoints 1315 to 1318. This is at waypoint 1318.

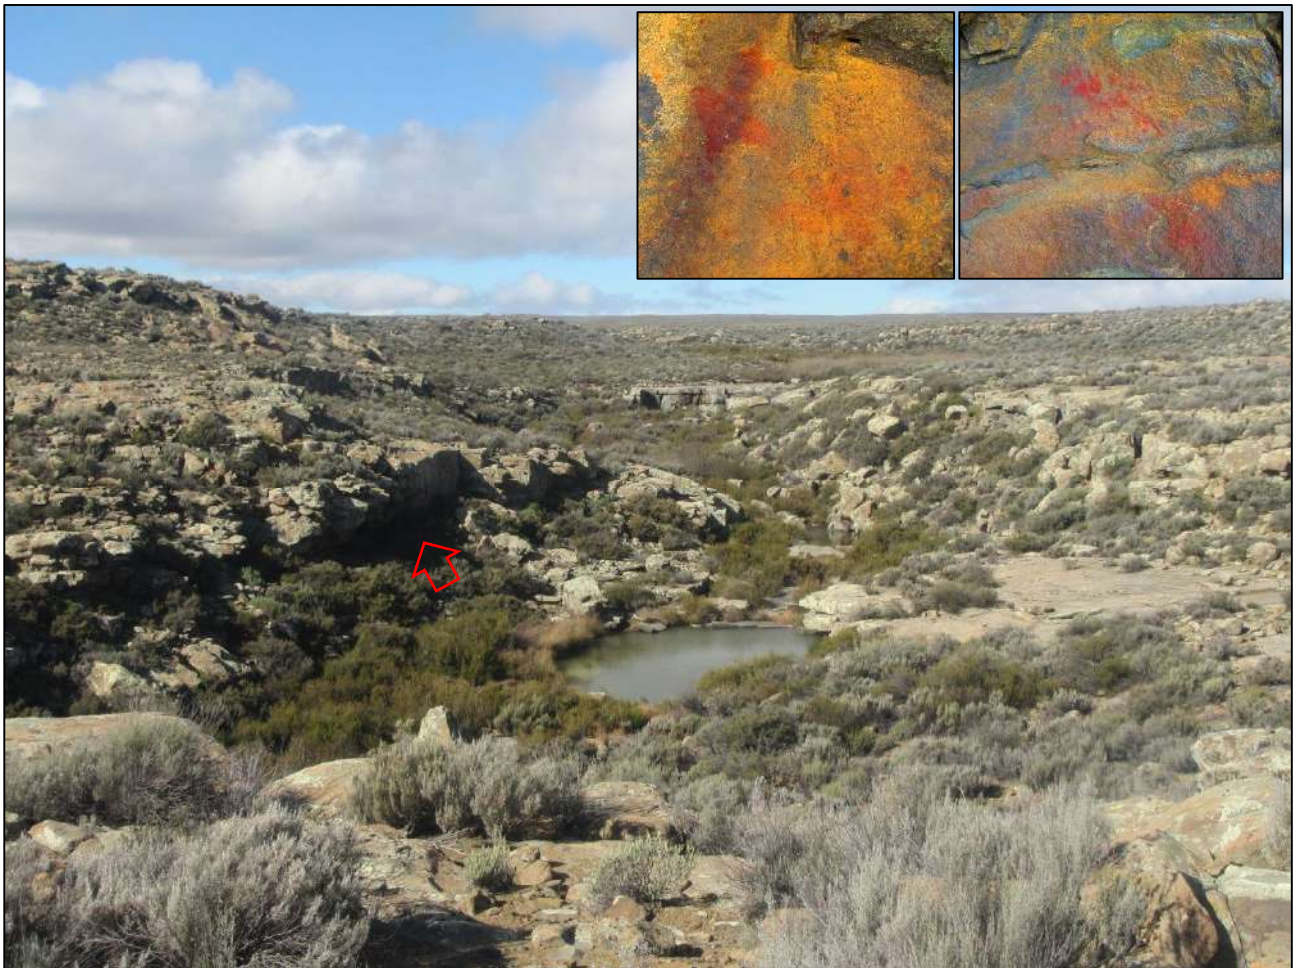
Figure 26: View towards the pool in the river and the adjacent rock shelter at waypoint 1319 (arrowed). The shelter contains faded red finger-painted imagery (insets with colour manipulation to enhance the paint).

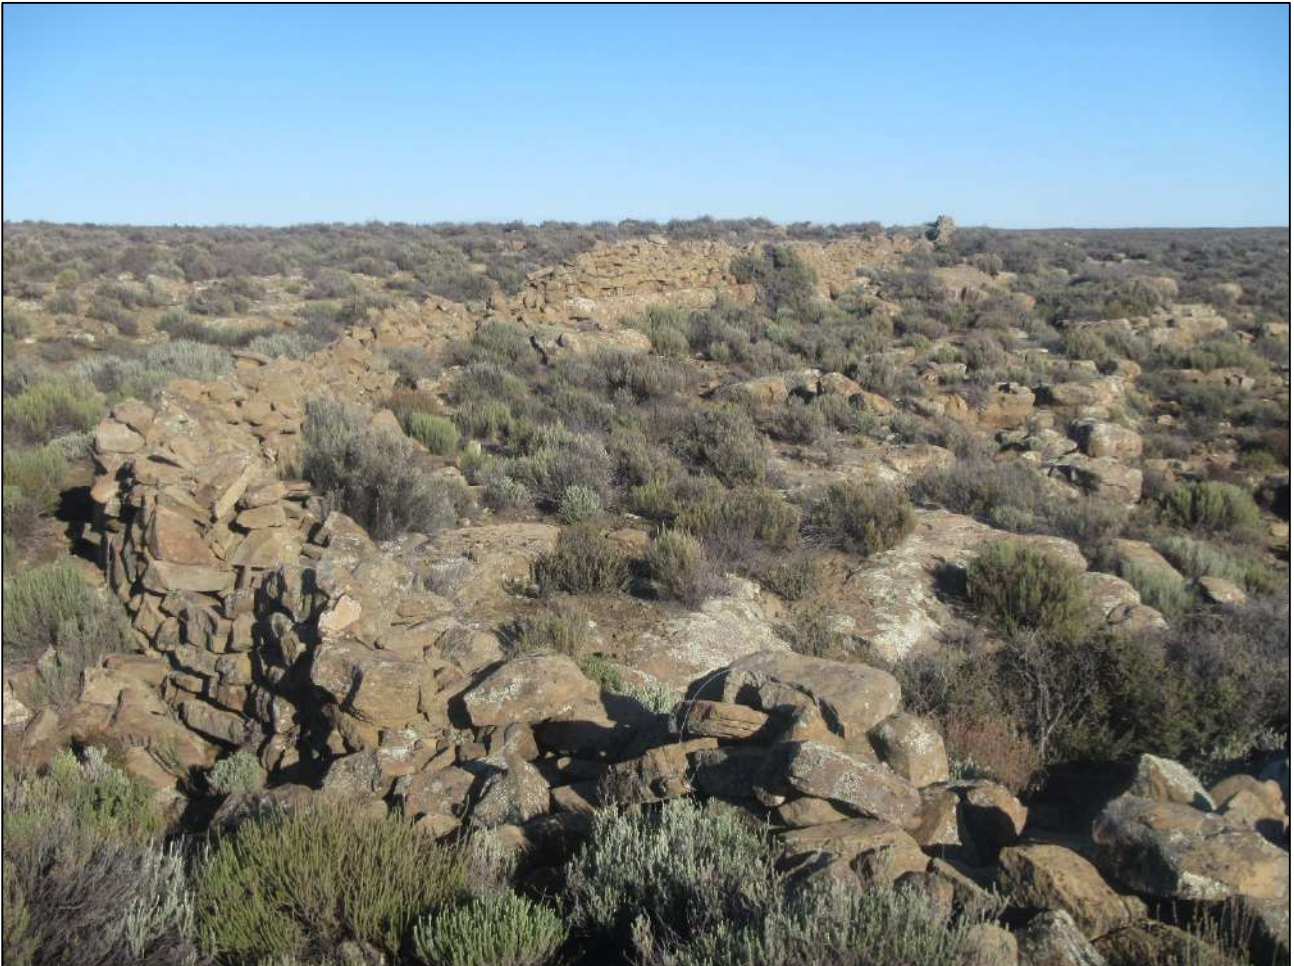
Figure 27: A long stone wall surrounds the valley that contains the largest dam on Theronsrus. Such walls were often built around areas with arable land to keep animals out of the crops. Waypoints 1174 and 1175 fall along this wall with this view being at the former point.

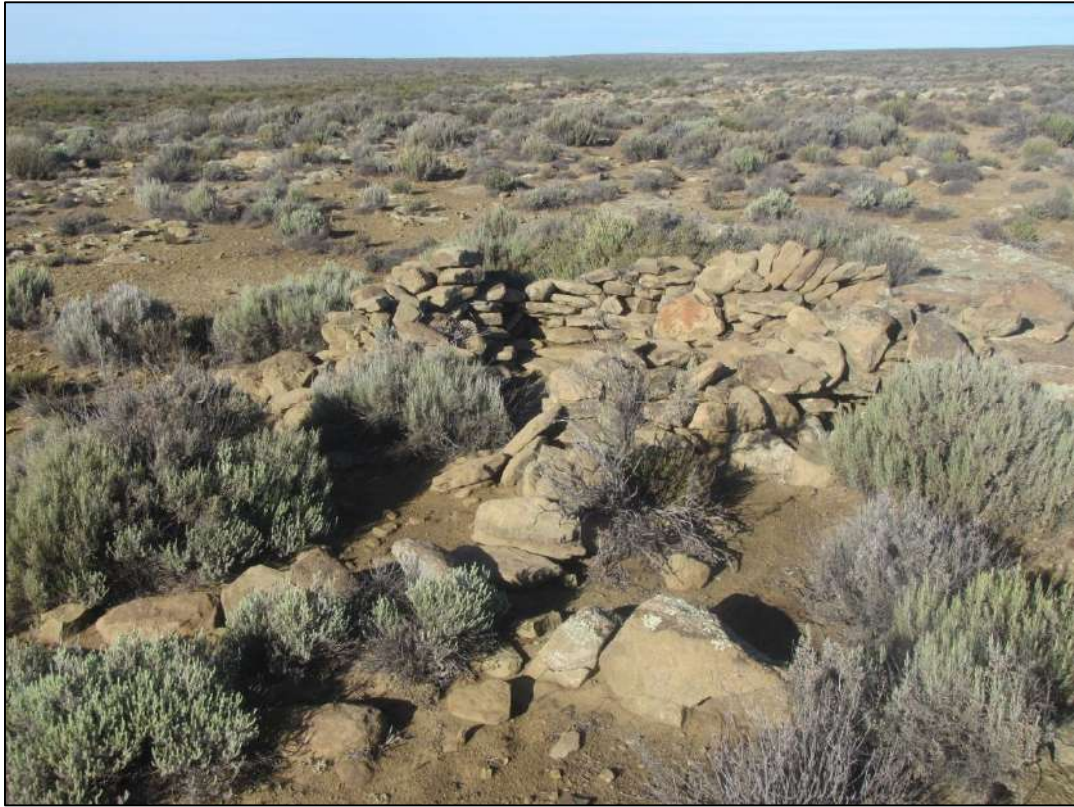
Figure 28: Small stone-walled structure at waypoint 1176. It was likely a shepherd's hut.

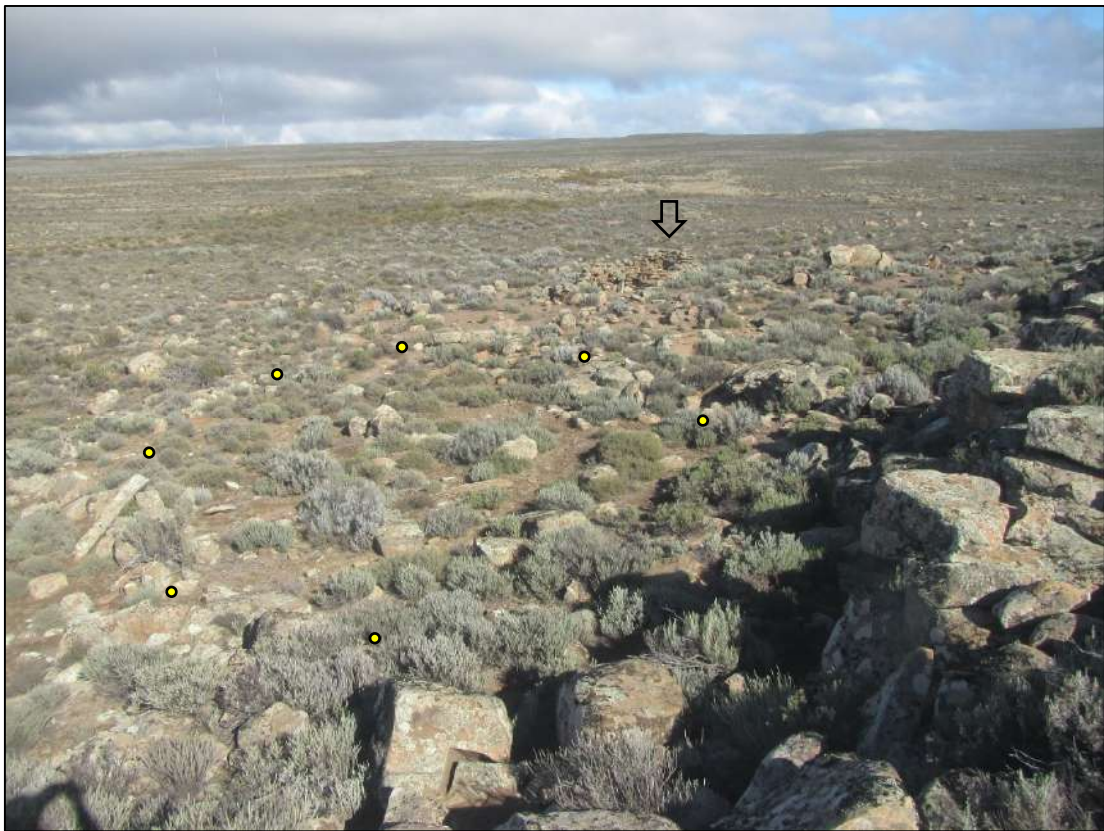
Figure 29: Semi-circular stone kraal against a scarp at waypoint 1313 (indicated by yellow dots) with the house ruin at waypoint 1314 in the background (arrowed).

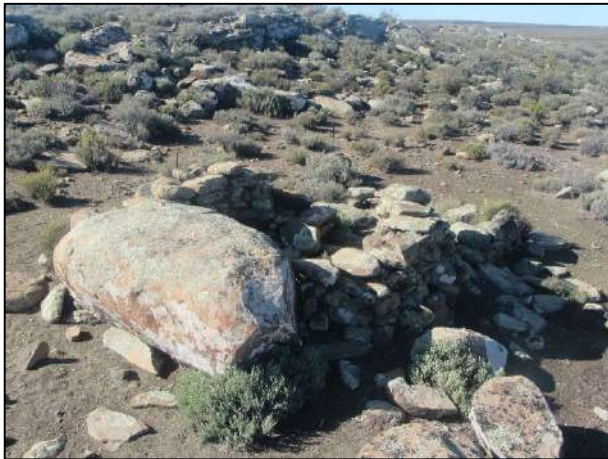
Figure 45: The small structure at waypoint 1203. Its western wall is formed by a boulder.

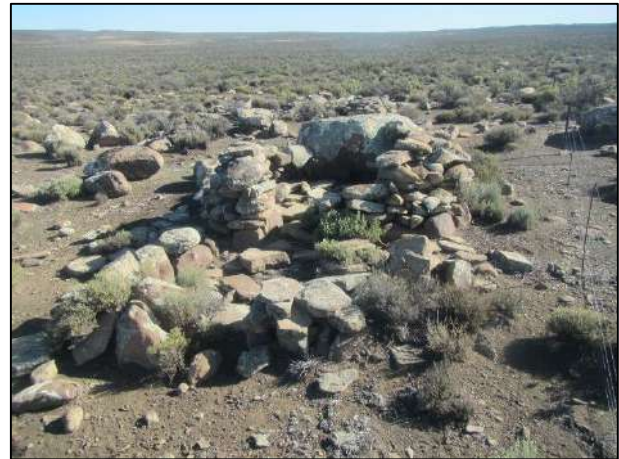
Figure 46: The small structure at waypoint 1203 showing the vestibule area. In the foreground

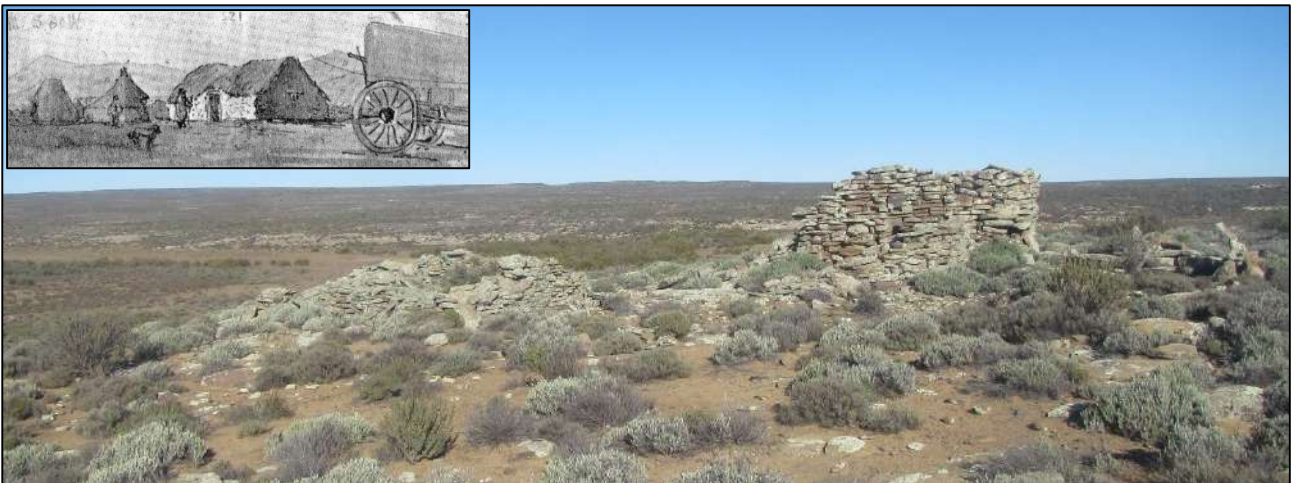
Figure 47: House ruin at waypoint 1204. It is part of a ruined early farm complex. The inset shows an 1811 drawing of a trekboer farmhouse by William Burchell with a similar doorway to that seen on this house. Source: Van Zyl (1975:103).

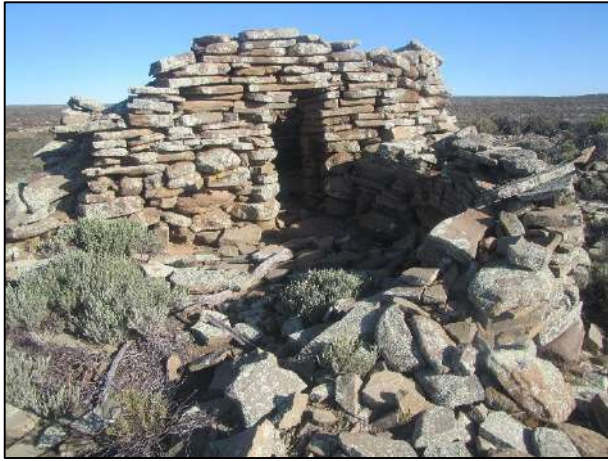
Figure 48: The doorway in the house at waypoint 1204 is fully preserved.

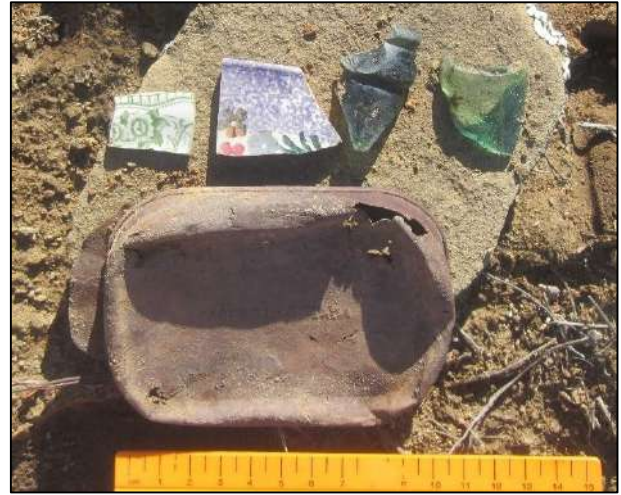
Figure 49: Artefacts seen around the house at waypoint 1204. Scale = 15 cm.

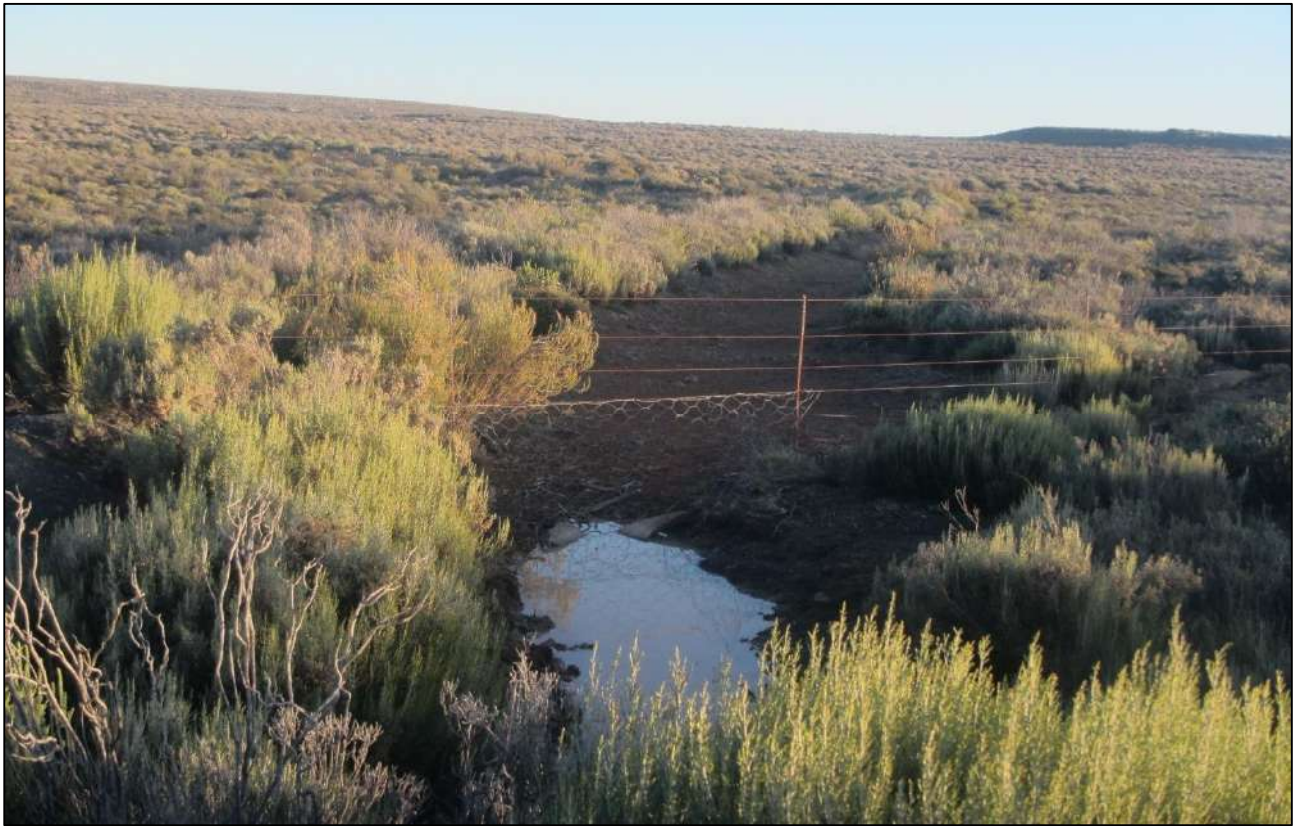
Figure 50: View of the historic leiwater furrow where it crosses the west-east gravel road through the site. This is at waypoint 1209.

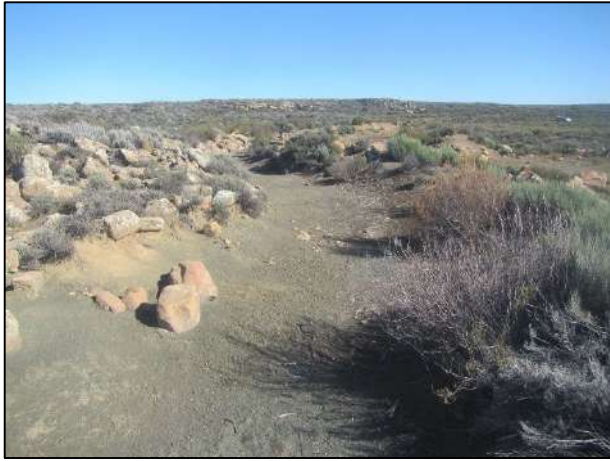
Figure 51: Section of the leiwater furrow at waypoint 1286.

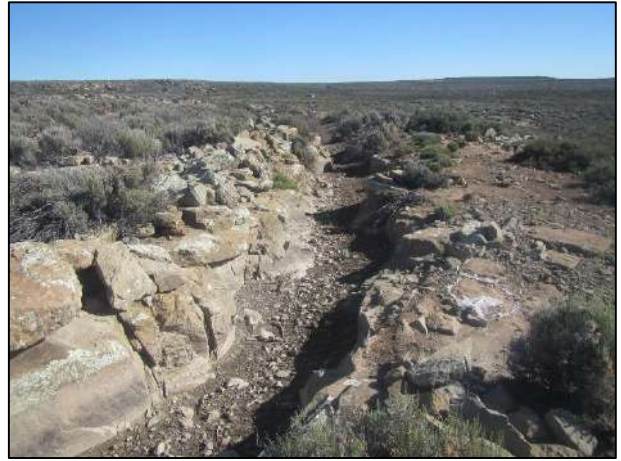
Figure 52: Section of the leiwater furrow (no specific waypoint)

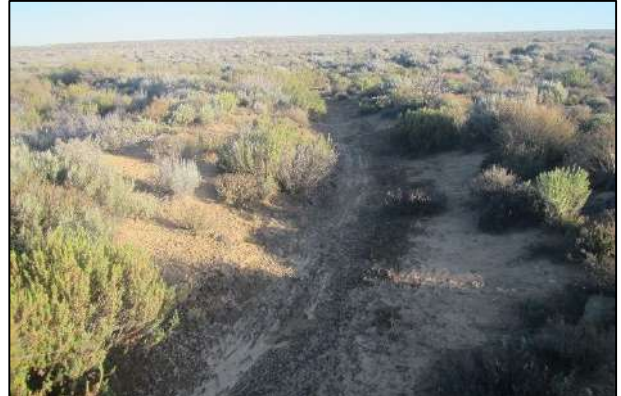
Figure 54: Section of the leiwater furrow at waypoint 1297.

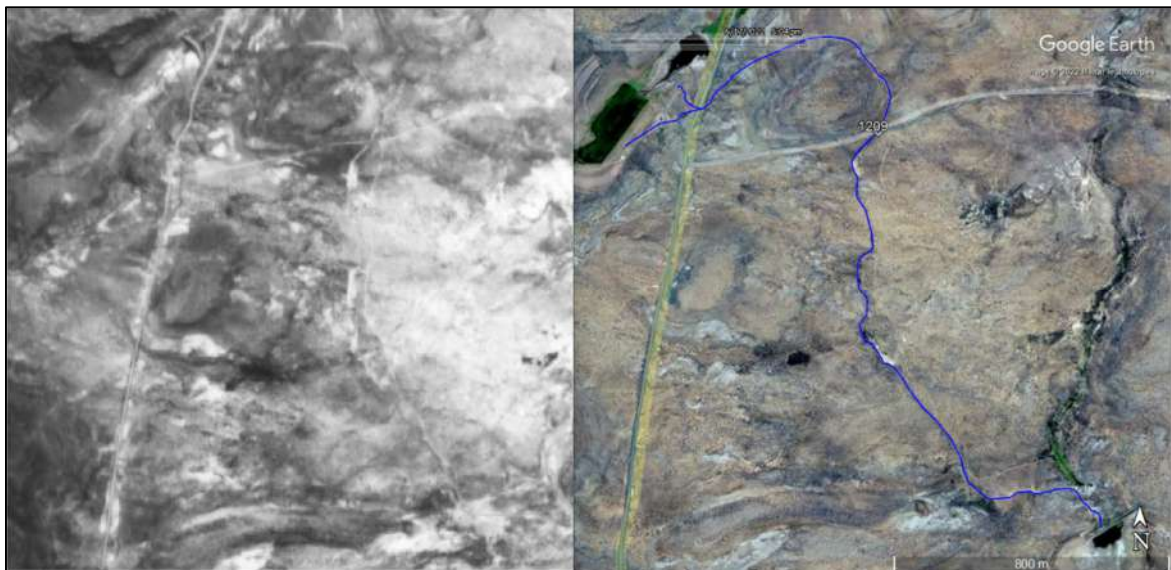
Figure 55: Comparative aerial photography from 1960 (450_012_05047) and 2014 (Google Earth) with the leiwater marked in blue on the latter image. This is the earliest available aerial photography for the study area but it shows the leiwater system to be older than 60 years.

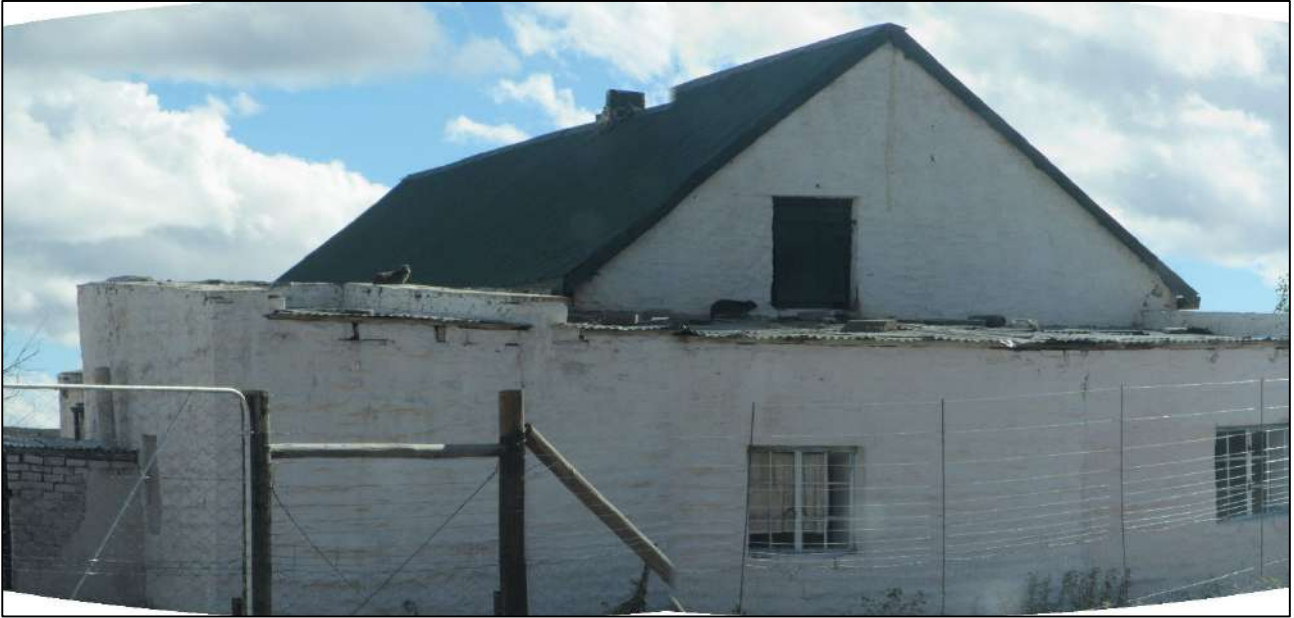
Figure 56: Abandoned farmhouse in the Ou Plaas farm complex at waypoint 1165. This is the northern end of the house showing a flat-roofed addition.

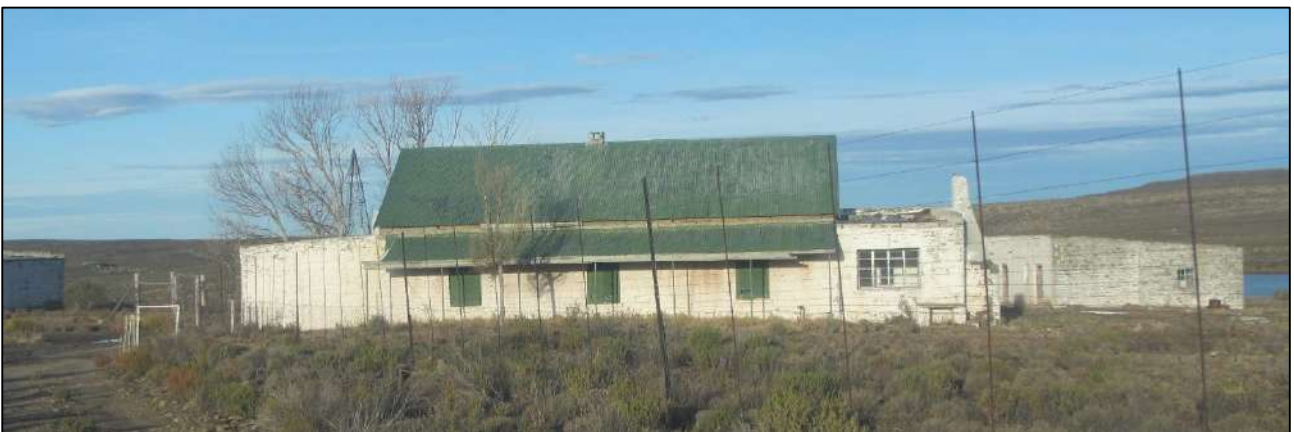
Figure 57: Western side of the abandoned farmhouse in the Ou Plaas farm complex at waypoint 1165. A veranda shades the three west-facing windows.

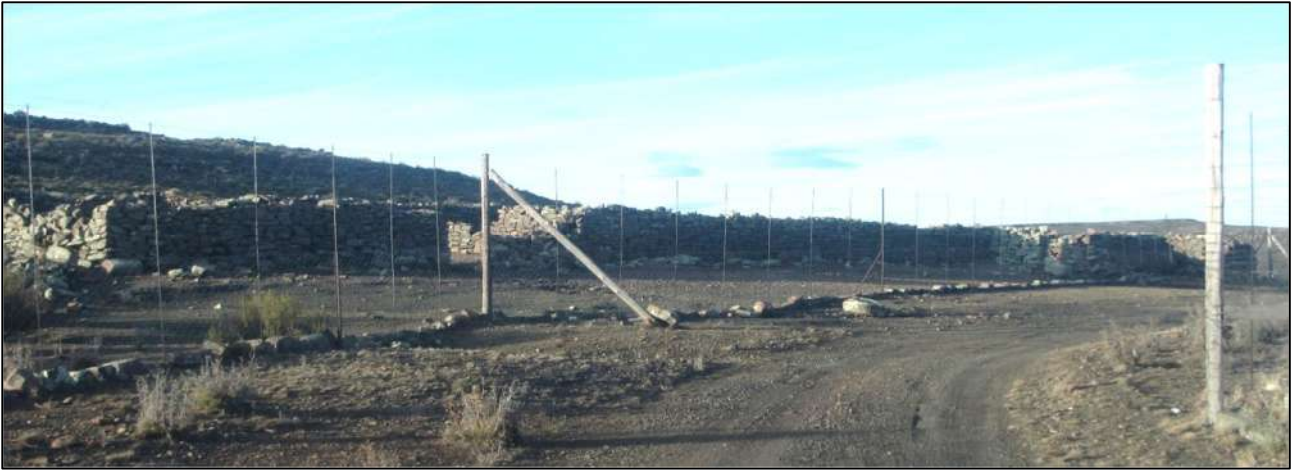
Figure 58: View of the stone-walled kraal in the Ou Plaas farm complex at waypoint 1165. The game fences flanking the road are visible.

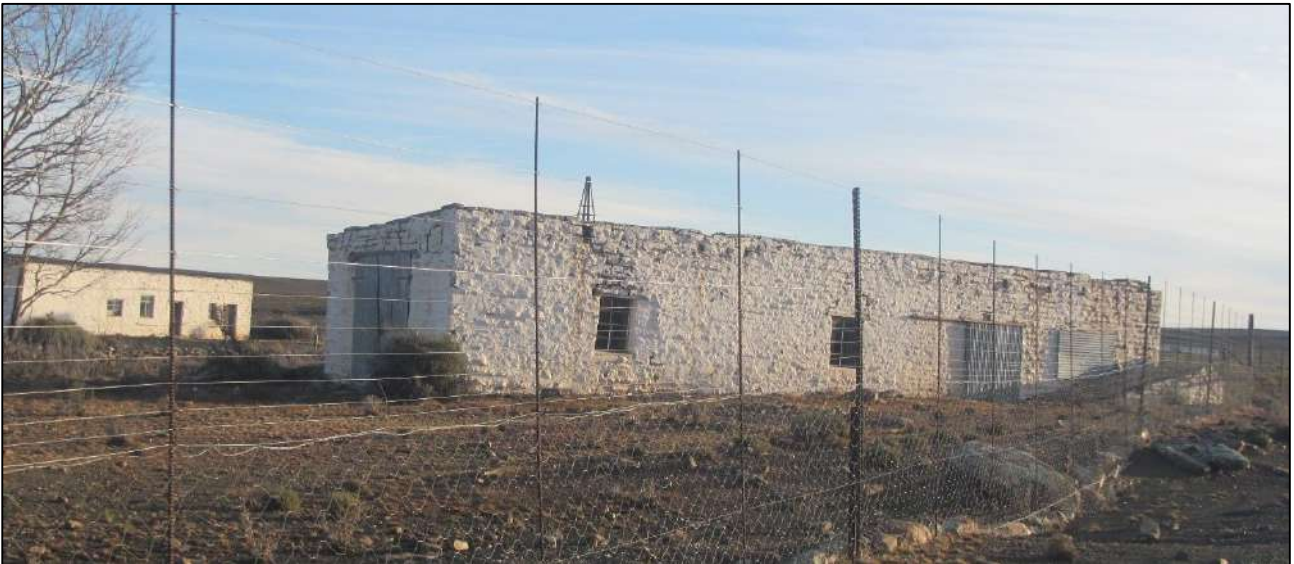
Figure 59: A stone-walled outbuilding in the Ou Plaas farm complex at waypoint 1165.

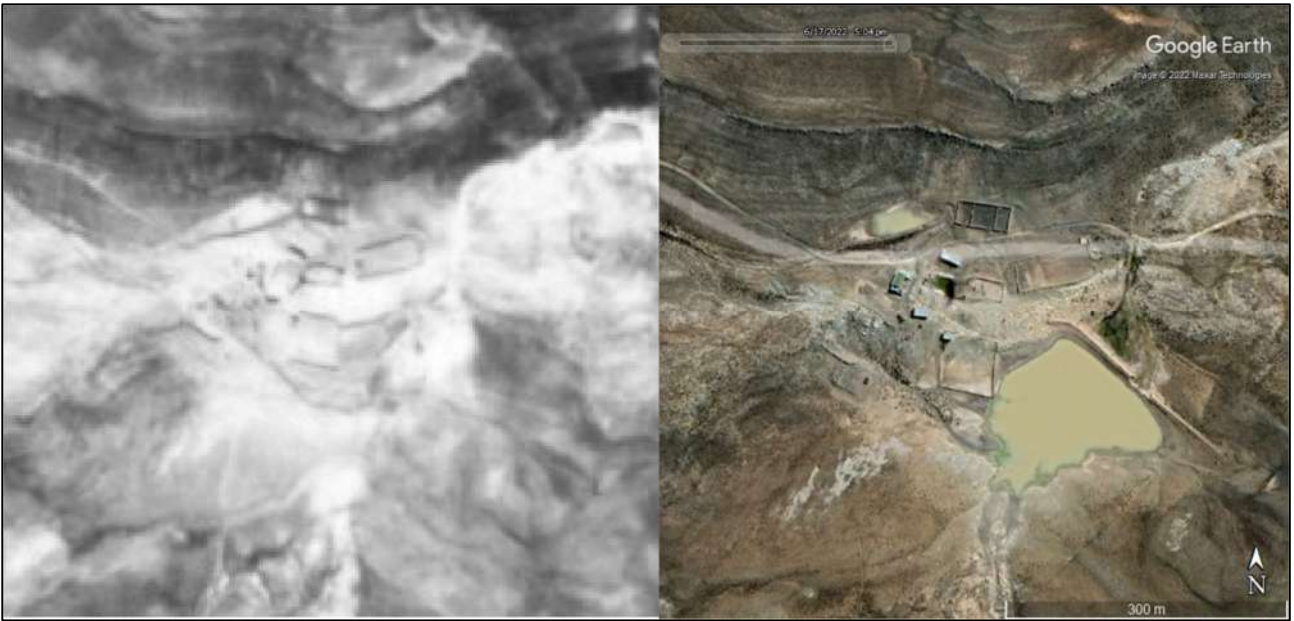
Figure 60: Comparative aerial photography from 1960 (450_012_05046) and 2014 (Google Earth) showing the Ou Plaas farmstead in the Komsberg Nature Reserve (Gunstfontein 151). The large dam post-dates 1960.

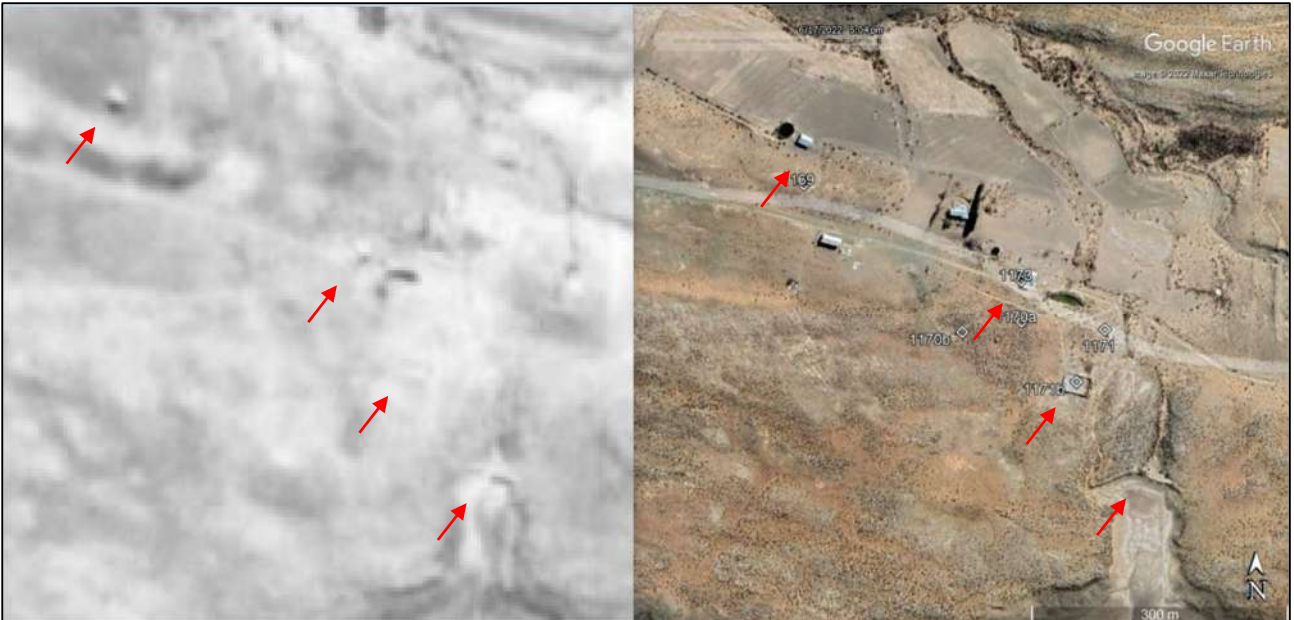
Further east is the Scholtzenhoz farm complex. It has fewer historical features than Ou Plaas (Figure 61). Just west of the farmstead are two stone-built boundary beacons that lie adjacent to the existing gravel road (Figures 62 & 63).

Figure 61: Comparative aerial photography from 1960 (450_011_04619) and 2014 (Google Earth) showing the Scholtzenhof farmstead (on Portion 1 of Beerenvally 150). Visible historical features are arrowed. They include, from northwest to southeast, a small structure (not recorded, but the ruin to its south was recorded as waypoint 1169), the house alongside the road that has been added to and renovated with a small dam alongside it (waypoint 1173), a stone kraal (waypoint 1171b) and the farm dam (not recorded). Other recorded features are too small to be visible.

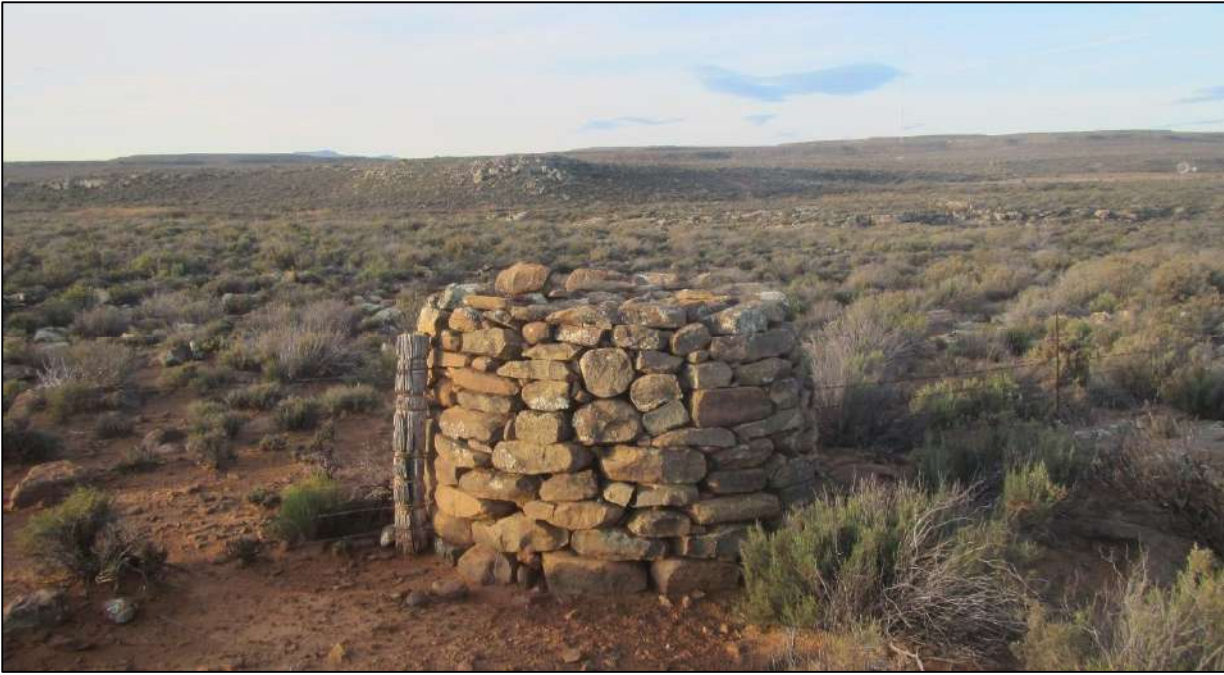
1167	S32 35 57.1 E20 53 15.8	Circular, packed stone boundary marker. It is about 1 m in diameter and about 1 m high. It is in good condition.	Medium	GPA Avoid
1168	S32 35 59.7 E20 53 25.5	Square, packed stone boundary marker which also serves as a gate post. It is in good condition.	Medium	GPA Avoid
1169	S32 36 02.4 E20 53 44.2	Stone-walled ruin which, although not examined in detail, seems to have its walls intact and roof missing. There are no openings in the south and west-facing walls which are visible from the road and there is a piled stone feature to the north of the structure.	Medium	GPA Avoid
1170a	S32 36 07.7 E20 53 54.2	A small stone-walled structure that is intact. It has a north facing door but no other openings. Its corrugated iron roof is still intact and slopes downhill towards the south. Although not examined in detail, it seems to have been built with mud mortar but has had some cement applied in places at a later stage.	Medium-High	IIIB Avoid

Figure 62: Stone boundary beacon at waypoint 1167.

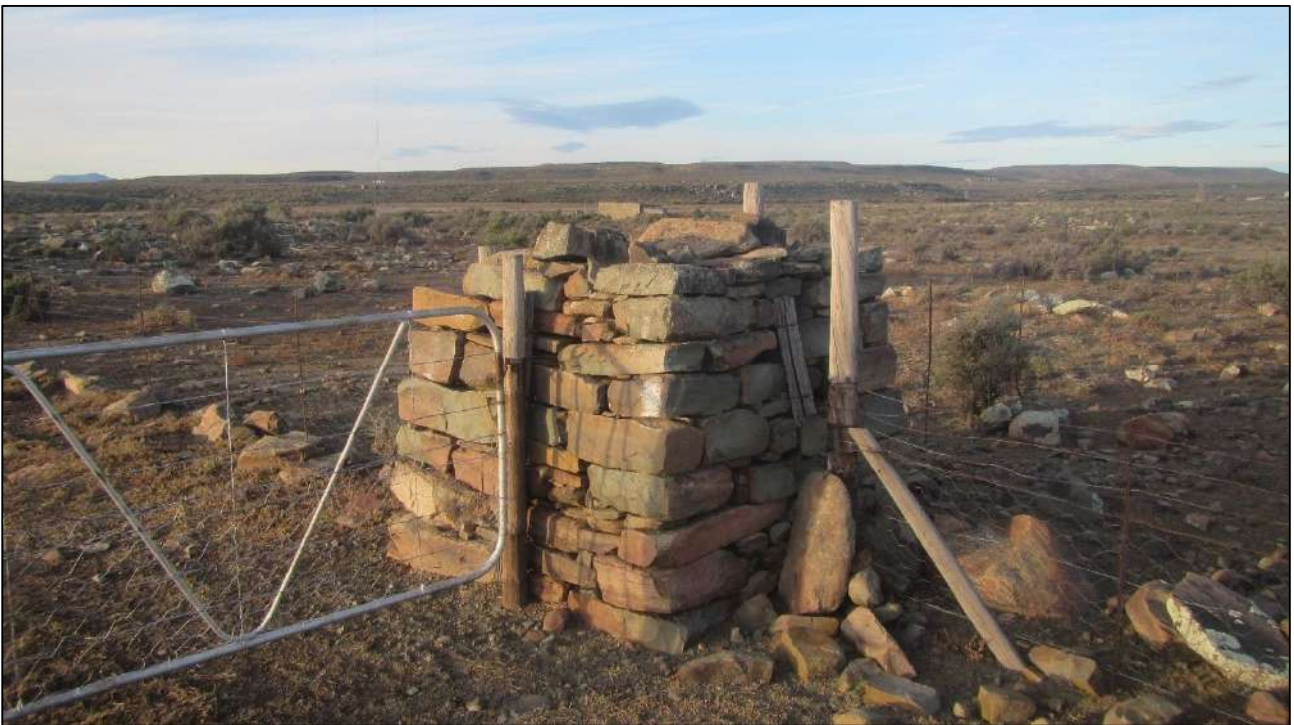
Figure 63: Stone boundary beacon at waypoint 1168.

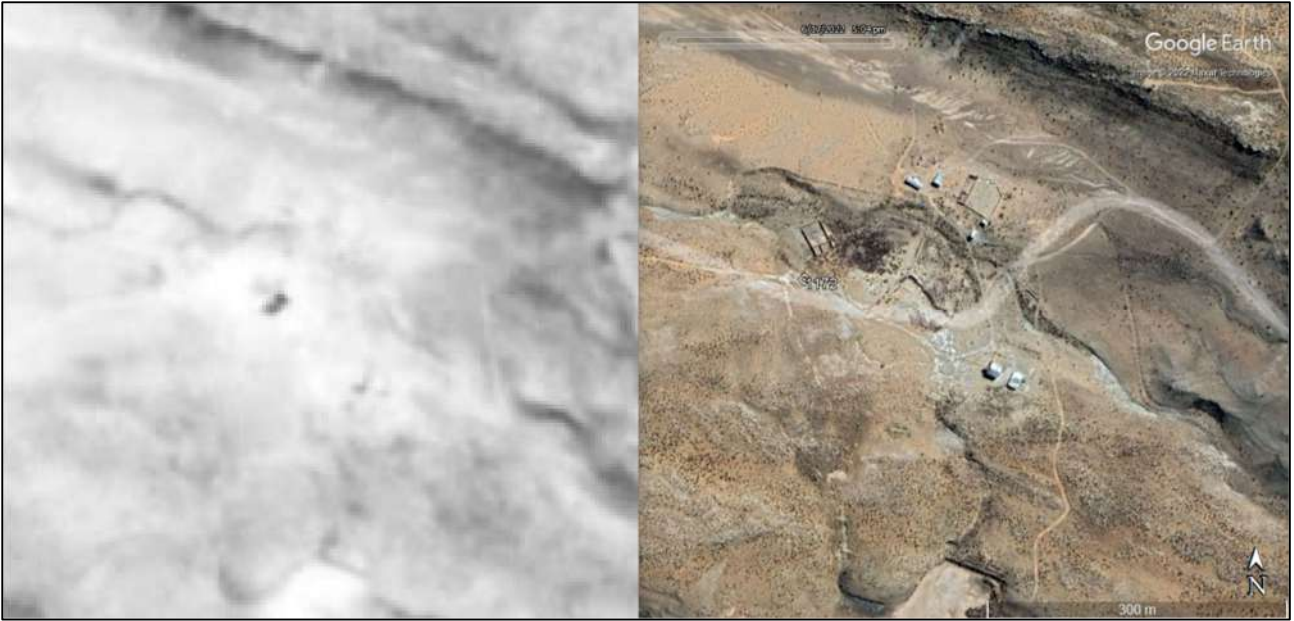
The individual features of the Beerfontein farmstead on the Remainder of Beerenvally 150 do not show up clearly on the historical aerial photography, but it is evident that the farmstead and dam to the southeast are present (Figure 64). A number of small historical structures occur in the southern part of the complex (e.g. Figure 65) and a stone boundary wall runs immediately adjacent to the road (Figure 66).

Figure 64: Comparative aerial photography from 1960 (450_011_04620) and 2014 (Google Earth) showing the Beerfontein farmstead (on the Remainder of Beerenvally 150).

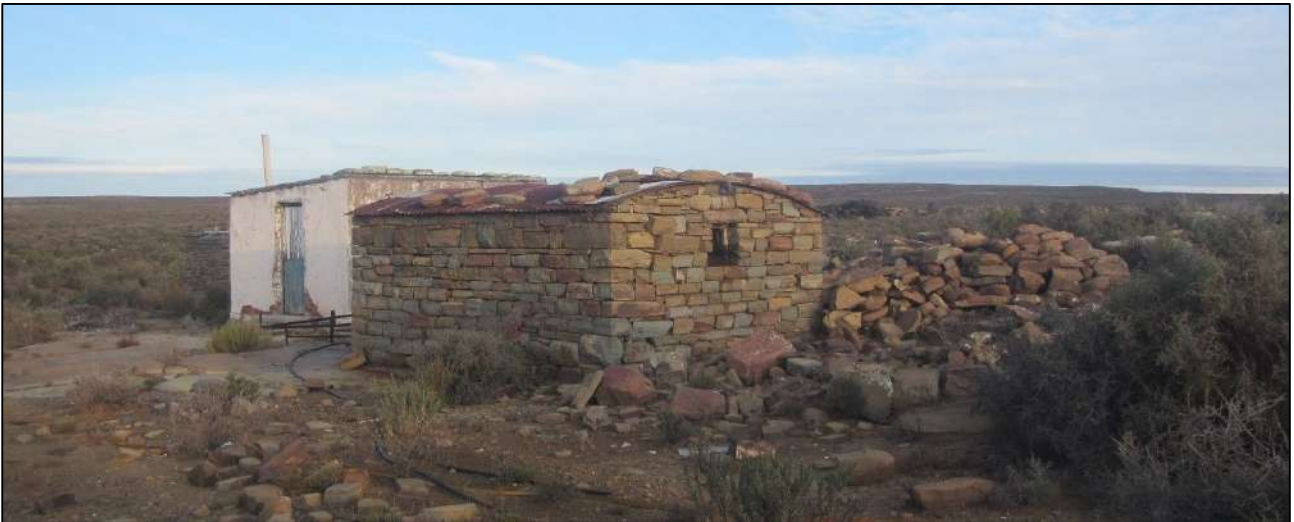
Figure 65: Stone structure within the Beerfontein farmstead at waypoint 1171a.
