PRECONSTRUCTION ARCHAEOLOGICAL SURVEY OF THE MAINSTREAM SUTHERLAND 2 WIND ENERGY FACILITY, NORTHERN CAPE

Required as a condition of authorisation.

Sutherland 2 WEF SAHRIS Case IDs: 9622, 10500, 14521
Sutherland Grid & MTS SAHRIS Case IDs: 10493, 14379, 16771, 17529, 17531

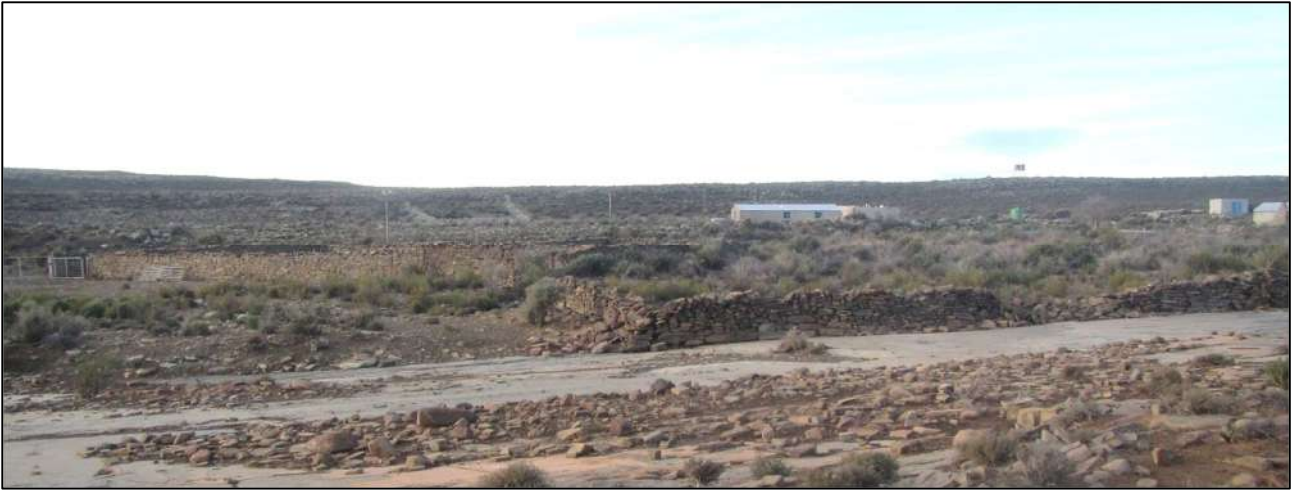
1172	S32 36 12.5 E20 54 21.6	There is a long stone wall running along the edge of the farm access road at this point. It is tumbled in places. Although the wall itself only merits grade GPB, the assigned significance and grade are for the farm complex as a whole.	Medium-High	IIIB Avoid
1173	S32 36 06.1 E20 53 54.2	Stone house in good condition and well maintained. It is currently occupied. It was not examined in detail but it looks like a relatively recent construction (or renovation), but in vernacular style and possibly using dressed stones recovered from an older building. Historical aerial photography is not of sufficient resolution to assist. Considered heritage for precautionary reasons.	Medium	--- Avoid
1174	S32 36 50.9 E20 44 49.3	A point taken along a stone wall that encloses a valley. H001, H001b, H001c, H001d, D002, D002a, H001e, H001f, H001g, H001h from Halkett and Webley (2011) are all on the same wall.	Medium	GPA Avoid

Figure 66: Stone boundary wall in the Beerfontein farmstead area at waypoint 1172.

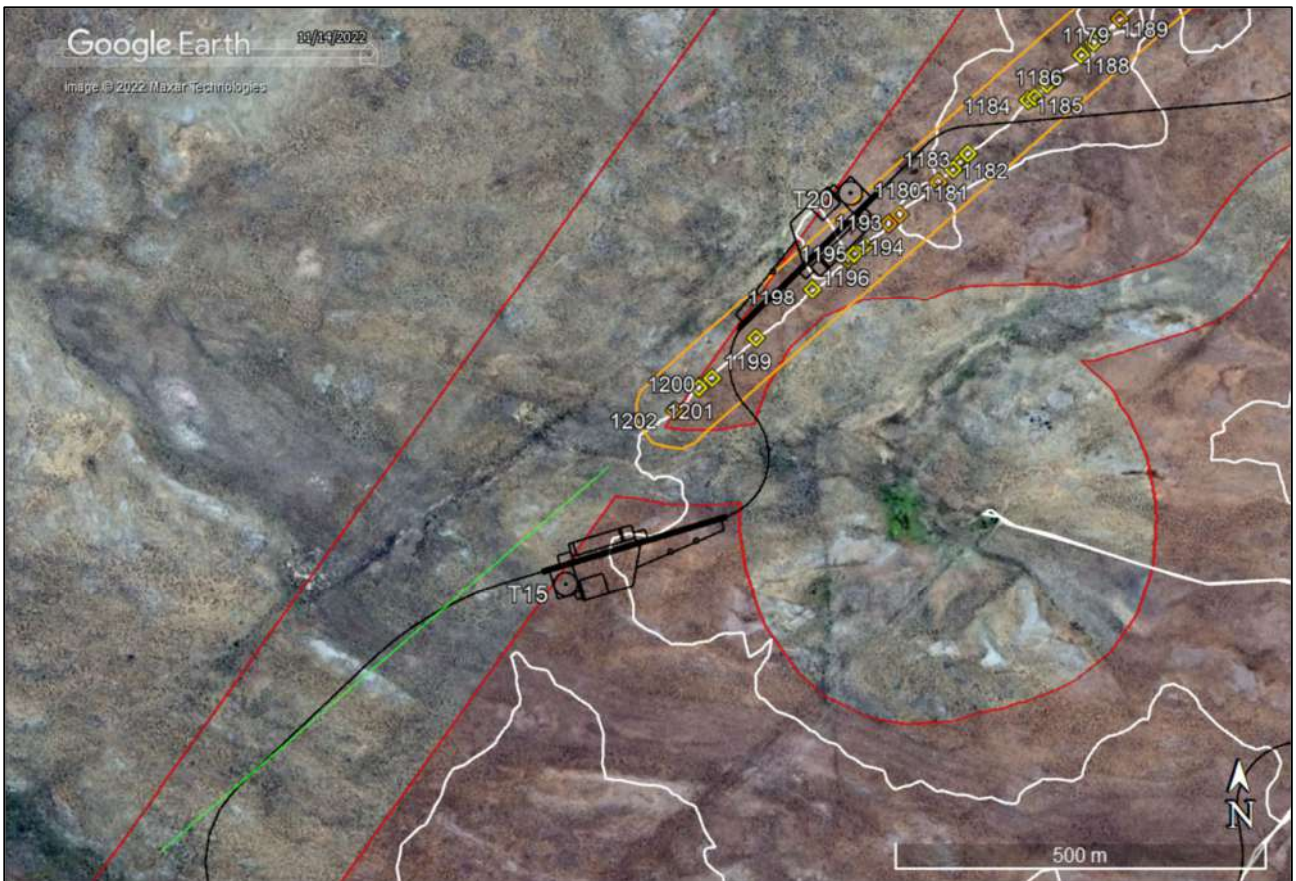
Figure 67: The vicinity of Turbines 15 and 20. The numbered waypoints indicate the mapped boundary beacons, while the green line shows the extension of their alignment. Although none were seen southwest of waypoint 1202, the survey (white lines) did not continue in that direction.

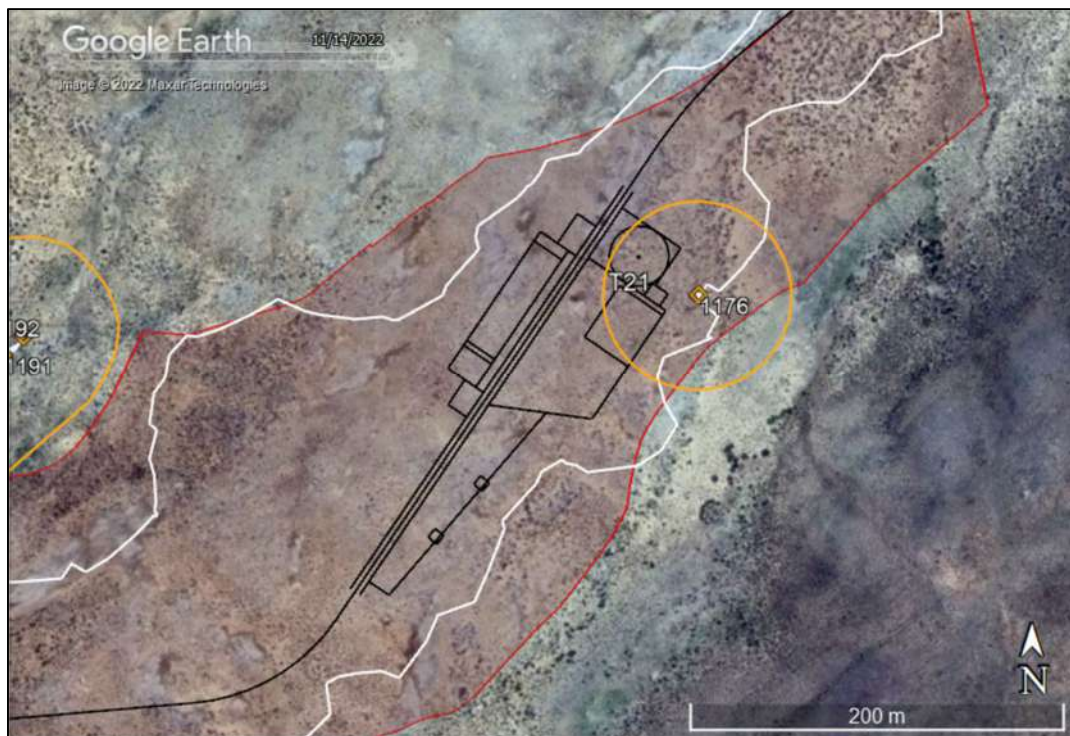
Figure 68: The vicinity of Turbine 21 and waypoint 1176.

- Wherever project infrastructure comes within 30 m of heritage resources the infrastructure should be micro-sited to get the distance between the resource and infrastructure as close to 30 m as possible. This applies to waypoints 1176, 1184, 1194-1199 inclusive, 1301 and 1309;

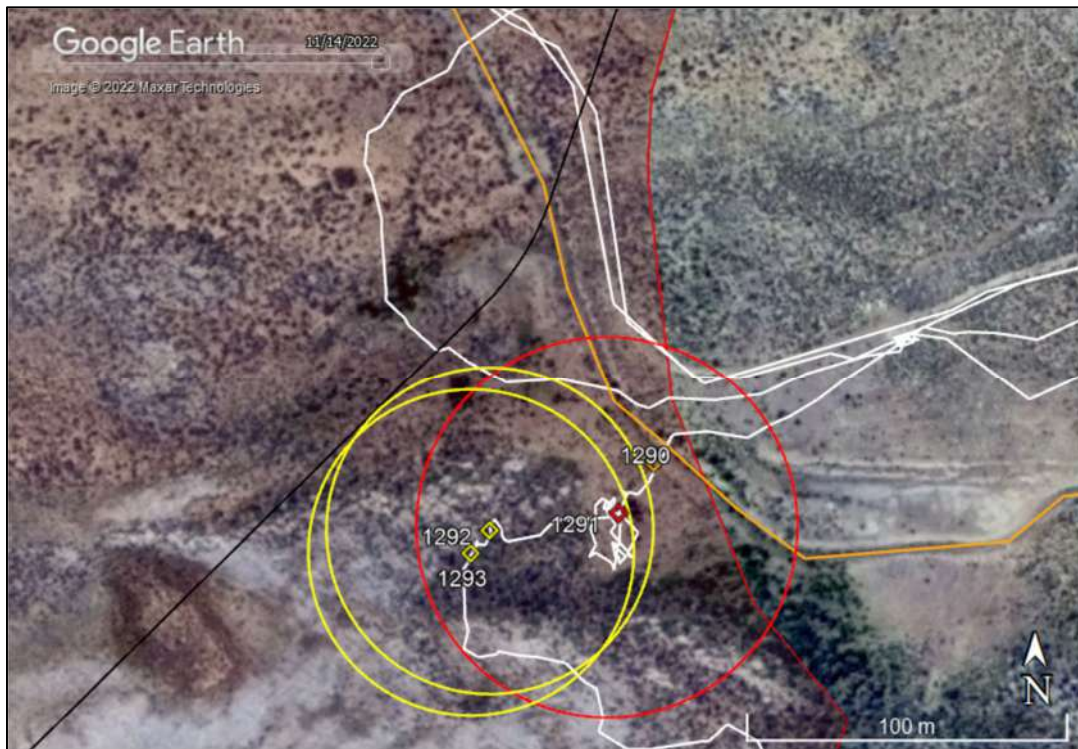
Figure 69: The vicinity of the road between Turbines 4 and 22. The buffered archaeological sites will be safe from harm but the WEF road crosses the leiwater furrow (orange line).

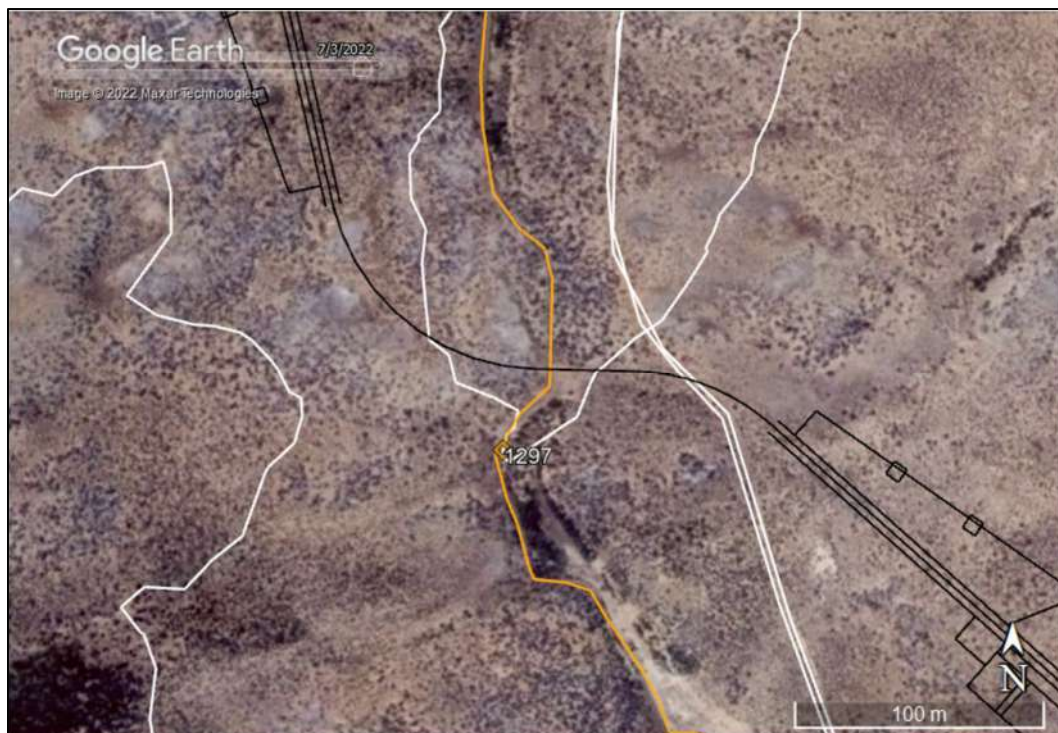
Figure 70: The vicinity of the road between Turbines 16 and 22. The WEF road crosses the leiwater furrow (orange line, waypoint 1297).

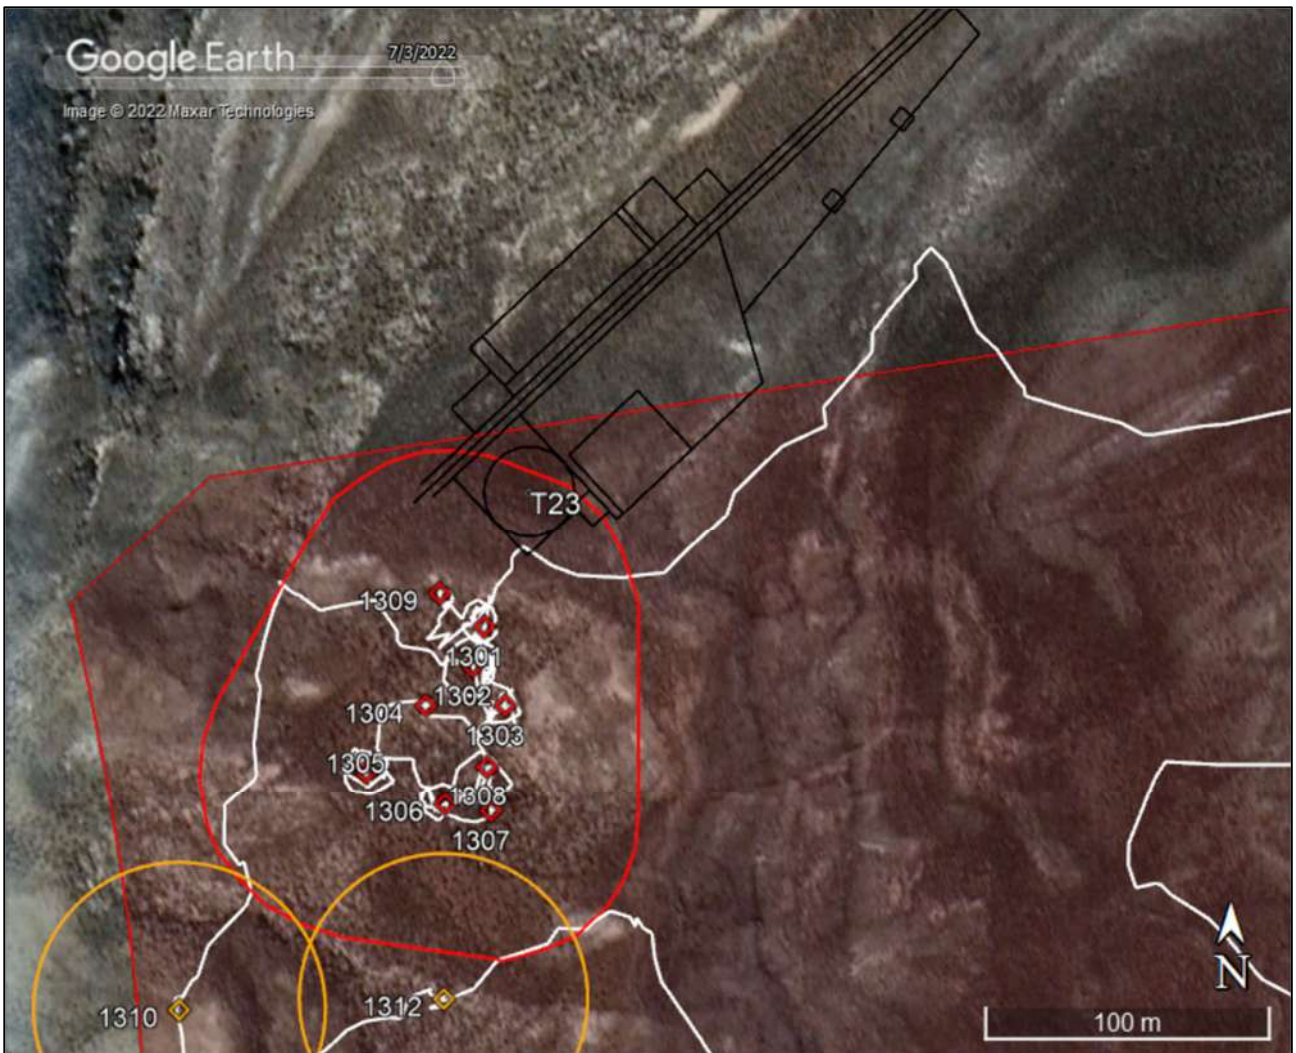
Figure 71: The vicinity of Turbine 23 and waypoints 1302 to 1309.

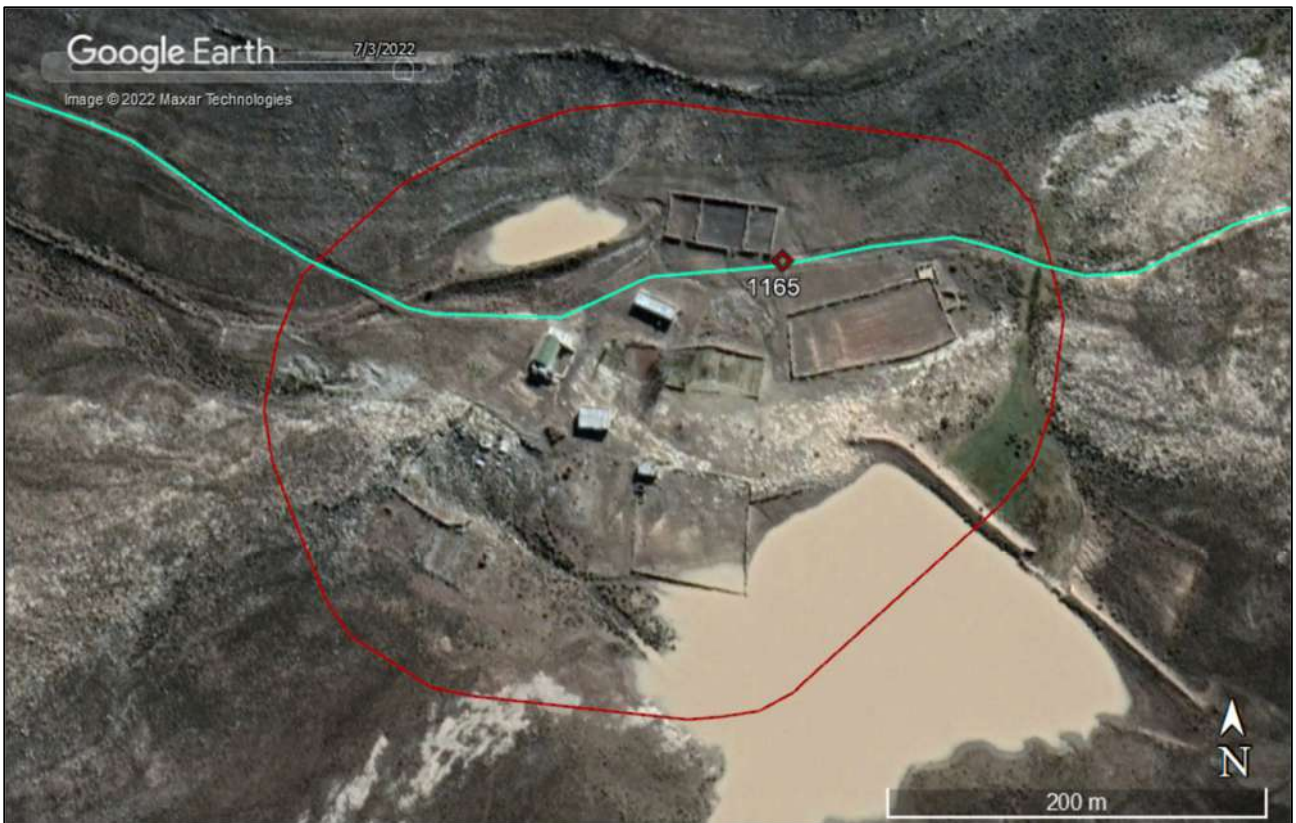
Figure 72: The powerline route (turquoise line) along the road servitude through the Ou Plaas farm complex at waypoint 1165.

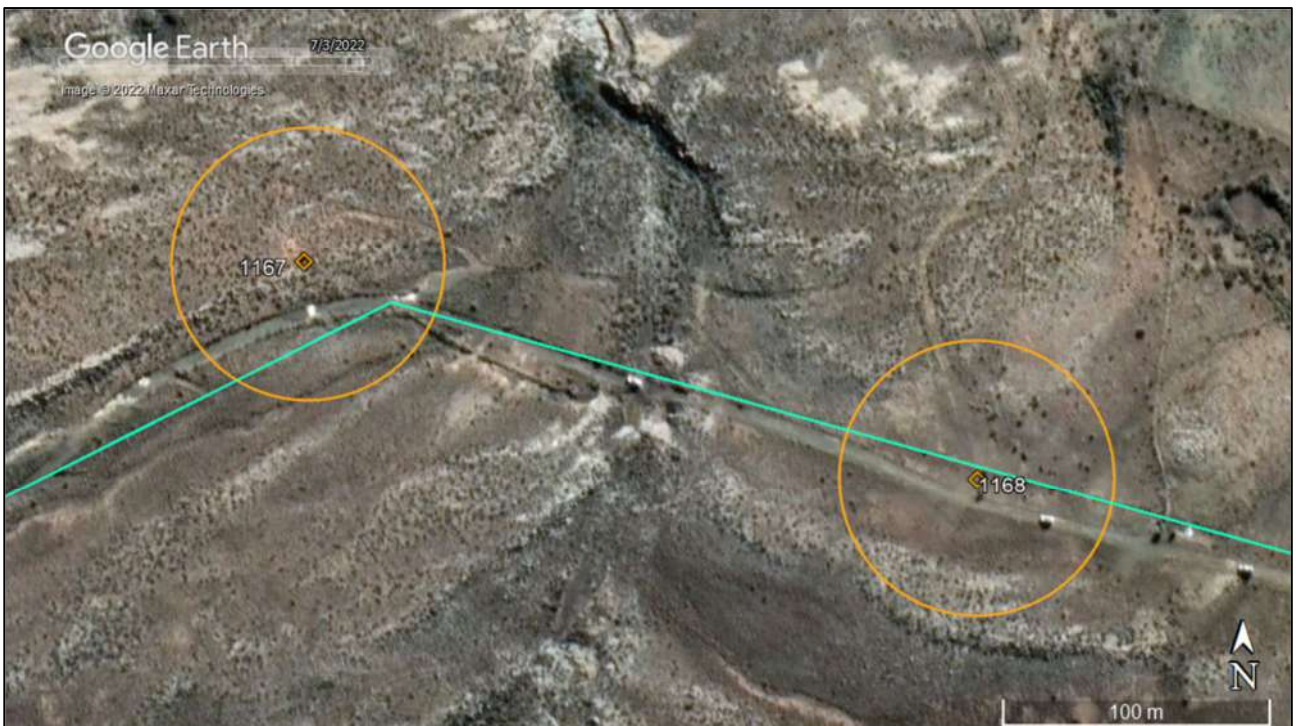
Figure 73: The powerline route (turquoise line) passing waypoints 1167 and 1168.

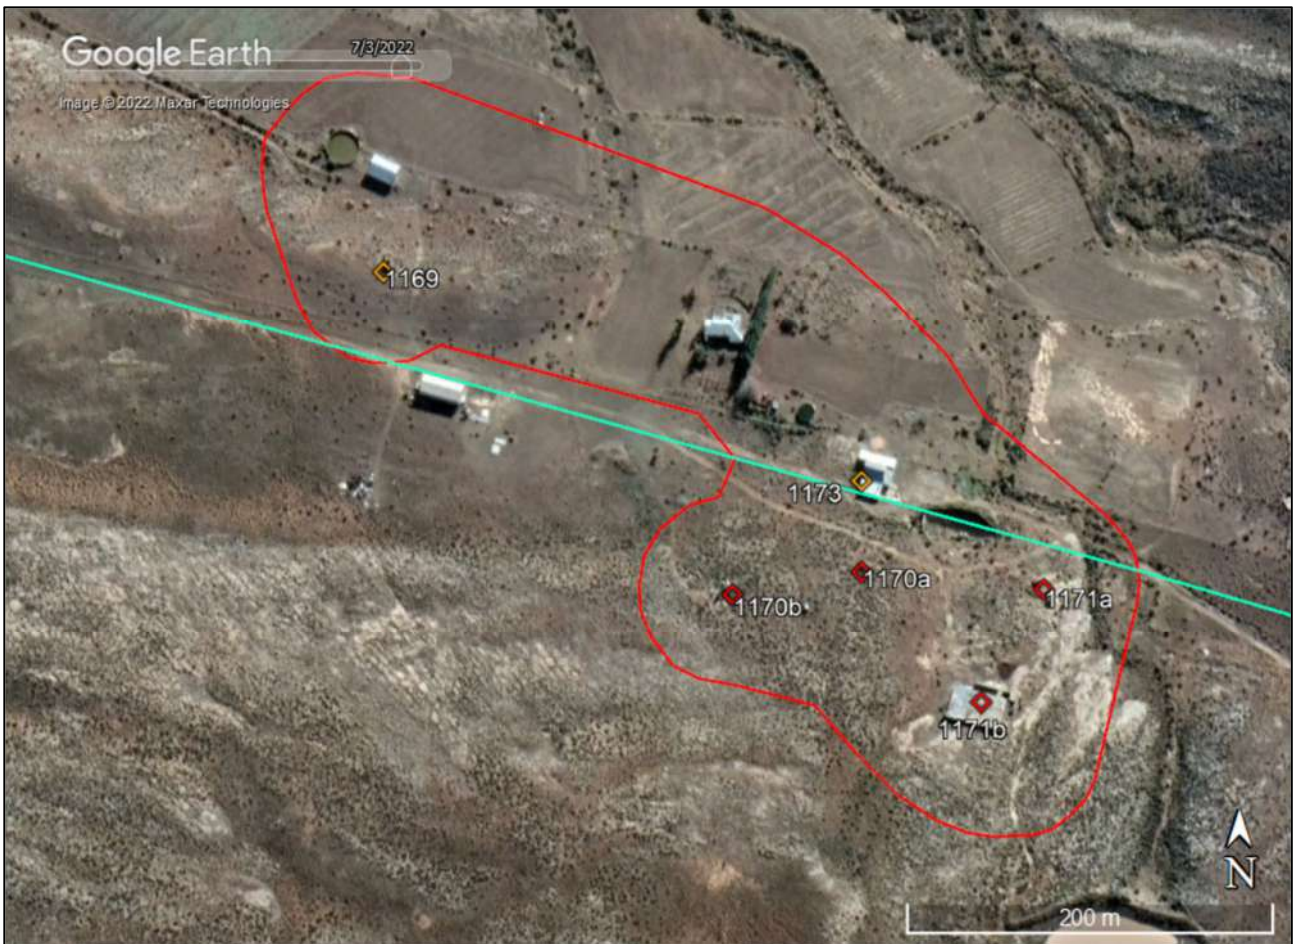
Figure 74: The powerline route (turquoise line) along the road servitude through the Scholtzenhof farm complex at waypoints 1169-1171 and 1173.

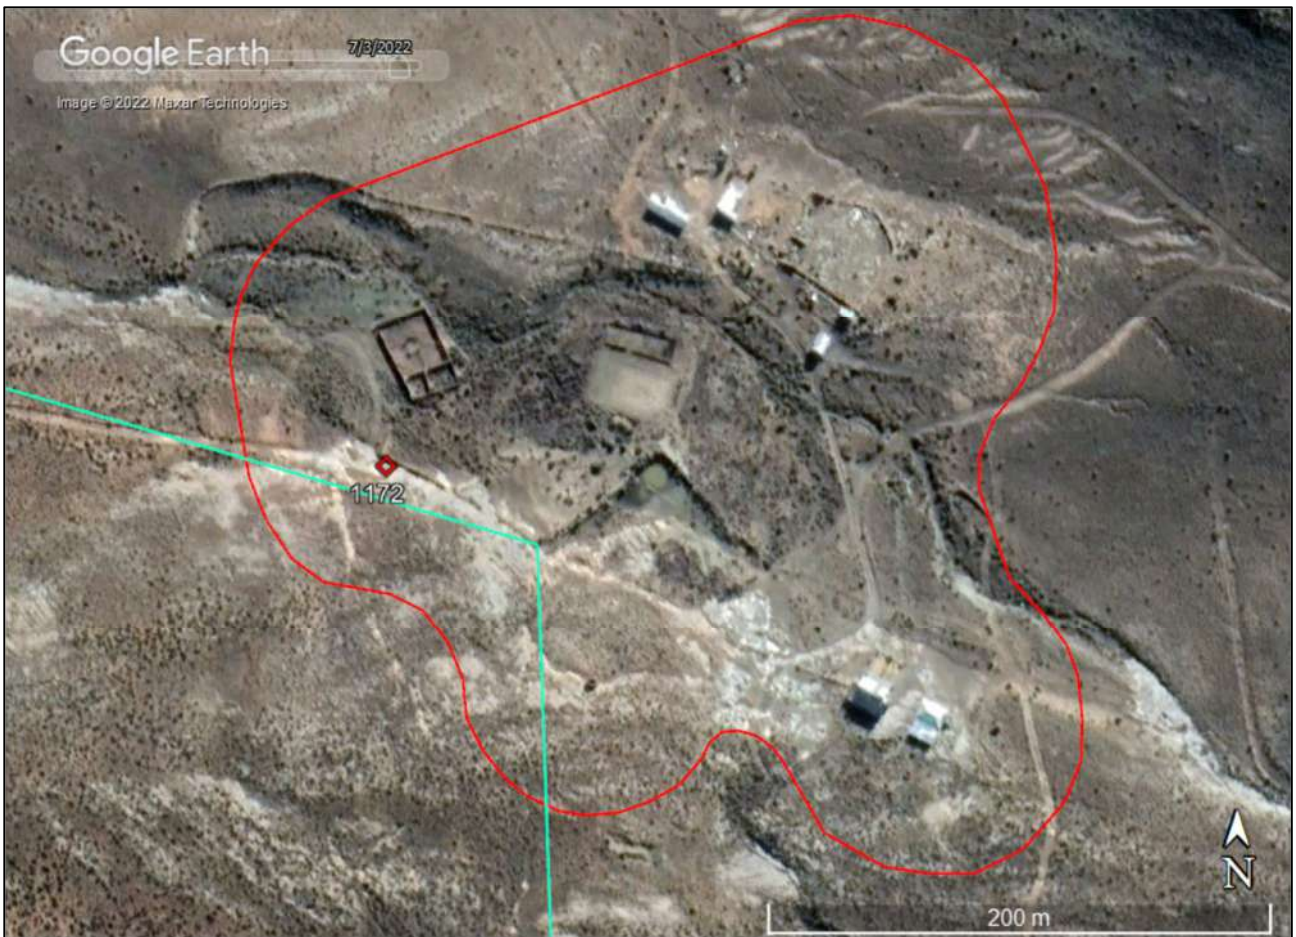
Figure 75: The powerline route (turquoise line) through the Beerfontein farm complex at waypoint 1172.
