**HERITAGE IMPACT ASSESSMENT FOR THE PROPOSED
KOKERBOOM 4 WIND ENERGY FACILITY ON
FARM 213/REM, NORTH OF LOERIESFONTEIN,
CALVINIA MAGISTERIAL DISTRICT, NORTHERN CAPE**

Required under Section 38 (8) of the National Heritage Resources Act (No. 25 of 1999).

1st draft: 28 September 2020
Final report: 23 April 2021

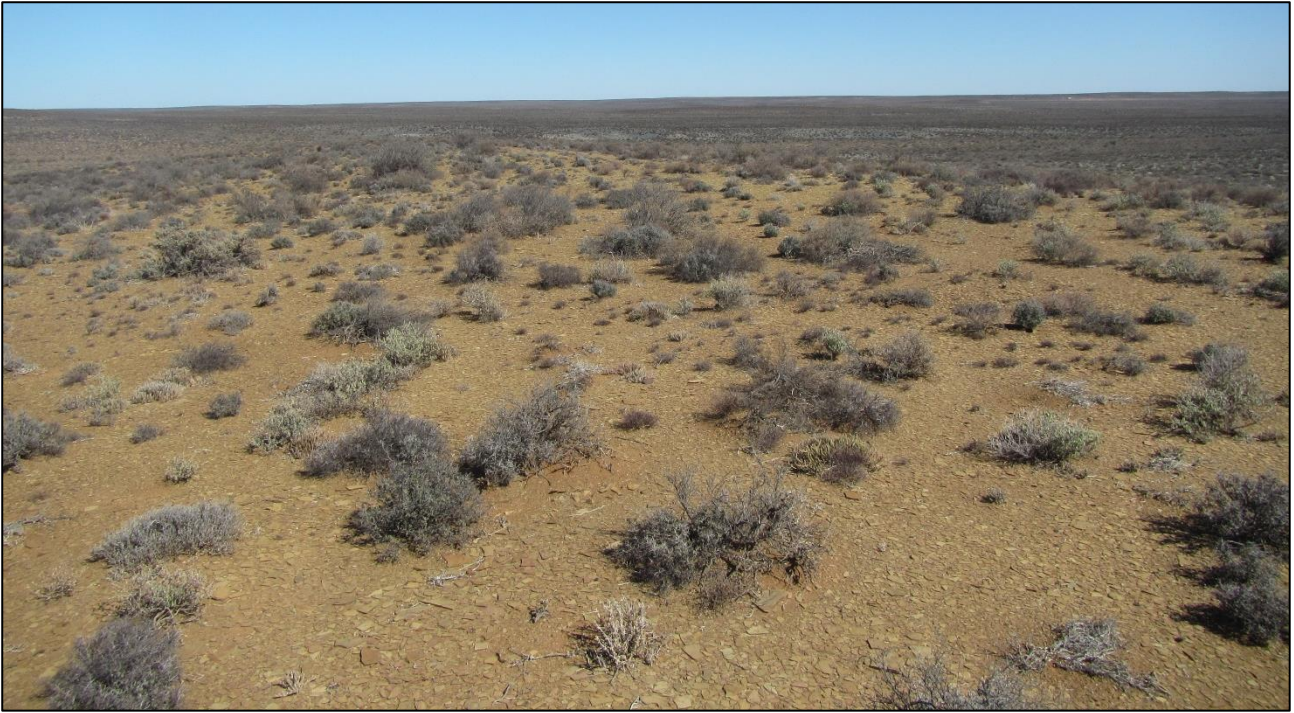
Figure 5: View towards the southwest showing the gravel substrate on a low hill in the northern part of the study area.

The site is generally flat (Figure 4), but, broadly, the southern part is somewhat higher-lying than the north. The flatter ground tends to be sandy and grassed, while on the higher ground erosion has resulted in the surfaces being gravelled (Figure 5). A number of ephemeral pans were evident in the southern part of the study area, generally associated with calcrete gravel (Figure 6).

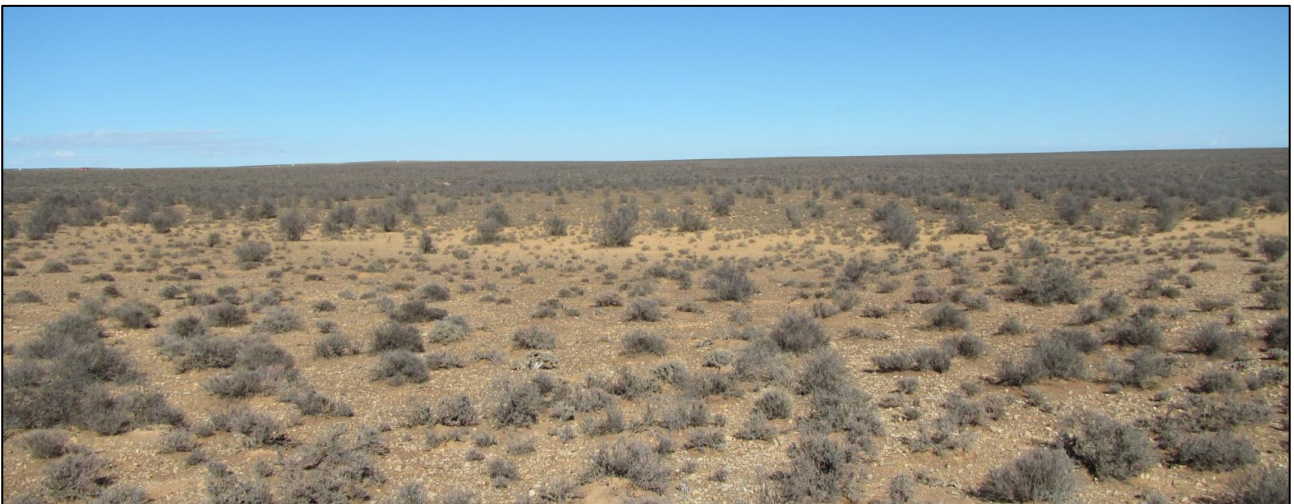
Figure 6: View towards the southwest across one of the ephemeral pans in the south-eastern part of the study area. The Khobab WEF was in the process of construction and the turbine bases are very faintly visible just below the skyline towards the left of the photograph.

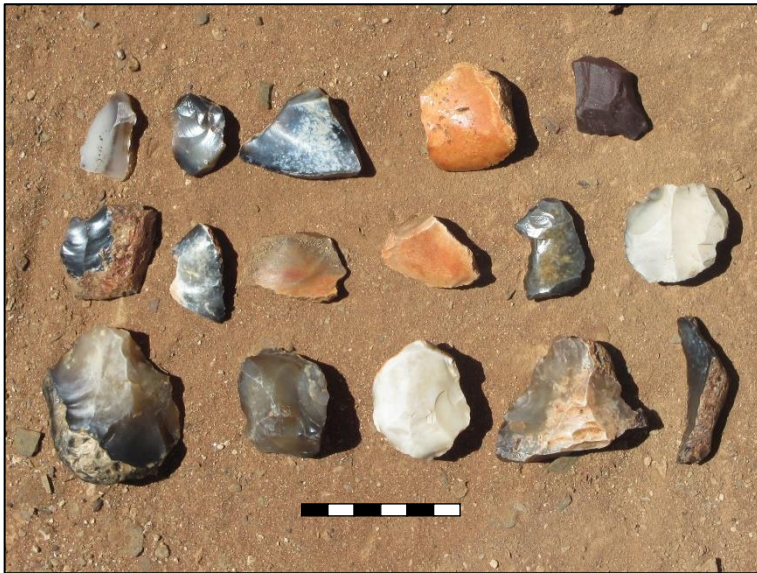
Although archaeological was fairly widespread in the study area, only one significant site was located (at waypoint 654) and this was on high ground in the western part of the study area (very close to the existing wind measuring mast). The site consisted of a fairly large surface scatter of LSA artefacts, largely made in CCS (Figure 8). There were a few clusters of slightly greater density scatter with lower density scatter in between. LSA material was seen at one other location (waypoint 656) but there was too little of it to be of concern. An unusual artefact present there, though, was a very long hornfels blade (Figure 9).

Figure 8: Artefacts from the Later Stone Age site found near the wind mas (waypoint 654). All are in CCS except the upper right which is quartzite. Scale in 10 mm intervals.

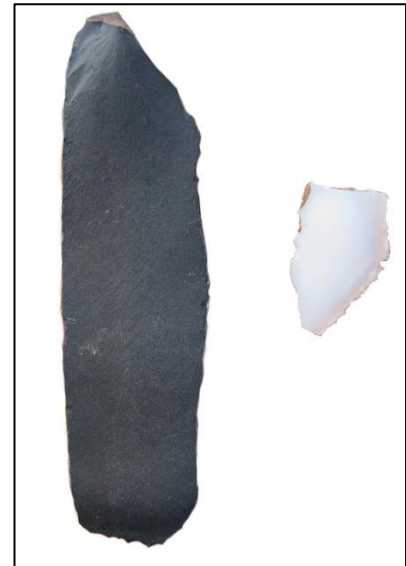
Figure 9: Hornfels cortical blade (left) and CCS flake from waypoint 656. The blade is c. 30 x 105 mm in size.

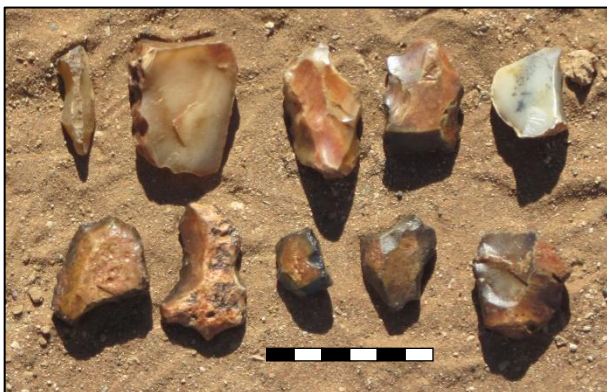
Other points recorded were related to what could be termed background scatter. These are artefacts that have been present on the landscape for a long period of time and have likely moved to a degree because of natural forces. Isolated artefacts of varying age are included here. Such artefacts are widespread with very low densities, although occasionally a slightly higher density area will be located and recorded. Figures 10 and 11 show examples. Figure 10 includes a single unpatinated artefact that is relatively recent, dating to the LSA, while the remaining artefacts were all quite well worn and patinated suggesting that they date to the MSA.

Figure 10: Artefacts relating to the background scatter from waypoint 653. All are in CCS and all are likely to pertain to the MSA except that at top right which is likely LSA. Scale in 10 mm intervals.

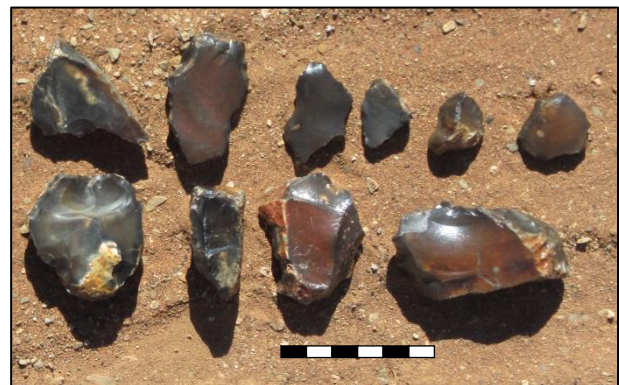
Figure 11: Artefacts relating to the background scatter at waypoint 657. All are in CCS. Scale in 10 mm intervals.

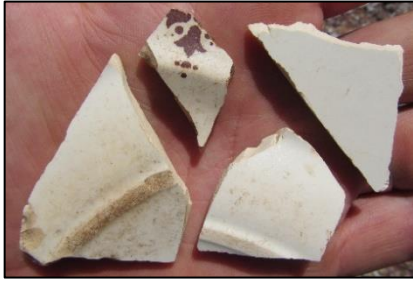
A large but very low density scatter of historical material was seen across a low hill in the north-eastern part of the study area (waypoints 655 and 655B). While some of the material may be from the late 19th century, there are some things that are very likely to be early 20th century in age (Figures

Figure 12: Ceramic fragments from waypoint 655.

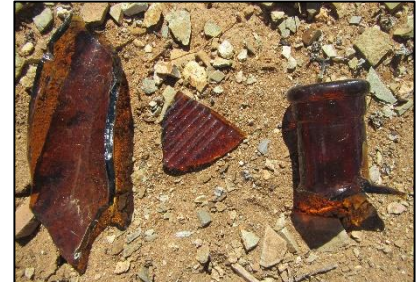
Figure 14: Glass fragments from waypoint 655.

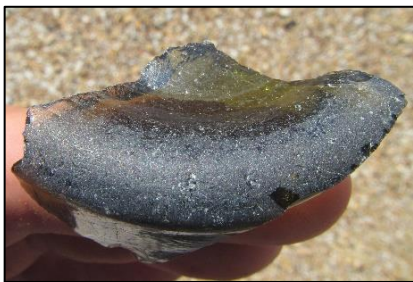
Figure 15: A fragment of a wine bottle base from waypoint 655.

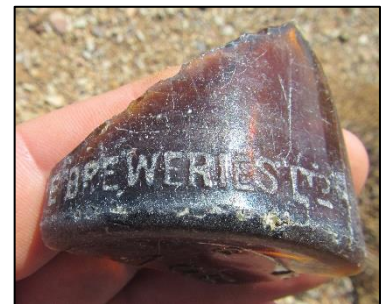
12 to 17). The latter would thus date the scatter to the early 20th century. Two early Ohlsson's Cape Brewery bottles were also present. Ohlsson's started in 1889 thus providing a maximum age for the bottles.

Figure 17: A fragment of an Ohlsson's Cape Breweries beer bottle from waypoint 655.

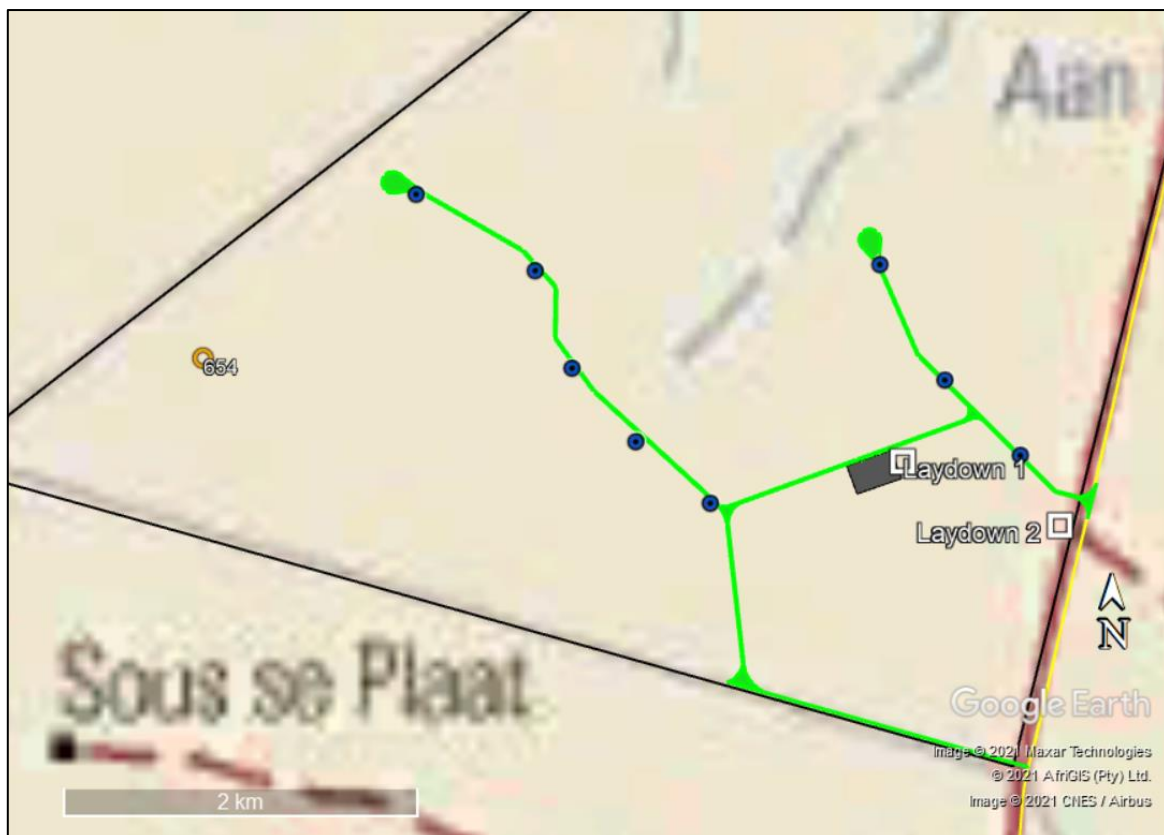
Figure 19: Aerial view of the study area showing the only significant site which is of low-medium cultural significance (and hence sensitivity) relative to the project layout.

This study has found just one significant heritage resource on the site (LSA artefact scatter at waypoint 654). Besides the landscape itself, which is of relatively low significance and has already been compromised by the other wind energy facilities, the only other heritage resource of concern is this archaeological site. Because it was identified early on in the project, it has been avoided by the layout developed for the final assessment. Although it is very likely that some isolated artefacts attributable to background scatter and other sites of low significance may be disturbed, the chances of highly significant sites falling within the footprint are considered to be very low. As such, no significant impacts to heritage resources are expected.

Because the layout has been designed to avoid all known significant heritage resources on the site, it is proposed that the project be allowed to proceed. However, the following conditions should be included as part of the authorisation should one be issued:

- The final layout must be examined in the field by an archaeologist prior to construction with recommendations made for mitigation as required; and
- If any archaeological material or human burials are uncovered during the course of development then the find should be protected from further disturbance and work in the immediate area should be halted if necessary. The find would need to be reported to the heritage authorities and may require inspection by an archaeologist. Such heritage is the property of the state and may require excavation and curation in an approved institution.
