Specialist Opinion Letter Regarding the Archaeological Impact Assessment (AIA) conducted for the proposed Wastewater Treatment Plant, Robben Island

The following opinion is applicable to the project entitled: The Basic Assessment Process for the Proposed Robben Island Wastewater Treatment Plant.

Archaeological Impact Assessment (AIA)
Report on the survey of a site on Robben Island
situated south of the Dog Unit (Robert Sobukwe House)
between Murray's Bay and Murray's Road

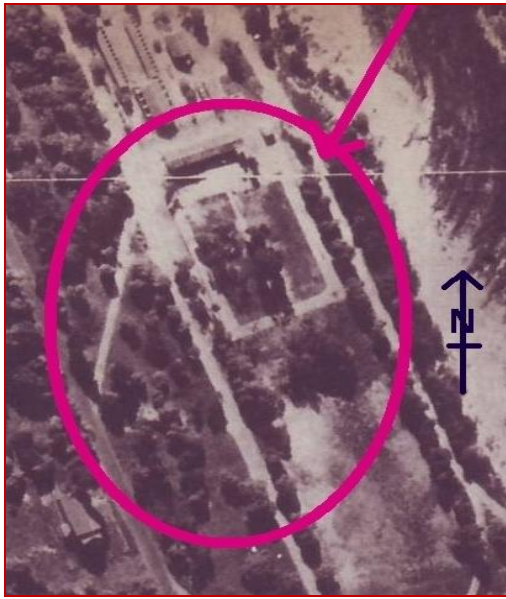
Fig. 5
Aerial photograph, dated 1974. The survey site is marked in pink, and was probably used as a sports field recreation ground.

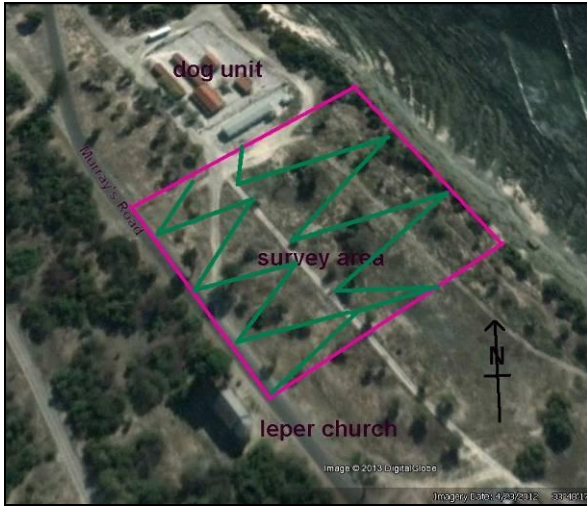
Fig. 7
The survey area (Google, 2013). The survey path is marked in green.

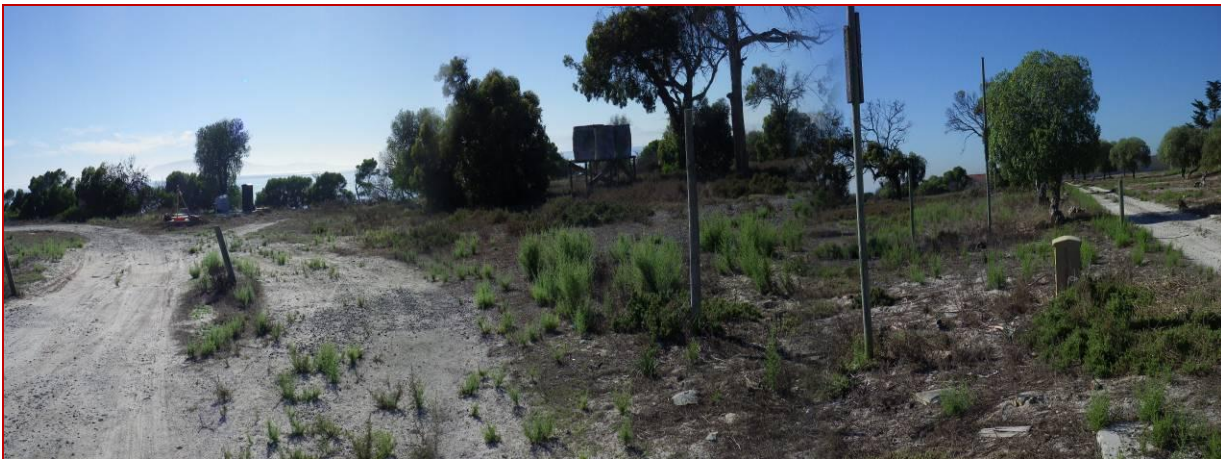
Fig. 9
Panorama of the site under investigation, facing east: to the left – in the back - the three concrete sewage pump stations, center: 3 fresh water tanks on a platform, to the right an electrical distribution box, wooden poles.
Note the primary gravel roads and paths.

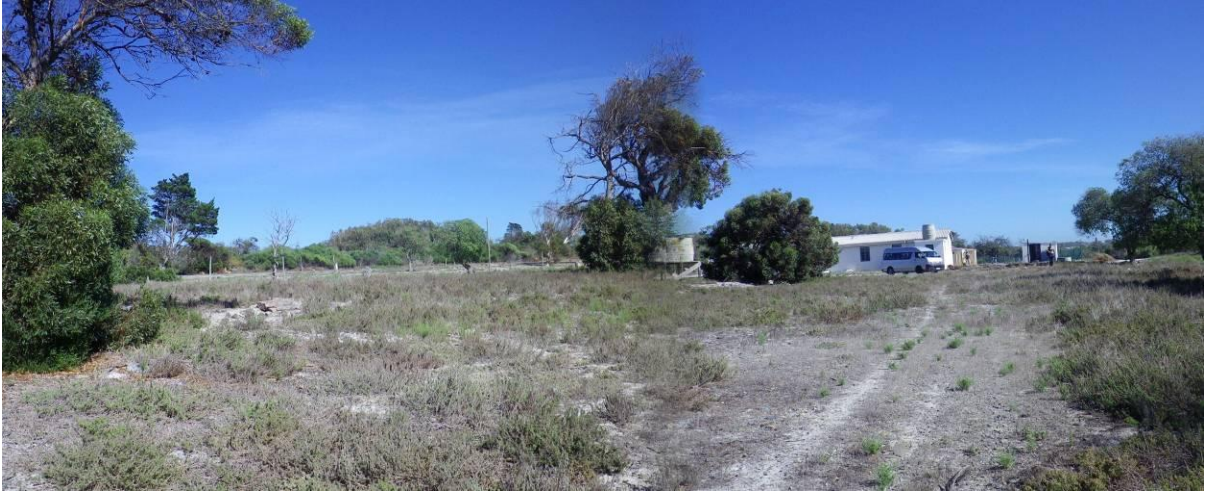
Fig. 10.
View to the north. In the back Robert Sobukwe House. Note the degraded *veld* and the remains of the fencing area.

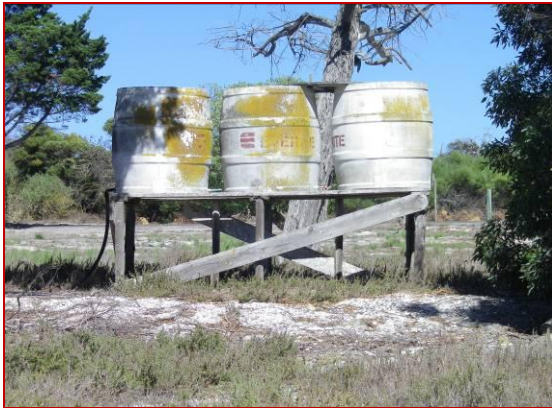
Fig. 11. The fresh water tanks in the survey. They are of no historical value.

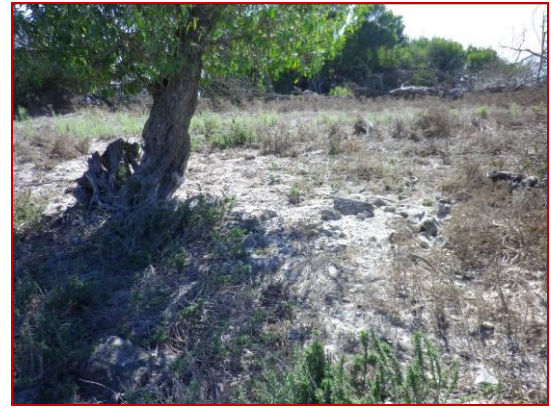
Fig. 12. Degraded *veld* below a *manatoka* tree.

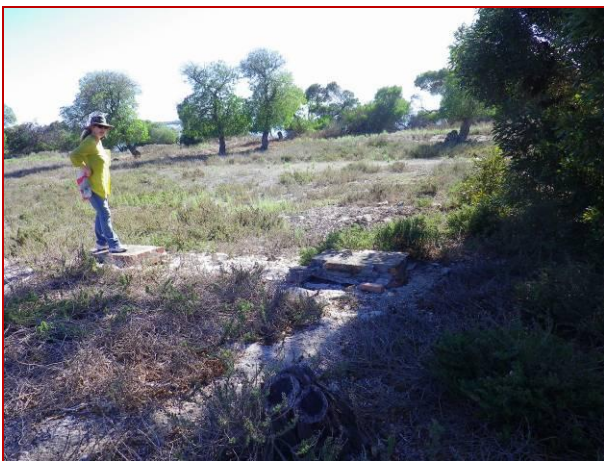
Fig. 13.
Unidentified concrete platform and brick pillars, but definitely NOT of WWII vintage

Major ADJ Gordon for supplying WWII maps and discussion of WWII military installations on Robben Island, and advising us that the small concrete platform with two brick pillars found on the site was NOT a gun emplacement,

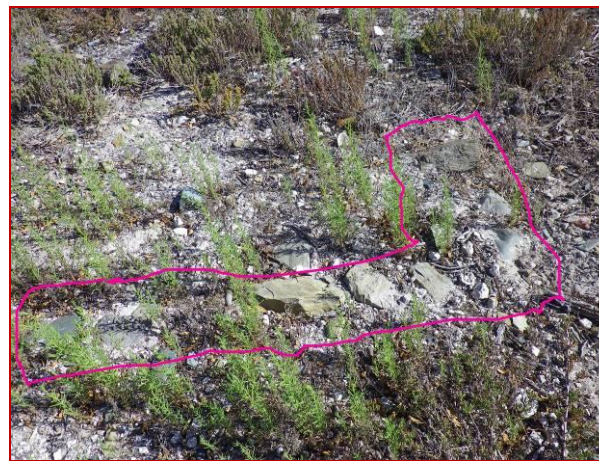
Fig. 14.
Outlined in pink: row of bluestone paving stones, unidentified.

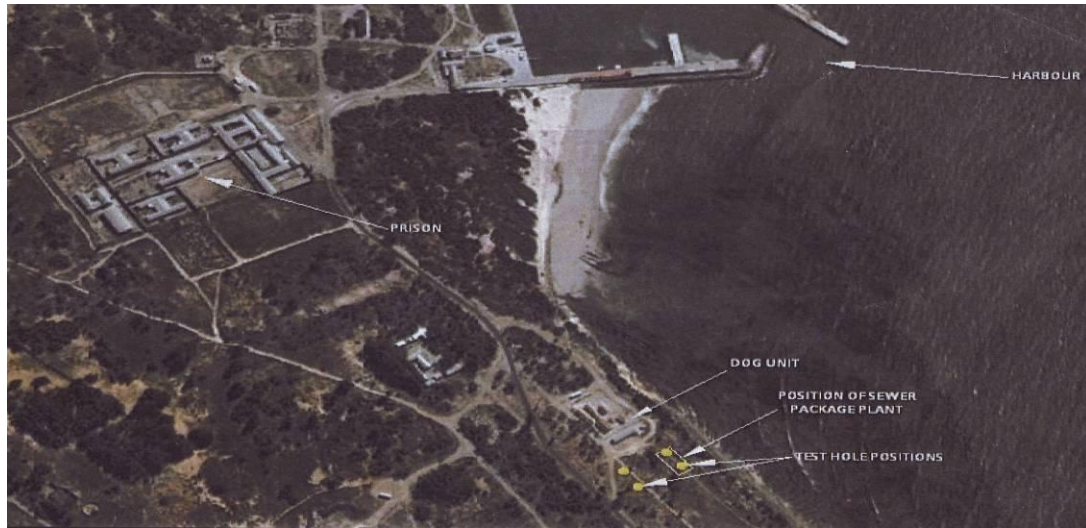
Fig. 15.

Position of the proposed Sewer Package Plant, 2013. (Reference: WSP Environmental (Pty) Ltd).

RECOMMENDATION: PERMISSION FOR THE EXCAVATION OF TEST HOLES FOR THE DEVELOPMENT OF THE SEWER PACKAGE PLANT TO BE GRANTED.
