**EXXARO PAARDEPLAATS PROJECT**  
**Heritage Impact Assessment Report**

**Issue Date:** 26 October 2012  
**Revision No.:** 1  
**Client:** EIMS REF NO. 0888

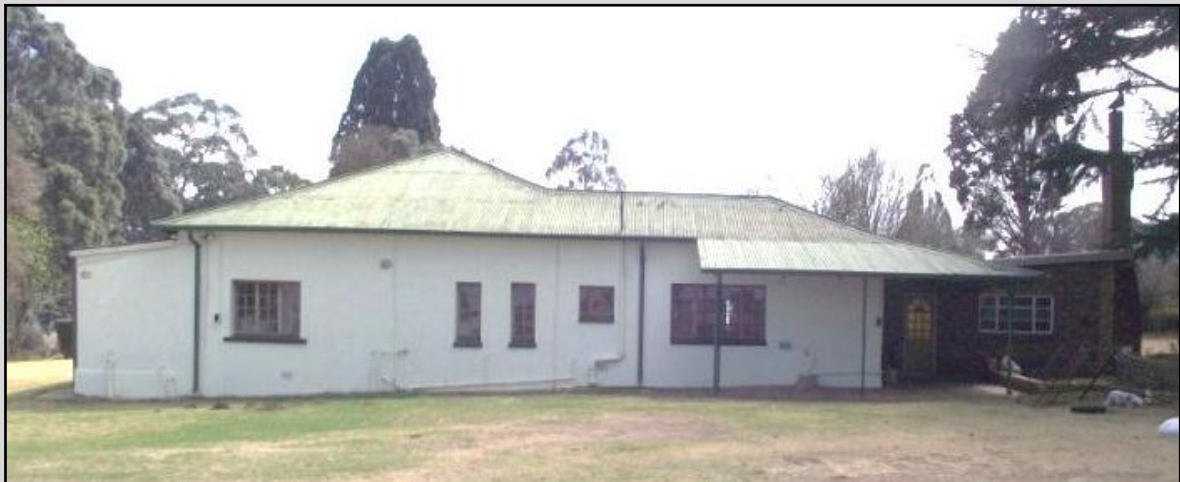
A farmstead with its associated buildings was identified at this location. The main house and other buildings were still intact and were occupied until recently before the property was sold to Exxaro (Pers.com). The main house measures approximately 20m x 20m and has a pitched corrugated iron roof (**Figure 7**). A kitchen and more rooms were added later to the back of the building. The original building has thick external walls which were plastered and painted. It also has a chimney for a coal stove. The house has wooden and metal door- and window frames. It also has external electricity and water systems on the older parts of the building and internal electricity and water systems on the later additional parts of the building.

*Figure 7 – PP 001: Main farmhouse building*

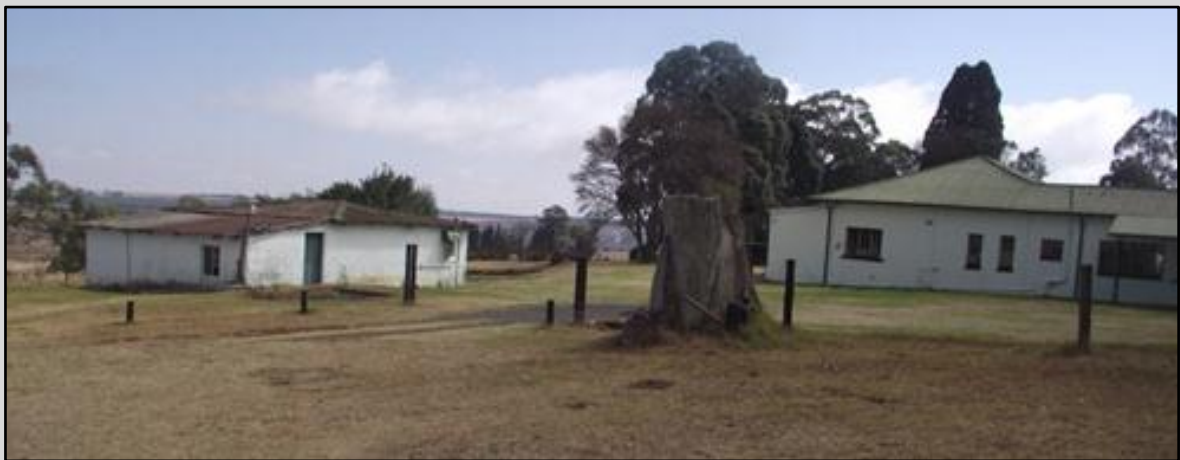
A storeroom or shed with farm implements was also identified. This storeroom measures approximately 12m x 8m and has a low pitched corrugated iron roof. The building is brick-built and has metal window frames and wooden door frames with homemade doors. It has an external electrical system (**Figure 8**).

*Figure 8 – PP 001: Main house and storeroom/shed*

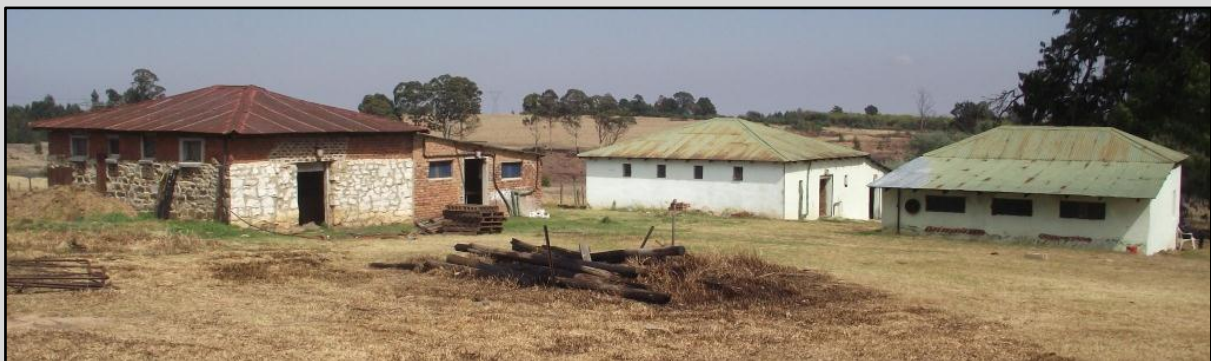
A pigsty was situated next to the cattle shed. The original structure is built with stone and mortar, but later extensions to raise the walls and additions are brick-built. The additions were most probably used as stables for horses. The building has a low pitched corrugated iron roof and external electrical and water systems. The building has no window or door frames and cement lintels were used for the window and door openings (**Figure 9**). The structure has a cement floor.

*Figure 9 – PP001: Pigsty and two sheds/Storerooms*

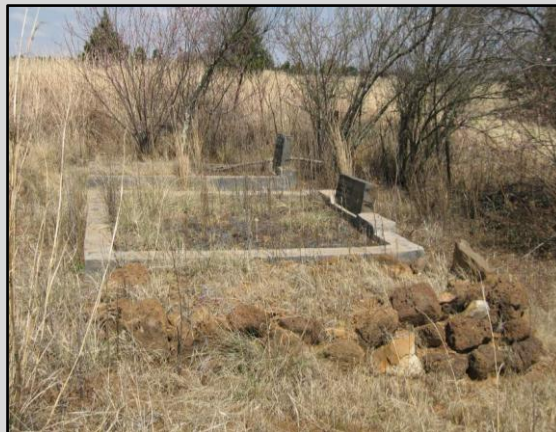
A cluster of four informal graves was identified at this location (**Figure 10**). The graves are situated in between a gravel road and a fence. The graves are placed next to each other along the fence and are orientated from west to east. One grave has a rectangular shaped cement outline as a dressing, with an inscribed granite headstone. This seems to be a double child's grave, as the headstone has two inscriptions painted on (**Figure 11**). Another grave is a double adult grave with a square shaped cement outline, which is filled with a layer of gravel. It also has an inscribed granite headstone. The fourth grave has an informal, elongated oval shaped mound of packed rocks as a dressing. It does not have an inscribed headstone. The graves are overgrown with vegetation, but it was evident that the graves had been cleared regularly as the vegetation was not overwhelming. The headstone inscriptions date the graves from the late 1960's and the 1970's and all the names on the graves are of the Mtweni family.

*Figure 10 – PP 002: Cemetery*

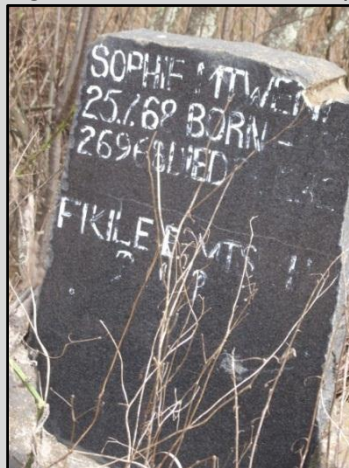
*Figure 11 – PP 002: Inscription on double child's grave*

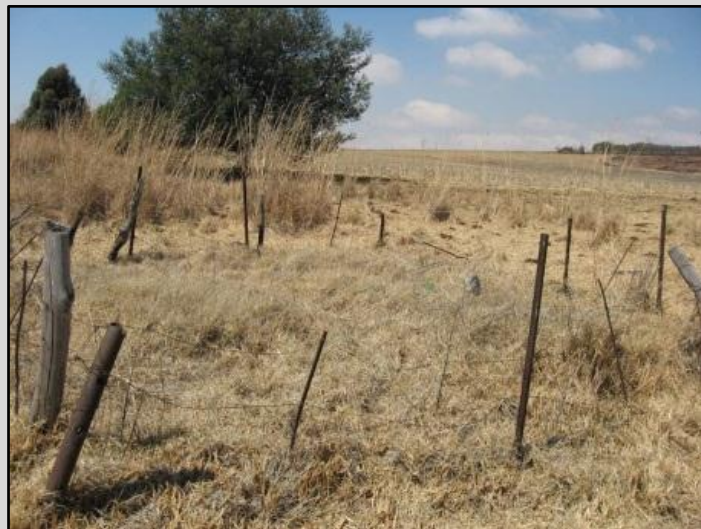
*Figure 12 – PP 003: Two Maseko graves*

Two informal graves were identified at this location. The graves are crudely fenced and are placed next to each other and orientated from west to east (**Figure 12**). The graves have large oval shaped outlines of packed rock as dressings. A flat rock serves as head stone for one grave. A plastic bottle and ceramic cup were placed on the graves as grave goods (**Figure 13**). The graves are not maintained and are overgrown with grass and other vegetation. The graves belong to the Maseko family, but their age was not known (local informant - Lina). The Maseko family apparently lives on the farm in the farmworkers houses located behind the farmstead (PP 001). Such graves are treated as being of 60 years or older unless evidence is obtained to the contrary.

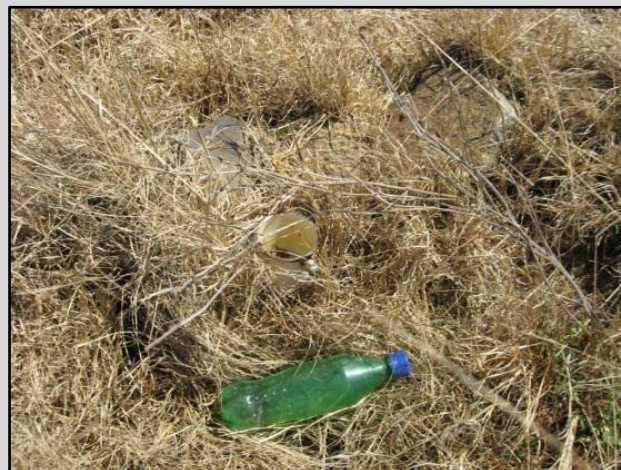
*Figure 13 – PP 003: Close-up of grave goods*

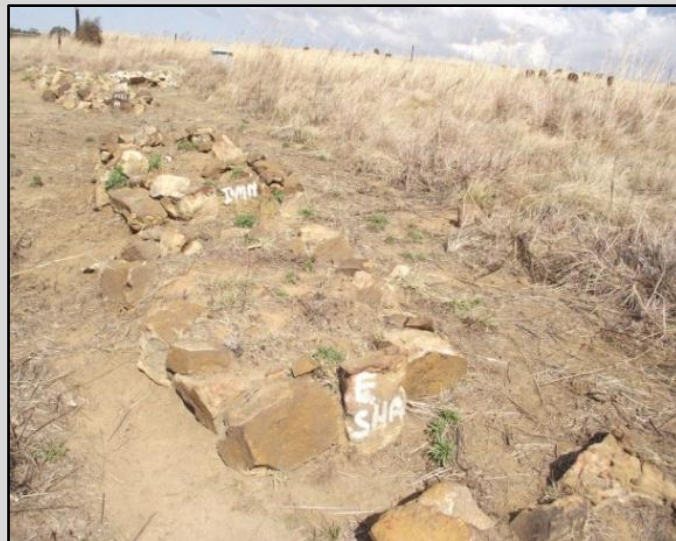
*Figure 14 – PP 004: Farmworker cemetery*

An informal cemetery with approximately 81 graves was identified at this location (**Figure 14**). The cemetery is not fenced and is located in the open veld. The graves are placed in 5 unequal lines next to each other. The graves are placed along the boundary fence of the property and they are orientated from west to east. Most of the graves have informal oval or rectangular shaped mounds or outlines of packed rocks as dressings. Some of the graves had been cleaned recently, but most of them are overgrown with grass and other vegetation. A number of graves have granite inscribed headstones and one grave has a formal granite dressing with an inscribed granite headstone.

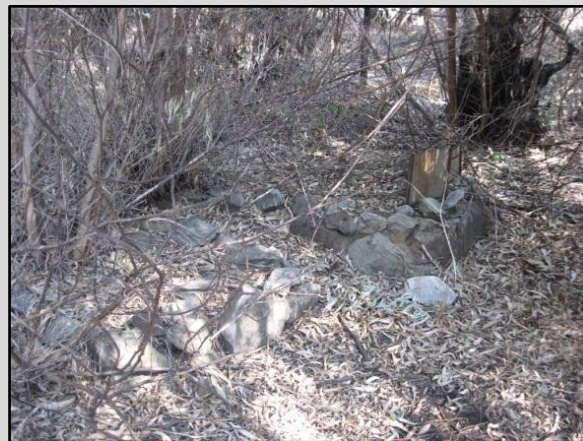
Another informal cemetery with approximately 40 graves was identified at this location. The cemetery is not fenced and is located amongst a plantation of blue-gum trees (**Figure 16**). The graves are placed in 5 unequal lines next to each other. The graves are also placed along the boundary fence of the property and they are orientated from west to east. Most of the graves have informal oval or rectangular shaped mounds or outlines of packed rocks as dressings. Most of the graves are overgrown with grass and other vegetation. Some graves have inscribed granite headstones and some graves have painted metal markers as headstones (**Figure 17**). Most of the graves have grave goods placed on the dressings.

*Figure 16 – PP 005: View of graves*

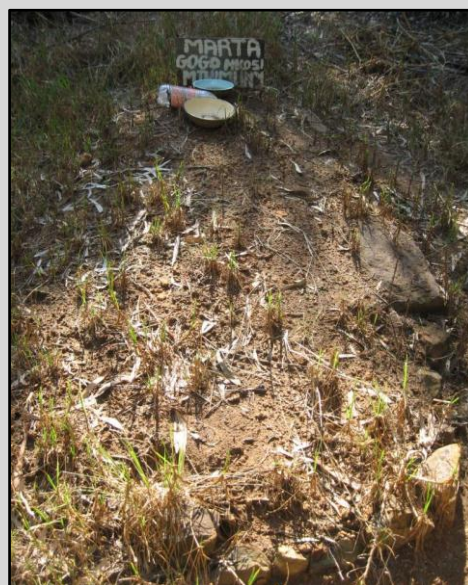
*Figure 17 – PP 005: Grave with marker and grave goods*

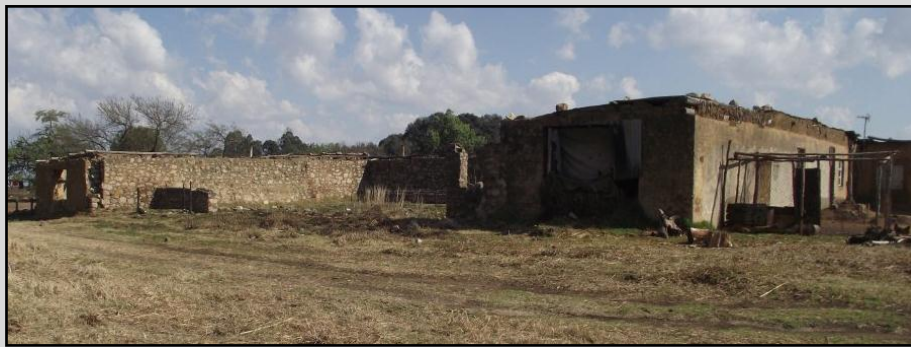
The remains of an old cattle kraal were identified at this location. The structure was built with stone and mortar and measures approximately 20m x 25m in size (**Figure 18**). The walls of the kraal are thick and measure approximately 0.75m thick and 2.2m high. The kraal has a storeroom attached to the one side and feeding troughs are placed along another wall (**Figure 19** and **Figure 20**). The storeroom is a later addition and is brick-built with a sloping corrugated iron roof. Three families had used parts of the old kraal structure to build their own homesteads. These families were working on the farm. The age of the kraal is not known.

*Figure 18 – PP 006: View of kraal with dwelling additions*

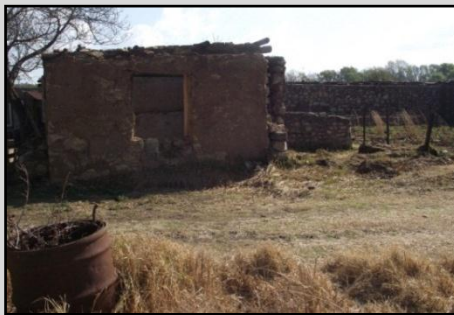
*Figure 19 – PP 006: Close-up of dwelling addition*

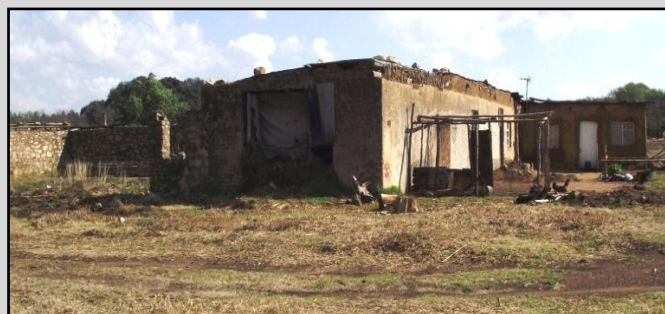
*Figure 20 – PP 006: Close-up of dwelling addition*

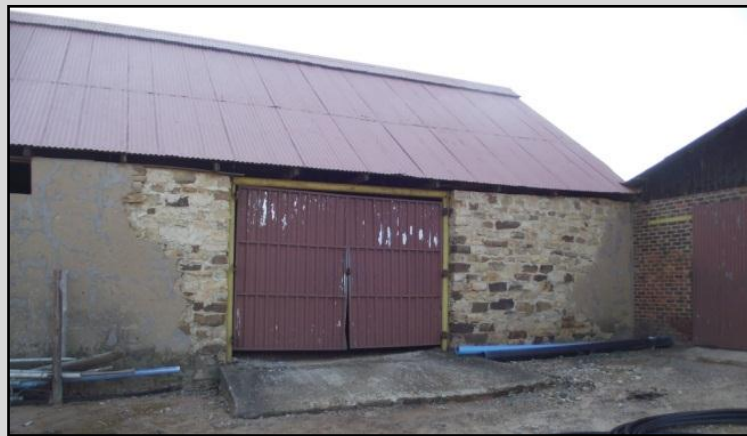
A large storeroom or shed was identified at this location. The storeroom measures approximately 20m x 12m in size and has a high pitched corrugated iron roof (**Figure 21**). It has large metal doors with metal door frames. These are most likely a later addition. The high windows have wooden frames and are open. The building also has an external electrical system. It has a cement floor and the building is still in use.

*Figure 21 – PP 007: Storeroom/shed*

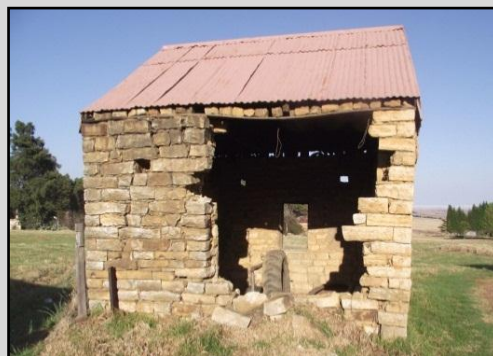
A small, square sandstone-built structure is situated next to the larger storeroom (**Figure 22**). This structure measures approximately 5m x 5m in size and also has a pitched corrugated iron roof. It is built with sandstone blocks and mortar and is in a rather weathered state. It does not have a door or door frame and a wooden lintel is used in the door opening. It has wooden window frames. The building has a dirt floor and does not have any water or electrical systems.

*Figure 22 – PP 007: Dilapidated square structure*

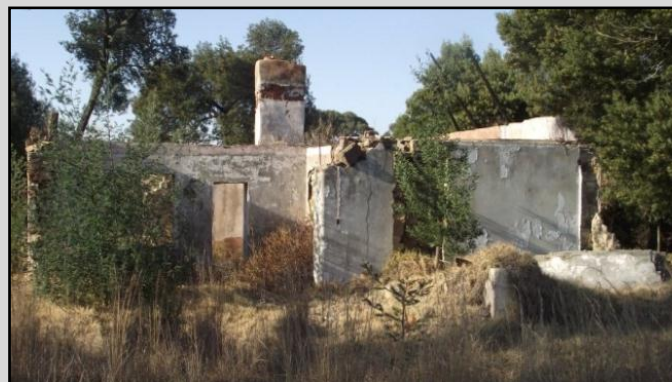
*Figure 23 – PP 008: Ruins of farmhouse*

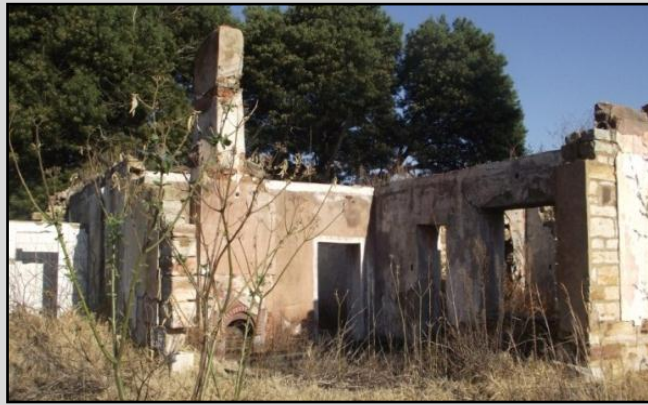
The building has no roof and all windows, doors and window and door frames had been removed. It has a sandstone chimney and some of the floors are tiled (**Figure 24**). The house had an internal electrical system which was a later addition.

*Figure 24 – PP 008: Ruins of farmhouse*

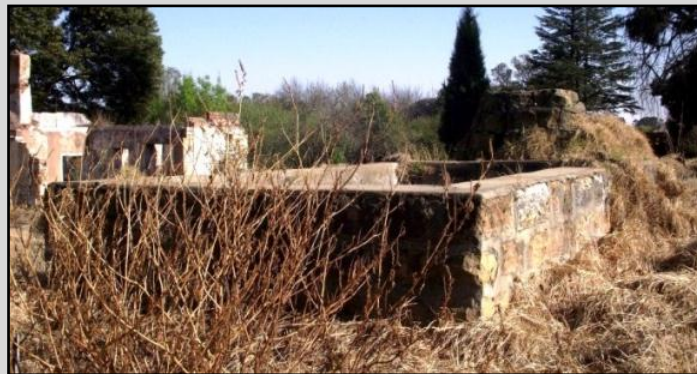
*Figure 25 – PP 008: Sandstone reservoir*

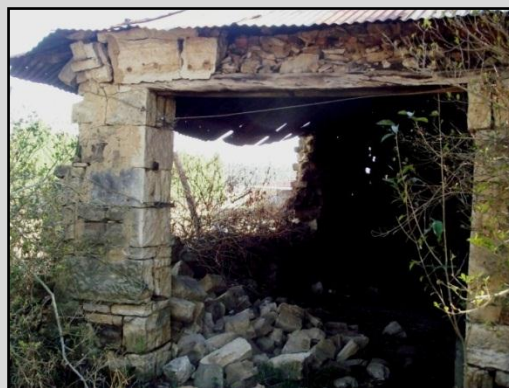
*Figure 27 - PP 008: Interior view of sandstone shed*

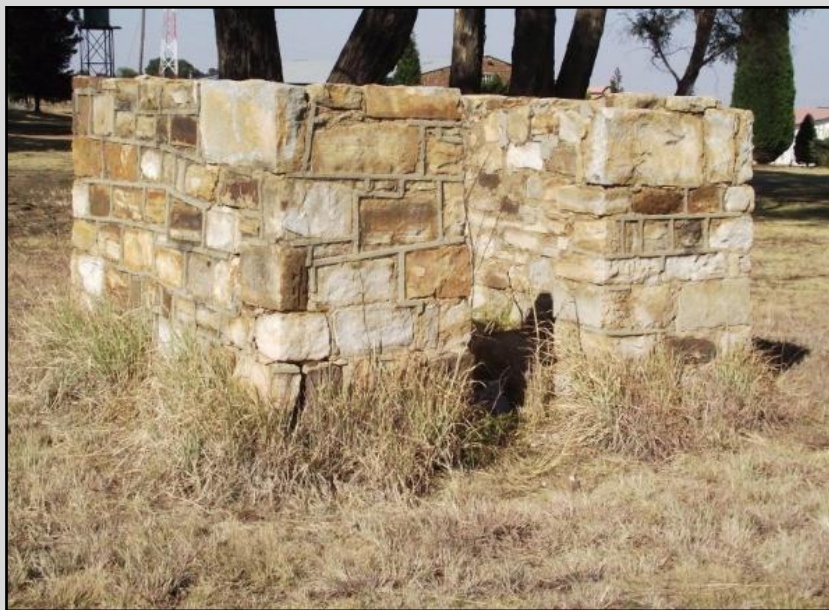
*Figure 28 – PP 009: Square sandstone structure*

The remains of a small, square structure were identified at this location (**Figure 28**). The structure is built with sandstone blocks and cement and measures approximately 4m x 4m in size. The structure has no roof and has only one entrance with no windows. It also has a gravel floor. The function and age of this structure is unknown.

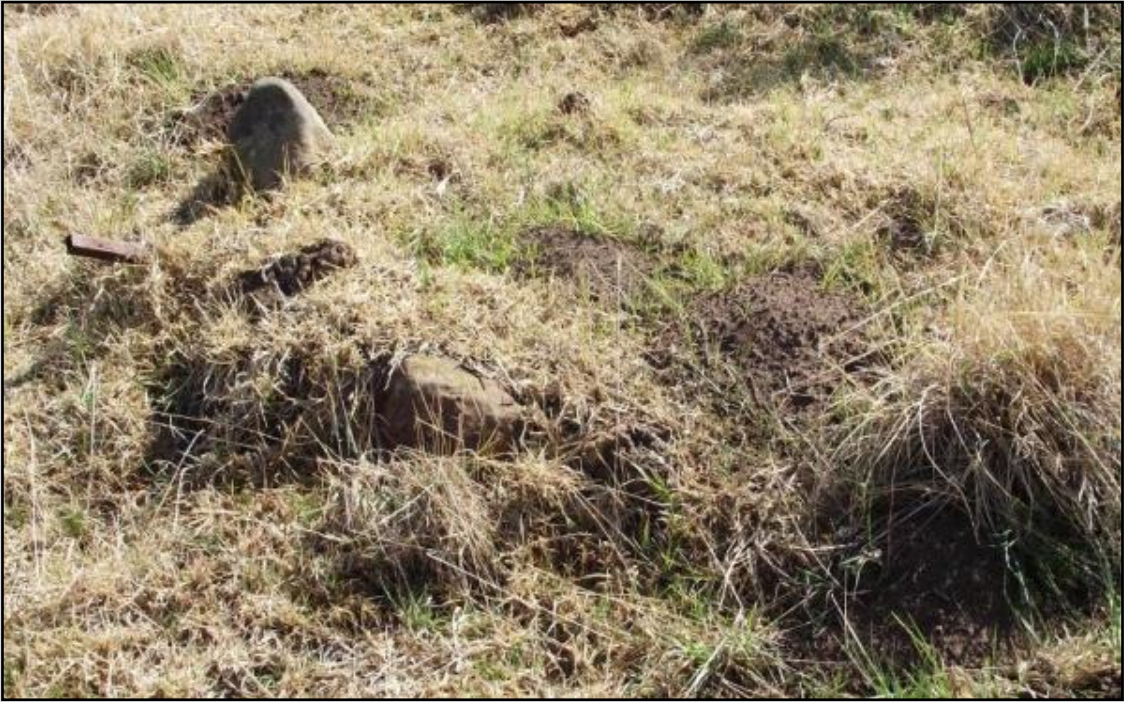
*Figure 29 - PP 010: Single grave, near PP 011*

A single, informal grave was identified at this location (**Figure 29**). The grave is situated approximately 40m from a farmstead, which has been identified as site PP 011 (below). The grave has an oval shaped outline of packed rocks as dressing and is orientated from west to east. A single rock is placed upright at the western end to serve as a headstone. The grave is not maintained and is overgrown with grass and other vegetation. The age of the grave is not known.

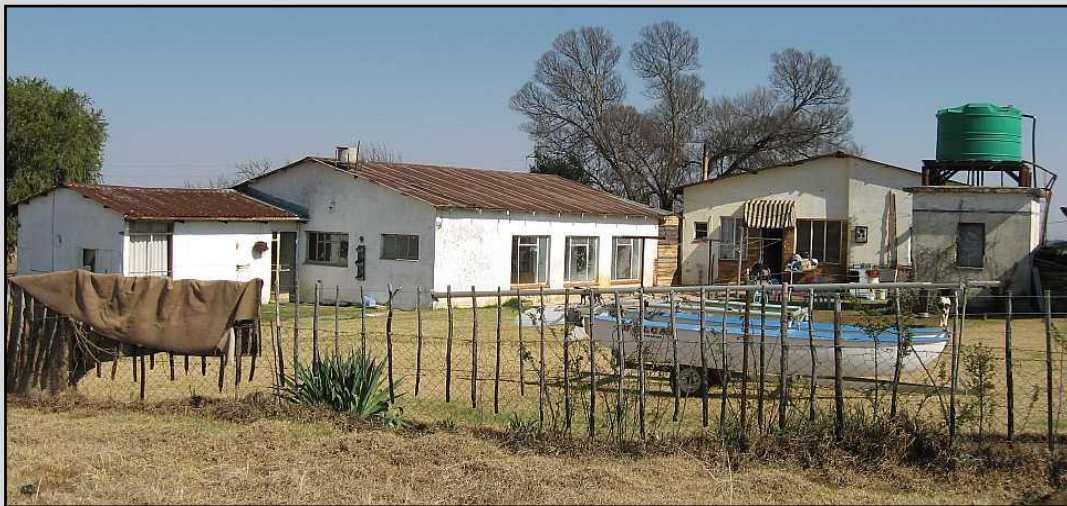
*Figure 30 – PP011: Farmstead (two houses)*

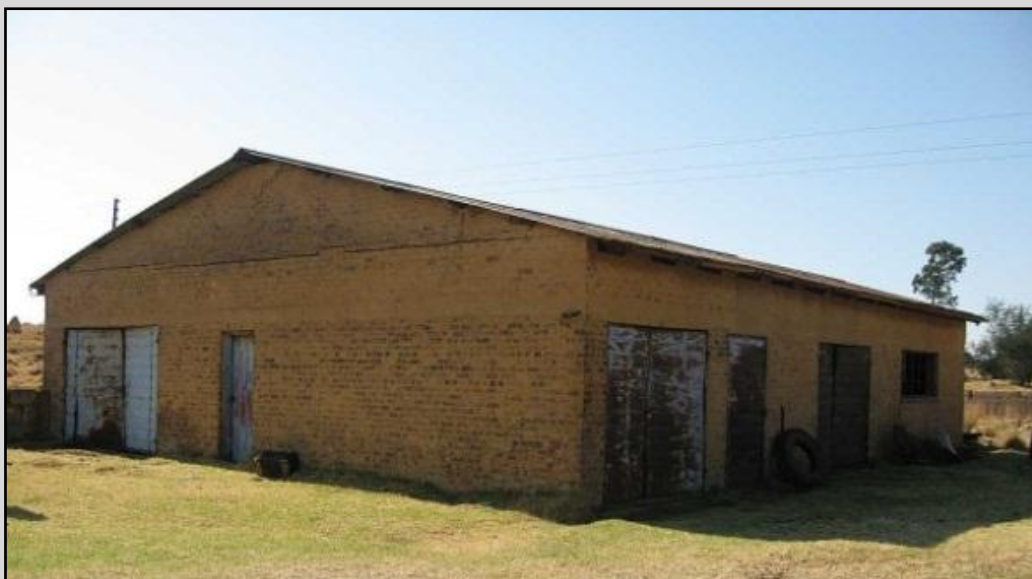
*Figure 31 - PP011: Brick shed*

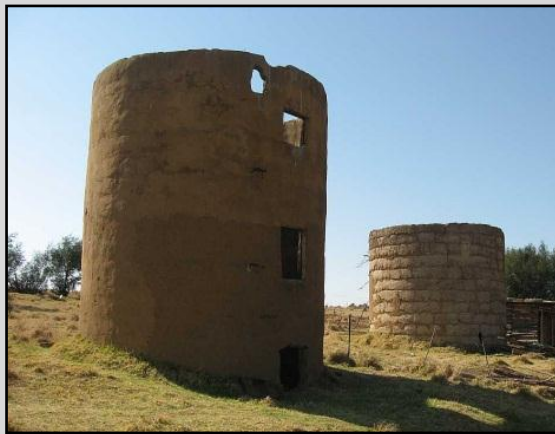
*Figure 33 – PP011: Two silos*

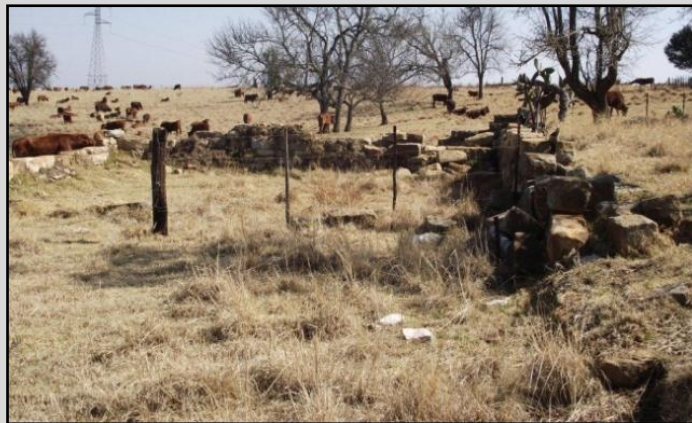
*Figure 34 – PP 011: Remains of kraal*

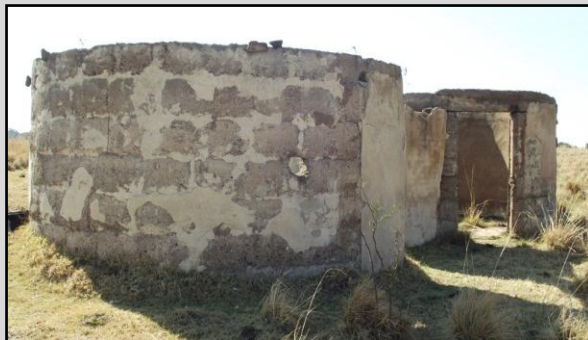
The remains of a double-rondawel workers' dwelling was also identified near the houses (**Figure 35**). The two rondawels were built of cement bricks and plastered. A brick curtain wall was added to join the two rondawels at a later date. The rondawel may be associated with the single grave (**PP010**). The age of this farmstead and its associated buildings was not known.

*Figure 35 – PP 011: Double rondawel*

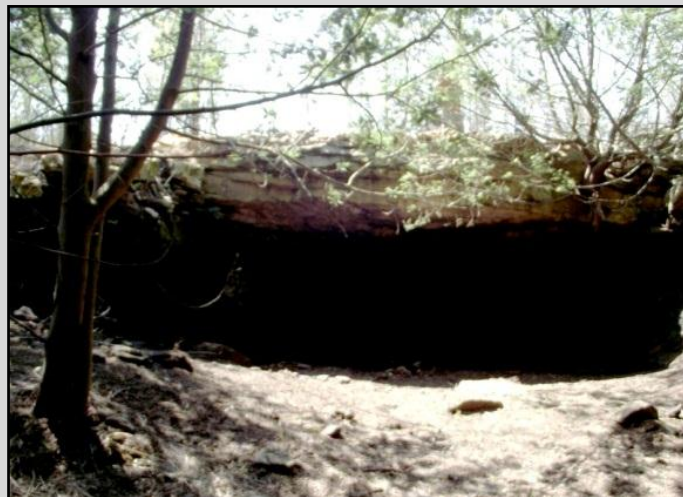
An abandoned coal mine shaft was identified at this location (**Figure 36**). The shaft measures approximately 2m x 5m and extends approximately 25m into the side of the hill. A second tunnel/shaft extended from the main shaft and its roof had collapsed at the end of this shaft/tunnel (**Figure 37**). Most of the shaft is flooded with water. Wooden supports to keep the roof of the shaft from collapsing are still in place. A ventilation hole had been dug in the roof which is visible on the surface of the rock outcrop. The age of this abandoned mine is not known. However, it is likely that it dates to over 100 years. Van der Merwe's book on the town of Belfast states that coal mining occurred in this area in historical times and was associated with Sammy Marks (1952).

*Figure 36 – PP 012: Mineshaft entrance*

- Two of these sites (PP012, PP013) are located on portion RE of Paardeplaats 425, which is indicated as not being affected by mining activities. These two sites should therefore be retained *in situ*. However, site PP017 is located on portion 2 of the Paardeplaats 425, which may be utilised for off-set activities. Therefore, if this site will be affected by mining activities, it is recommended that it shaft should be mapped and investigated further before it is destroyed.

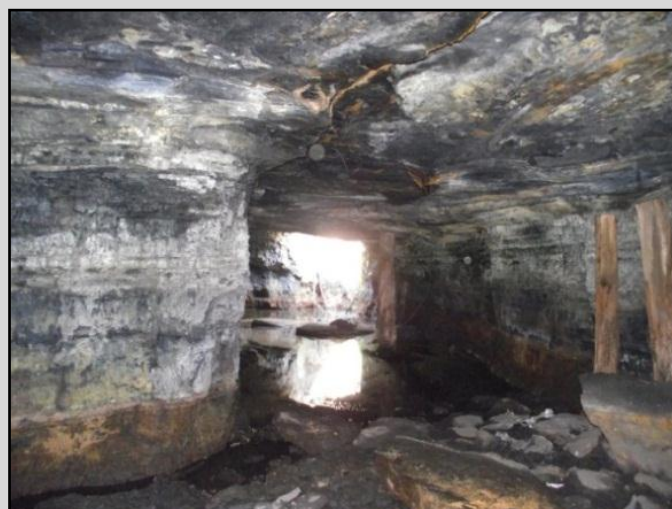
*Figure 37 – PP 012: Interior of mine shaft*

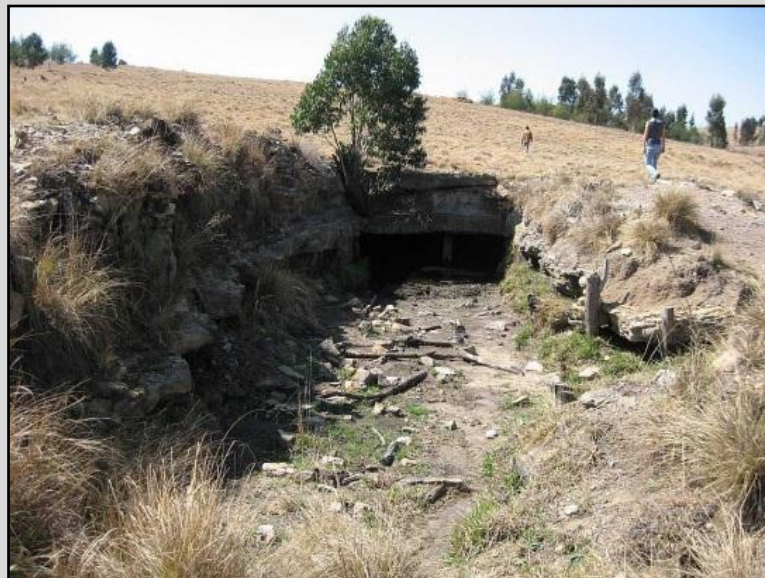
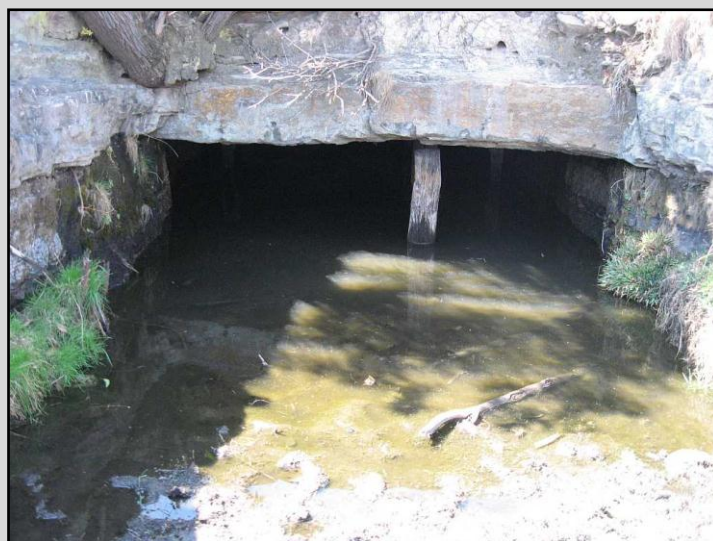
*Figure 38 – PP 013: General view of mine shaft*

Another abandoned mine shaft was identified at this location (**Figure 38** and **Figure 39**). The shaft also measures approximately 2m x 5m and extends approximately 25m into the side of the hill. Most of the shaft is flooded with water. Wooden supports to keep the roof of the shaft from collapsing are still in place. The age of this abandoned mine was not known. However, as noted above, it probably dates to the historical period. The coal spoil heap is also still present close to the entrance of the shaft.

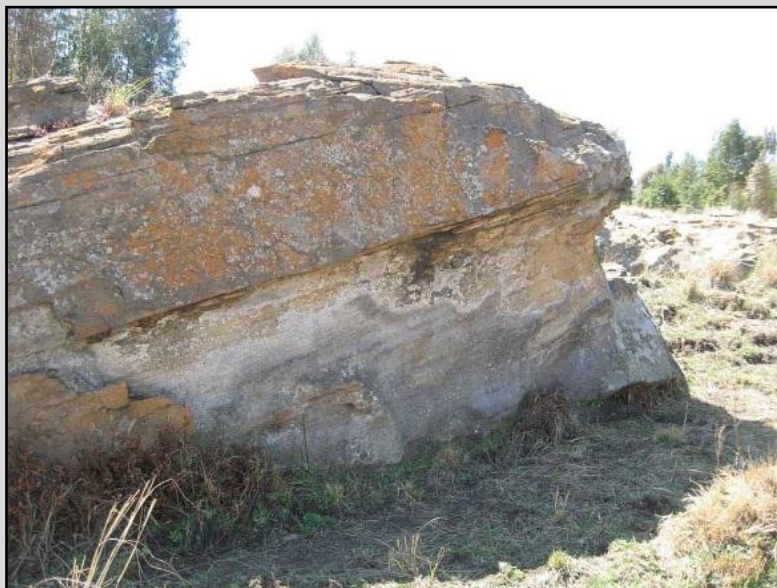
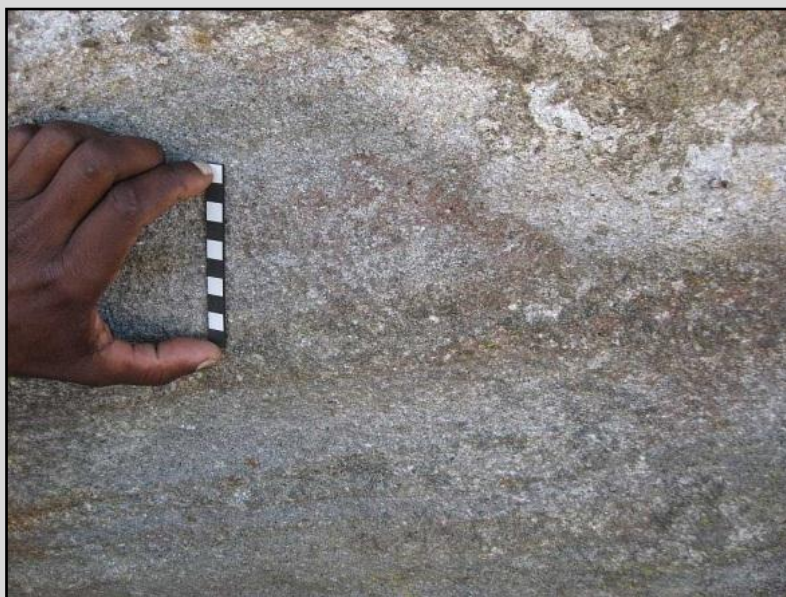
*Figure 40 – PP014: Rock outcrop with possible rock art*

**Figure 40**). The position of the panel is situated on the southern side of an exposed rock bank which formed a slight overhang. Two extremely faded figures were identified (**Figure 41**). These figures were red in colour, but could not be identified clearly. The figures measure approximately 20cm in size. The rock face is also deteriorating. No archaeological deposit was identified at the foot of the rock face.

It is recommended that the site be demarcated as a no-go area and that a specialist on rock art be contracted to evaluate and confirm the existence of the rock art and if confirmed develop further management recommendations for the site.

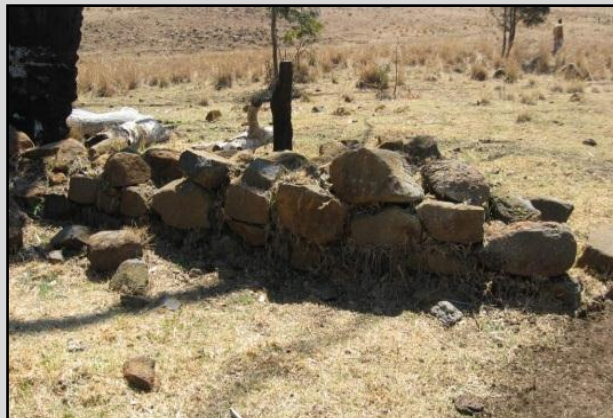
The ruined stone walled cattle kraal was situated approximately 35m to the west of the homestead (**Figure 42** and **Figure 43**). The kraal measures approximately 10m x 10m in size and the walls measure approximately 0.5m wide and 0.75m high.

*Figure 42 – PP 015: Remains of kraal*

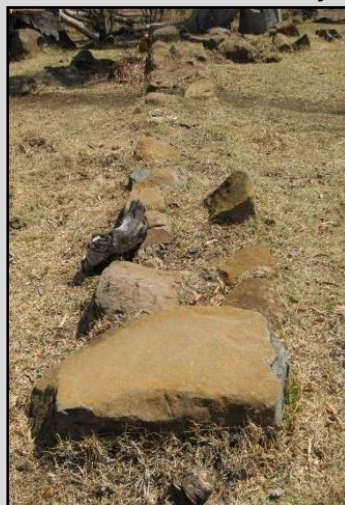
*Figure 43 – PP 015: Close-up of kraal wall*

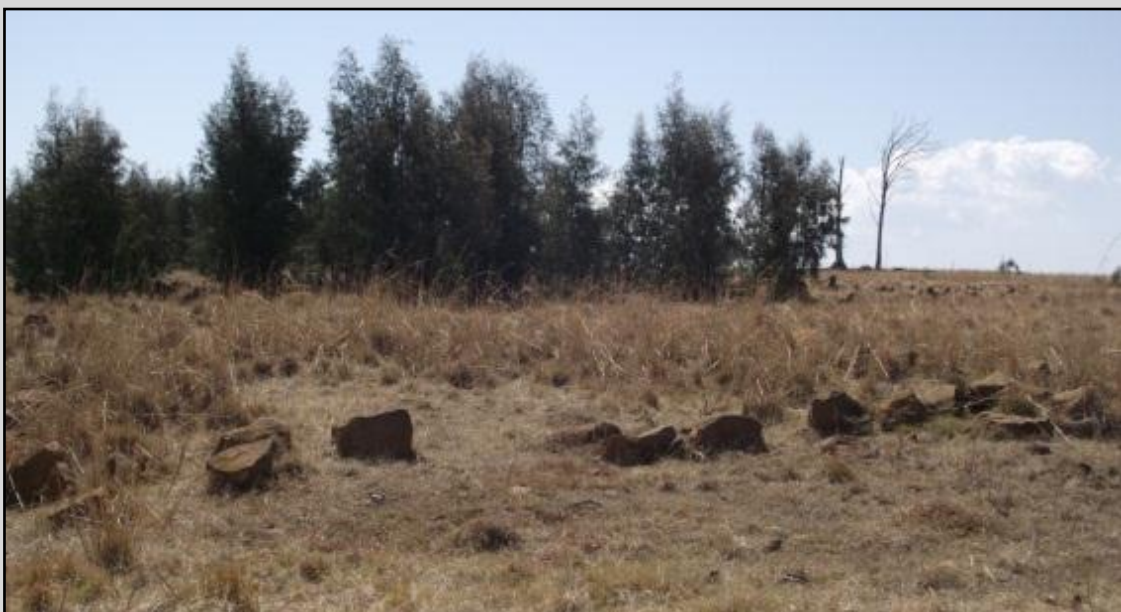
*Figure 44 – PP 016: remains of kraal walling*

The remains of a mud brick homestead with a stone walled cattle kraal were identified at this location (**Figure 44**). The remains of the mud brick homestead consist of the foundations of one rectangular structure, which measures approximately 7m x 4m in size, and a multi-roomed rectangular structure, which measured 8m x 10m each. Another circular structure measures approximately 4m in diameter. This structure was most probably the cooking hut. Rocks were used in the foundations to support the mud brick walls of the structures. A lower grinding stone was also identified with the remains of the structures. Several modern metal artefacts were such as wire, corrugated iron and cans were found scattered around the site.

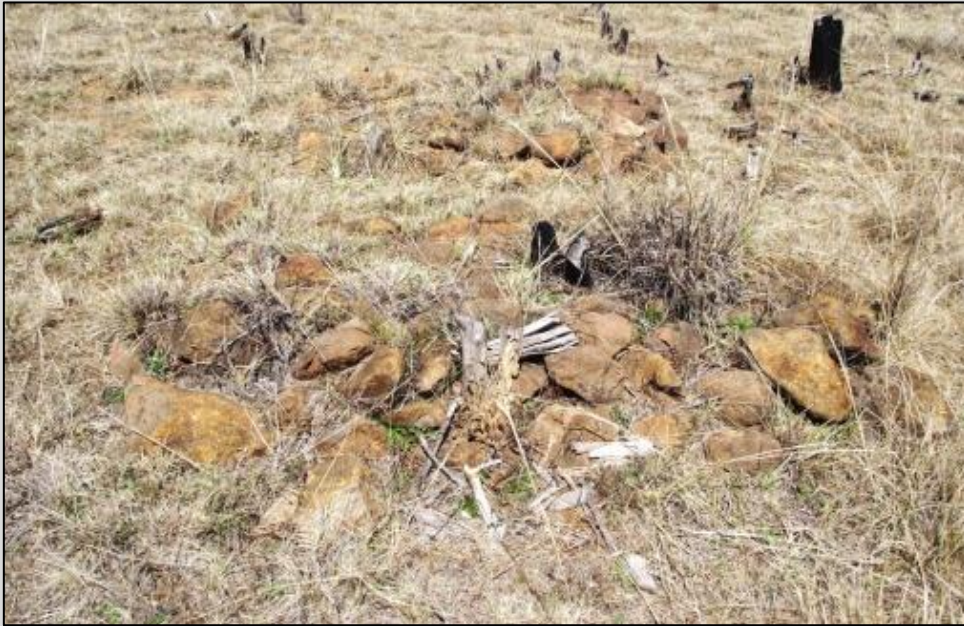
*Figure 45 – PP 016: Two graves*

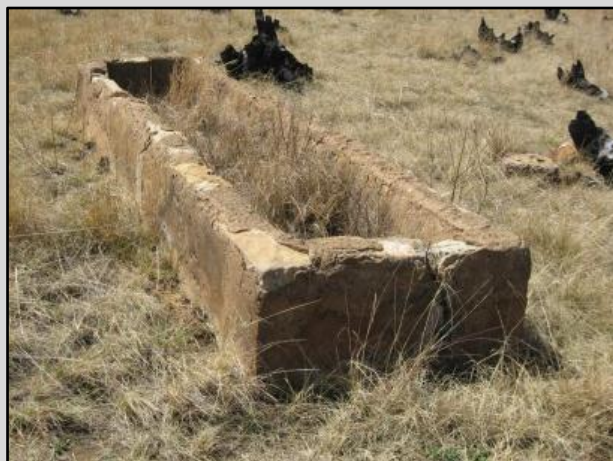
An old animal drinking trough was identified at this location (**Figure 48**). The trough is constructed with sandstone blocks and cement and is plastered. The trough measures approximately 5m x 1m and is approximately 0.75m high. No other structures or features are associated with the trough. The age of the trough is not known.

*Figure 48 – PP 018: Water trough*

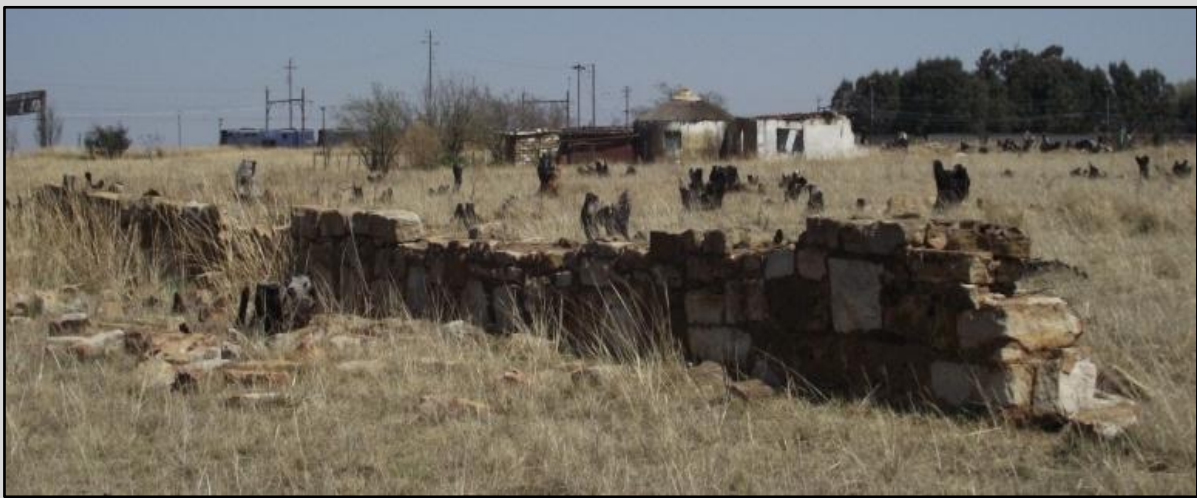
A ruined stone-walled cattle kraal was identified at this location (**Figure 49**). The kraal measures approximately 20m x 10m in size and the walls measure approximately 0.5m wide and 1m high. Most of the sandstone blocks used in the walls of the kraal have been robbed (used somewhere else) and the original kraal is in a very dilapidated state (**Figure 50**).

*Figure 49 – PP 019: Remains of stone kraal*

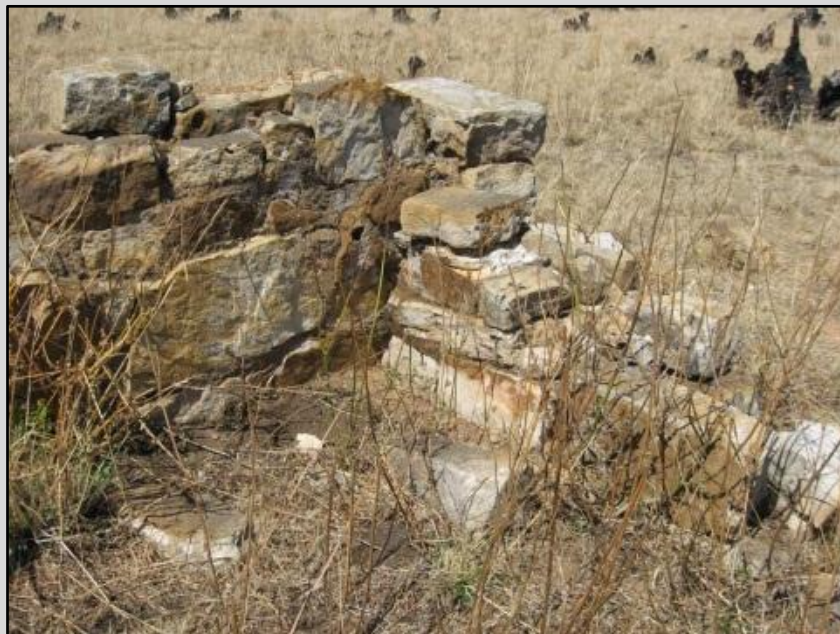
*Figure 50 – PP 019: Close-up of remains of kraal wall*

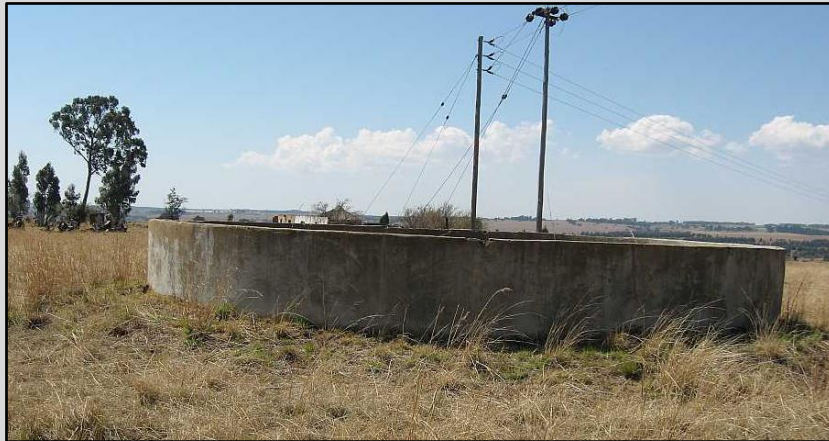
*Figure 51 - PP 020: Cement Dam*

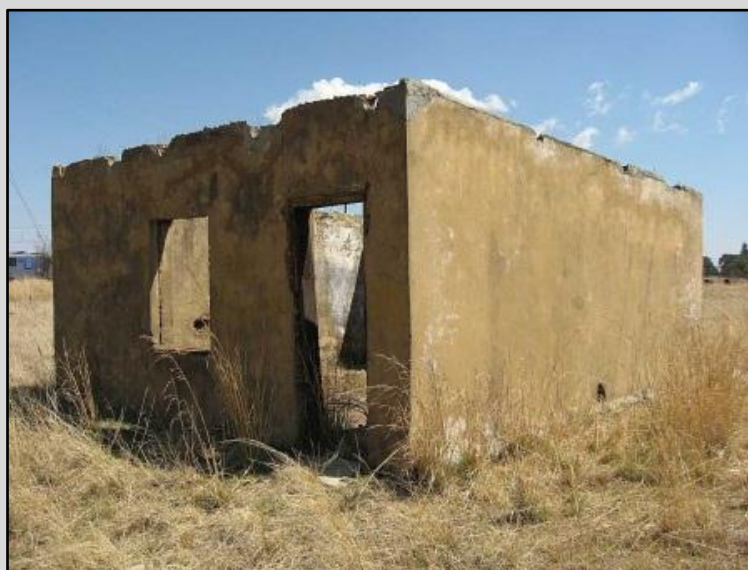
A 6m x 6m square brick-built building is situated next to the cement dam (**Figure 52**). The building is plastered and has a wooden door frame. The building's roof, windows and doors had been removed. The age of this building is not known.

*Figure 52 – PP 020: Brick structure*

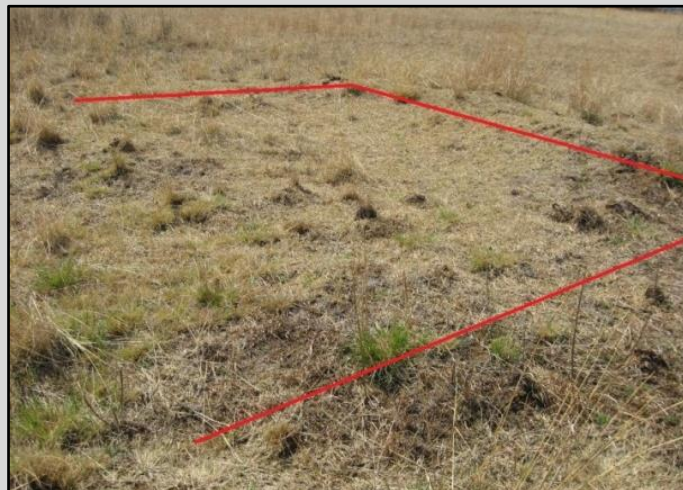
*Figure 53 – PP 021: Foundations of rectangular structure*

The remains of a mud brick homestead were identified at this location. The remains of the mud brick homestead consist of the foundations of one rectangular structure (**Figure 53**), which measure approximately 7m x 4m in size, and a multi-roomed I-shaped structure, which measures 8m x 12. A further circular structure measures approximately 4m in diameter (**Figure 54**). This structure was most probably the cooking hut. Rocks were used in the foundations to support the mud brick walls of the structures. A lower grinding stone was also identified with the remains of the structures (**Figure 55**). Several modern metal artefacts were such as wire, corrugated iron and cans were found scattered around the site.

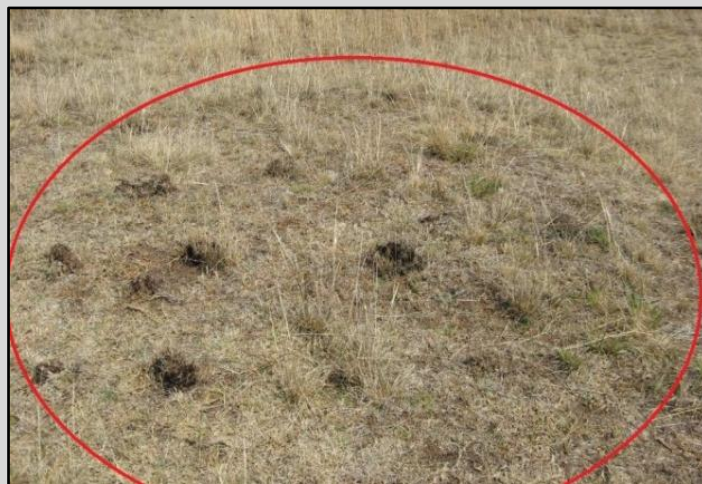
*Figure 54 – PP 021: Remains of circular structure*

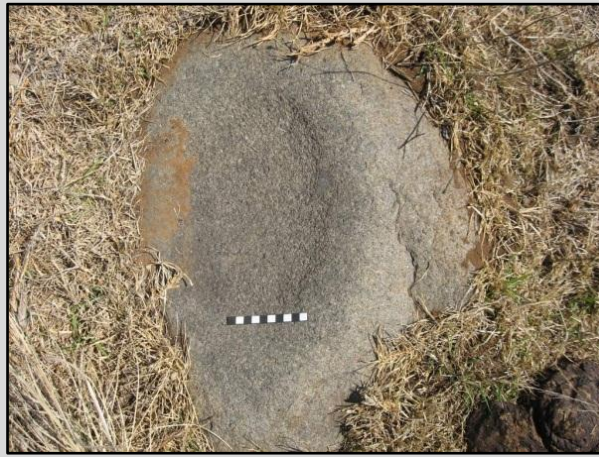
Figure 55 – PP 021: Lower grindstone

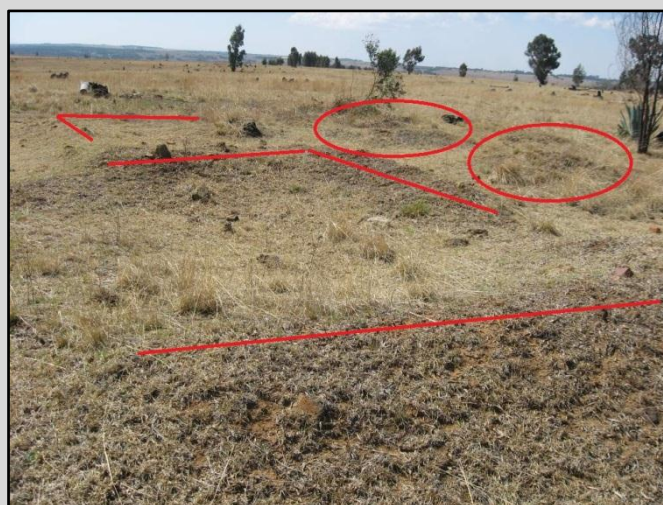
The remains of a mud brick homestead were identified at this location. The remains of the mud brick homestead consist of the foundations of one rectangular multi-roomed structure, which measures approximately 10m x 15m in size; two rectangular shaped structures, which measure 4m x 6m each; and a square room, which measures 4m x 4m (**Figure 56**). There was also a circular structure, which measures approximately 4m in diameter. This structure was most probably the cooking hut. The structures are arranged in an open square which formed a central lapa area. Rocks were used in the foundations to support the mud brick walls of the structures. Several modern metal artefacts such as wire, corrugated iron and cans were found scattered around the site.

Figure 56 – PP 022: Foundations of multi-roomed structure

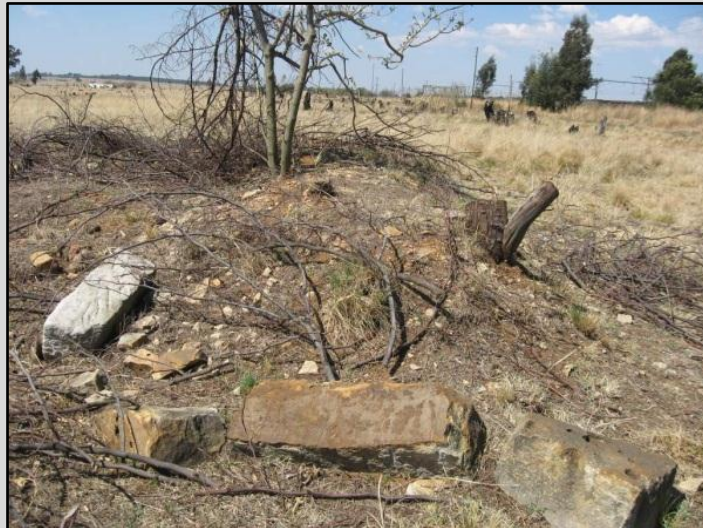
*Figure 57 – PP 023: Remains of sandstone building*

The remains of an old sandstone building were identified at this location (**Figure 57** and **Figure 58**). Most of the remains of the building had been removed and only the sandstone blocks which formed the foundations of the building are left. Several bricks were also found scattered across the site. There were no other features such as windows, doors or any floors to identify the structure with. These remains are most probably parts of an old farm house, which were broken down and removed from this site in the past. The structure measures approximately 18m x 20m in size. The exact function and age of this structure is not known.

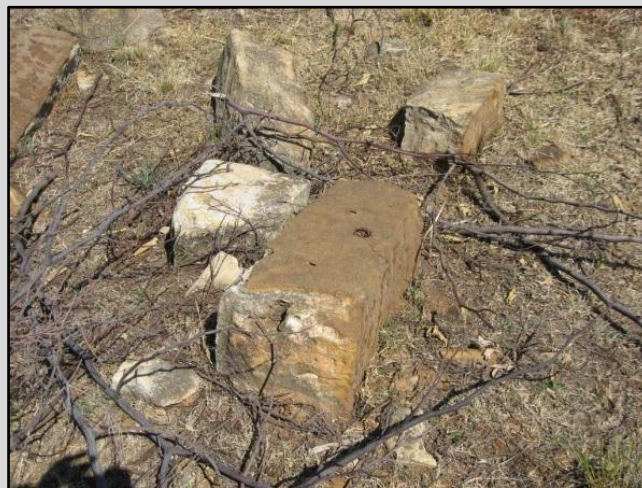
*Figure 58 – PP 023: Sandstone blocks*

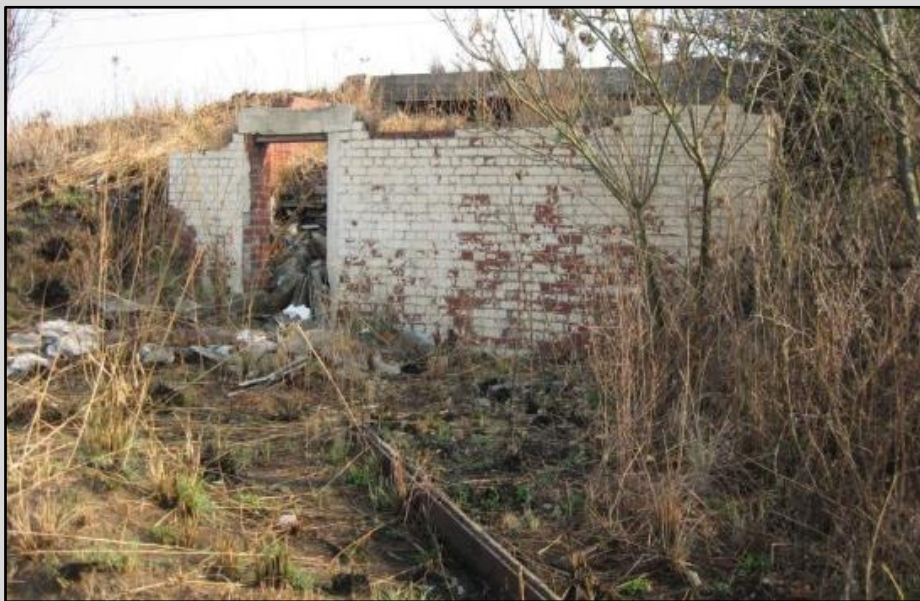
The ruined remains of the Sunbury railway station were identified at this location (**Figure 59**). The structure is constructed of red brick that was plastered and painted. The structure has been stripped of its roof, doors, windows and all other features. Only a few of its walls remain. The structure is in ruins and is overgrown with vegetation. The age of the station is not known.

*Figure 59 - PP 024: Remains of Sunbury railway station building*

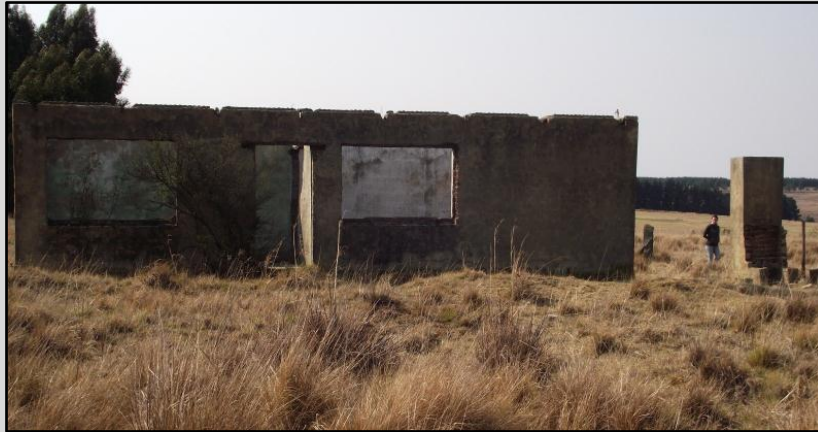
*Figure 60 – PP 025: Ruins of farmworker dwelling and “donkey” structure*
