**EXXARO PAARDEPLAATS PROJECT**  
**Heritage Impact Assessment Report**

**Issue Date:** 26 October 2012  
**Revision No.:** 1  
**Client:** EIMS REF NO. 0888

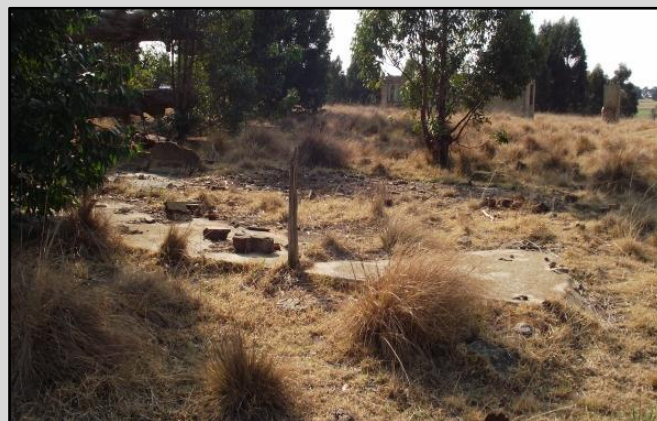
The remains of a cattle or pig shed were also identified approximately 50m to the west of the labourer quarters (**Figure 61**). A brick and cement drinking trough was identified near the remains of the cattle/pig shed (**Figure 62**).

*Figure 61 – PP 025: Remains of shed*

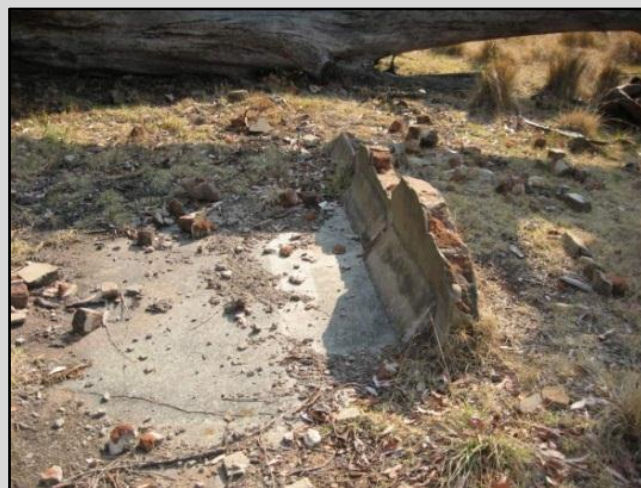
*Figure 62 – PP 025: Close-up of shed wall*

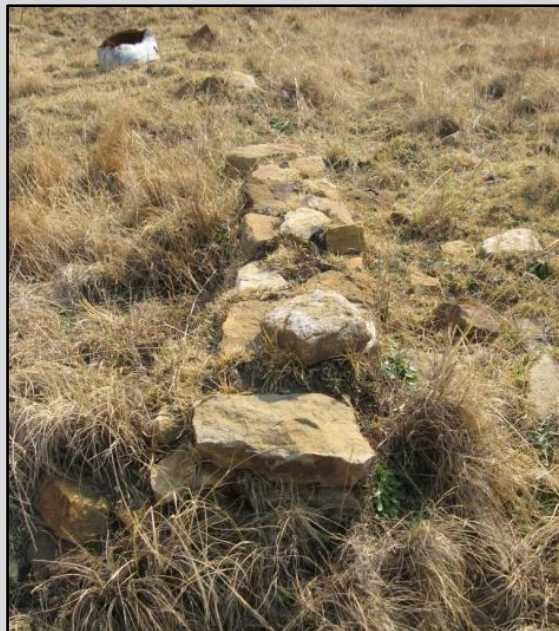
*Figure 63 – PP 026: Foundation of homestead wall*

The remains of a mud brick homestead were identified at this location (**Figure 63**). The mud brick homestead consist of the foundations of two square structures, which measure approximately 4m x 4m in size each, and a multi-roomed rectangular structure, which measures 8m x 15m. Another circular structure measures approximately 4m in diameter. This structure was most probably the cooking hut. Rocks were used in the foundations to support the mud brick walls of the structures. Several modern metal artefacts were such as wire, corrugated iron and cans were found scattered around the site.

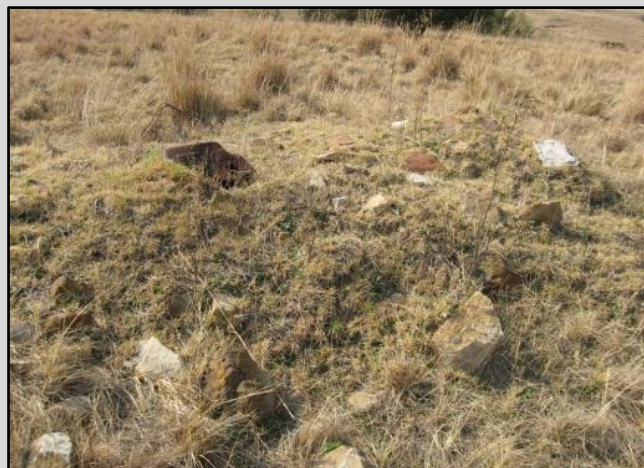
*Figure 64 – PP 026: Remains of circular structure*

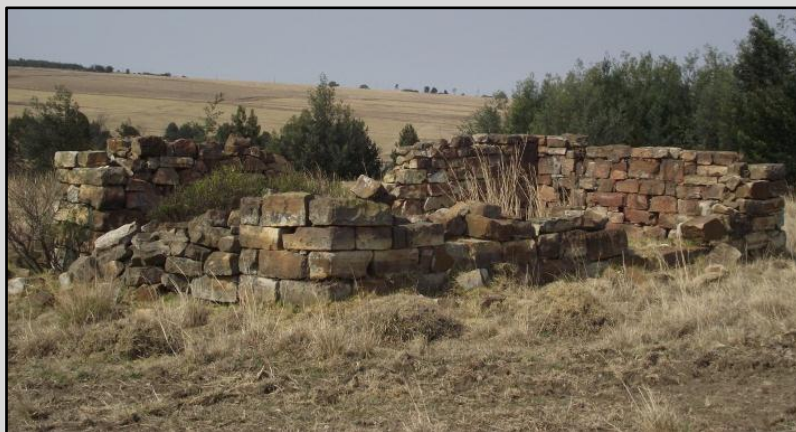
The remains of a sandstone building were identified at this location. The structure measures approximately 12m x 5m and is constructed with sandstone blocks without mortar or cement (**Figure 65**). The original entrance to the structure has been filled up with other sandstone blocks. The walls of this structure measure approximately 0.5m wide and approximately 2m high. The structure was most probably a shed or a storeroom.

*Figure 65 – PP 027: Ruins of sandstone shed*

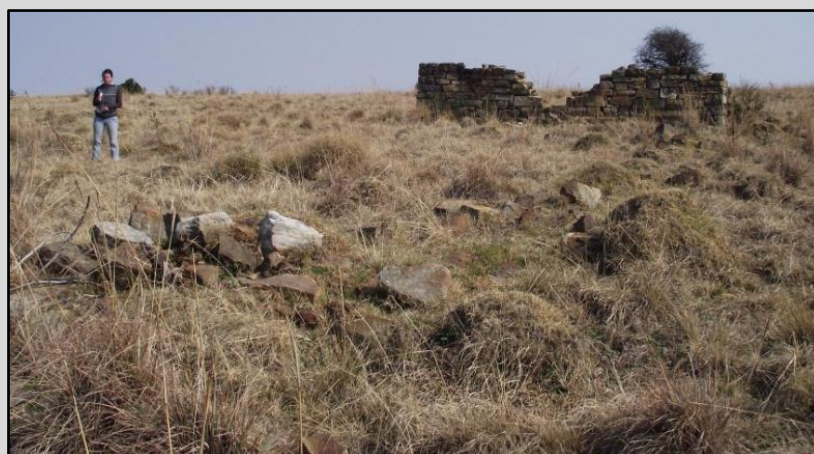
The remains of a stone walled kraal were identified next to the sandstone structure (**Figure 66**). Most of the walling for the kraal has been removed and only some sandstone blocks from the foundations are left. The kraal measures approximately 10m x 25m.

*Figure 66 – PP 027: Remains of kraal walls attached to shed*

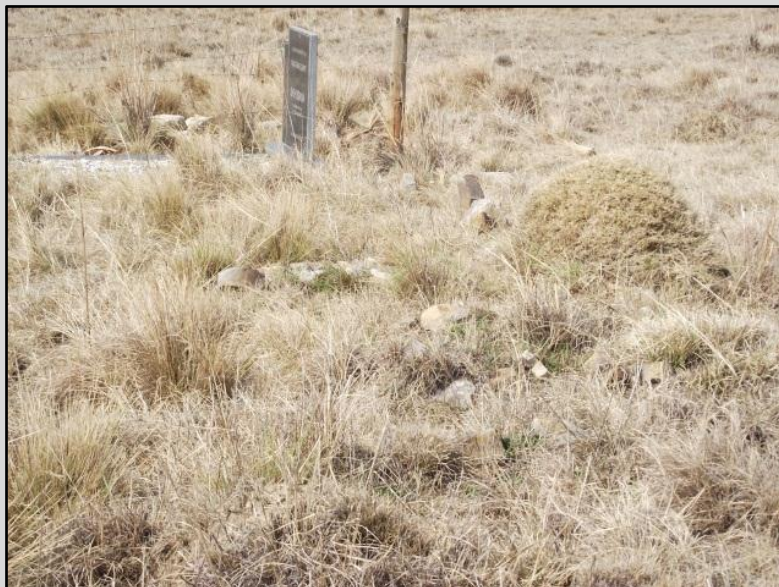
A small informal cemetery with eight graves was identified at this location (**Figure 67**). The cemetery is fenced and is situated in the open veld. The graves are placed in one line next to each other and all are orientated from west to east. Seven of the graves have informal, oval shaped outlines of packed rocks which are filled with soil. Rocks are placed upright at the western ends to serve as headstones. One grave has a formal granite dressing and an inscribed granite headstone (**Figure 68**). This grave dates from the early 1960's and belongs to the Skhosana family. Most of the graves are overgrown with grass and other vegetation. No grave goods were found with these graves.

*Figure 67 – PP 028: Skhosana Cemetery*

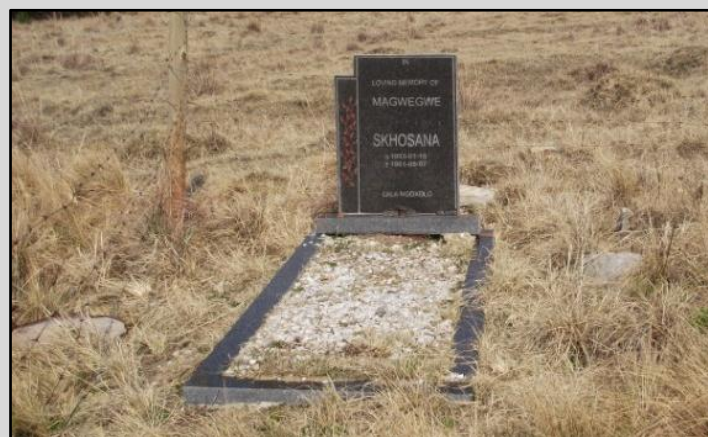
*Figure 68 - PP 028: Close-up of formal grave (Skhosana, 1961)*

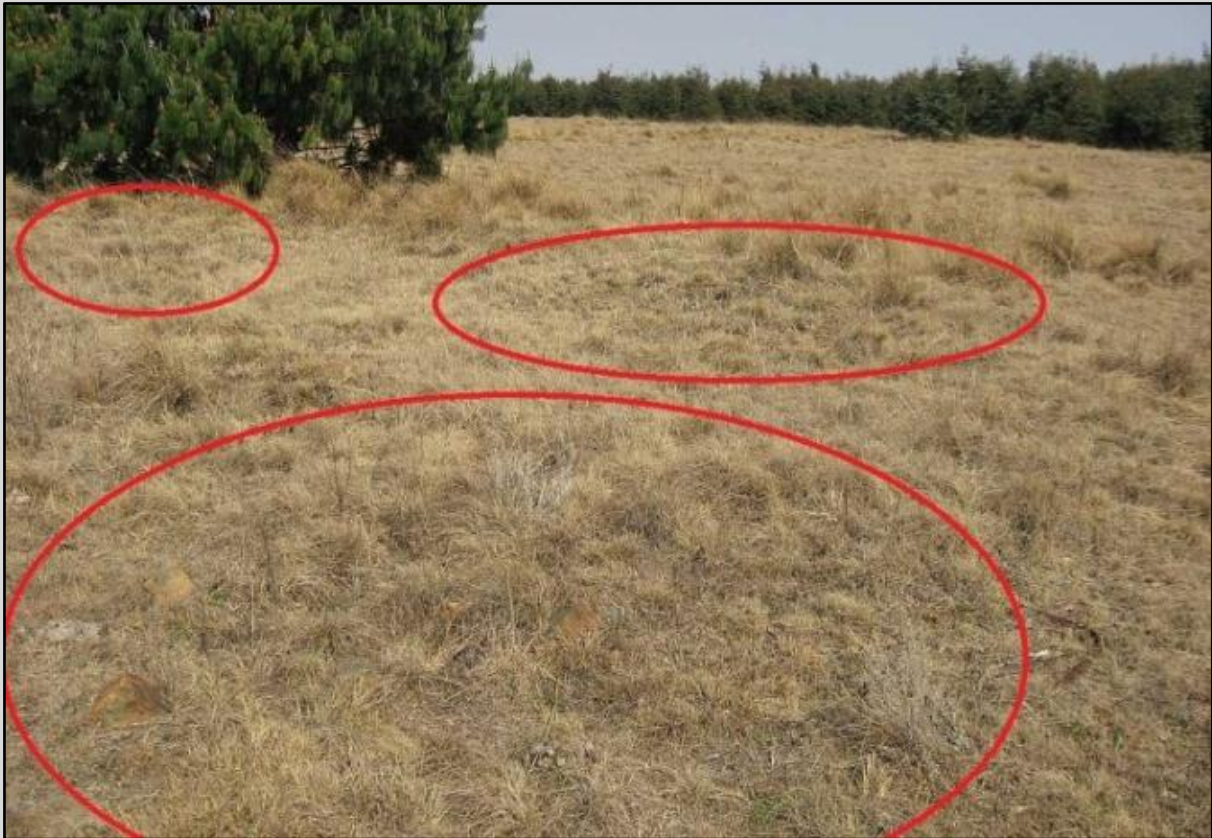
The remains of an extended mud brick settlement were identified at this location. The remains of this mud brick settlement cover an area of approximately 200m x 200 and consist of at least nine different homesteads or structures which formed part of the larger settlement (**Figure 69**). Most of the structures are ruined and were very difficult to identify. The numbers, sizes and shapes of these structures of this settlement are not clearly identifiable. Rocks were used in the foundations to support the mud brick walls of the structures. Several modern metal artefacts such as wire, corrugated iron and cans were found scattered around the site.

*Figure 69 – PP 029: General view of foundation remains*

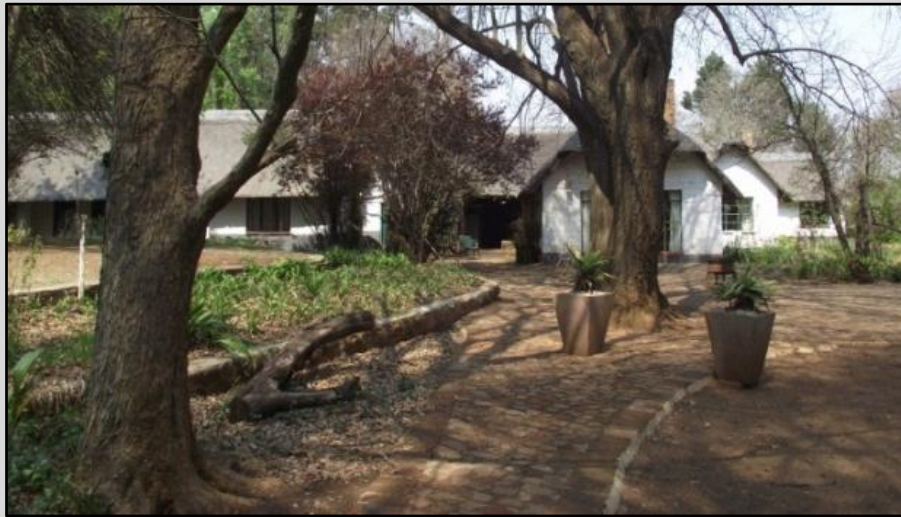
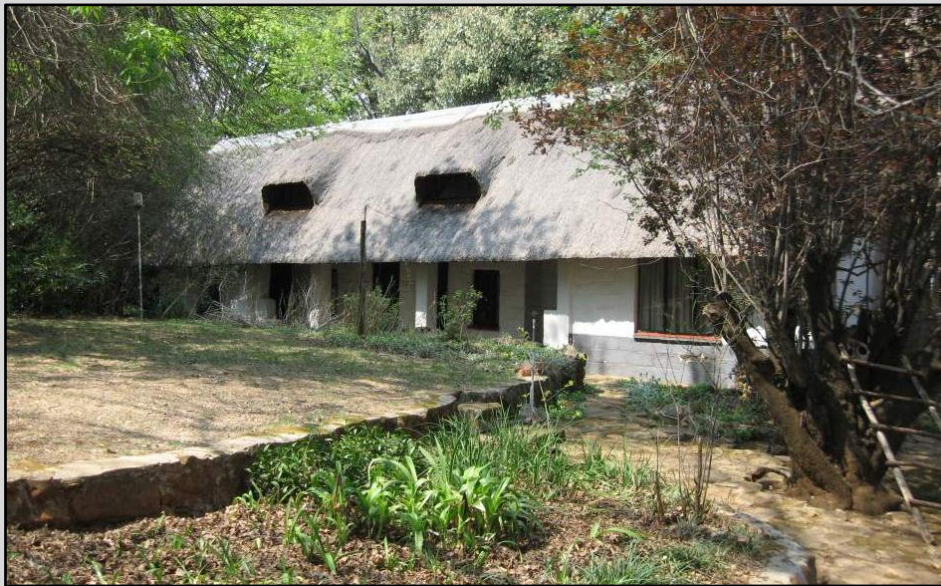
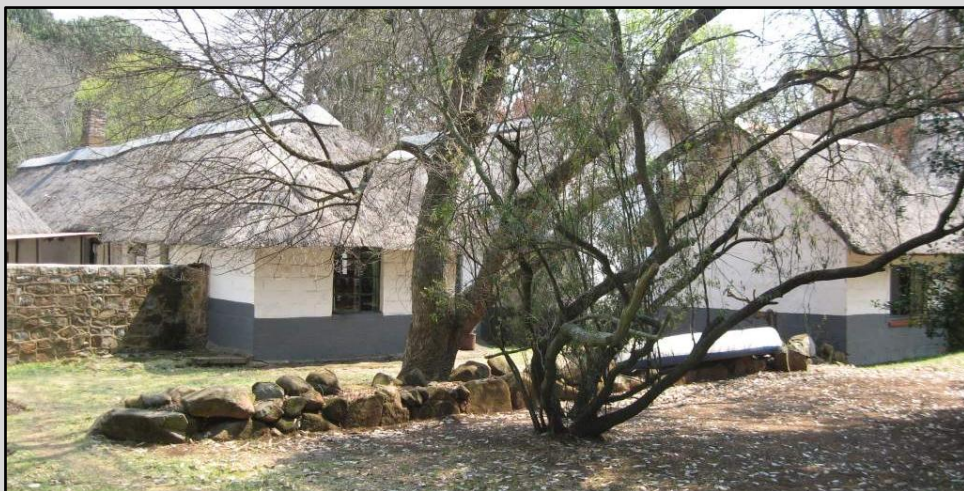
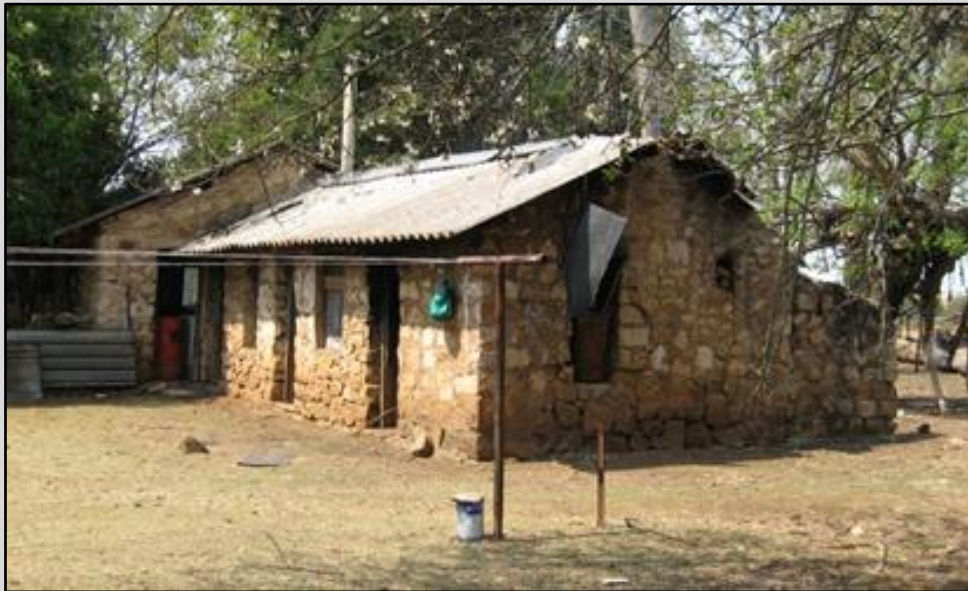
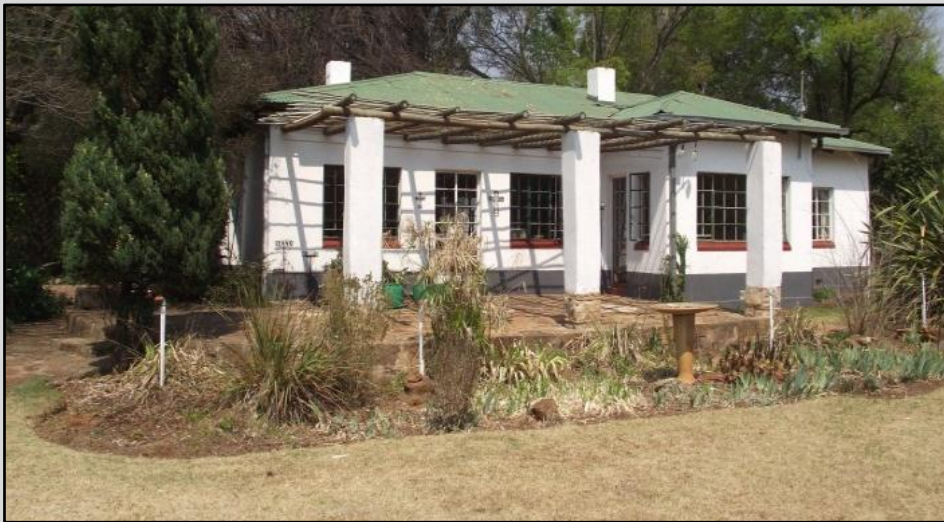
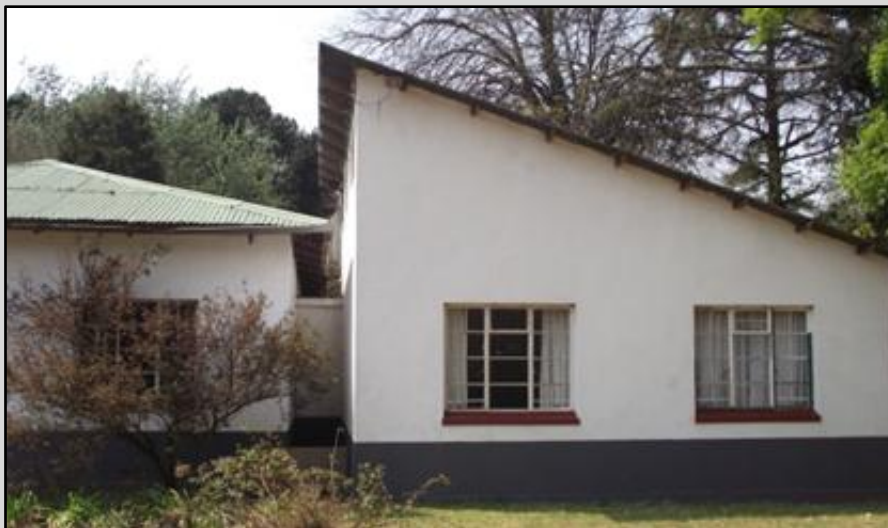
*Figure 70 – PP 030: Wilkie farmhouse, historical building with additions*

*Figure 71 - PP 030: View of Wilkie farmhouse*

*Figure 72 – PP 030: View of rear of main farmhouse*

*Figure 73 – PP 030: Two sandstone sheds*

*Figure 74 - PP 030: Second farmhouse, original building*

*Figure 75 – PP 030: Modern addition to rear of second farmhouse*

- Site PP030, must be evaluated by a heritage architect in terms of its heritage significance. This will result in a detailed report with specific recommendations on proposed mitigation measures.

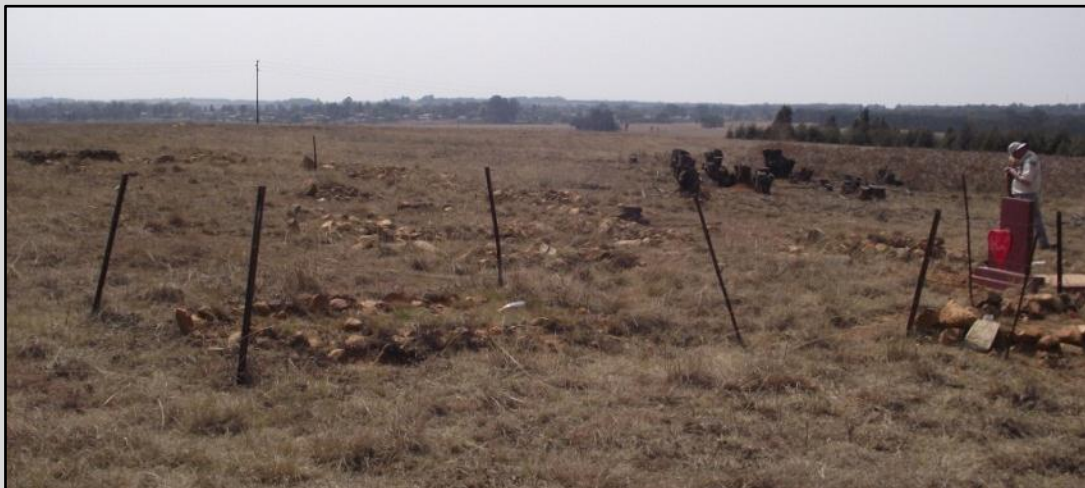
An informal cemetery with approximately 39 graves was identified at this location (**Figure 76**). The cemetery is not fenced and is located in a ploughed and planted field. The graves are placed in 3 unequal lines next to each other aligned east-west (**Figure 77**). Most of the graves have informal oval or rectangular shaped mounds or outlines of packed rocks as dressings. One grave has a formal granite dressing and an inscribed granite headstone. Some of the graves had been cleaned recently, but most of them are overgrown with grass and other vegetation. Some graves have granite inscribed headstones (**Figure 78** and **Figure 79**). According to a locals, the graves are farmworker graves. Some families still live on the farm and others live in the local township (Siyathuthuka).

*Figure 76 – PP 031: View of farmworker cemetery*

<ul style="list-style-type: none"> <li>■ Recommended Mitigation Measures ■ ■ ■</li> </ul>					
<p><i>The graves should be relocated after a full grave relocation process that includes comprehensive social consultation. The grave relocation process should include:</i></p> <ul style="list-style-type: none"> <li>● A detailed social consultation process, that will trace the next-of-kin and obtain their consent for the relocation of the graves within 60 days in length;</li> <li>● Site notices indicating the intent of the relocation</li> <li>● Newspaper Notice indicating the intent of the relocation</li> <li>● A permit from the local authority;</li> <li>● A permit from the Provincial Department of Health;</li> <li>● A permit from the South African Heritage Resources Agency, if the graves are older than 60 years, or unidentified and thus older than 60 years;</li> <li>● An exhumation process that keeps the dignity of the remains and family intact;</li> <li>● The whole process must be done by a reputable company that is well versed in relocations;</li> <li>■ The exhumation process must be conducted in such a manner as to safeguard the legal rights of the families as well as the community.</li> </ul>

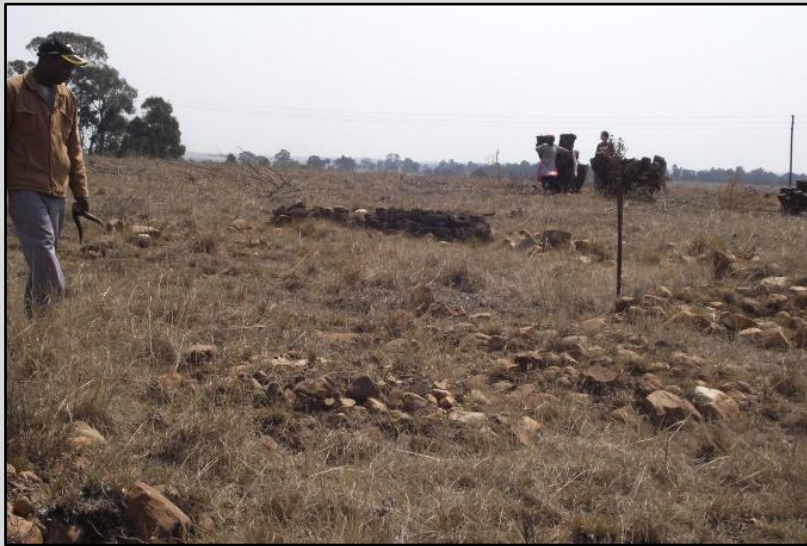
*Figure 77 – PP 031: View of grave*

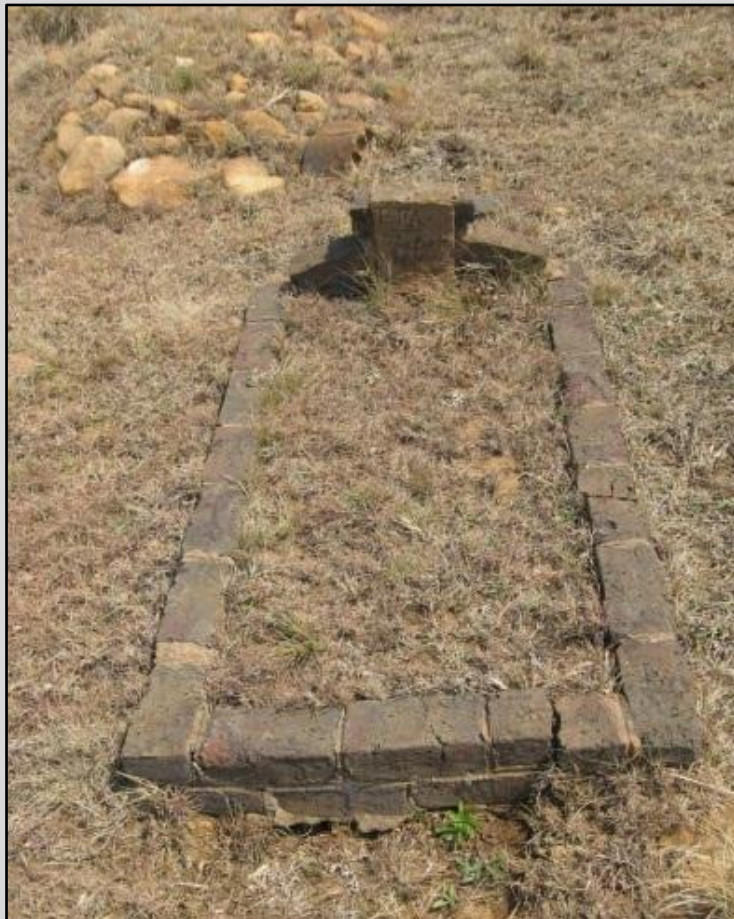
*Figure 78 – PP 031: Close-up of grave with inscribed headstone*

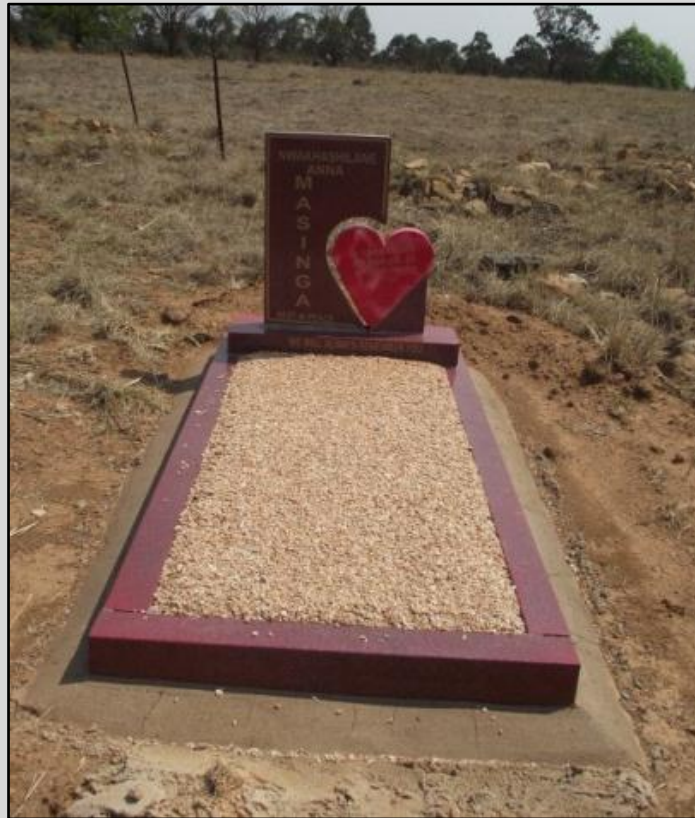
Figure 79 – PP 031: Close-up of grave with formal headstone

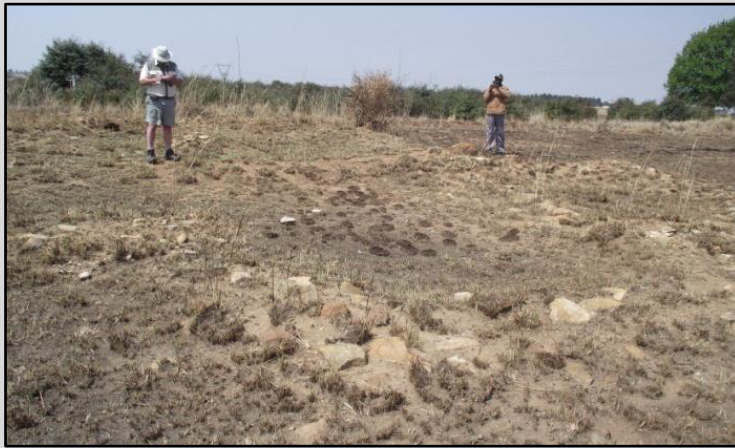
The remains of another mud brick homestead were identified at this location (**Figure 80**). The remains of the mud brick homestead consist of the foundations of four square structures, which each measure approximately 4m x 4m in size, and a circular structure which measured approximately 4m in diameter. This structure was most probably the cooking hut. The structures are all placed around a central lapa area. Rocks were used in the foundations to support the mud brick walls of the structures (**Figure 81**). Several modern metal artefacts such as wire, corrugated iron and cans were found scattered around the site.

*Figure 80 – PP 032: Foundation remains of homestead*

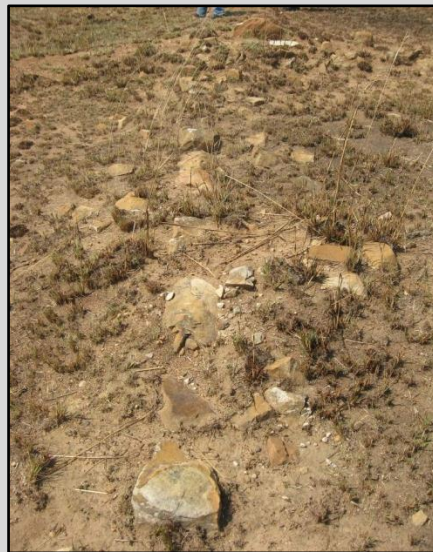
*Figure 81 – PP 032: Close-up of wall foundations*

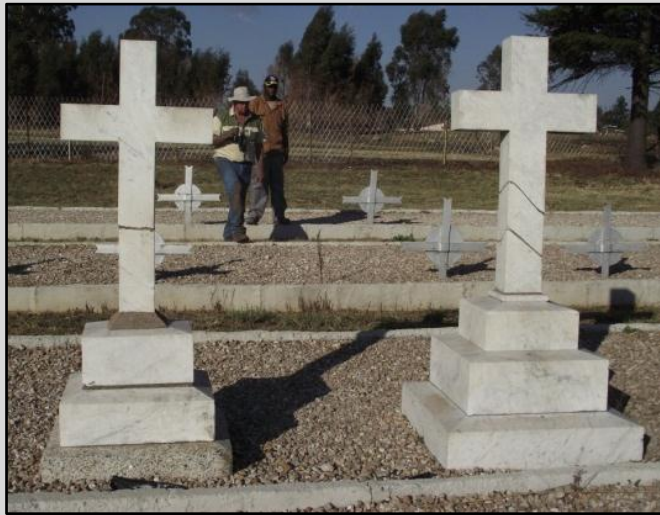
Evidence of damage to the headstones of several graves, both military and civilian is evident. Some of the damage seems to be recent (relatively unweathered broken surfaces) while past damage has been repaired on several occasions (**Figure 87 to Figure 90**).

Figure 86 – British Military graves: Repaired marble crosses

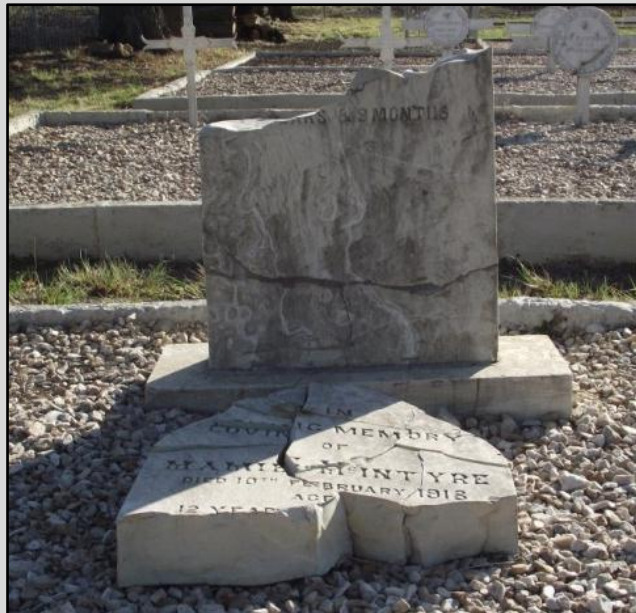
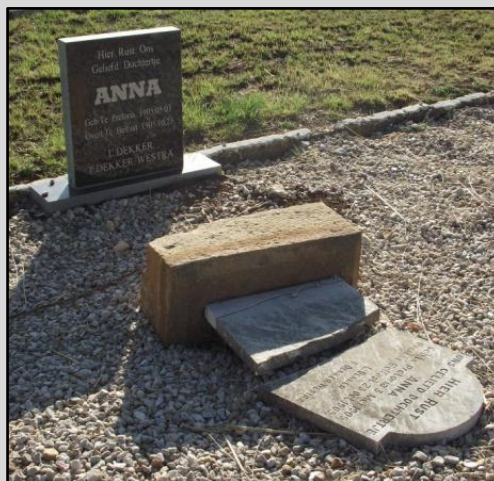
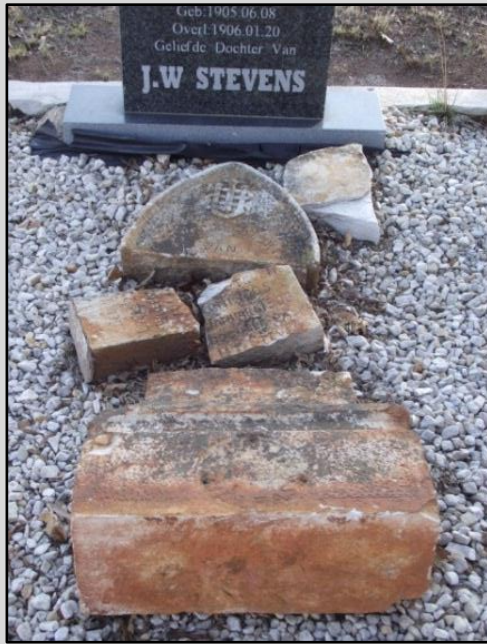
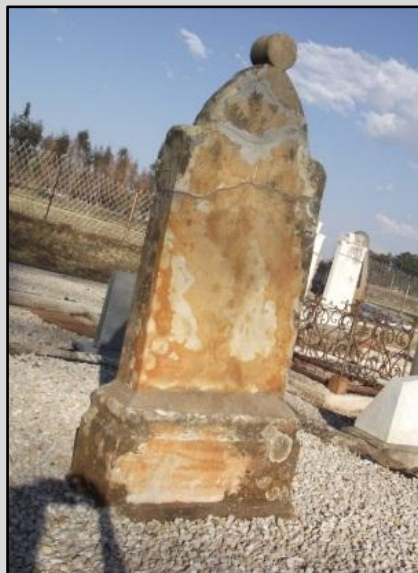
Figure 87 – Damaged headstone: civilian grave (1918)

Figure 88 – Damaged civilian grave

*Figure 89 - Damaged civilian grave*

*Figure 90 – Headstone with repaired breaks*

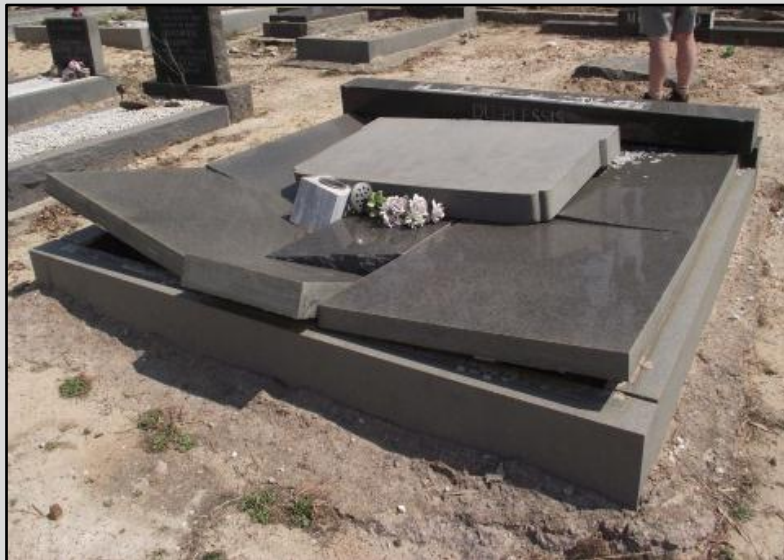
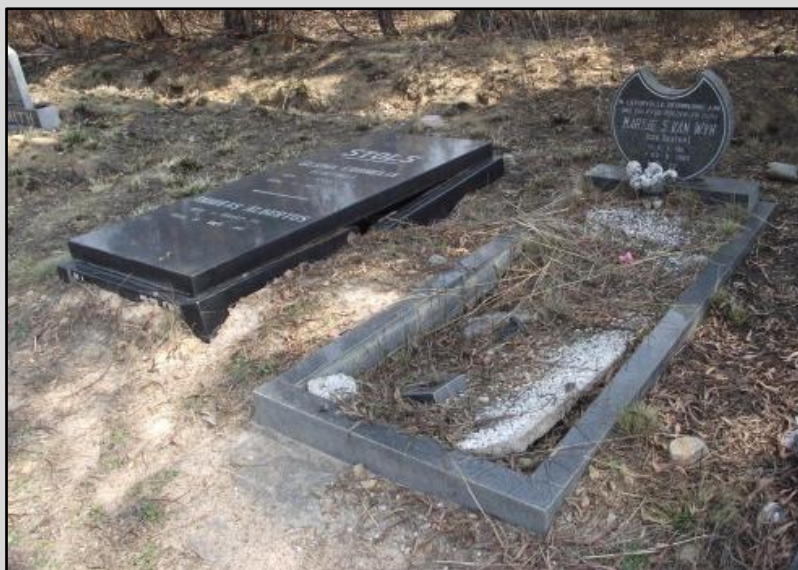
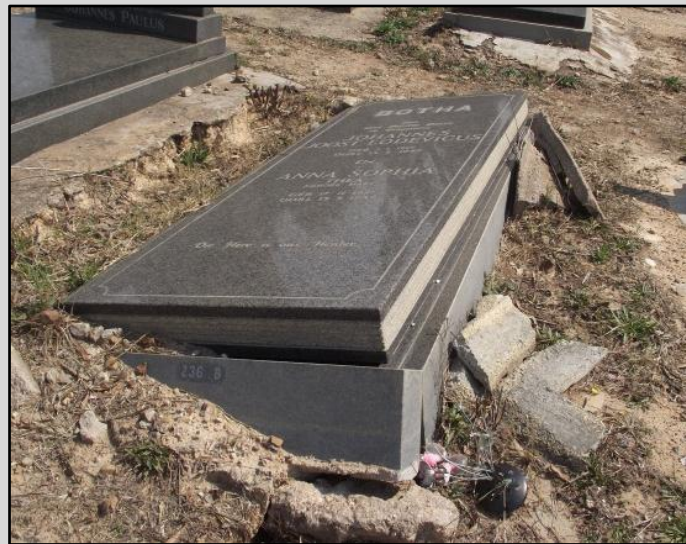
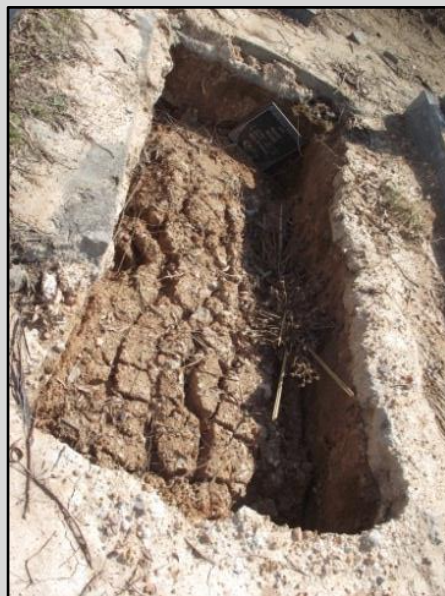
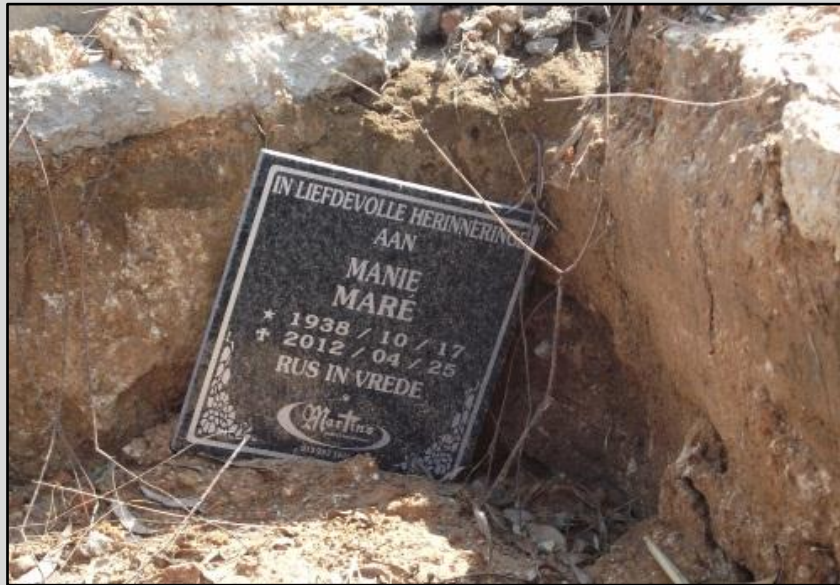
However, since most of the damage seems to be due to subsidence, it is not clear if there is a connection with the blasting activities at the Glisa Mine or not (**Figure 91** to **Figure 97**)

*Figure 92 – Damaged slabs and headstone*

*Figure 93 – Evidence of subsidence*

*Figure 95 – Damaged and subsiding grave slab*

*Figure 96 – Recent grave (2012) with subsidence*

Figure 97 – Recent grave, close-up

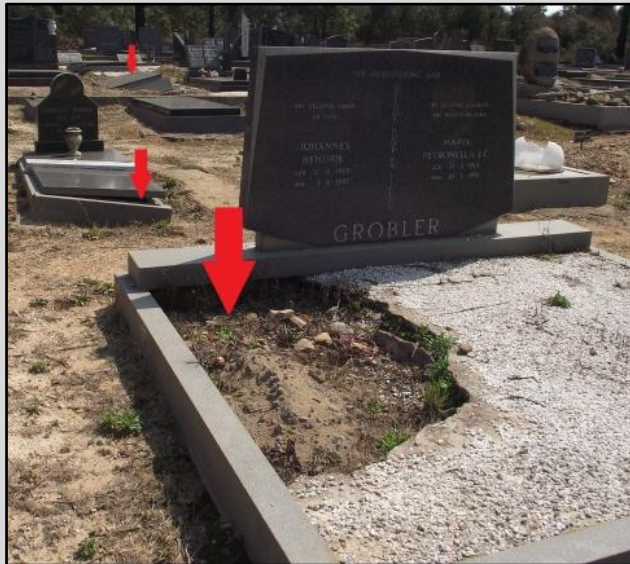
*Figure 94 – Extent of visible subsidence*
