NETHERLANDS CONSULATE GENERAL

EVANGELICAL LUTHERAN CHURCH COMPLEX

RE 9245, CNR STRAND & BUITENGRACHT STREETS, CAPE TOWN

HERITAGE REPORT

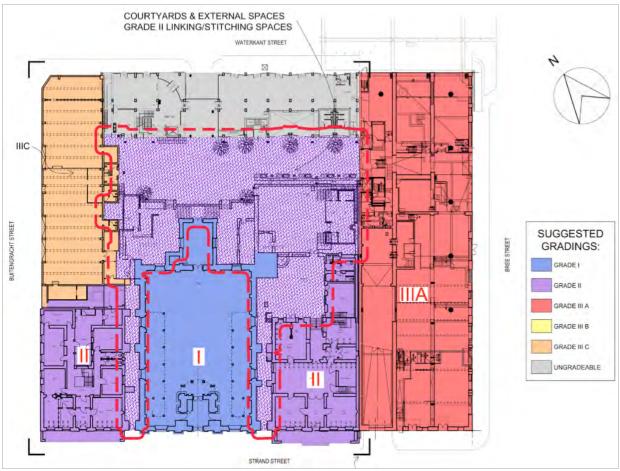
Figure 1: Grading and linkage between the spaces of the ELC complex, Strand Street (Mike Scurr, 2013)

Although the Sexton's House forms an integral part of the ELC complex, it lacks sufficient authenticity itself to be considered of Grade I status, and is considered a Grade II resource (Provincial Heritage Site) within the overall Grade I site because of its rarity, representivity and social significance. This elemental grading provides guidance on the extent that changes may be permitted¹.

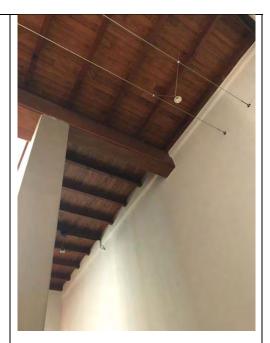
Passage ceiling where bulletproof panels are proposed to be installed between the beams, the result will be similar to the photograph below. The temporary visual loss of the floorboards above will be offset by the increased public access to the spaces and the fact that the intervention is removable.

Bullet proof screens inserted between ceiling beams to protect the floor above in the Consular offices.

There is also a requirement to secure the ceiling above this side passage with the installation of steel panels between the joists, similar to those previously installed in the front room/current waiting room. This will be unobtrusive and appear as the underside of the floor above, painted a hue that blends in with the adjacent beams. They are removable.
