**PHASE I HERITAGE IMPACT ASSESSMENT (INCLUDING
PALAEOLOGICAL DESKTOP ASSESSMENT) REQUESTED IN TERMS OF
SECTION 38 OF THE NATIONAL HERITAGE RESOURCES ACT NO 25/1999
FOR THE PROPOSED MINING PERMIT APPLICATION ON THE REMAINDER OF
PORTION 3 (BESTPAN), PORTION 14 (TIPPERARY) AND PORTION 15 (ANNEX
TIPPERARY) OF THE FARM ZOUTPANSFONTEIN NO. 34
IN THE DISTRICT OF KIMBERLEY**

Edward Matenga

Thursday, 05 September 2019

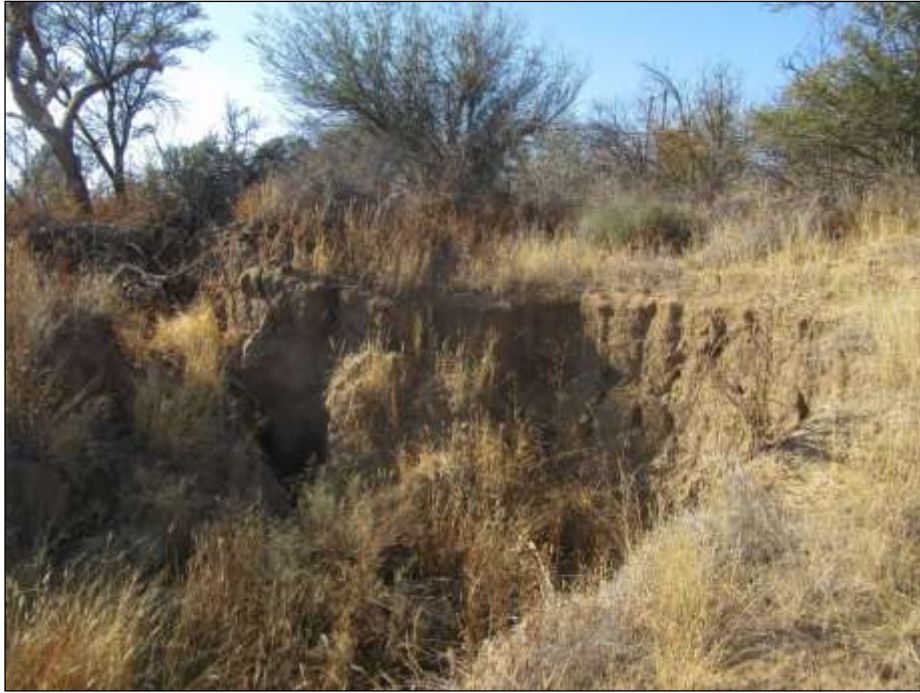
Figure4: Profile of the eastern bank of the Vaal River shows clay rich silt.

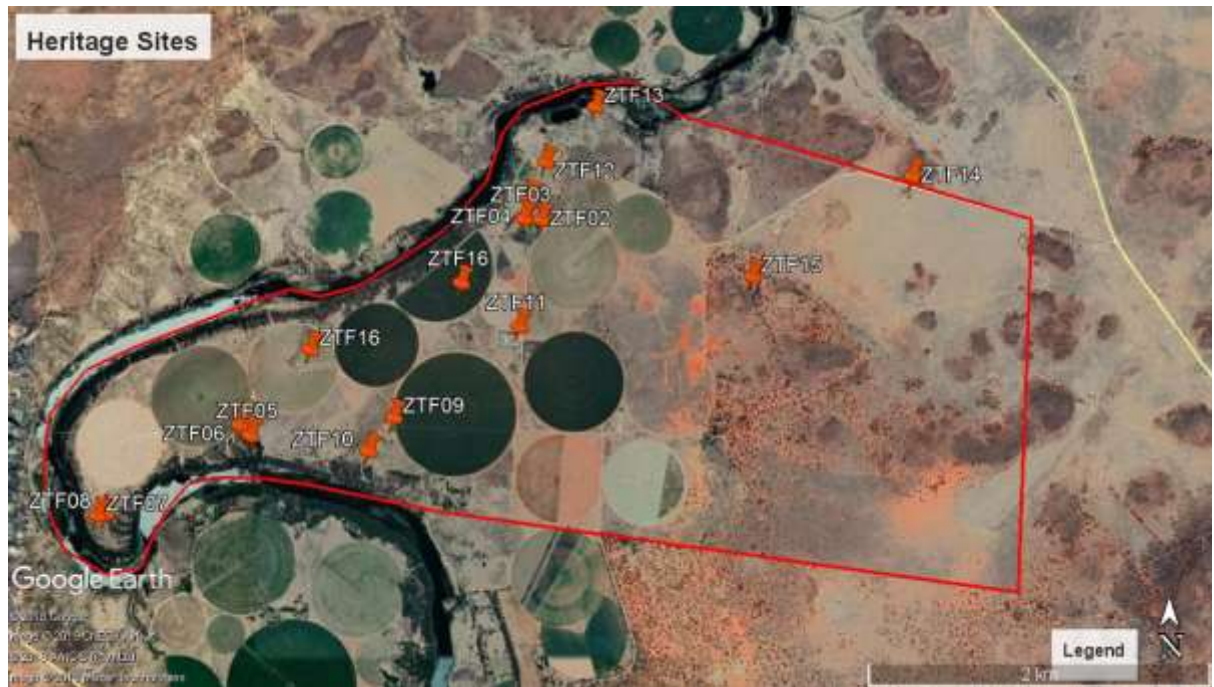
Figure 11: Location of heritage sites.

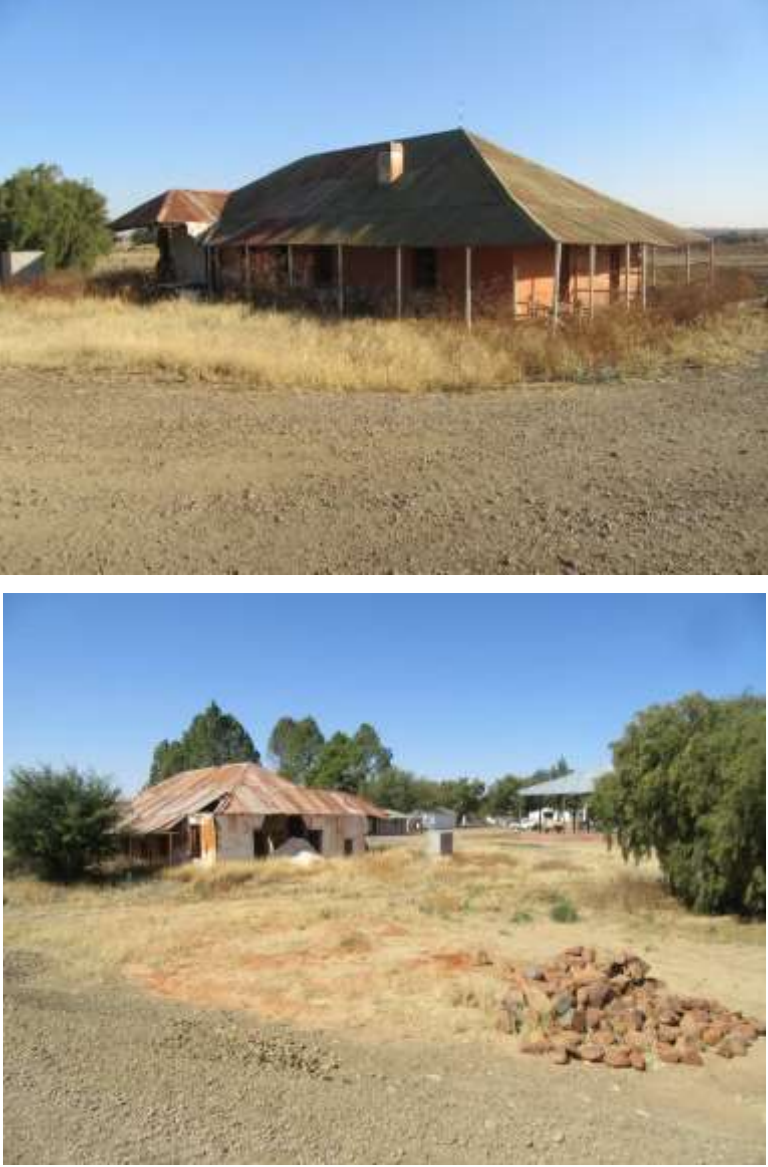
SITE NO	COORDINATES		PERIOD
ZTF01	28°27'47.20"S	24°42'41.26"E	Early Commercial Farming

The oldest building at the farmstead (ZTF01) is in a very poor state although it is noted that efforts have been made to keep it standing by the introduction of timber supports. It is significant as an exemplar of principal dwellings of early commercial farmers. The other building with a Dutch gable roof probably dating to the early 20th century (ZTF02) has inspired the construction of four near replicas which now form a cluster and together they contribute to retaining the spirit and sense of the place. The reservoir and water feature with coursed masonry walls are other structures worth retaining (ZTF04). There are no compelling circumstances for alteration or destruction of these buildings.

<p>DESCRIPTION: The oldest building at the farmstead possibly dating to the 19th century. Plastered fired earthen brick frame with a cross hipped corrugated iron roof. Skirted by a veranda facing south. Building in a poor state with broken walls, rusted roof and decayed timber.</p>			
HERITAGE SIGNIFICANCE		Association with early commercial farmers.	
MITIGATION		Building in a poor state, but will be protected.

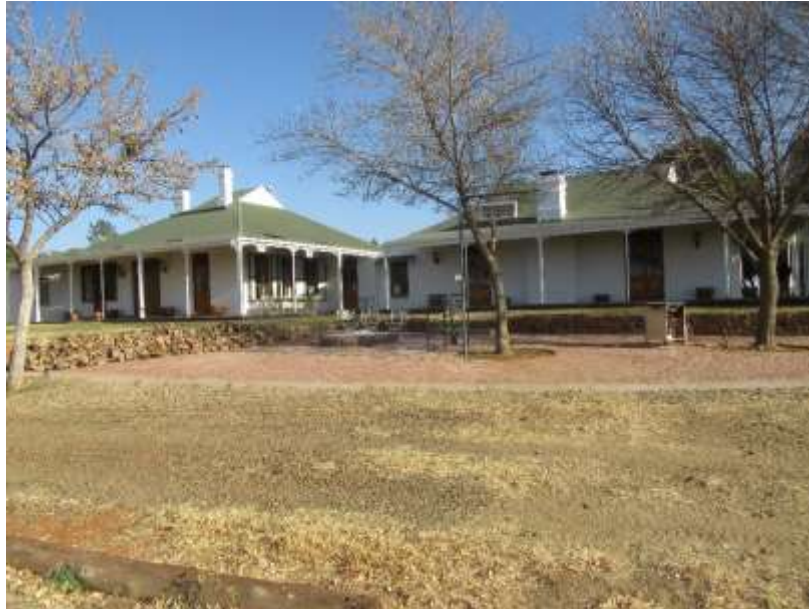
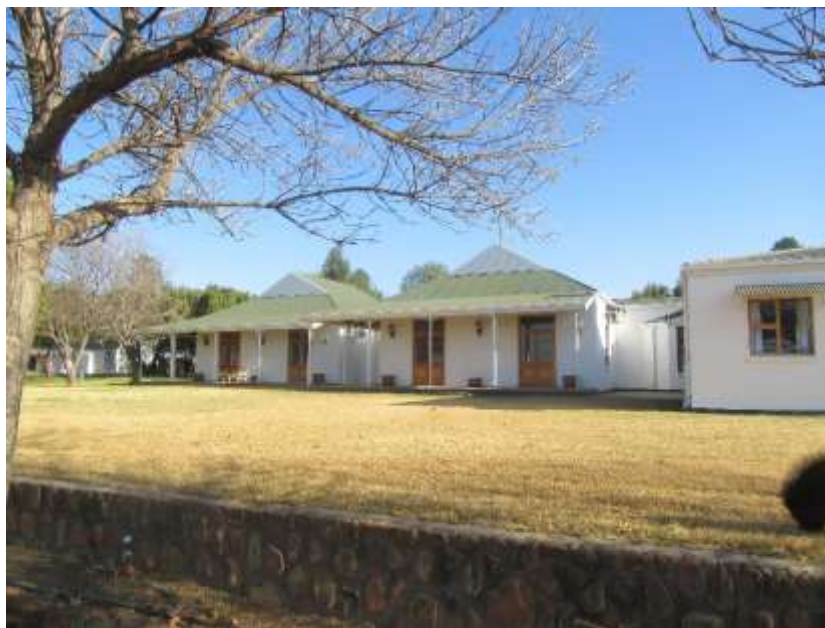
SITE NO	COORDINATES		PERIOD
ZTF02	28°27'51.71"S	24°42'44.07"E	Modern

DESCRIPTION: At the farmstead. Four buildings in a row are the principal dwellings at the farmstead. Dutch gable roof (gabled) which is a combination of a small gable at the top and hipped roof below. Skirted by verandas to the south and east (2 buildings), and to the south (2). The 2nd building from the east is the oldest (the prototype) which has inspired 3 recent near replicas 2010, 2018, 2019.

HERITAGE SIGNIFICANCE	Buildings associated commercial farmsteads. The additions contribute to aesthetics and sense of place.
MITIGATION	Buildings will be protected.

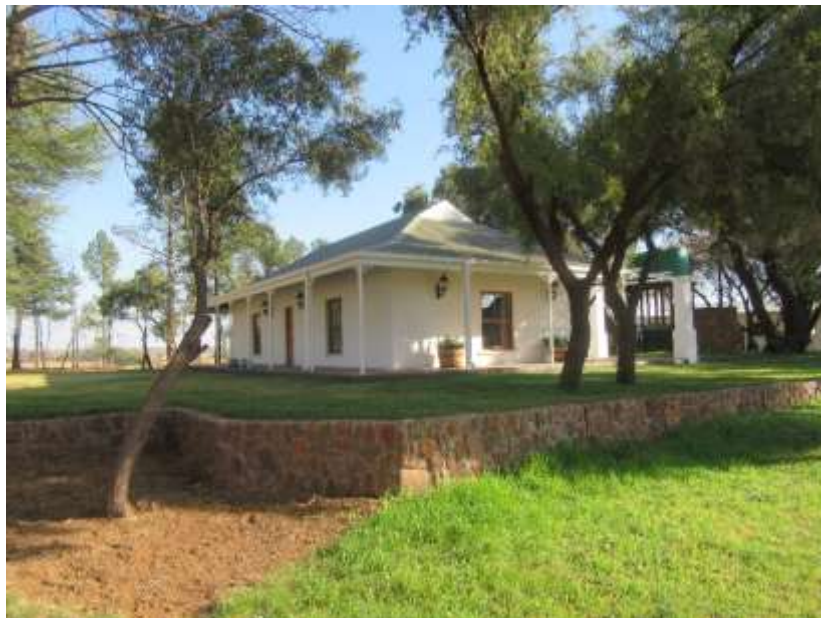
SITE NO	COORDINATES		PERIOD
ZTF03	28°27'51.50"S	24°42'40.10"E	Modern

DESCRIPTION: An isolated building one of the principal dwellings at the farmstead. Dutch gable roof (gabled) which is a combination of gable at the top and hipped roof below. Skirted by verandas to the south and east.

HERITAGE SIGNIFICANCE	Building associated commercial farmsteads. Though it is a recent addition, it contribute to aesthetics and sense of place.
MITIGATION	Building will be protected.

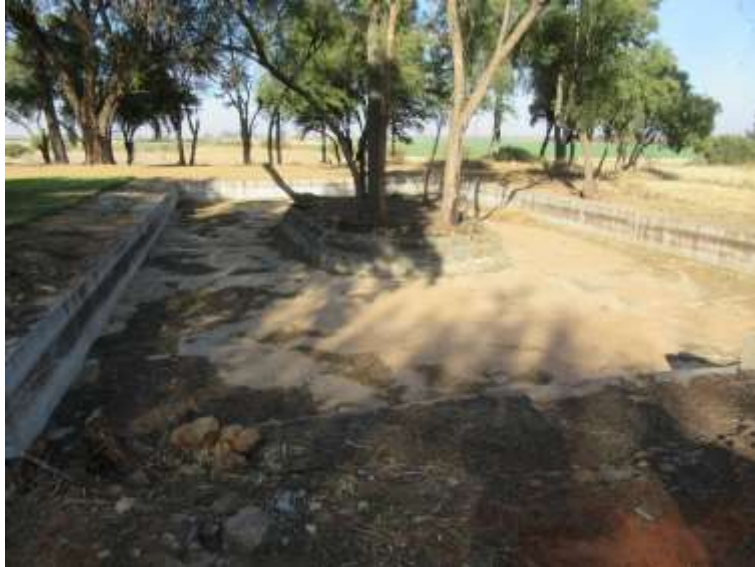
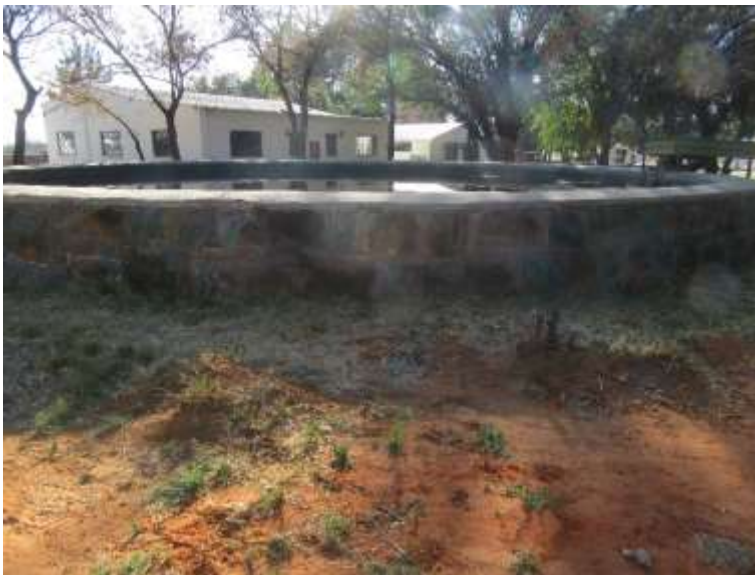
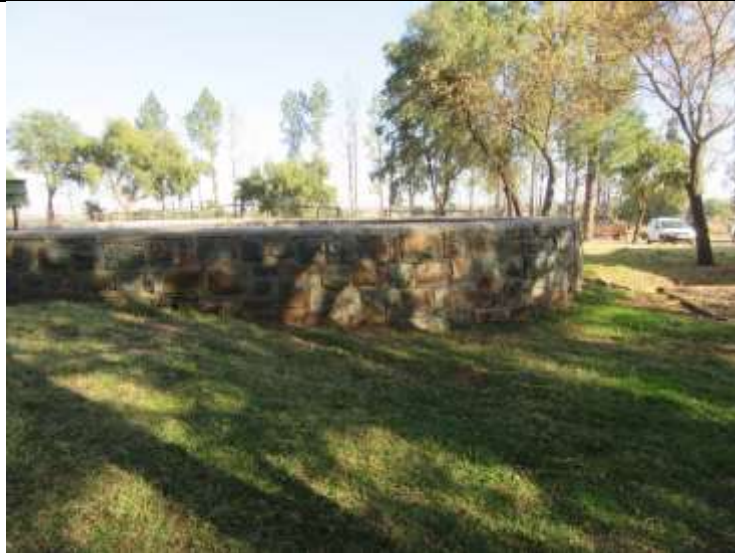
SITE NO	COORDINATES		PERIOD
ZTF04	28°27'51.28"S	24°42'40.55"E	Modern

DESCRIPTION: Situated at the farmstead. A rectangular structure possibly a water feature or pond 25 m x 15 m x 1.00 m deep. An island located at the centre with a revetment of mortar-bound dressed stone walling. Mature trees standing on the island. Circular water tank or reservoir, excavated into the ground and standing 1 m above the ground. Cladding with coursed (dressed) stones.

HERITAGE SIGNIFICANCE	Structures associated with commercial farmsteads
MITIGATION	Structures will be protected.

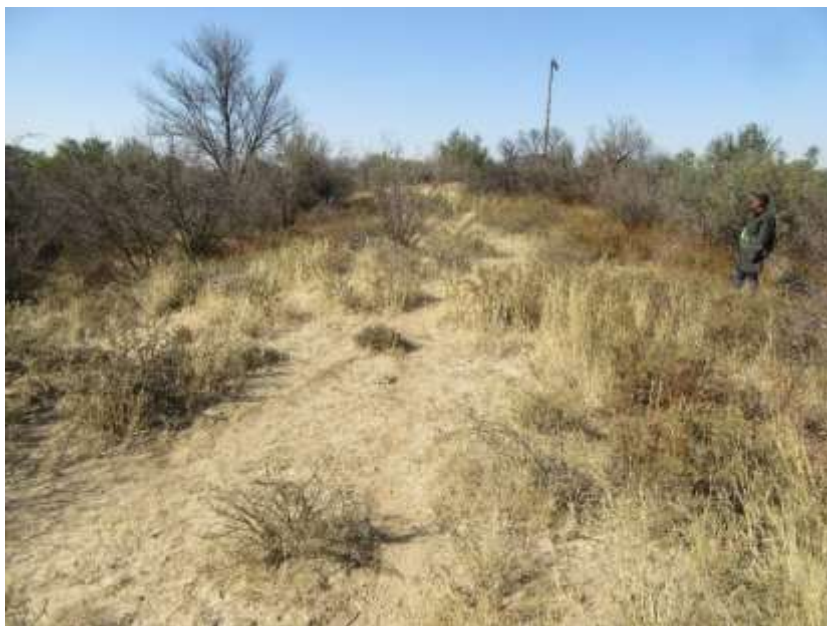
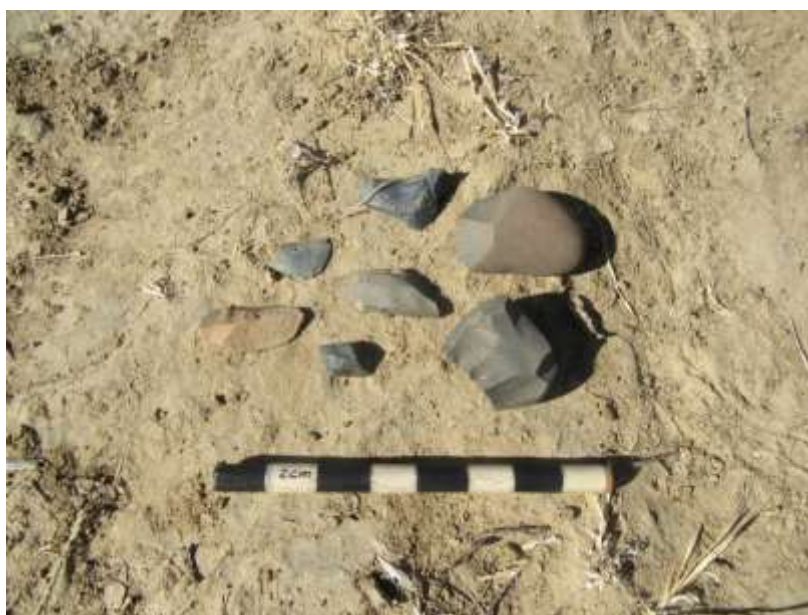
SITE NO	COORDINATES		PERIOD
ZTF05	28°28'34.20"S	24°41'40.10"E	MSA/LSA

DESCRIPTION: Near the Vaal River bank. Bushes including acacia. 7 lithics: 2 cores, 2 blades, 2 scrapers and a flake.

HERITAGE SIGNIFICANCE	Evidence of hunter-gatherer activities during the MSA/LSA.
MITIGATION	No further action required.

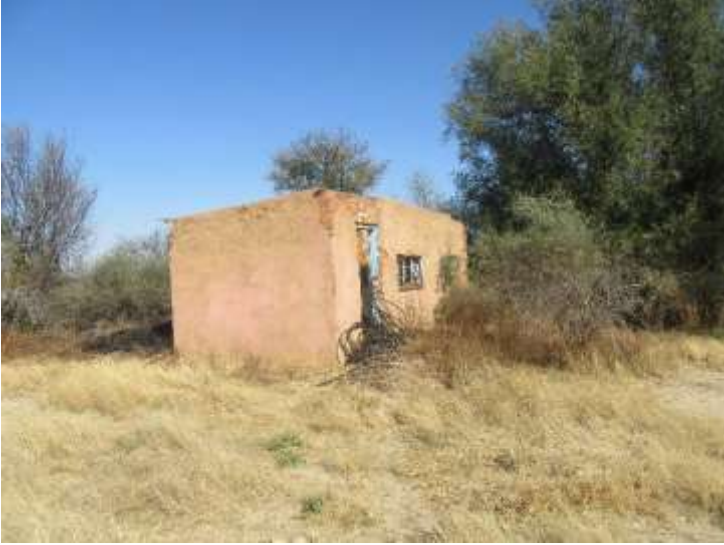
SITE NO	COORDINATES		PERIOD
ZTF06	28°28'32.10"S	24°41'37.70"E	MSA/LSA

<p>DESCRIPTION: Abandoned building of earthen bricks and plaster, without roof.</p>			
HERITAGE SIGNIFICANCE		Building associated with farming activities.	
MITIGATION		Low significance. No further action required.

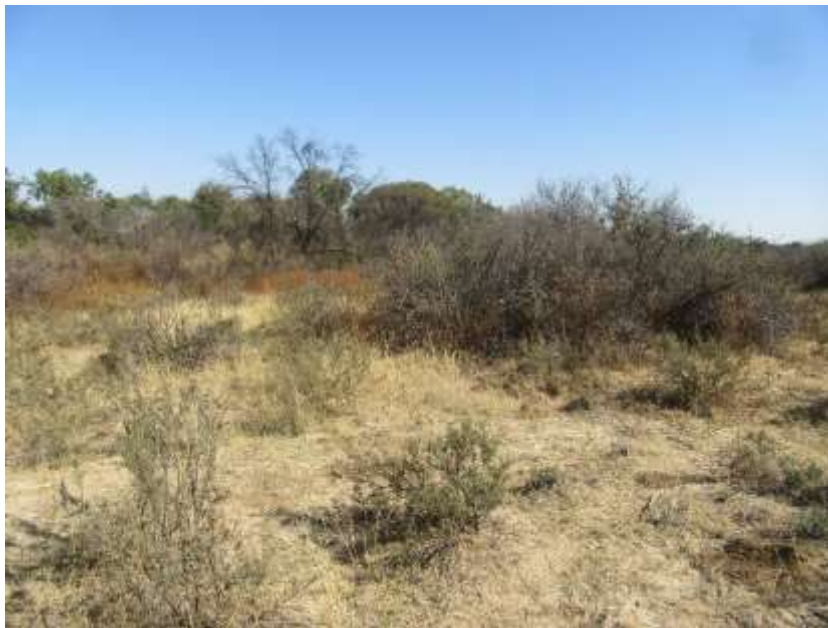
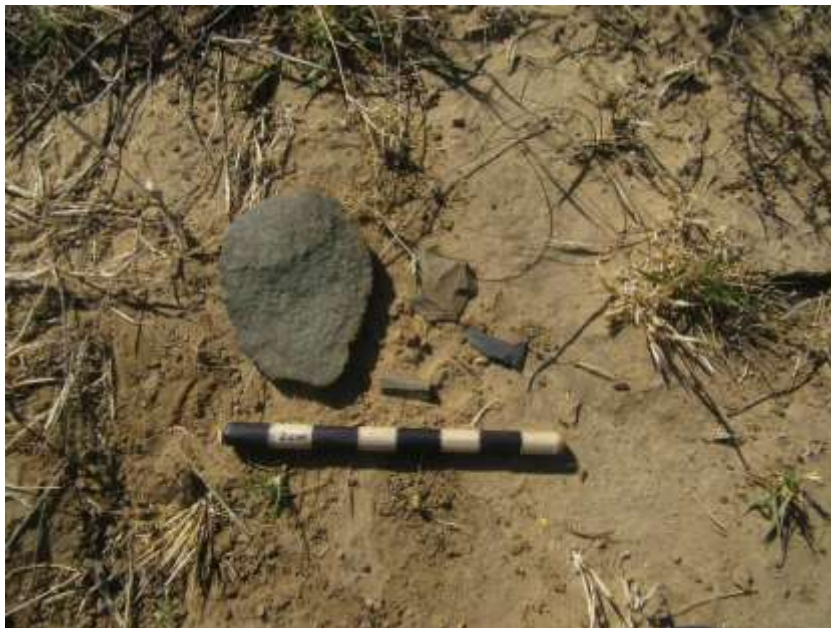
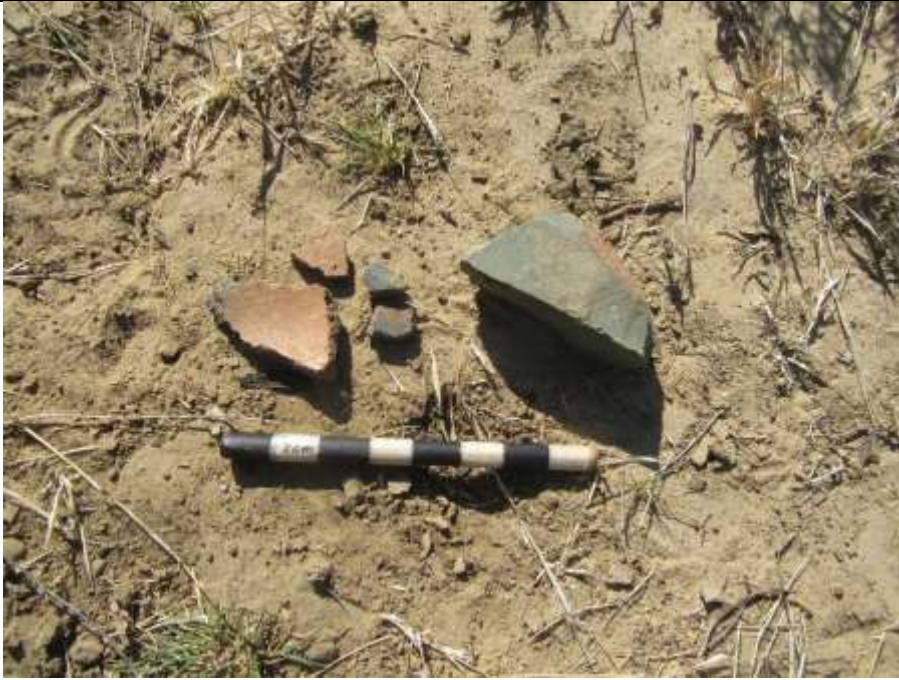
SITE NO	COORDINATES		PERIOD
ZTF07	28°28'49.50"S	24°41'7.20"E	MSA/LSA, LIA

DESCRIPTION: Near the banks of the Vaal River. 4 lithics: handaxe, scraper, 2 bladelets. LIA material comprising 4 potsheds and a polished stone.

HERITAGE SIGNIFICANCE	Evidence of hunter-gatherer activities during the MSA/LSA. LIA occupation.
MITIGATION	No further action required.

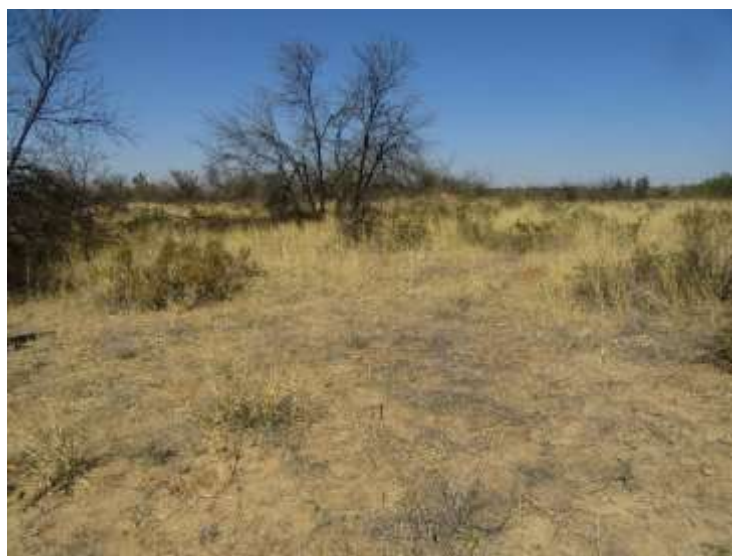
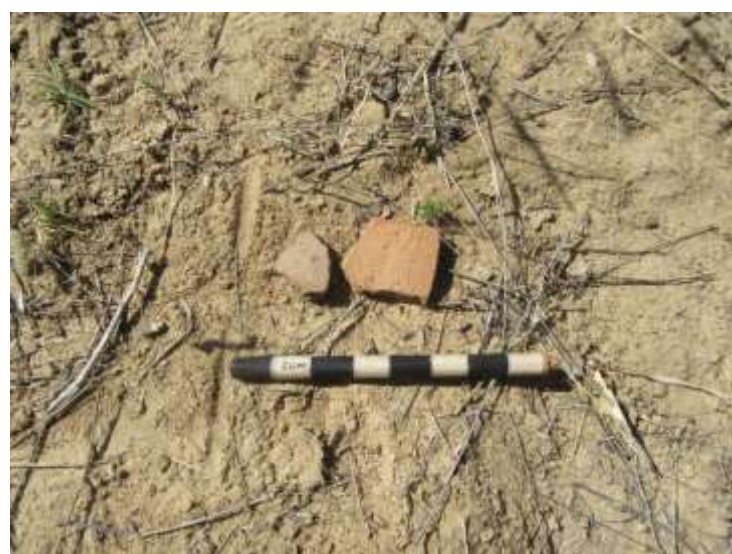
SITE NO	COORDINATES		PERIOD
ZTF08	28°28'49.00"S	24°41'9.10"E	LIA

DESCRIPTION: Near the Vaal River bank. Sparse bushes. 2 potsherds.

No further action required.

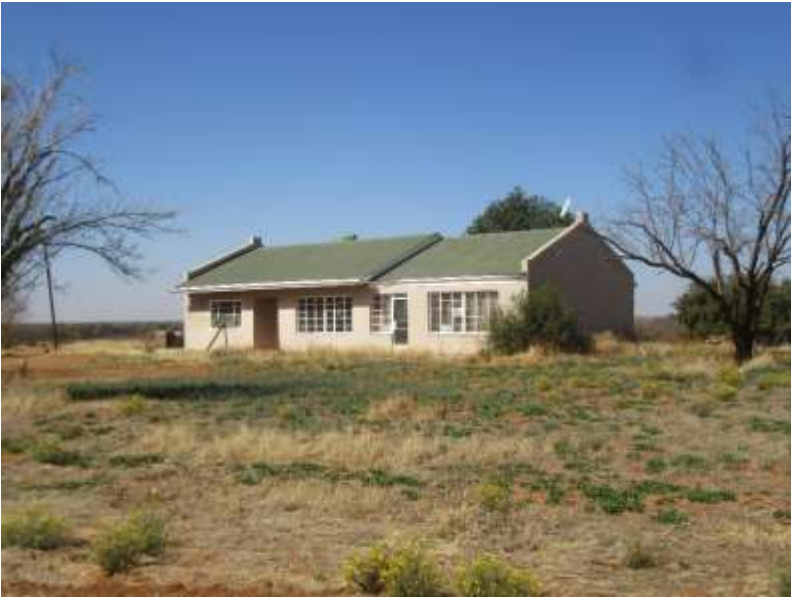
SITE NO	COORDINATES		PERIOD
ZTF09	28°28'30.67"S	24°42'11.77"E	MSA/LSA

<p>DESCRIPTION: Near the Vaal River bank. Gabled building now used as staff quarters. Standing before 1994.</p>			
HERITAGE SIGNIFICANCE		Association with commercial farming.	
MITIGATION		Building will be protected.

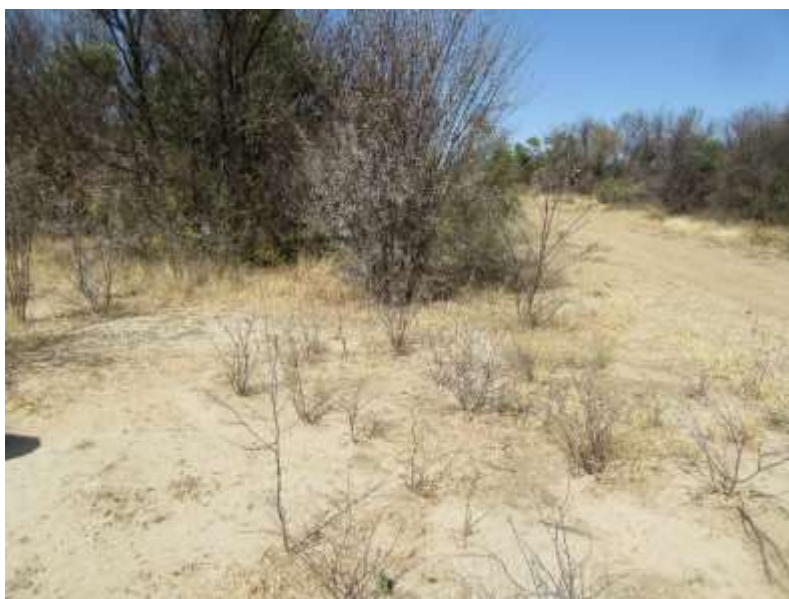
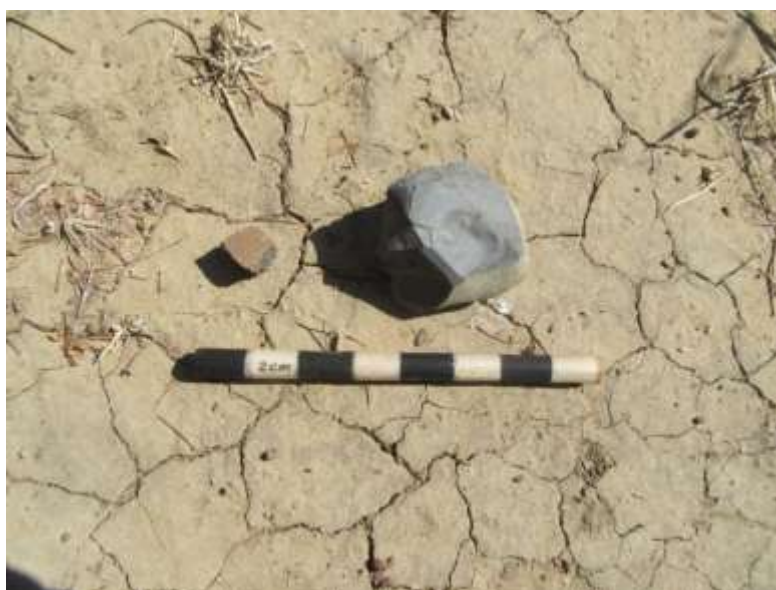
SITE NO	COORDINATES		PERIOD
ZTF10	28°28'37.20"S	24°42'6.30"E	MSA/LSA. LIA

DESCRIPTION: Near the Vaal River bank. A core and small potsherd.

HERITAGE SIGNIFICANCE	Evidence of hunter-gatherer activities during the MSA/LSA. LIA artefact.
MITIGATION	No further action required.

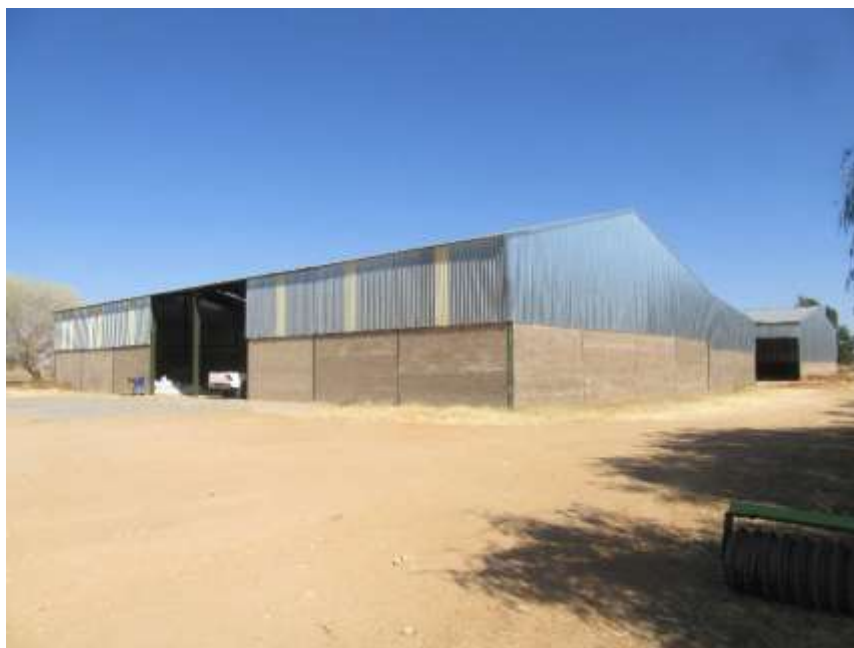
SITE NO	COORDINATES		PERIOD
ZTF11	28°28'12.99"S	24°42'39.35"E	MSA/LSA

DESCRIPTION: This shed has been refurbished with a new corrugated iron roof. It was the processing and dispatch centre of grapes produced at what was then the largest wine-fields in South Africa and in the southern hemisphere. Operations ceased in the 1990s.

HERITAGE SIGNIFICANCE	Associated with commercial farming
MITIGATION	Building will not be affected.

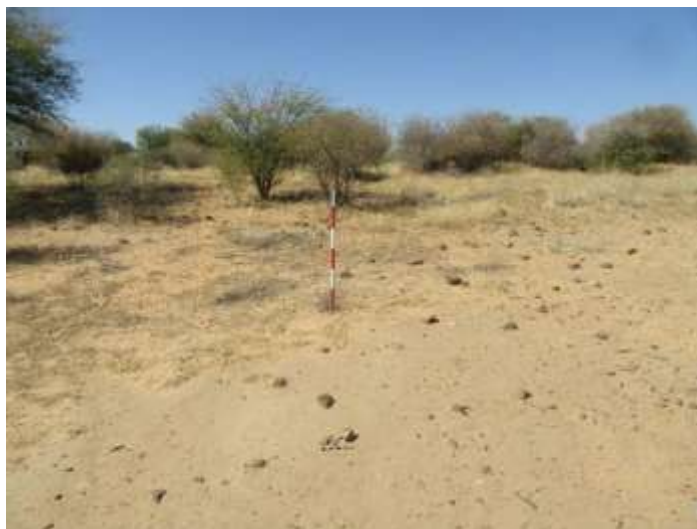
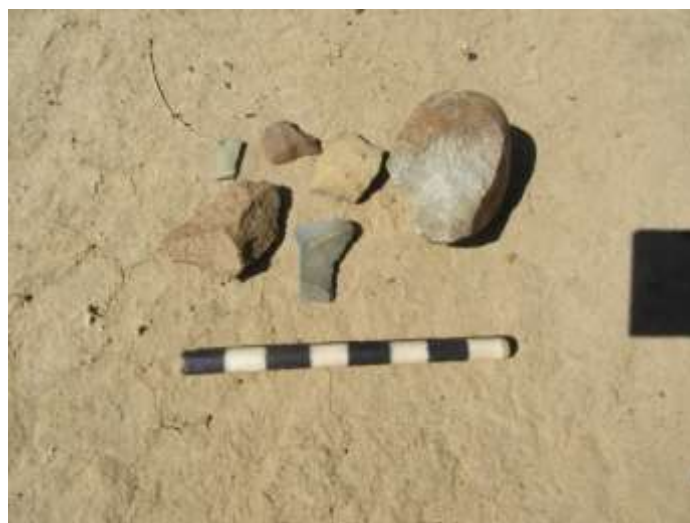
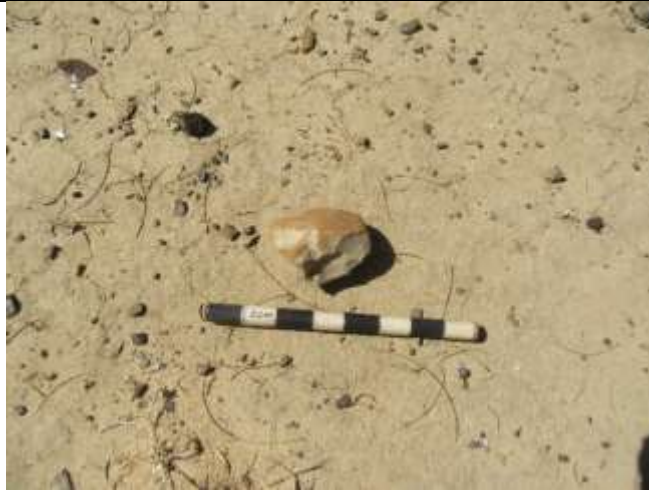
SITE NO	COORDINATES		PERIOD
ZTF12	28°27'40.00"S	24°42'45.00"E	MSA/LSA

DESCRIPTION: North of the homestead, near the Vaal River bank. 7 lithics: 2 cores, 3 scrapers, 2 blades.

HERITAGE SIGNIFICANCE	Evidence of hunter-gatherer activities during the MSA/LSA
MITIGATION	No further action required.

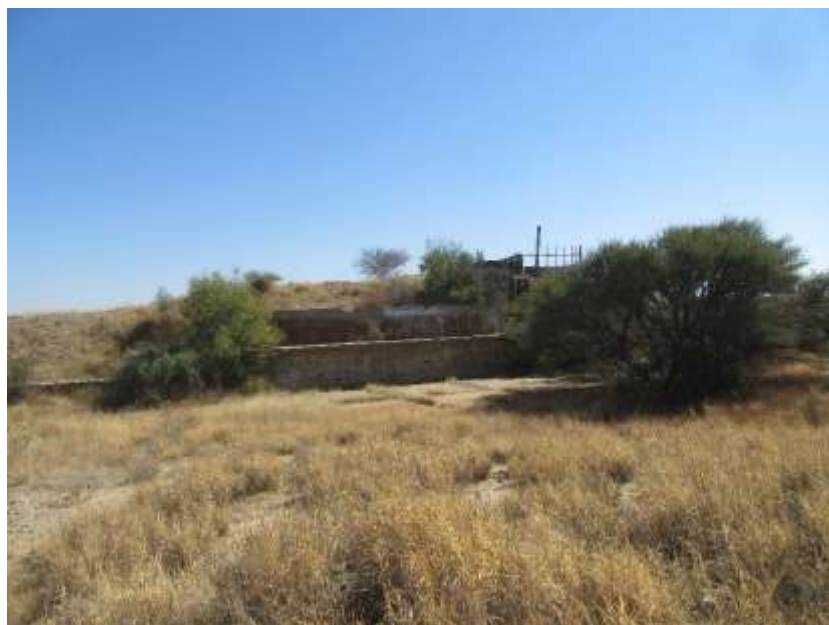
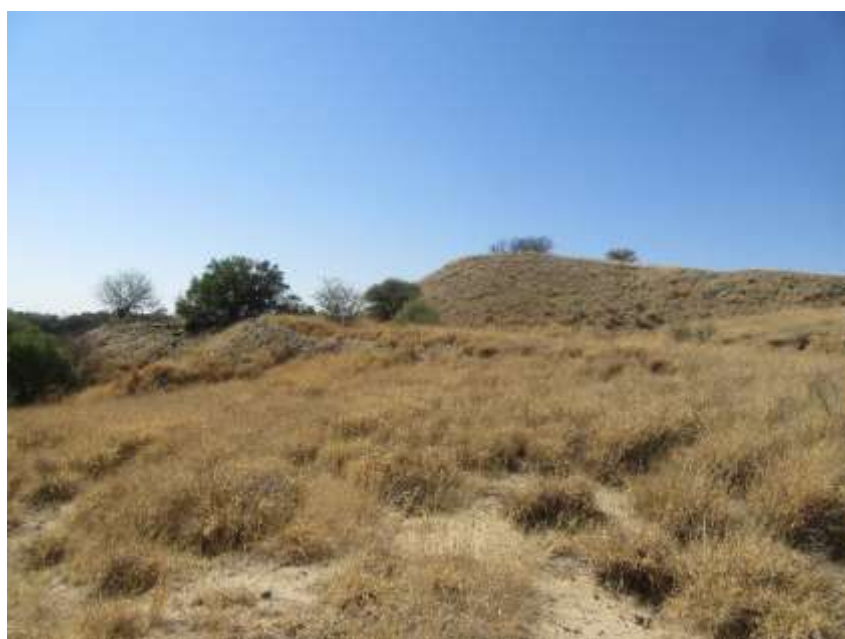
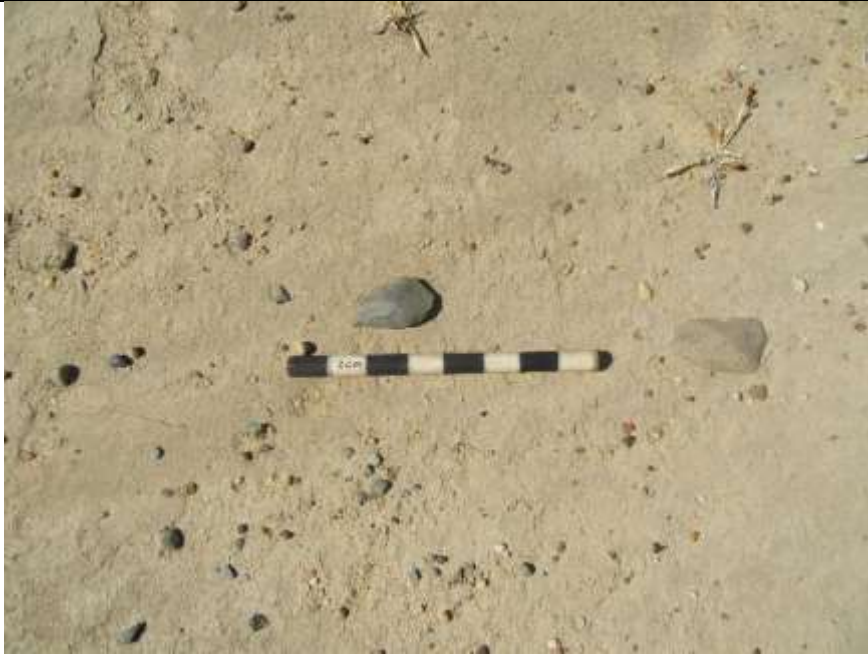
SITE NO	COORDINATES		PERIOD
ZTF13	28°27'28.58"S	24°42'56.22"E	MSA/LSA, Early Mining.

DESCRIPTION: Overlooking the Vaal River. A ramp built from mining discard, concrete revetment on the east side. It was mounting processing equipment (separators). 1 lithic, a scraper found on the surface.

HERITAGE SIGNIFICANCE	MSA/LSA evidence, and early diamond mining and processing
MITIGATION	No further action required.

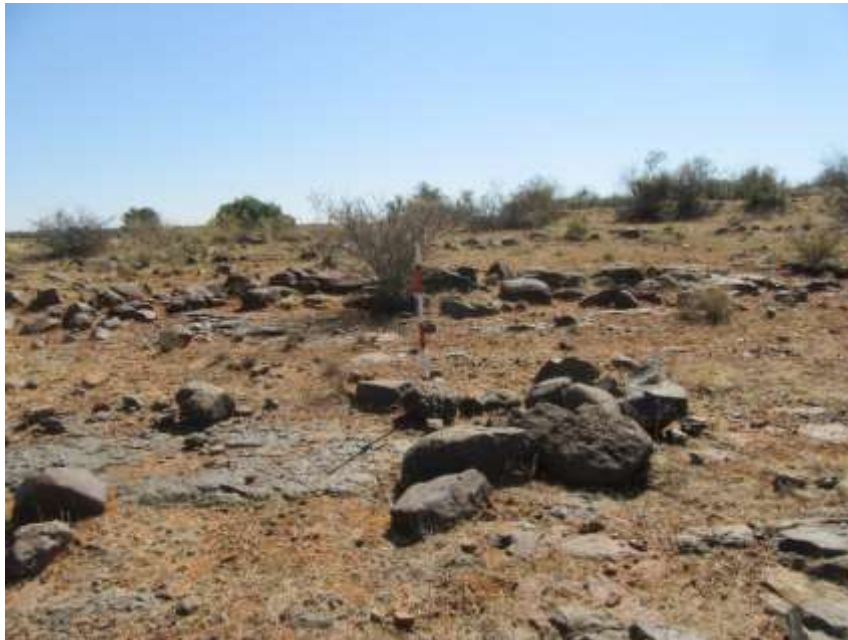
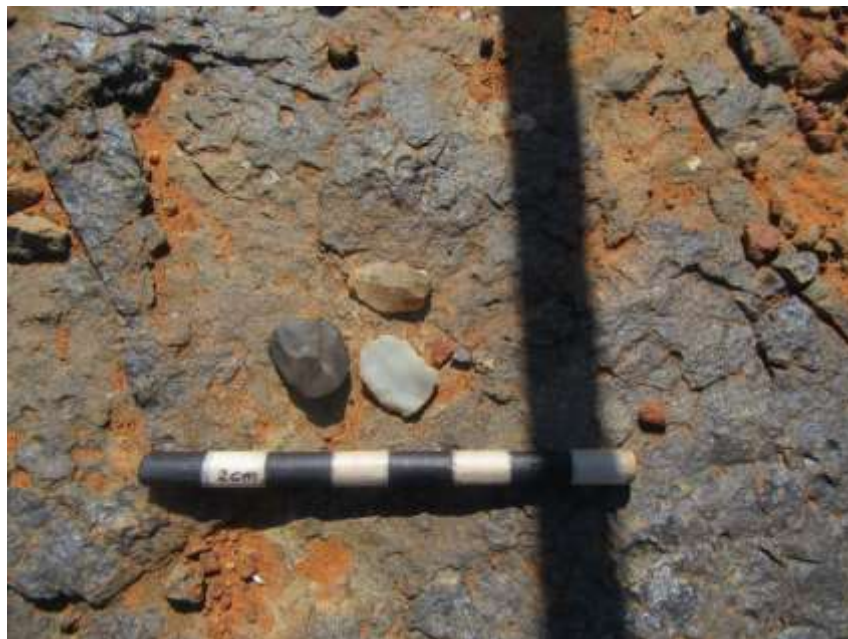
SITE NO	COORDINATES		PERIOD
ZTF14	28°27'42.90"S	24°44'8.00"E	MSA/LSA

DESCRIPTION: Eastern area of the property, southern foot of the ridge, conglomerate stones and bedrock. 3 lithics – scrapers including 2 quartz.

HERITAGE SIGNIFICANCE	Evidence of hunter-gatherer activities during the MSA/LSA
------------------------------	---

MITIGATION	No further action required.
-------------------	-----------------------------

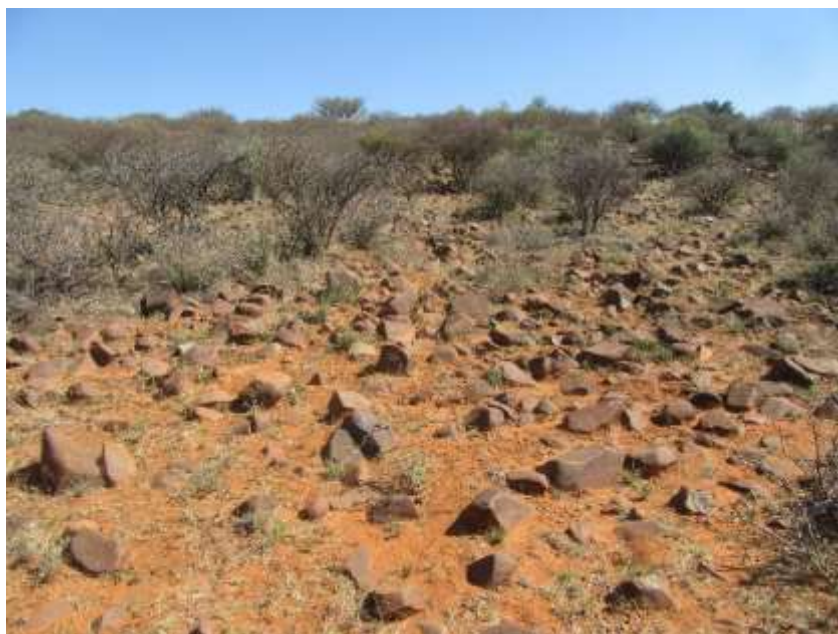
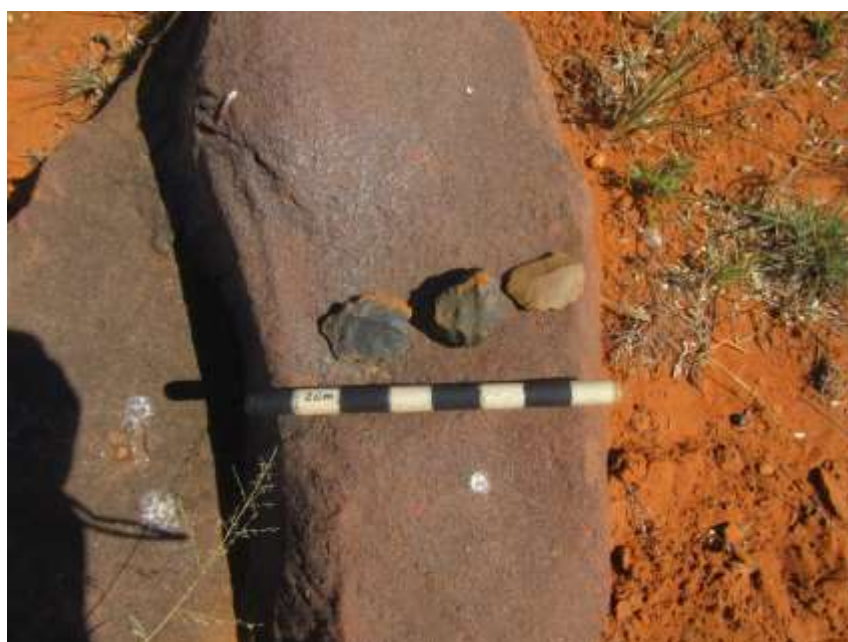
SITE NO	COORDINATES		PERIOD
ZTF15	28°28'3.10"S	24°43'31.40"E	MSA/LSA

DESCRIPTION: Eastern foot of a dolerite ridge, eastern part of the property. Haakbos. 3 lithics – scrapers.

No further action required.

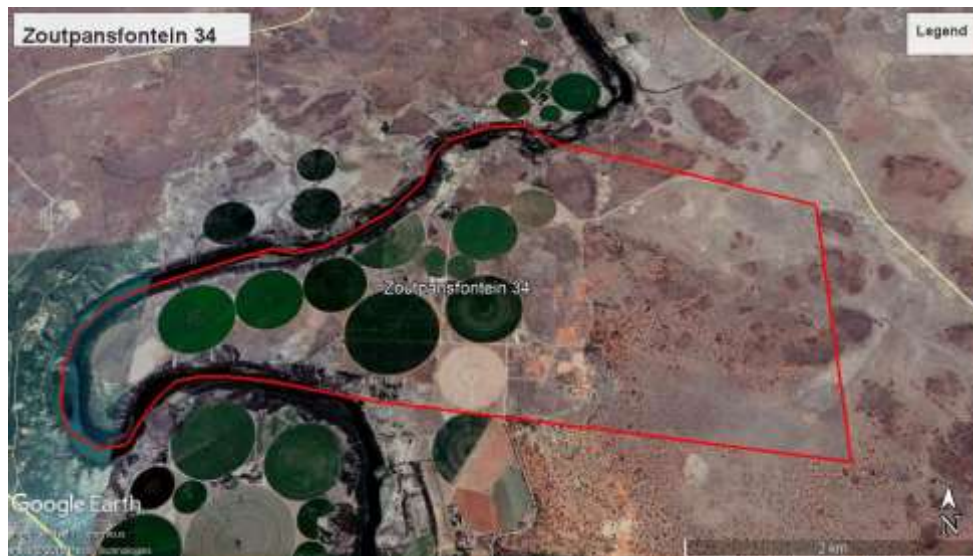
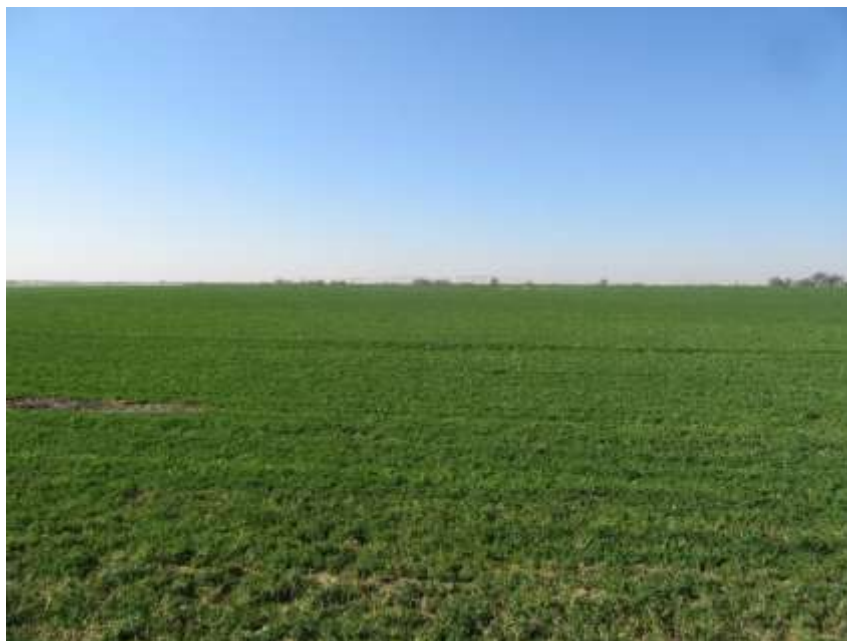
SITE NO	COORDINATES		PERIOD
ZTF16	28°28'4.26"S	24°42'26.23"E	MSA/LSA

DESCRIPTION: Green fields under pivot irrigation.

HERITAGE SIGNIFICANCE	Cultural landscape of modern commercial farming
MITIGATION	Mining will not encroach into the fields
