# **HERITAGE IMPACT ASSESSMENT: PROPOSED JUNO WIND ENERGY FACILITY ON DE BOOM 273/REMAINDER, VREDENDAL MAGISTERIAL DISTRICT, WESTERN CAPE**

HWC Case No.: 18030613AS0308E

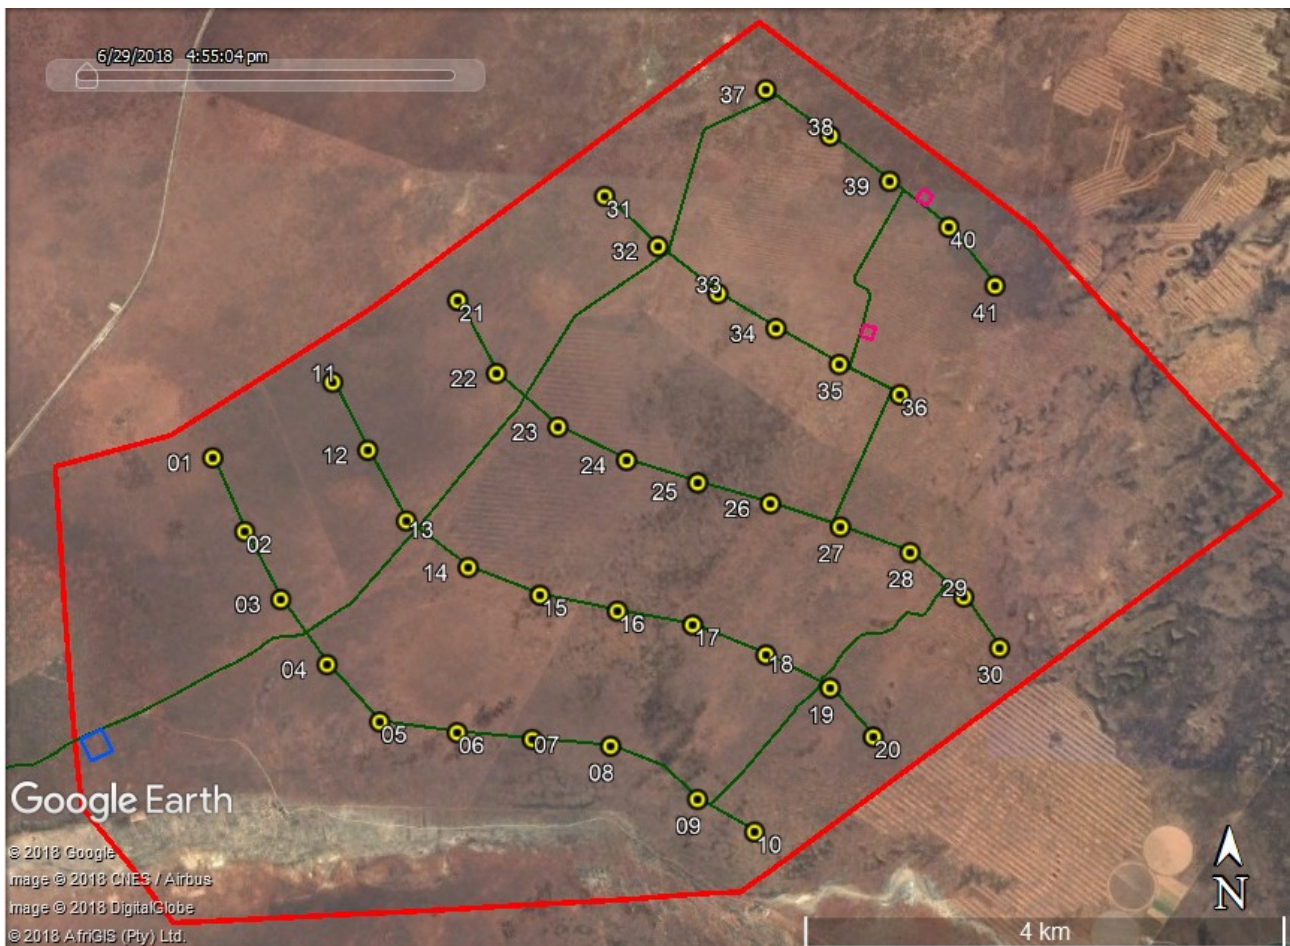
**Figure 2:** Aerial view of the study area (red polygon) showing the proposed layout. Black and yellow dots represent turbine locations, green lines are roads, the pink squares are substation alternatives and the blue square in the west is a laydown area and construction camp.

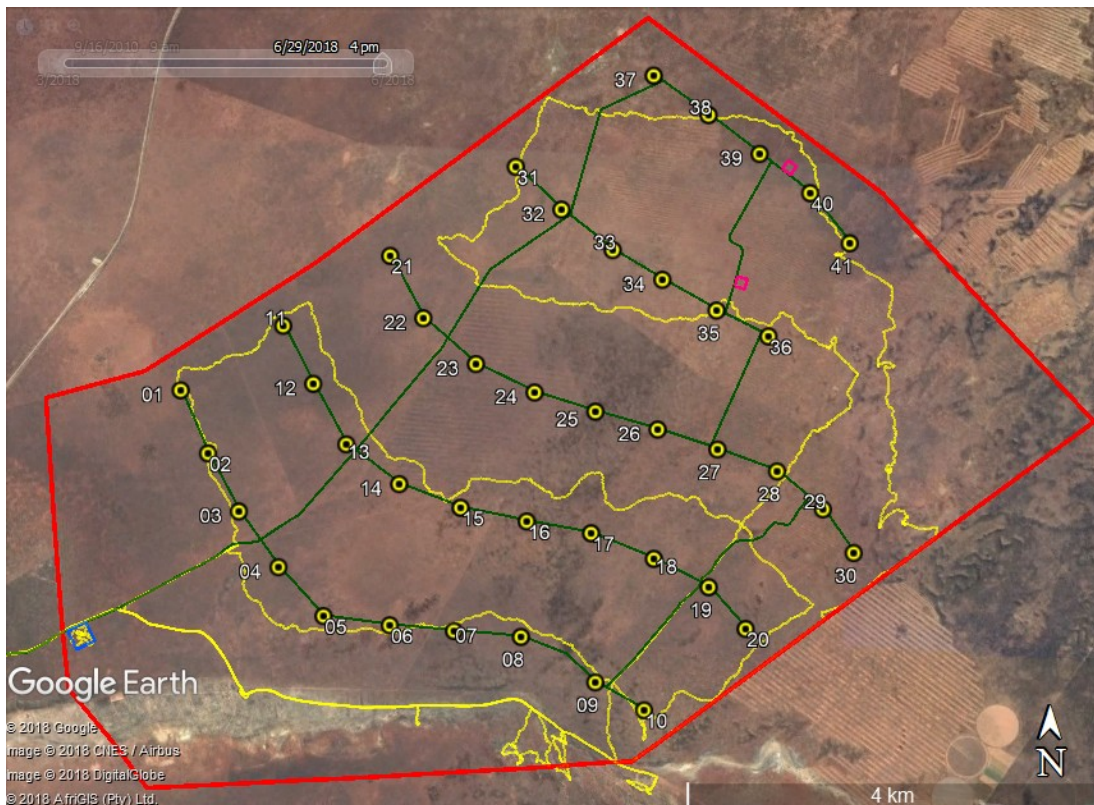
**Figure 3:** Aerial view of the study area (red polygon) showing the proposed facility layout (black and yellow dots and green lines) and the walk paths (yellow lines). Note that the survey tracks do not match the layout because the layout was revised based on scoping inputs.

The preliminary layout was subjected to a detailed foot survey on 13<sup>th</sup> and 14<sup>th</sup> March 2018 (Figures 3 & 4). This was in late summer, although in this relatively dry part of the country seasonality makes little or no difference to the vegetation cover and hence ground visibility. During the survey the positions of finds were recorded on a hand-held Global Positioning System (GPS) receiver set to the WGS84 datum. Photographs were taken at times in order to capture representative samples of both the affected heritage and the landscape setting of the proposed development. It should be noted that the survey focused strongly on the supplied layout with relatively little work in other areas. However, extra emphasis was placed on looking at more ground in the east (where dunes and deflations were noted to occur) and in the far south (where rocky outcrops along the valley margin were likely to be sensitive).

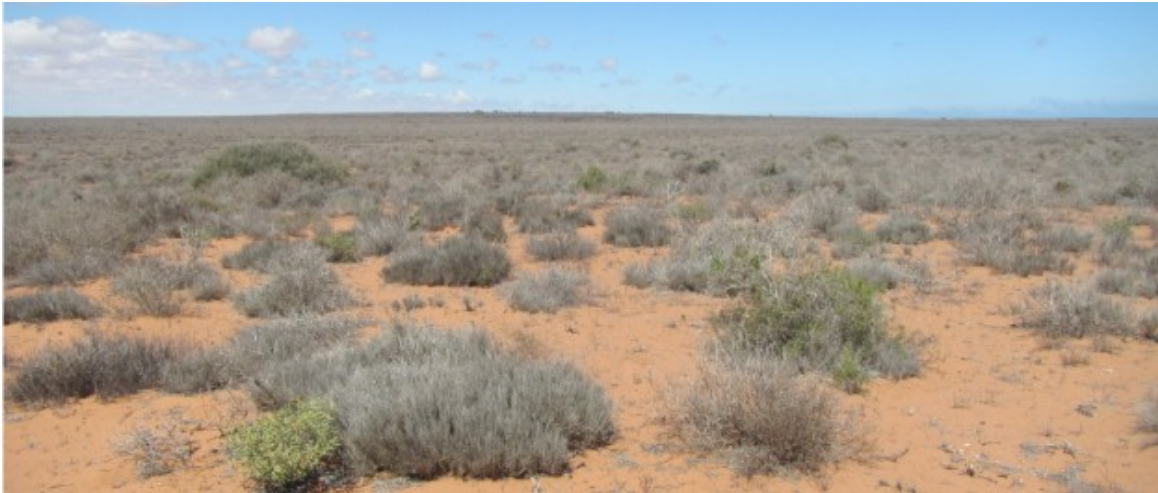
**Figure 5:** View towards the southeast across the north-western part of the site showing the very uniform vegetation cover there.

The site is on a relatively flat, sandy plain. Parts of the site were ploughed in the past, as revealed by aerial photography, but this is not at all evident on the ground. The vegetation cover over most of the site is quite homogenous and is largely waist-high and sparsely distributed (Figure 5). There is a belt of low 'dunes' running from north to south in the central part of the study area. These are almost certainly in fact ancient termitaria (*heuweltjies*) that are covered in more recent aeolian sand. These varied in the density of vegetation, perhaps dependent on the depth of covering sand (Figures 6 & 7). In the eastern part of the study area there was a belt of proper sand dunes, a very few of which had developed deflation hollows in them (Figure 8).

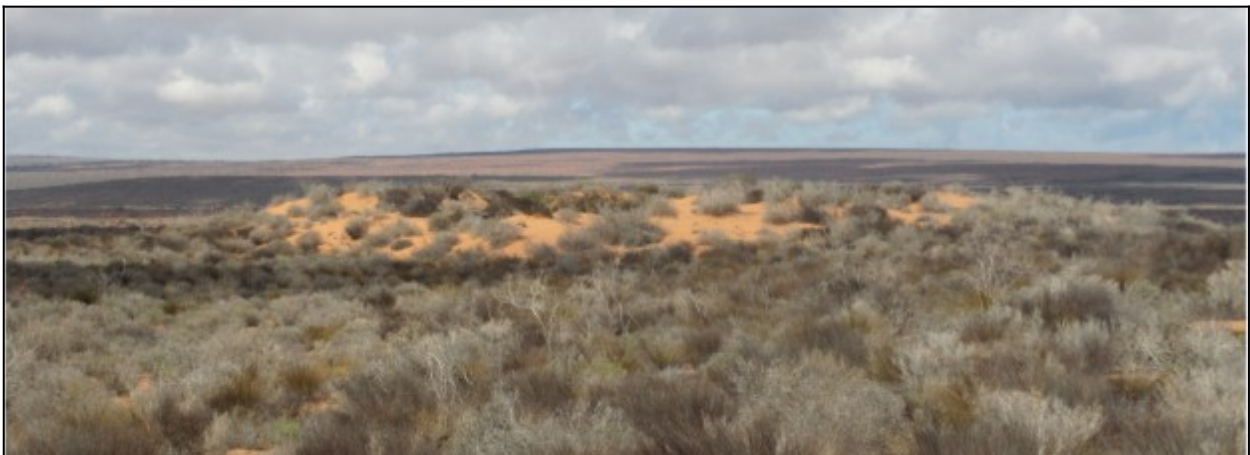
**Figure 8:** View towards the southeast of one of the more prominent deflation hollows in the eastern part of the site.

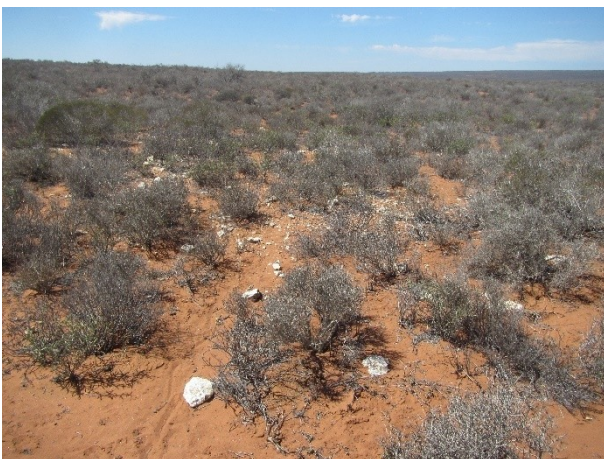
**Figure 9:** Some parts of the WEF area in the south were noted to have exposed calcrete.

While the vast majority of the study area is mantled in sand, there are patches in the southern part, along the north bank of the Sandlaagte River, where calcrete is exposed. This was always present as crumbled fragments with no solid outcrops noted at all (Figure 9). Within the Sandlaagte Valley the vegetation was slightly denser than over the remainder of the study area.

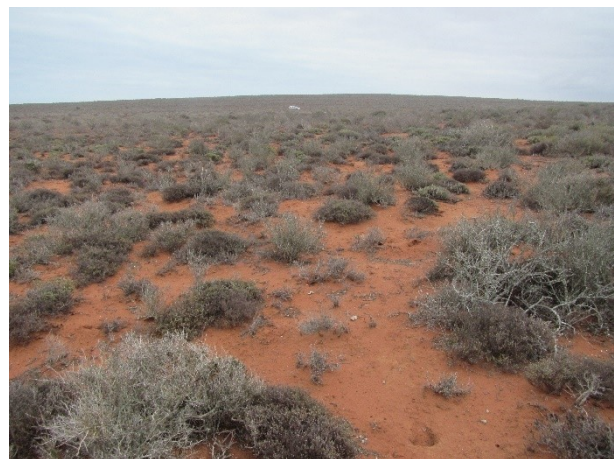
**Figure 10:** Construction camp and laydown area.

The vicinity of the construction camp and laydown area was comprised of harder soil (probably exposed hardpan) with occasional tiny dunes and more succulent vegetation that was seldom more than knee-height (Figure 10).

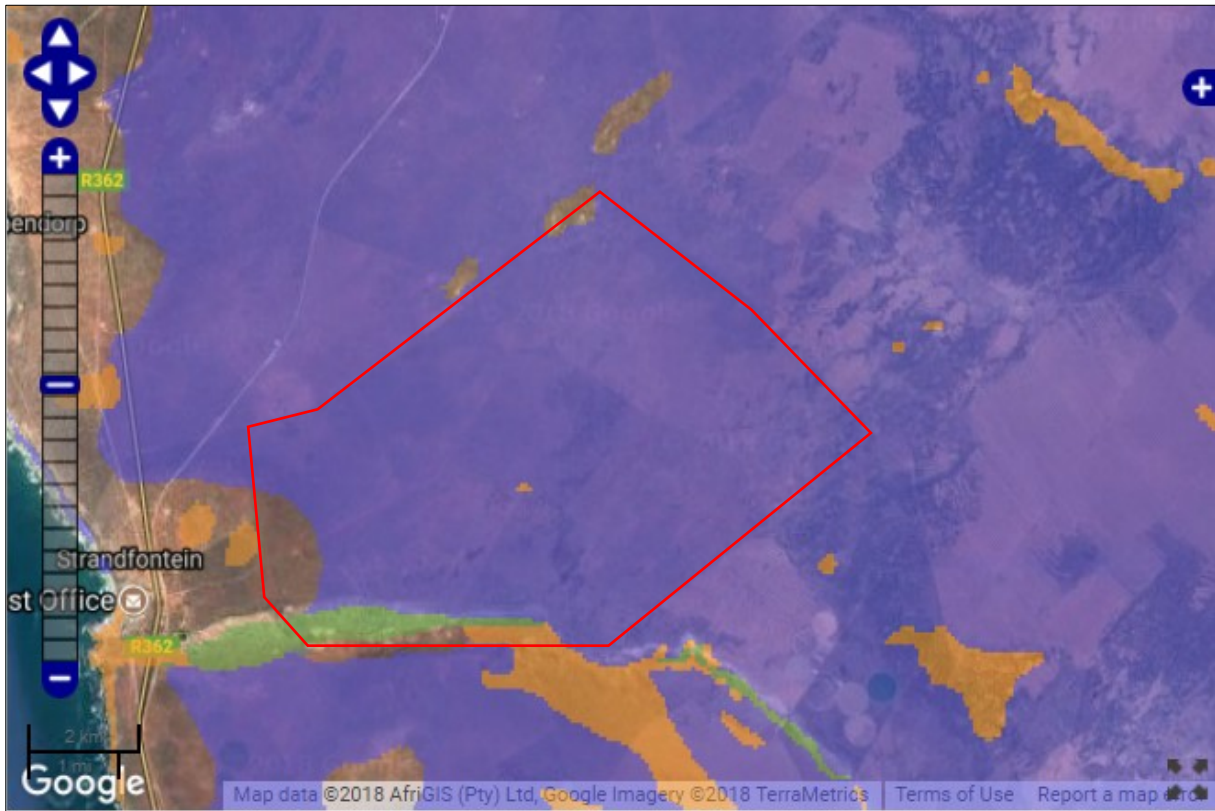
**Figure 12:** Extract from the SAHRIS Palaeosensitivity map showing the surface sediments in the study area to be of generally low palaeontological sensitivity (blue shading). The river valley section along the southern boundary has moderate (green) and high (orange) sensitivity sediments but is excluded from the development footprint.

The surface geology in this area is expected to be largely of low palaeontological sensitivity which generally does not call for any specialist study of palaeontological impacts. Figure 12 shows that the project layout area is all of low sensitivity with the only more sensitive areas of the property being along its southern periphery where valley infill sediments of moderate to high sensitivity may be found. However, these low sensitivity surface sediments can overlie more sensitive sediments, especially in coastal and near-coastal environments. As such, HWC has requested a specialist assessment of palaeontological impacts.

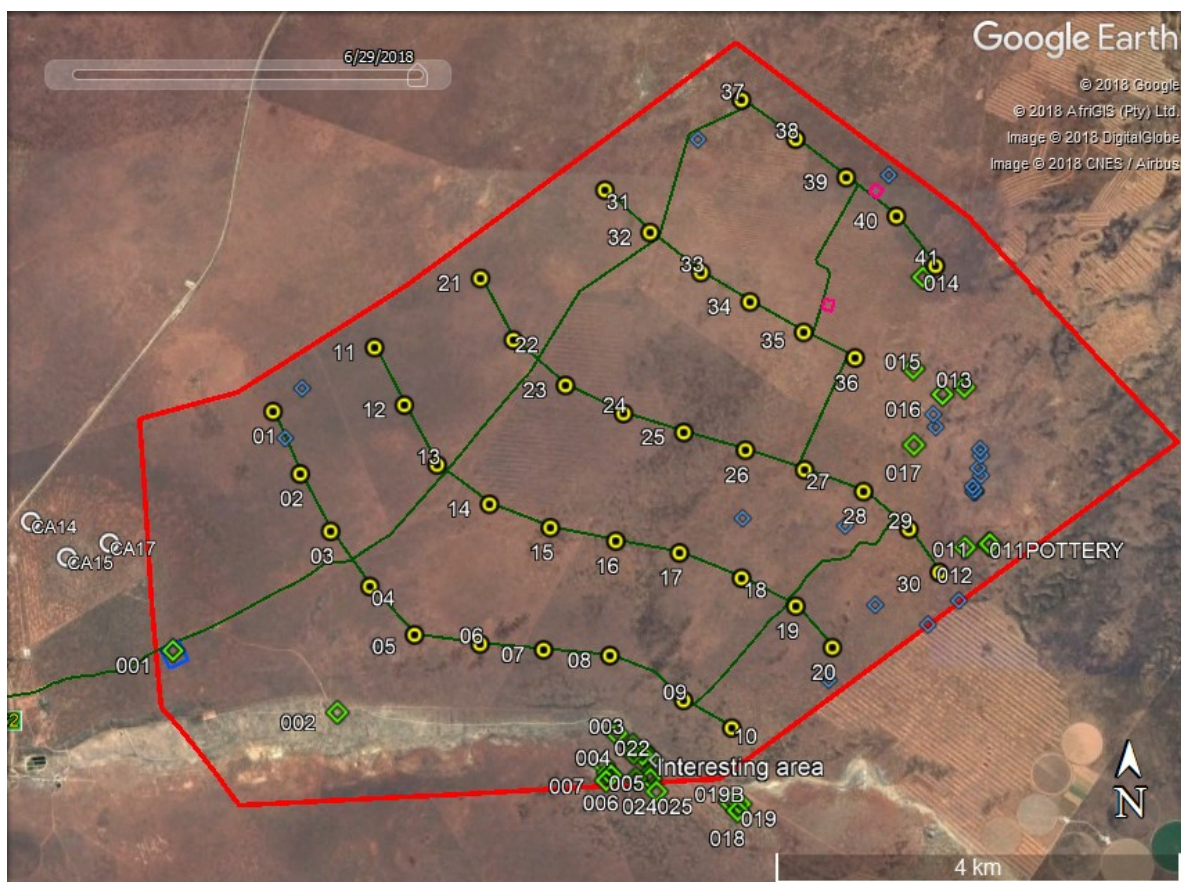
**Figure 13:** Aerial view of the study area showing the locations of finds. Green numbered symbols indicate sites or areas with multiple artefacts, while the light blue symbols mark isolated artefacts. The three white symbols in the west are sites recorded by Yates (2003). The most interesting find was at one of the deflation hollow sites (DBM2018/010; waypoint 011). Along the southern margin of the site there was a collection of potsherds that no doubt originated from the same pot that was either buried and then lost, with natural degradation leading to its break up, or else broken on site and was subsequently abandoned. The fragments were located in loose sand around a dune with a *restio* growing on it (Figure 16). The pottery included the base of the pot but no rim or other diagnostic sherds were seen (Figure 17). The only other site of any significance was a deflation hollow that had a scatter of at least 100 quartz artefacts in it (DBM2018/011; waypoint 012; Figure 18). It also had a double-sided lower grindstone on a sandstone

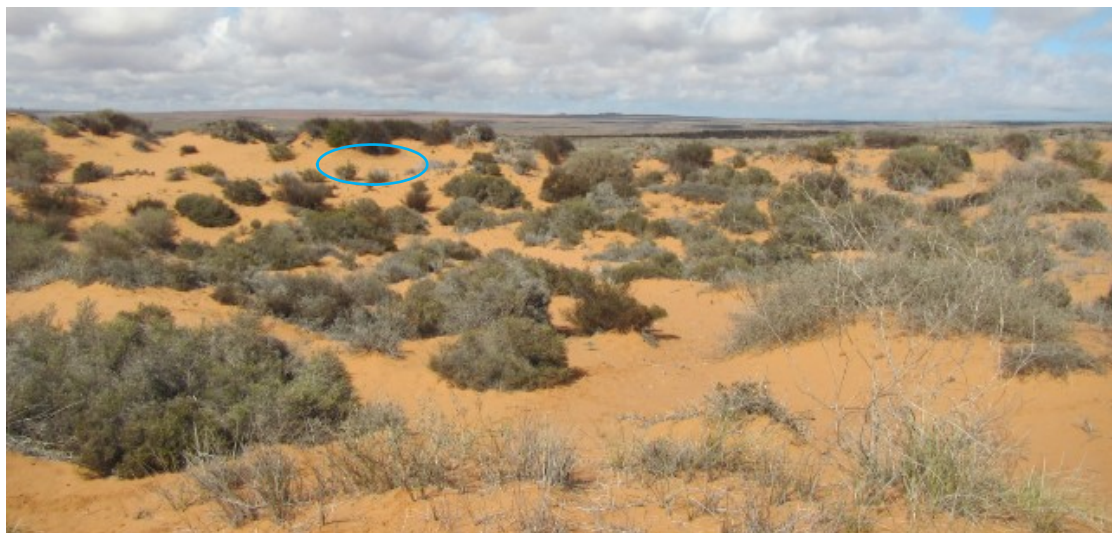
**Figure 16:** View of the deflation hollow at DBM2018/010 (waypoint 011). The turquoise oval marks the location of the pottery scatter.

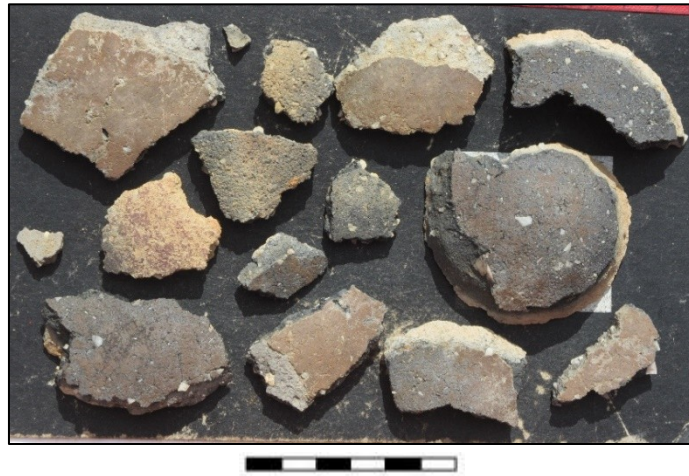
**Figure 17:** Photograph of the potsherds eroding from the base of a dune at DBM2018/010 (waypoint 011). The large piece at the right is the base of the pot. Scale in cm intervals.

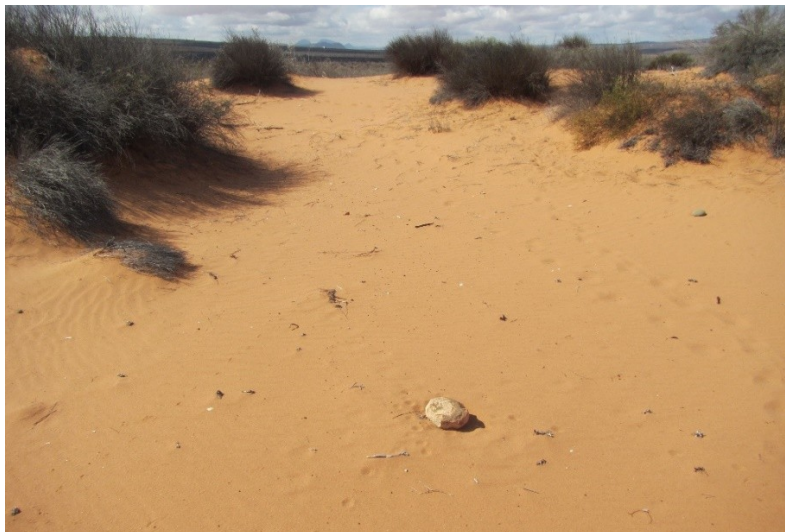
**Figure 18:** View of the deflation hollow at DBM2018/011 (waypoint 012).

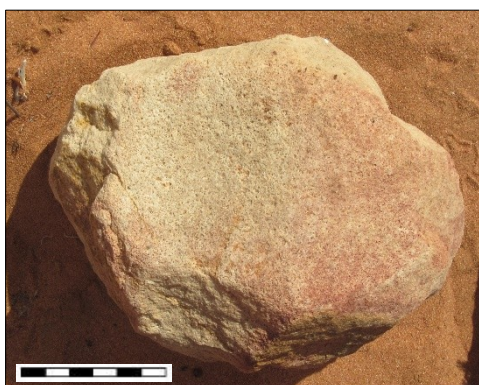
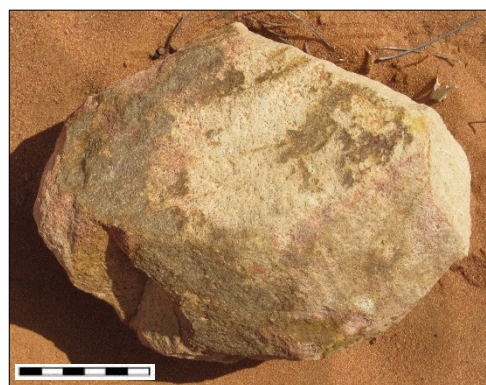
**Figure 19:** The lower surface of the sandstone lower grindstone at DBM2018/011 (waypoint 012).

**Figure 20:** The upper surface of the sandstone lower grindstone at DBM2018/011 (waypoint 012).

cobble and a hammer stone hammered on both ends and made on an igneous cobble. The lower grindstone displayed only light use (Figures 19 & 20).

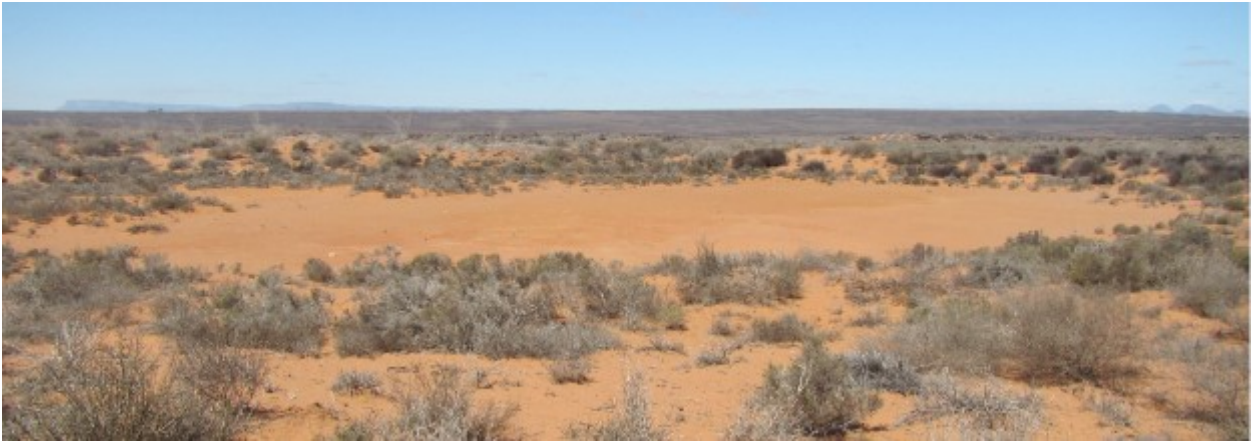
**Figure 21:** View of the pan located amongst the dunes in the eastern part of the study area (DBM2015/013; waypoint 015).

There was one occasion in the present study area where a pan had formed on this harder layer (DBM2015/013; waypoint 015; Figure 21). This has resulted in a concentration of artefacts, either because of the visibility or else, if the pan is old, because people were attracted to it. However, the overall density is still low, too low to be of research value.

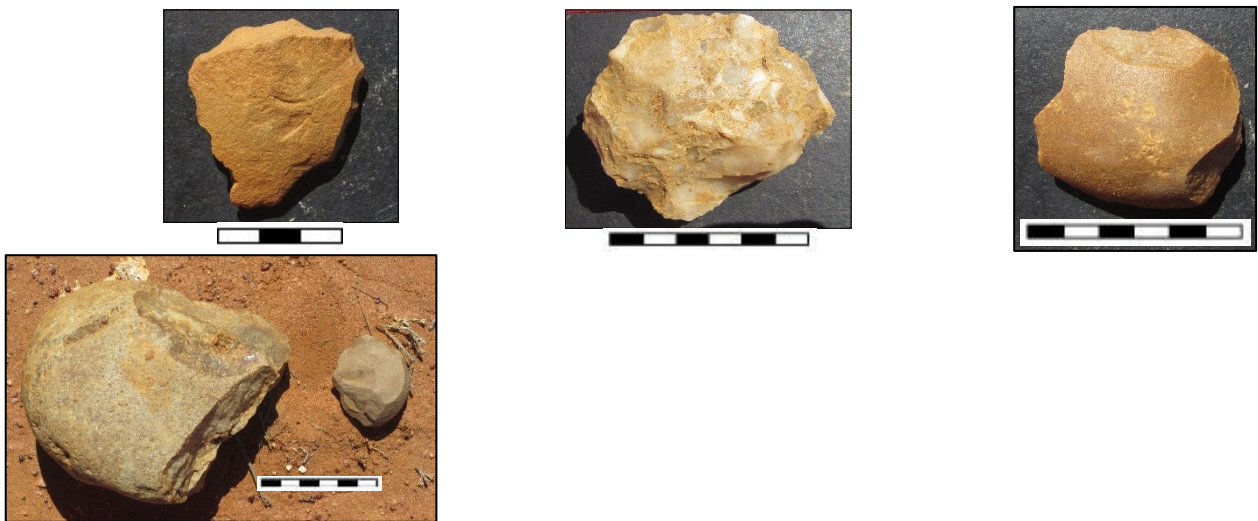
**Figure 22:** A selection of stone artefacts found at DBM2018/013 (waypoint 015). They include a quartzite flake (left), a silcrete radial core (2<sup>nd</sup> from left), a quartzite irregular core on a cobble (3<sup>rd</sup> from left) and two cores on cobbles of quartzite and 'other' (right). All are likely to be MSA.

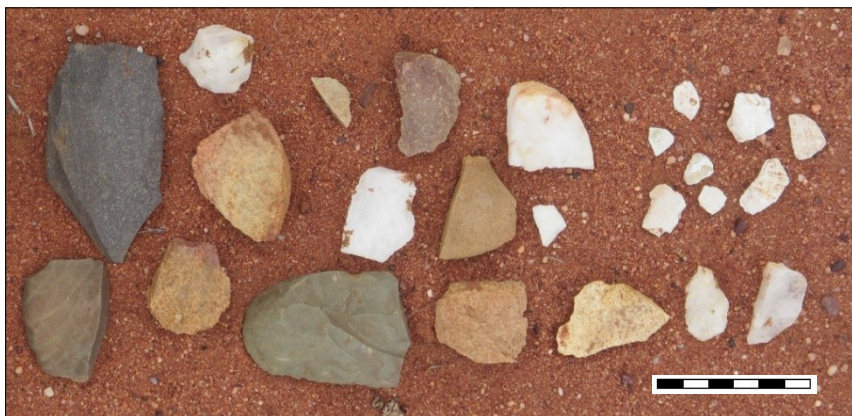
**Figure 23:** Stone artefacts and marine shell fragments found at DBM2018/001 (waypoint 001). The shells are at upper right. Scale in cm intervals.

In the far west of the study area, at the location proposed for the laydown area and construction camp, a number of artefacts were noted spread about in very low density. These are what is usually termed background scatter. However, in one area there was a concentration of artefacts with a number of associated shell fragments (Figure 23). This spot was likely used as a brief campsite during the LSA, although some of the artefacts

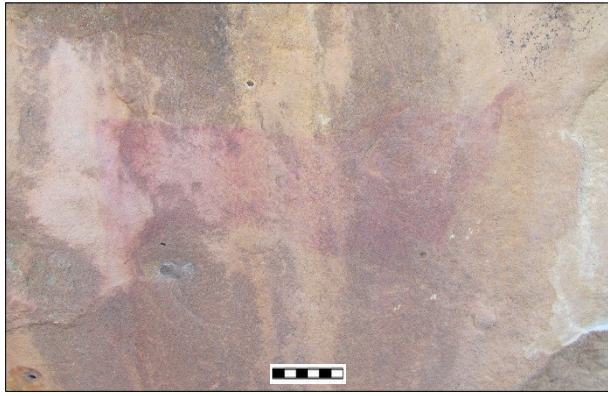
**Figure 24:** Eland torso from DBM2018/018 (waypoint 021, panel 3). Scale in cm intervals.

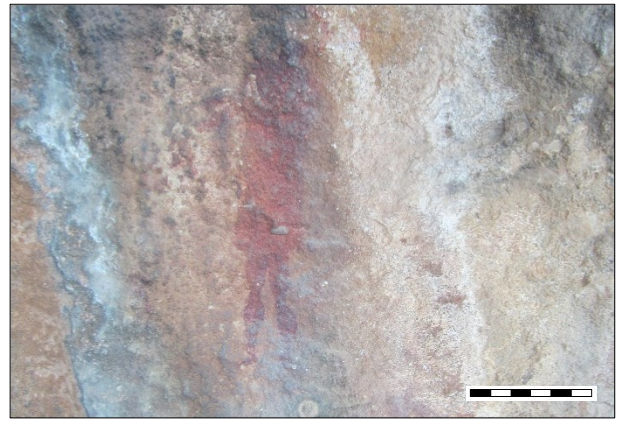
**Figure 25:** Human figure from DBM2018/020 (waypoint 023). Scale in cm intervals.

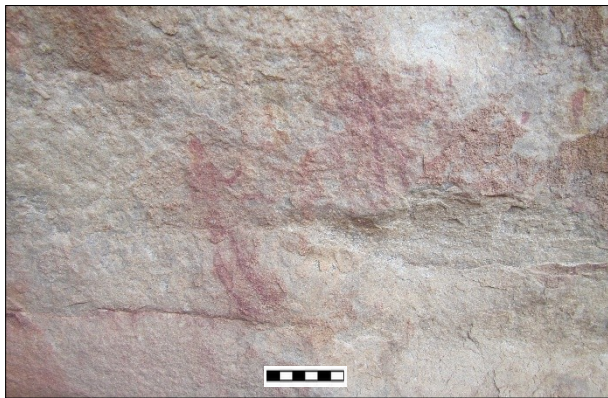
**Figure 26:** Small section of a large panel from DBM2018/003 (waypoint 004, panel 1) showing two discernible human figures. Scale in cm intervals.

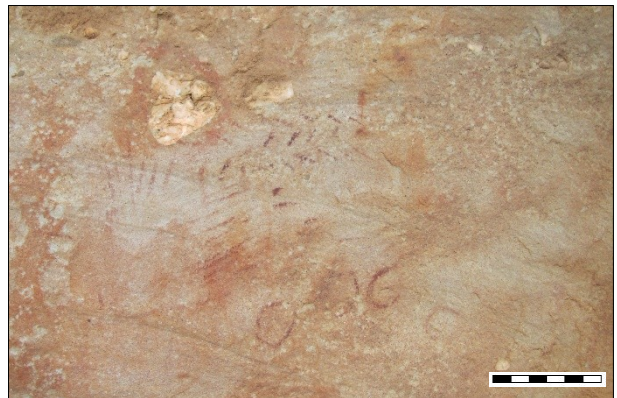
**Figure 27:** Small section of a large panel from DBM2018/003 (waypoint 004, panel 4) showing finger painted imagery. Scale in 2 cm intervals.

Two types of rock art were observed. The majority of images belong to the so-called ‘fine-line tradition’ which includes representational images of humans, animals and various objects of material culture. It also includes geometric images referred to as ‘entoptic phenomena’ which relate to trance. A number of these fine-line images were recorded. These included a faded but still fairly well-preserved right-facing eland torso (Figure 24) and a poorly preserved human figure from site DBM2018/018 (waypoint 021), a human figure, possibly clad in a kaross (Figure 25) from DBM2018/020 (waypoint 020), a large but poorly preserved panel with two moderately preserved, human figures from DBM2018/003 (waypoint 004, Figure 26) and another larger panel from the same site that includes some relatively fine finger painted imagery that may be entoptic phenomena (waypoint 004, Figure 27).

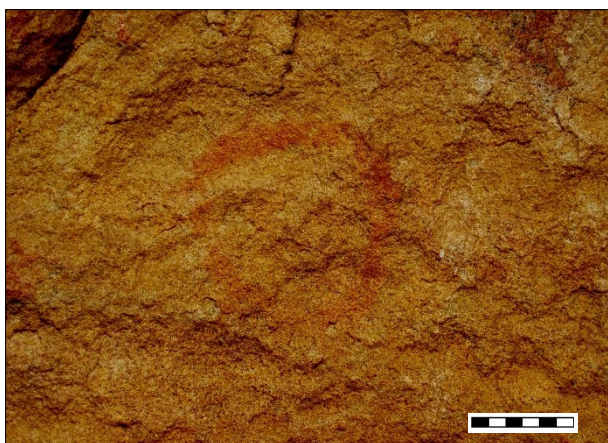
**Figure 28:** Finger-painted circular image from DBM2018/005 (waypoint 006). Scale in cm intervals. Brightness and contrast

Some sites also contained examples of geometric tradition rock art which is known to occur in the west coast area (Orton 2013b). These included a plain circle from DBM2018/005 (waypoint 006; Figure 28), another poorly preserved circular image, possibly of concentric circles from DBM2018/006 (waypoint 007), an image of a square or circle (unclear) containing vertical lines that extend beneath the enclosing shape as what are referred to as tassels from DBM2018/003 (waypoint 004; Figure 29) and a large composition (c. 1.5 m by 1.5 m) of black finger dots in three unusual ‘images’ that may represent human figures (waypoint 021; Figure 30).

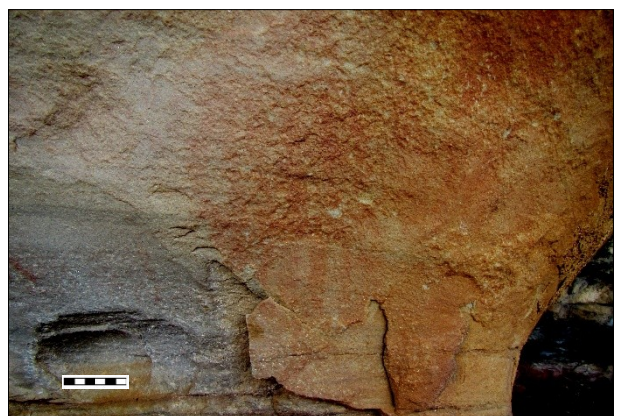
**Figure 29:** Finger-painted geometric image from DBM2018/003 (waypoint 004, panel 4). Scale in cm intervals. Brightness and contrast

*adjusted to emphasize art.*

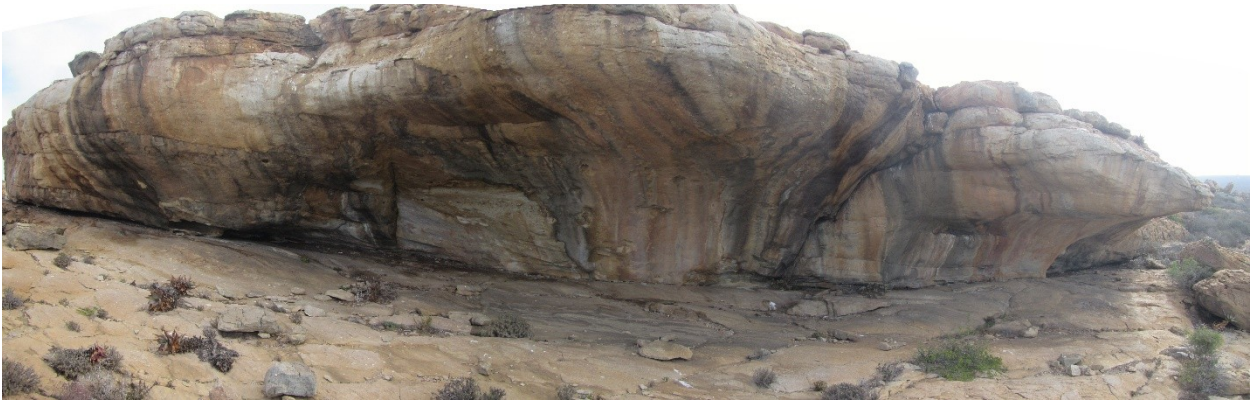
**Figure 31:** The rock shelter at DBM2018/003 (waypoint 004). The numbers show the locations of the four painted panels.

The painted sites themselves varied in form. DBM2018/003 (Figure 31) was a fairly large rock shelter (by regional standards), while DBM2018/018 (Figure 32) and DBM2018/020 (Figure 33) are examples of smaller rock shelter and boulder sites respectively.

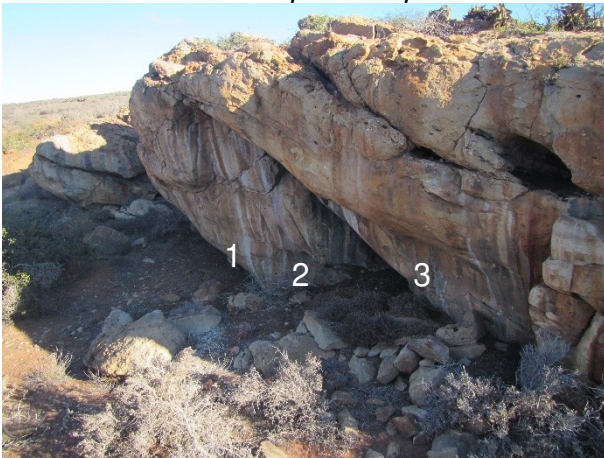
**Figure 32:** The painted rock shelter at DBM2018/018 (waypoint 021). The numbers show the locations of the three painted panels.

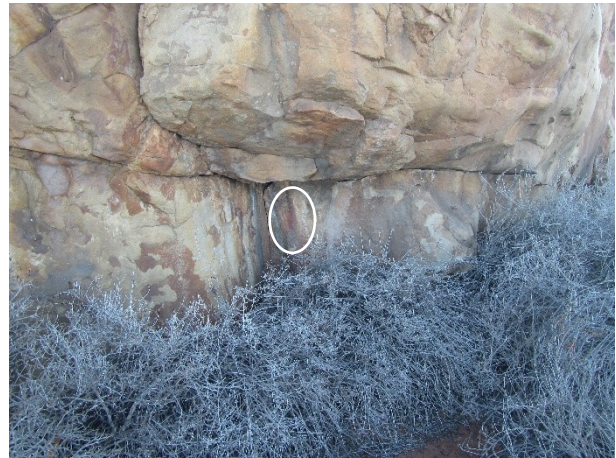
**Figure 33:** The painted boulder at DBM2018/020 (waypoint 023). The oval encloses the painted human figure.

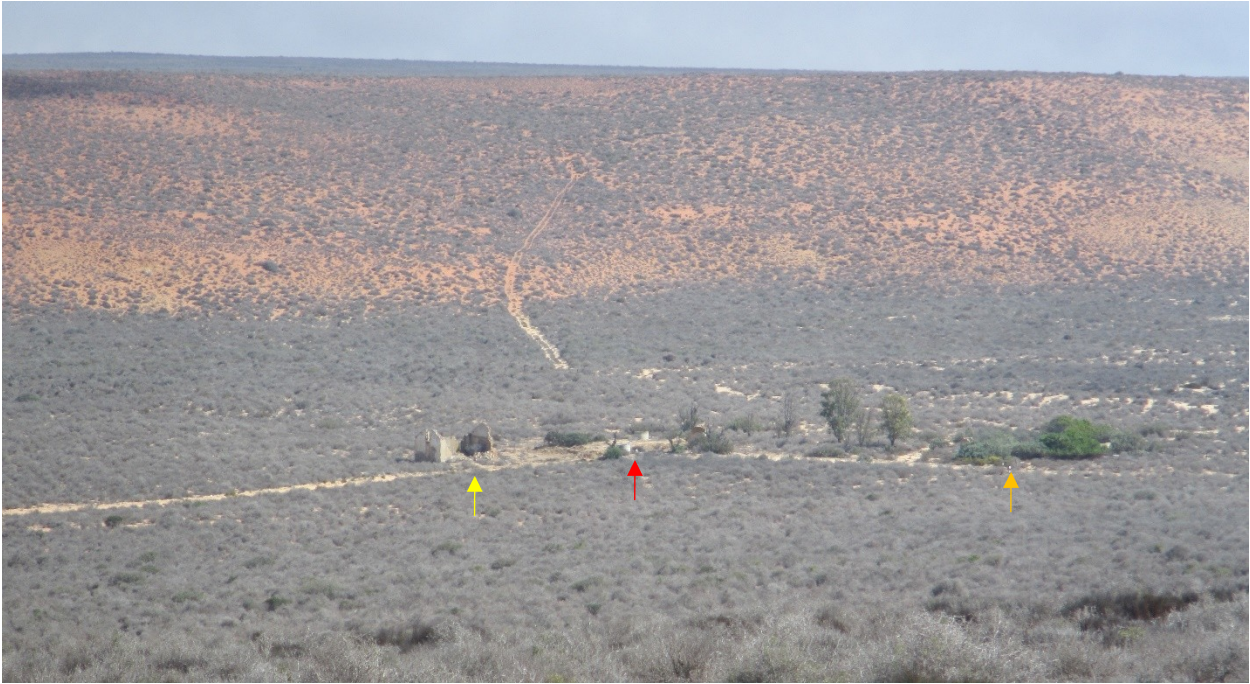
**Figure 34:** View of the old De Boom farmstead looking towards the southwest and seen from the high ground to the north of the Sandlaagte. The yellow, red and orange arrows mark the cottage, main farm house and outbuilding respectively.

The last archaeological site to be described is a historical farm complex at DBM2018/002 (waypoint 002; Figure 34). It is the original farm complex for the De Boom farm and is located in the Sandlaagte valley in the far south of the study area some 4 km from the coast. The site consists of three buildings (Figures 35 to 38) built via the 'twos skins and a rubble fill' technique. There was a large amount of artefactual material spread around the cottage and main house (Figure 39). The finds included glass, ceramics (refined white earthenware and stoneware), metal fragments (including a rifle cartridge), some writing slate fragments, some leather, ostrich eggshell fragments, marine shells and animal bones. There was no evidence of a dump in close proximity to the structures but there may be one present further afield in the surrounding bushes.

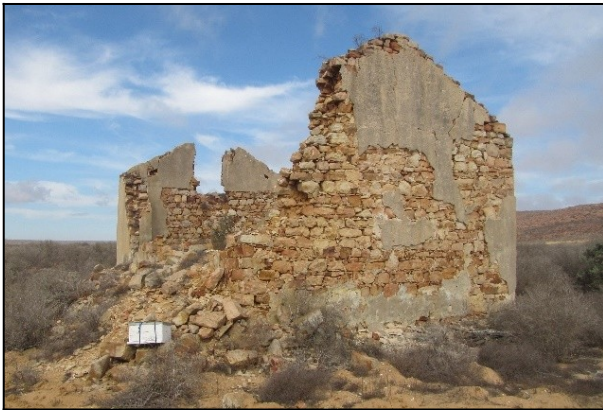
**Figure 35:** View of the northwest corner of the cottage ruin at De Boom 2018/002 (waypoint 002). Most walls are still standing but all joinery is absent.

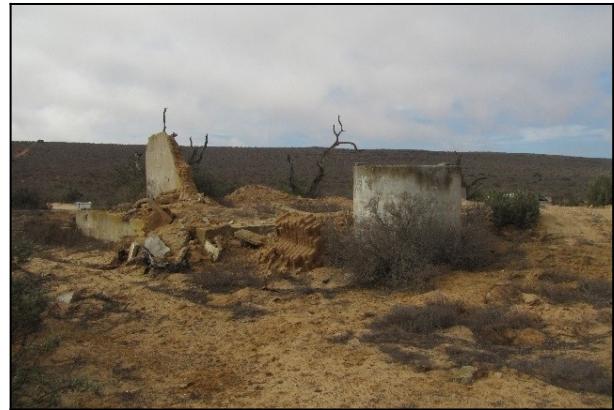
**Figure 36:** View of the southeast corner of the main house at De Boom 2018/002 (waypoint 002) showing the last remaining standing wall at left and a small cement reservoir towards the right.

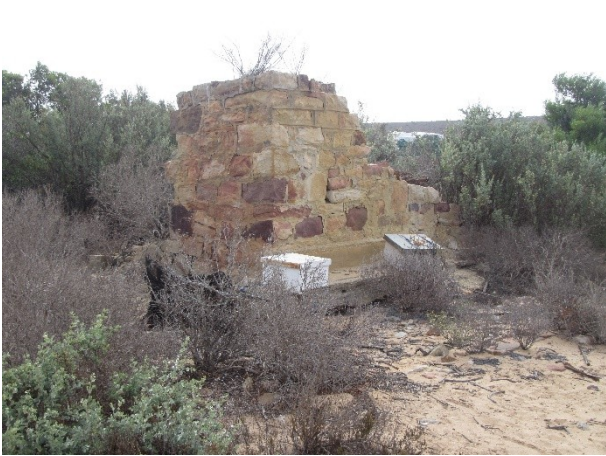
**Figure 37:** View Towards the northwest of the third ruin, presumably an outbuilding, at De Boom 2018/002 (waypoint 002).

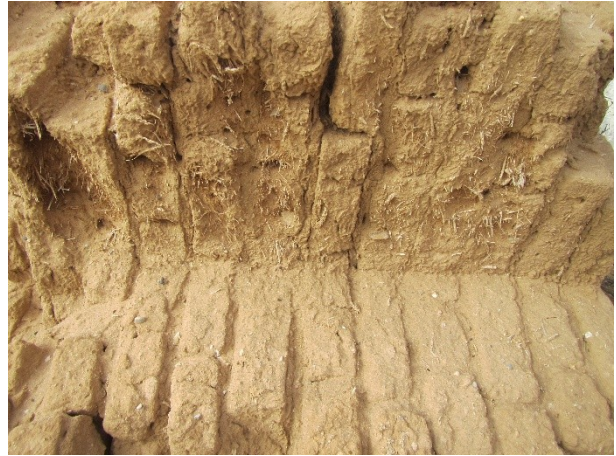
**Figure 38:** View of a section of fallen brick wall from the main house at De Boom 2018/002 (waypoint 002) showing locally made sundried bricks containing wheat stalks.

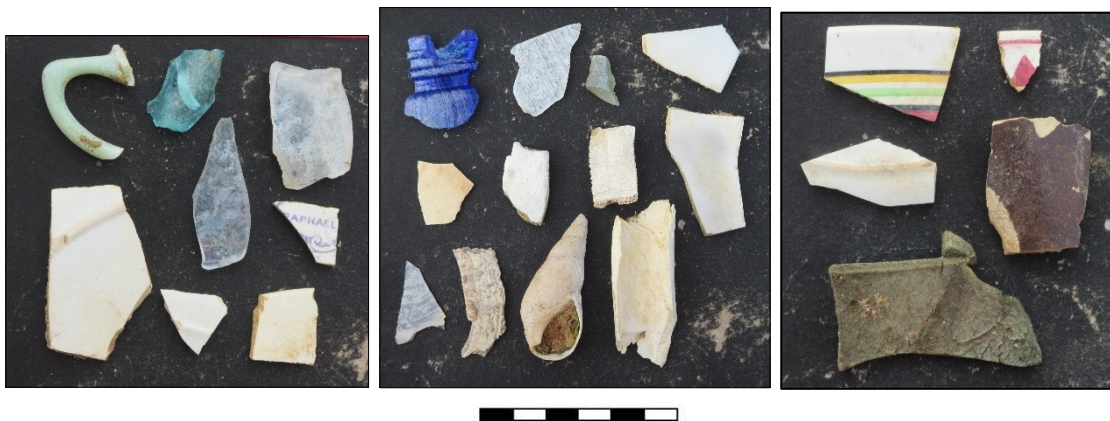
**Figure 39:** Artefacts from around the ruins at De Boom 2018/002. Scale in cm.

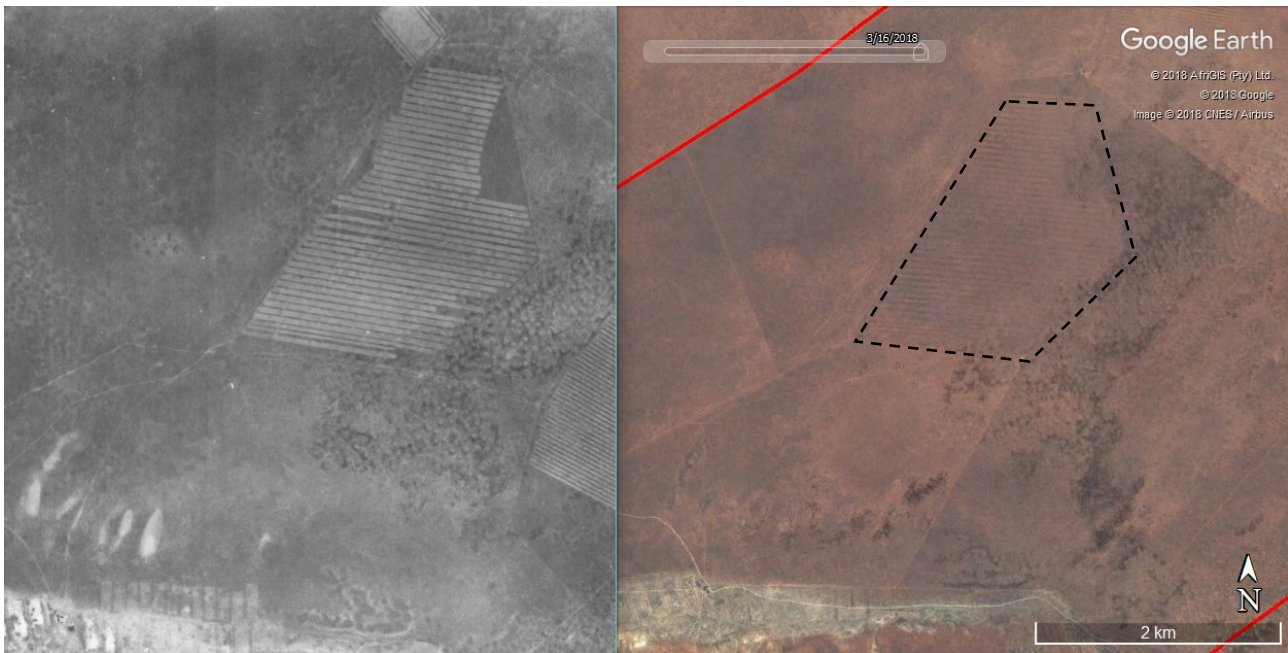
**Figure 41:** Aerial views of the study area from 1958 (Job 409, strip 24, photograph 6736) and 2016 (Google Earth) showing ploughed land that was not present in the 1942 aerial photograph. The main area is outlined by a black dashed line, while a second ploughed area to the southwest is clear in 1958 but virtually invisible today. Note also the deflation hollows in the southwest of this view that have revegetated today and were not recognised during the survey.

Cultural landscapes are the product of the interactions between humans and nature in a particular area. Sauer (1925) defined them thus: “The cultural landscape is fashioned from a natural landscape by a cultural group. Culture is the agent, the natural area is the medium, the cultural landscape the result”. There are three aspects that require discussion here. The first is the historical cultural landscape which is generally very weakly developed on and around the site since the historical human imprint on the land has been light, although a large part of the study area was ploughed in the past (after 1942 but before

1958) as revealed by aerial photography (Figure 41). Interestingly, although visible on modern aerial photography, there is no evidence of this ploughing on the ground today. Some of the fields made along the Sandlaagte Valley – those on the slopes rather than in the valley bottom – are only discernible on modern aerial photographs when directly compared with the historical imagery. A few sandy vehicle tracks, farm fences and infrastructure related to animal watering are the main historical cultural landscape components on and around the site. Because of this light human imprint, the wider landscape, excluding the Olifants River Valley located 11 km away to the northeast, is quite strongly natural in character.

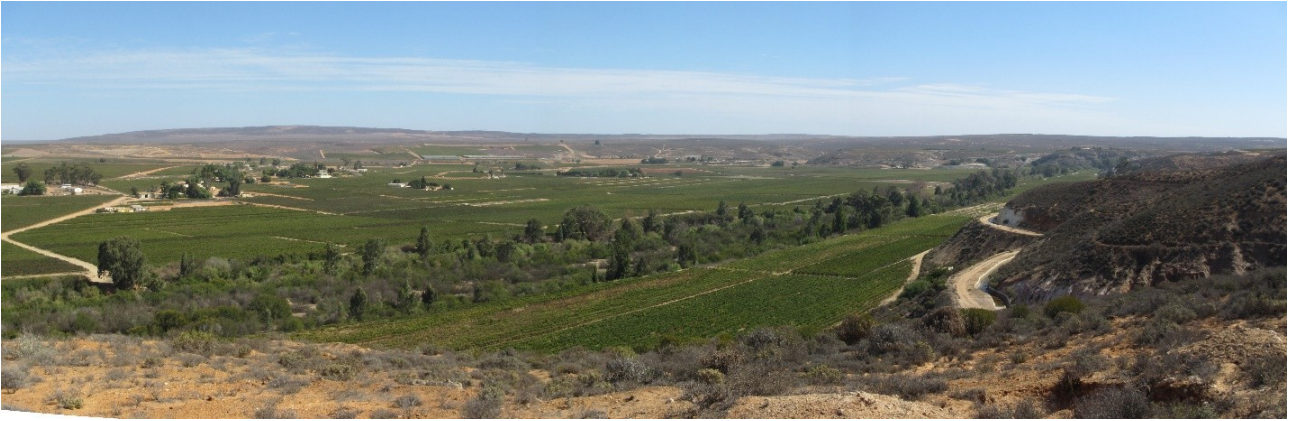
**Figure 44:** View towards the southwest across the Olifants River Valley. The WEF would be located just beyond the skyline (but protruding well above it) in the centre of the photograph. The skyline in this view is 8.5 km distant and the nearest turbines a further 5.0 km back.

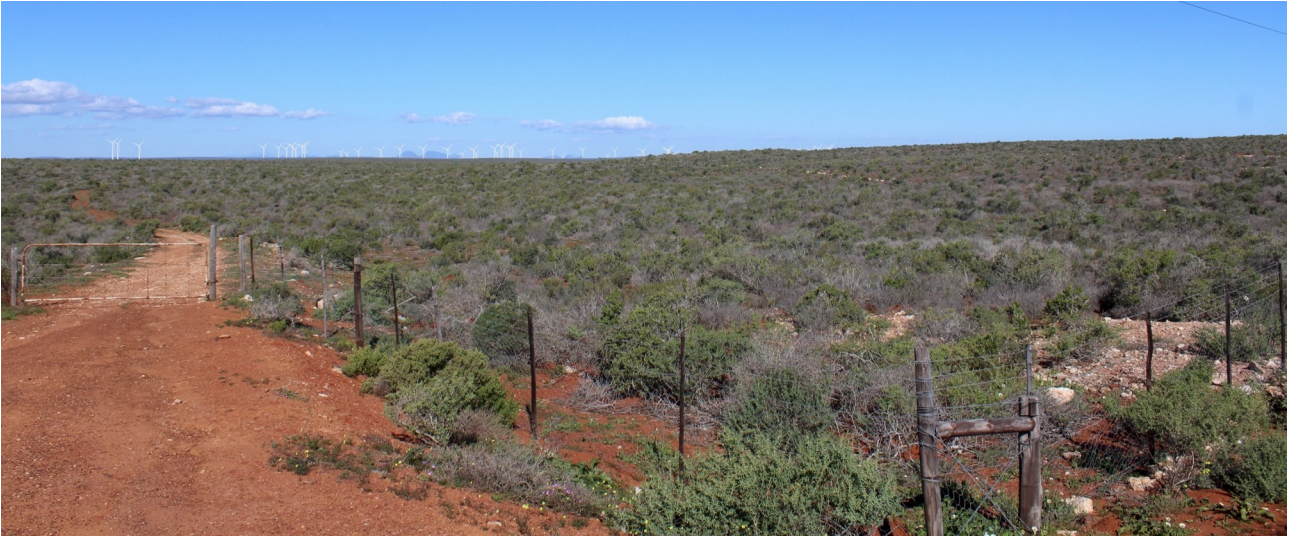
**Figure 48:** Photomontage showing the visibility of the proposed WEF from a point on the R362 midway between Ebenhaeser and Papendorp. The nearest turbines are 7.7 km away and the project is openly visible (Source: Claasen & Volschenk 2019 Annexure 2: photograph 1).

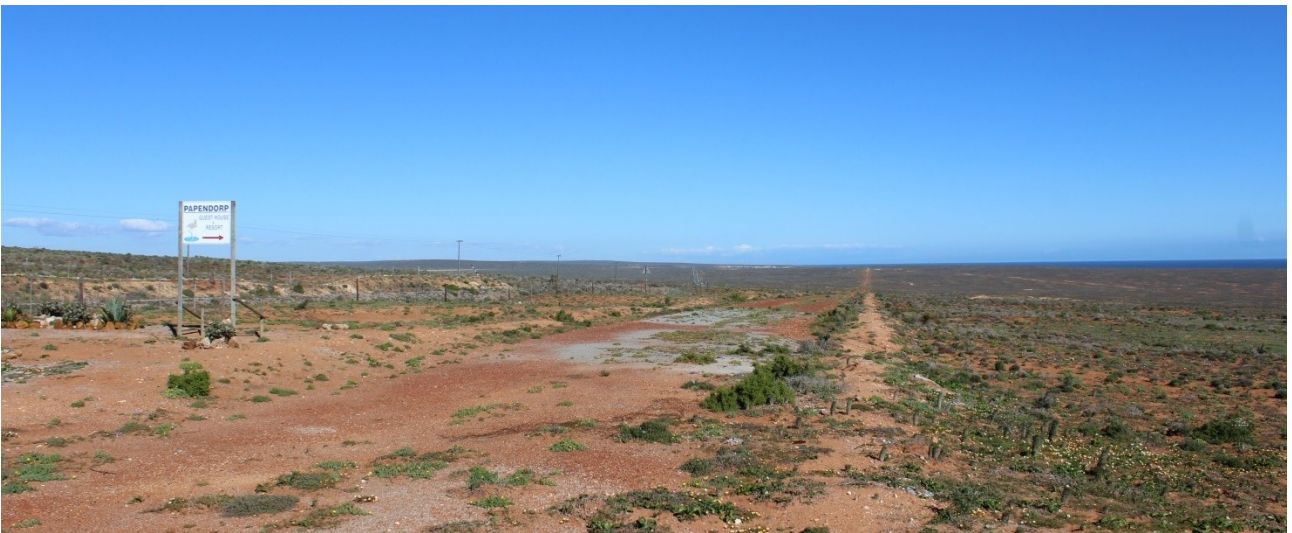
**Figure 49:** Photomontage showing the visibility of the proposed WEF from a point on the R362 at the turnoff to Papendorp. The nearest turbines are 6.2 km away but localised topographic screening means the project would not be visible (Claasen & Volschenk 2019 Annexure 2: photograph 2).

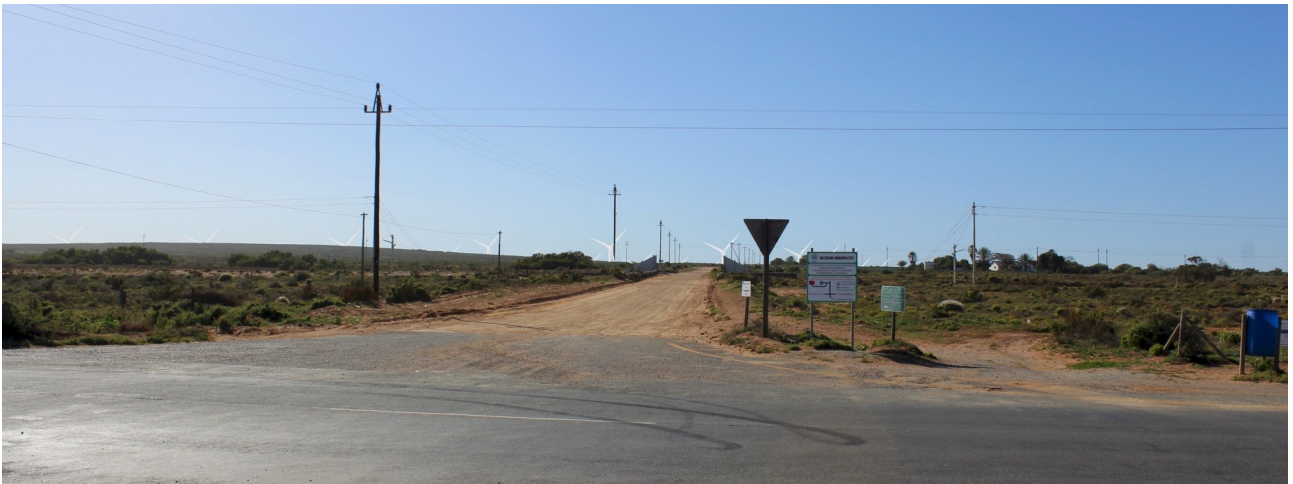
**Figure 50:** *Photomontage showing the visibility of the proposed WEF from a point on the R362 at the turnoff to Strandfontein. The nearest turbines are 4.3 km away but localised topographic screening means that only the tops of the turbines would be visible (Claasen & Volschenk 2019 Annexure 2: photograph 3).*

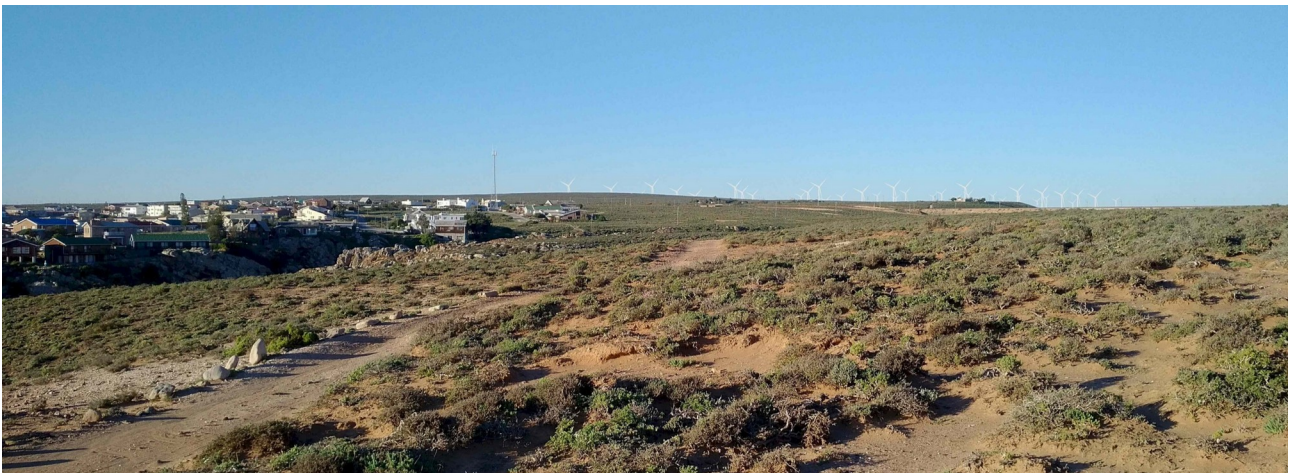
**Figure 51:** *Photomontage showing the visibility of the proposed WEF from a point above the cliffs immediately south of Strandfontein. The nearest turbines are 5.9 km away but localised topographic screening means that only the tops of the turbines would be visible (Claasen & Volschenk 2019 Annexure 2: photograph 4).*
