# **HERITAGE IMPACT ASSESSMENT: PROPOSED JUNO WIND ENERGY FACILITY ON DE BOOM 273/REMAINDER, VREDENDAL MAGISTERIAL DISTRICT, WESTERN CAPE**

HWC Case No.: 18030613AS0308E

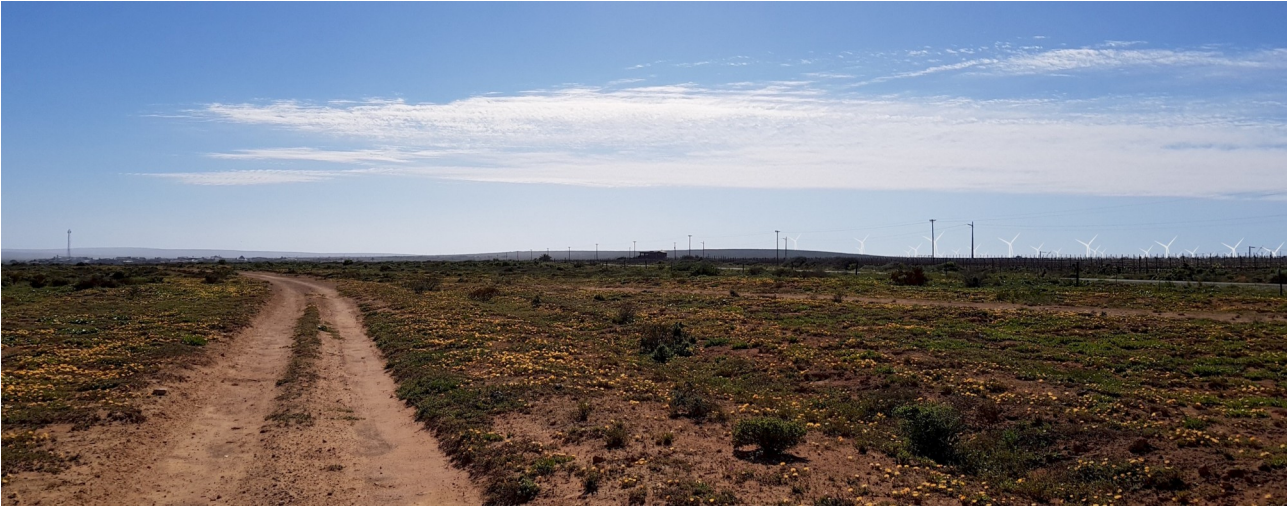
**Figure 52:** *Photomontage showing the visibility of the proposed WEF from a point just west of the R362 and a short distance to the south of Strandfontein. The nearest turbines are 5.9 km away but localised topographic screening means that only the tops of the turbines would be visible (Claasen & Volschenk 2019 Annexure 2: photograph 5).*

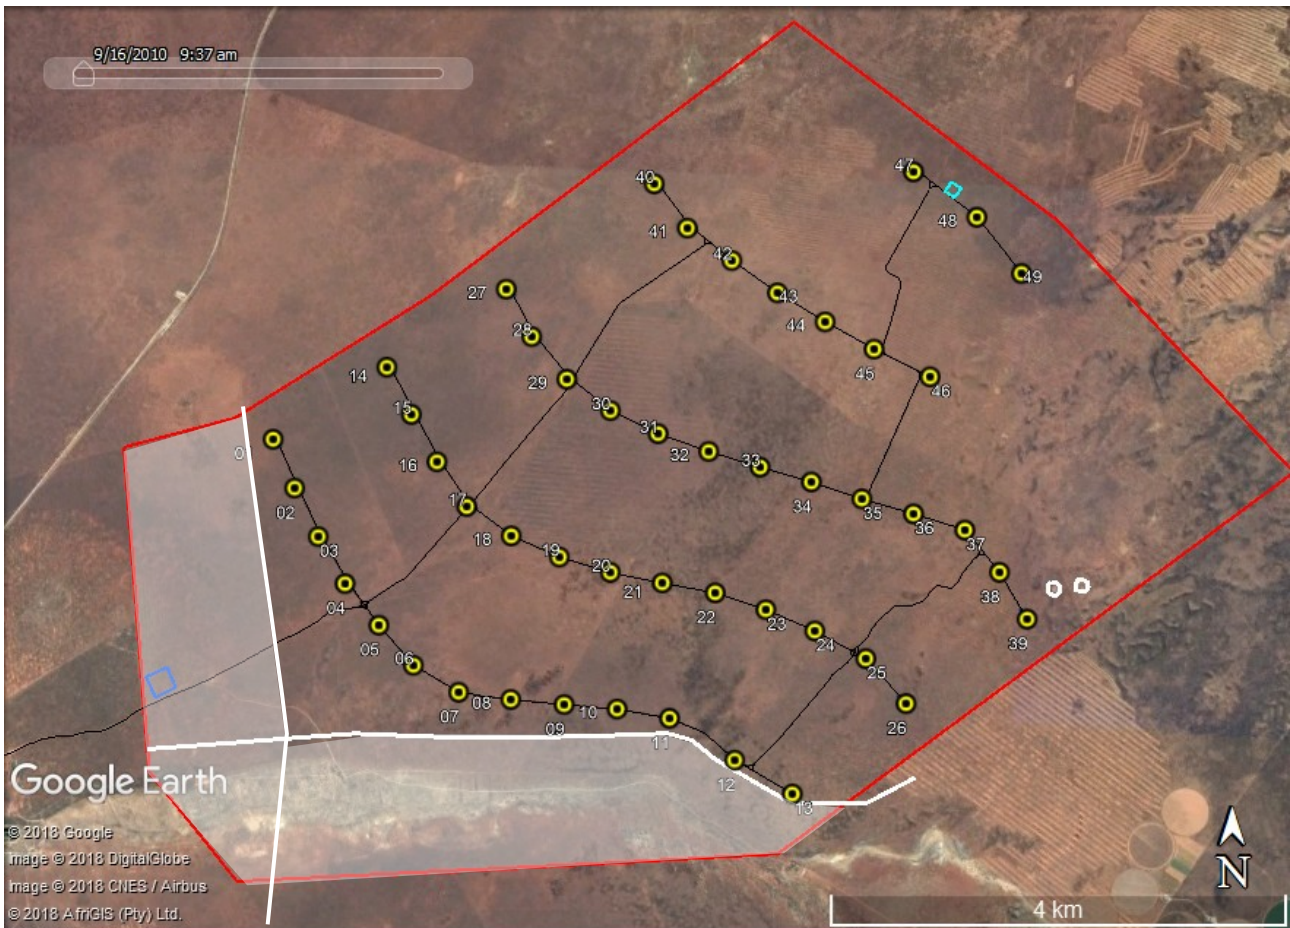
**Figure 53:** Aerial view of the study area showing the suggested on site heritage no-go areas for turbines (white shading) relative to the final turbine and road layout. The turquoise square is the final substation layout and the blue square the laydown area. All land within 500 m of the centre of the Sandlaagte (south of white line) has been avoided as have the two significant archaeological sites each with a minimum 30 m buffer (white circles).
