**ARCHAEOLOGICAL IMPACT ASSESSMENT
OF THE PROPOSED EXTENSION OF A BORROW PIT
ON KLIP HEUWEL 416, CALEDON AREA, OVERBERG
DISTRICT MUNICIPALITY, WESTERN CAPE**

(Assessment conducted under Section 38 (8) of the National Heritage Resources Act as part
of a Heritage Impact Assessment)

OCTOBER 2012

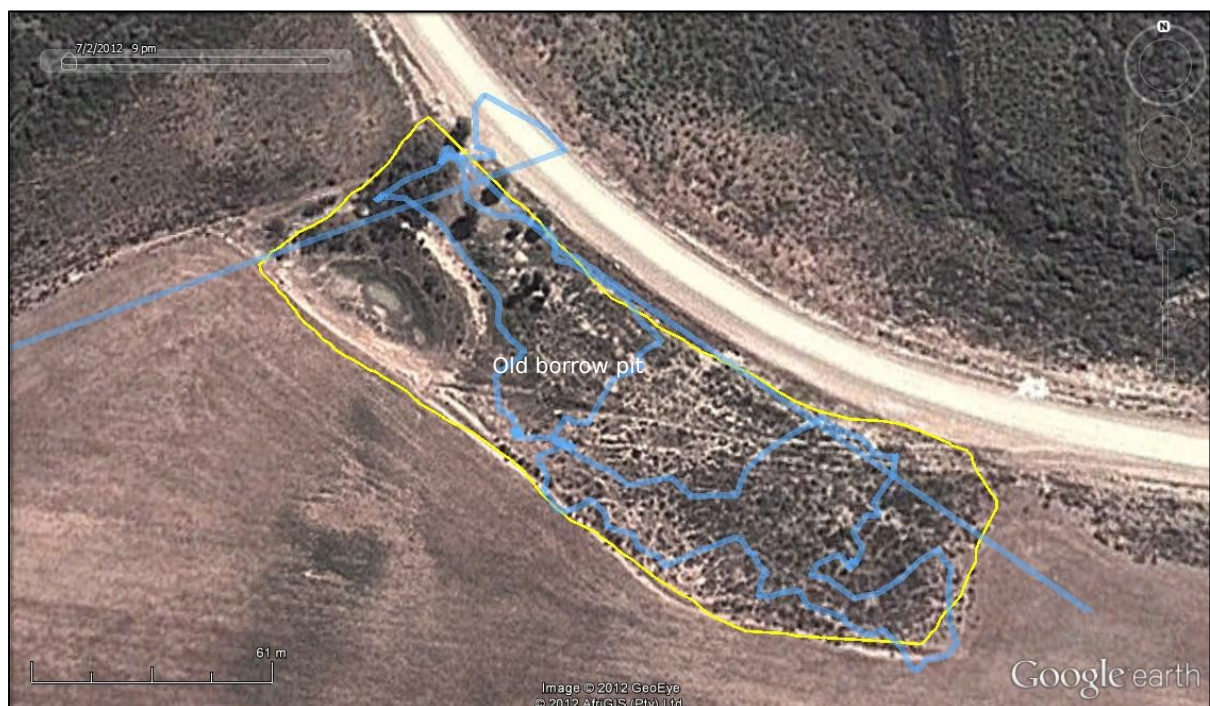
Figure 2: Google earth image showing the proposed extension of the existing borrow pit 177, the tracks of the field survey and the location of the existing borrow pit and dam. Please note that the straight blue lines do not indicate survey tracks.

Fieldwork was undertaken on 17 September 2012. A site plan indicating the affected area was provided by Nadeson for the Phase 1 survey. The area was covered on foot and tracks were recorded by a Garmin GPSMAP 62s set on the WGS84 datum (Figure 2). The site was extensively photographed.

Environment: The affected area consists of uncultivated farmland. It is bounded by the MR00276 (Boontjieskraal Road) to the northeast, a small dam and blue gum trees to the northwest, wheat fields to the southwest and southeast (Figures 2 and 3). The existing small borrow pit (Figure 5) lies east of the dam. There is evidence of digging and other disturbance throughout most of the site and several heaps of soil have been dumped near the dam and blue gum trees. Further disturbance is caused by a water pipeline which crosses the length of the site. The terrain, which slopes down towards the north and northeast, is covered by gravelly, partly ferruginised colluvium and fine, medium and coarse sandstone and quartz gravel in a silty sand matrix (Figures 8 and 10). The gravelly colluvium overlies Bokkeveld Group sandstones and mudrocks. Some of the sandstone crops out in the higher-lying south-eastern part of the site (Figures 6 and 7). The Shale Renosterveld vegetation (H. Stummer, pers.comm.) varies in density across the site, but archaeological visibility of material on the ground was generally good as the bushes (e.g. *Elytropappus* sp., *Eriocephalus* sp. and other Asteraceae) are mostly scattered. Grass cover and denser bushes occur in the central portion of the affected area and reduced visibility somewhat.

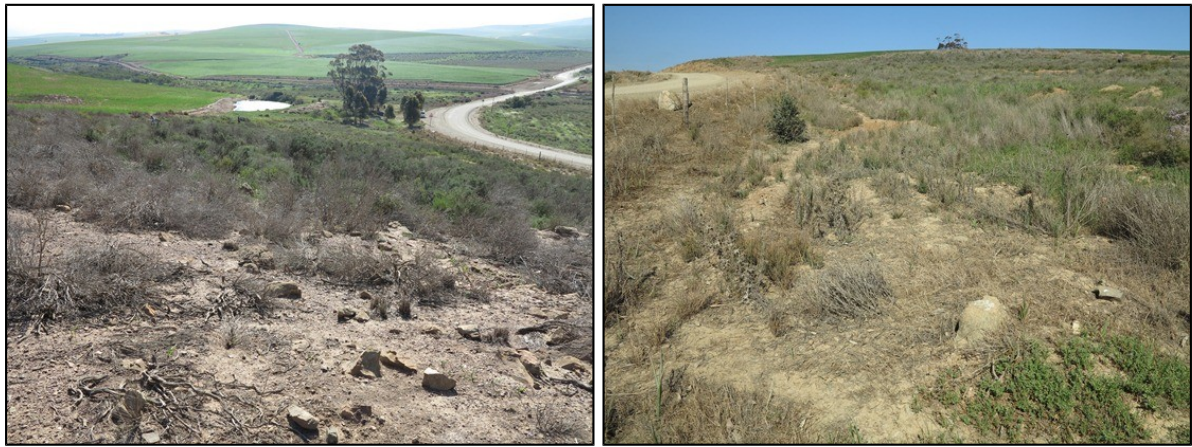
Figures 3 and 4: View over the affected area towards the north with the dam and blue gum trees indicating the northwestern boundary; view from the northern corner upslope towards the southeast.

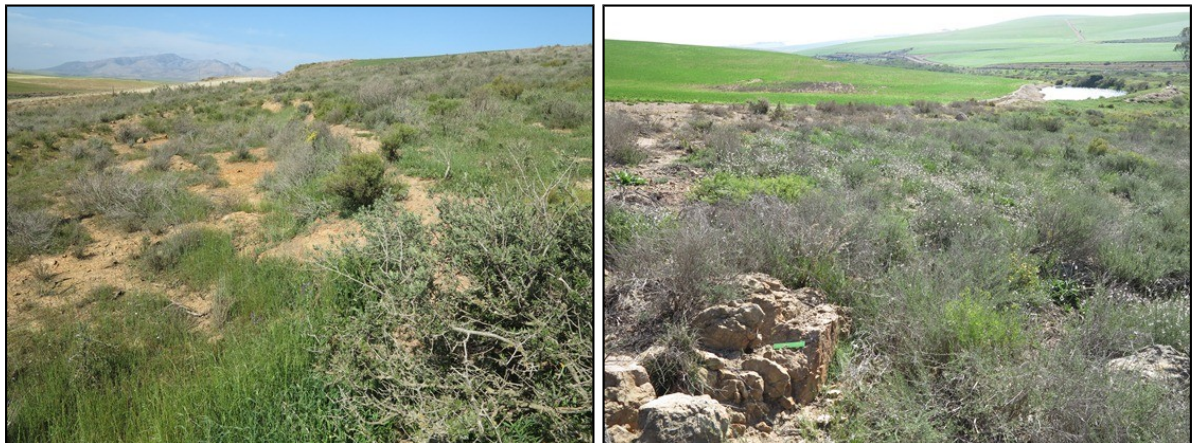
Figures 5 and 6: View across the existing small borrow pit towards the southeast; view towards the northwest with an outcrop of sandstone in the foreground. The vegetation is denser in the central part of the affected area. The ruler is about 15cm in length.

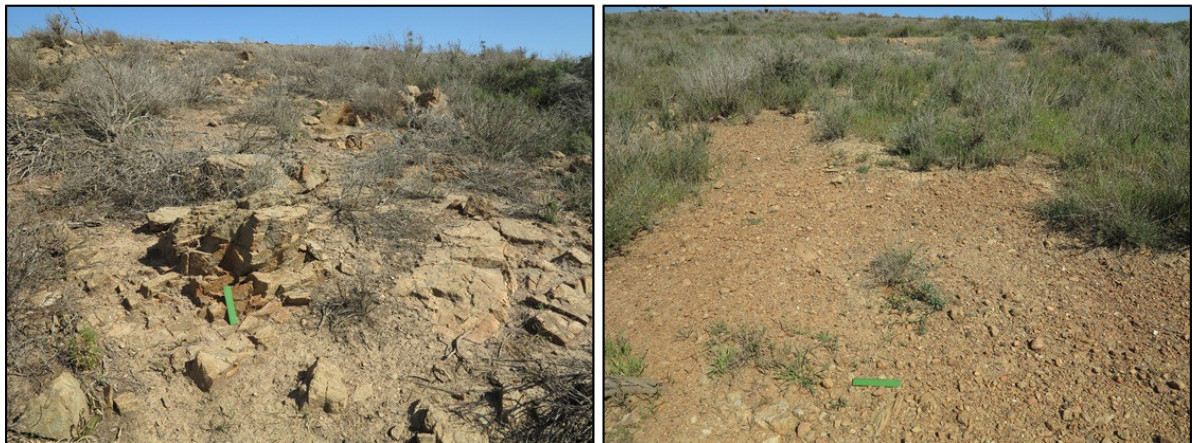
Figures 7 and 8: View towards the west of more outcrop of sandstone; detail of ferruginised gravel. The ruler is about 15cm in length.

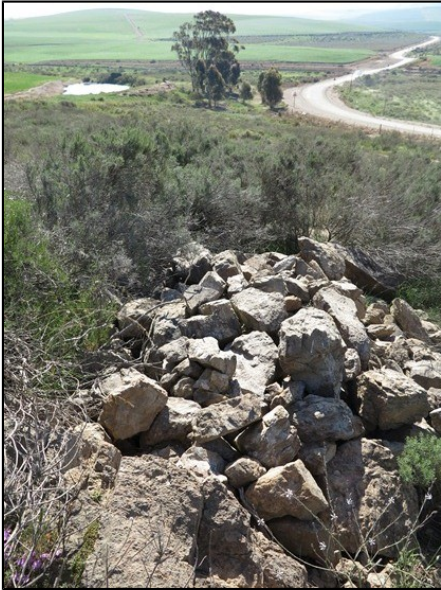
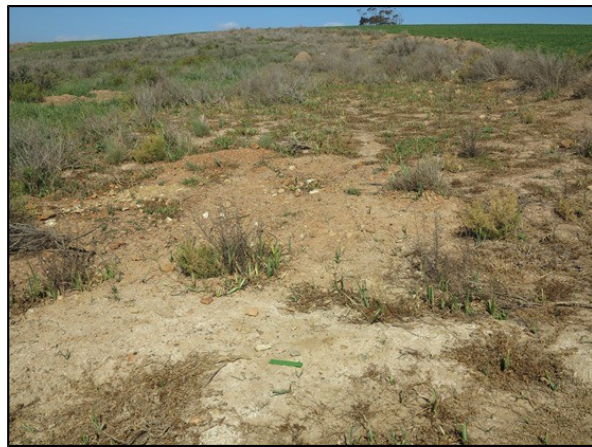
With the exception of a single quartzite flake of indeterminate age (Figure 11), no archaeological material was observed. The flake was found in a disturbed context at the bottom of the slope, close to the southern edge of the dam (Figure10). Outcrops of rock were examined for traces of quarrying but none were noted. A heap of sandstone blocks (Figure 9) was also inspected for flaked material but none was found.

Figures 9 and 10: View towards the north with heap of sandstone blocks in the foreground; view towards the southeast showing the context of the single quartzite flake found which lies next to the ruler (about 15cm in length).

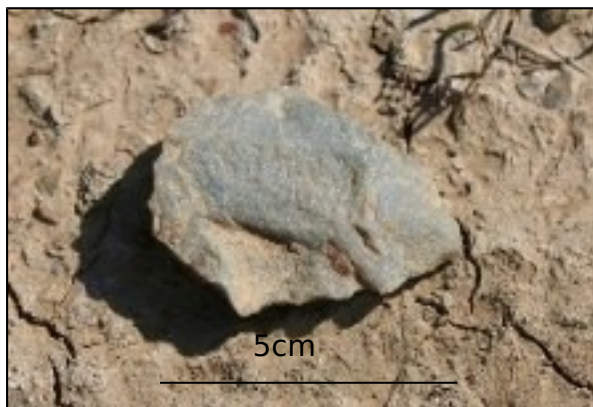
Figure 11: Quartzite flake observed (photo: H Stummer).

The presence of an isolated, single flake in a disturbed context indicates that the proposed extension site is of low archaeological heritage significance. No significant impact on such resources is expected if the proposed extension is developed. No further archaeological studies or mitigation are recommended.
