HERITAGE IMPACT ASSESSMENT

29 October 2012

DR 1303 Greyton

Overberg District Municipality, Western Cape

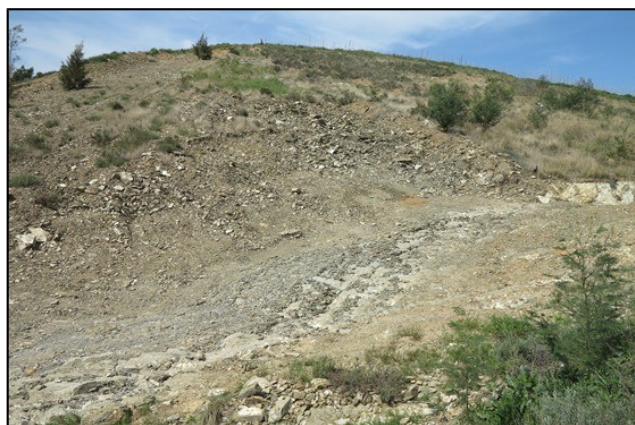
Figure 2: View towards the south of the existing pit in the eastern half of the affected area (Tusenius 2012: 7)

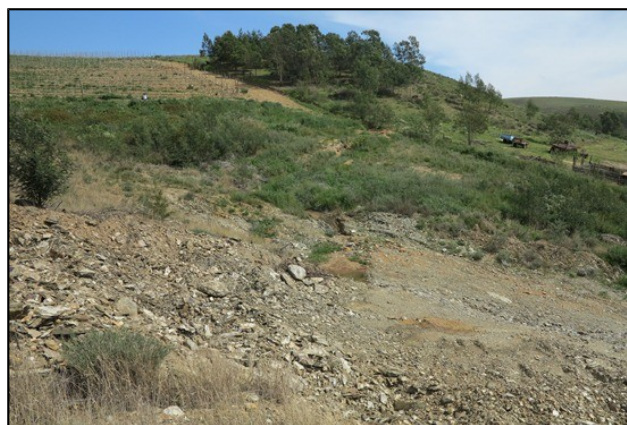
Figure 3: view towards the densely vegetated north-western portion of the site from the slope of the existing quarry (Tusenius 2012: 7)

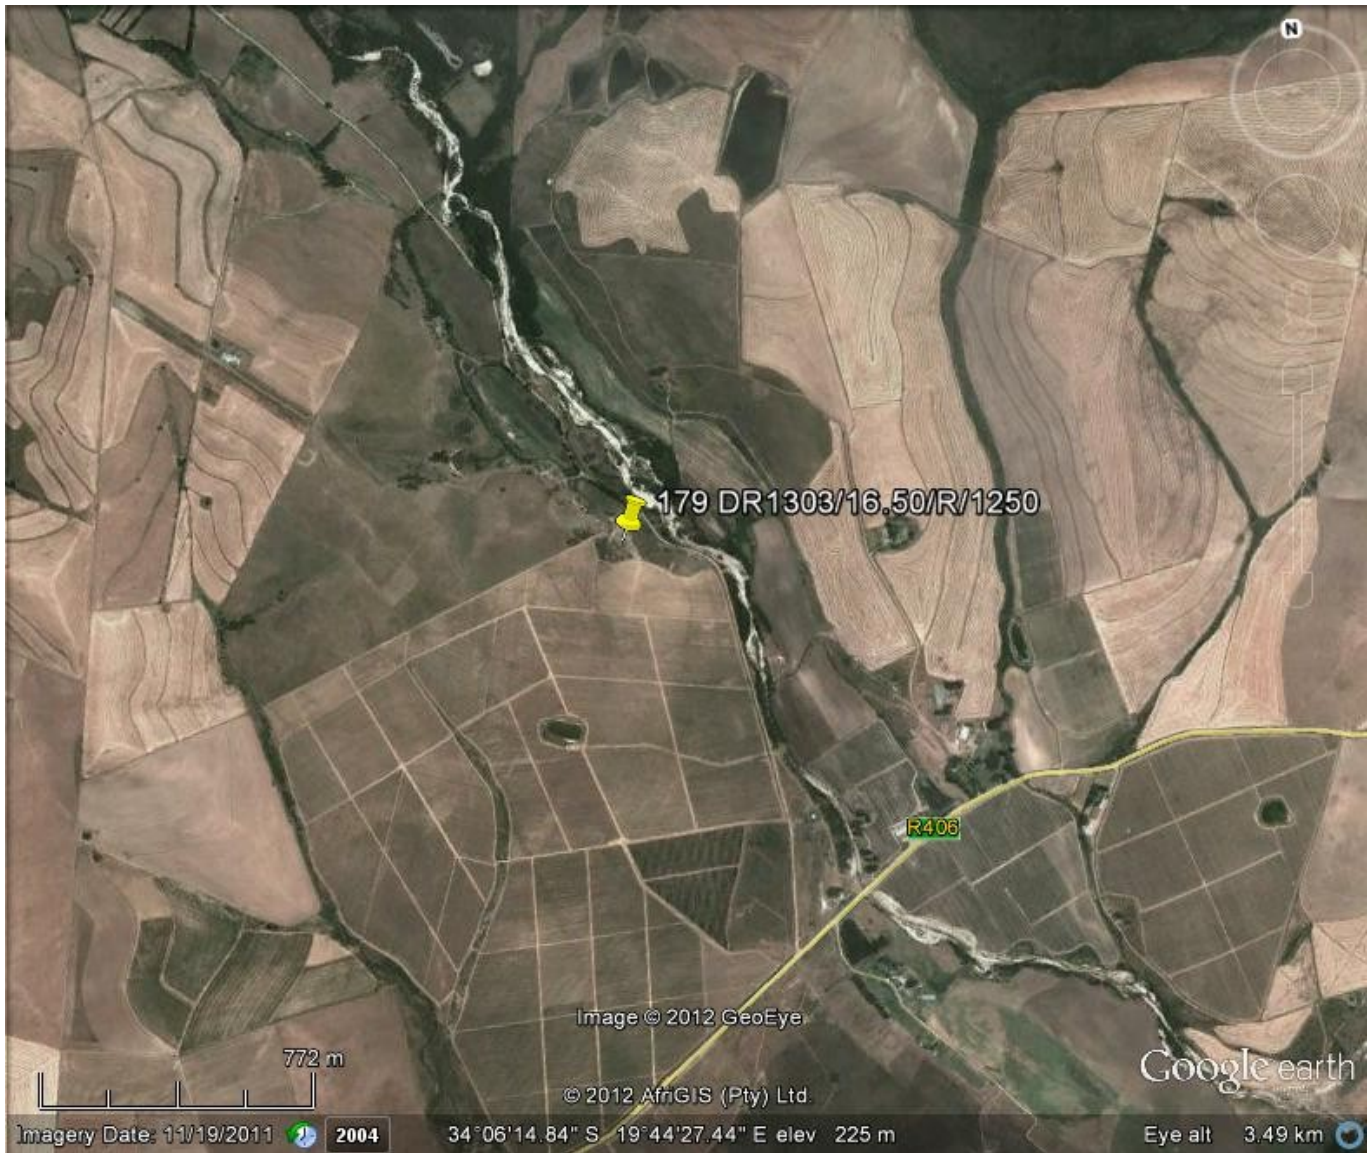
Figure 4: Aerial view of existing borrow pit locations (Google earth image, October 2012)

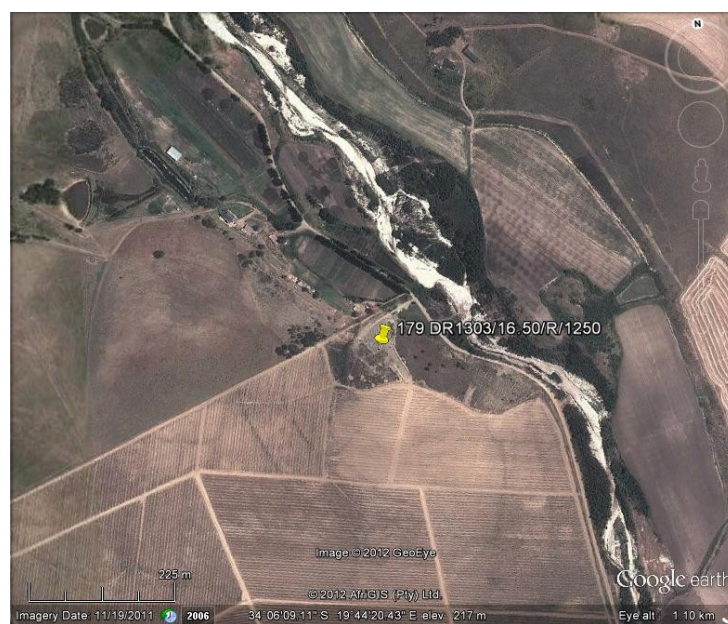
Figure 5: Aerial view of existing borrow pit and expropriation area (Google earth image, October 2012)

Summary of borrow pit	
	at km 16.50
Expropriation area	7 740 m ²
Maximum depth	2 m
Material description	Bokkeveld shale
Proposed usage after rehabilitation	Re-vegetation
Volume of material to be sourced	9 288 m ³
