CONSTRUCTION OF A WATER SUPPLY PIPELINE AND SCOUR PIPELINE, LENASIA SOUTH, GAUTENG PROVINCE

Heritage Impact Assessment

December 2014

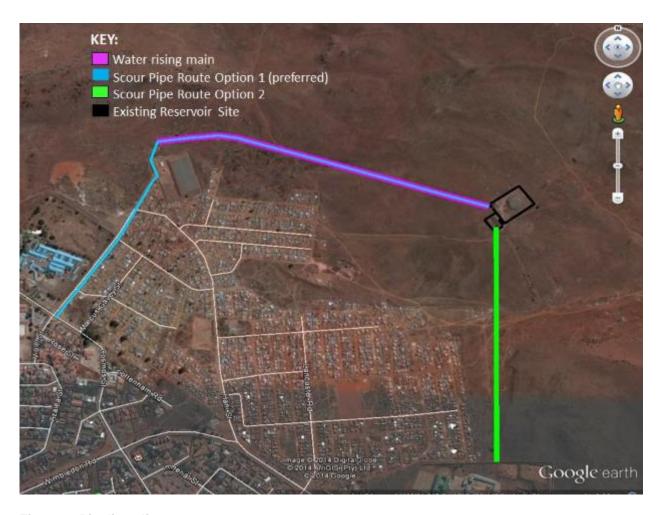
Figure 2: Pipeline alignments

It is proposed that the water supply pipeline (depicted in pink in above) will be situated between the Lenasia High Level reservoir and Hospital Hill Reservoir. The alignment of the pipeline is depicted below in **Figure 2**. The water supply pipeline is a ND600 pipeline that is approximately 1045 m in length.

There are two routes proposed for the scour pipeline. The preferred (or proposed) route, referred to as Route 1, is approximately 1725 m in length and is indicated in blue in **Figure 2**. It is proposed that this pipeline will be laid on top of the new water supply pipeline between the scour pond at the existing reservoir and Hospital Hill reservoir.

The alternative route, Route 2, is shorter that Route 1 in length at 784 m and is indicated as the green line in **Figure 2**. This alternative runs directly south from the reservoir to a residential area where it will discharge scour water into the stormwater system.

In terms of the route alternatives for the scour pipeline, it is recommended that Route 1 is utilised. Route 1 will be laid for some distance on top of the new water supply pipeline between the existing Lenasia reservoir and the Hospital Hill reservoir. The water supply pipeline has to connect the two reservoirs hence there are no alternative alignments for this pipeline hence it makes sense that potential impact of this proposed linear development is kept to one area or corridor and not two which would be the case if Route 2 is used.

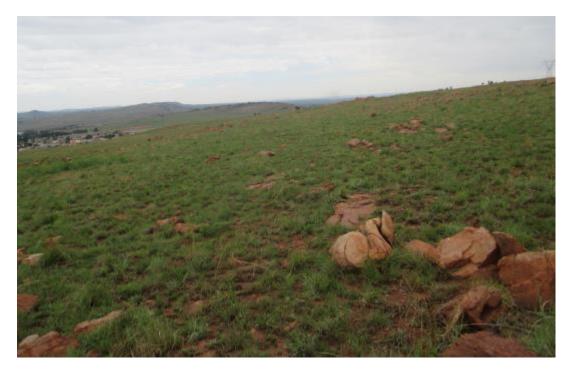
Figure 3: Terrain along alignment of water supply pipeline and scour pipeline Route 1

Formal and informal residential areas are found to the south west, south and east of project area and the topography of all the pipeline routes is hilly with a number of rocky outcrops.

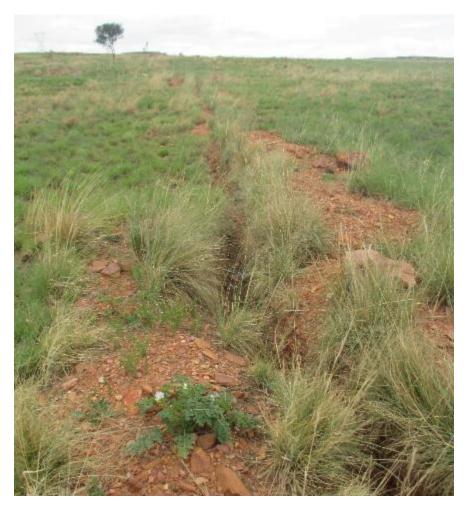
Figure 4: Existing trench

A trench has been dug near the proposed alignment of the water supply pipeline (see **Figure 4**). The trench appears to have been dug a few years ago and a short concrete pipeline has been left in the veld close to the trench. A number of concrete squares indicating the possible route of a cable were also found (see **Figure 6**).

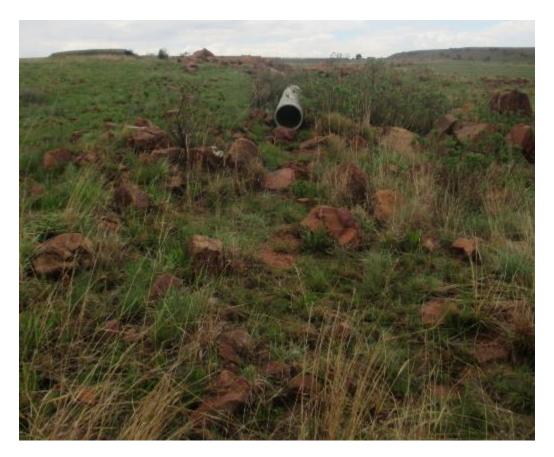
Figure 5: Abandoned length of pipeline

A trench has been dug near the proposed route or alignment of the water supply pipeline and the preferred route for the scour pipeline that runs parallel to the water pipeline. The trench appears to have been dug a few years ago and a short concrete pipeline has been left in the veld close to the trench. The topography of all the pipeline routes is hilly with a number of rocky outcrops.

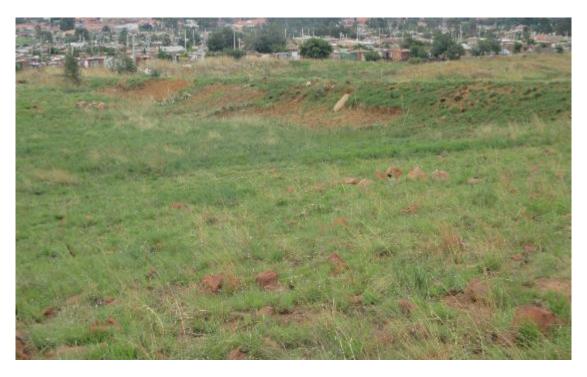
Figure 7: Old dam wall

Closer to Hospital Hill reservoir and next to the route of the water supply pipeline, an old dam wall was discovered (see **Figure 7**). There is also evidence of dumping of building rubble closer to the Hospital Hill reservoir that is fairly old as grass has grown over the mounds of rubble (**Figure 8**).

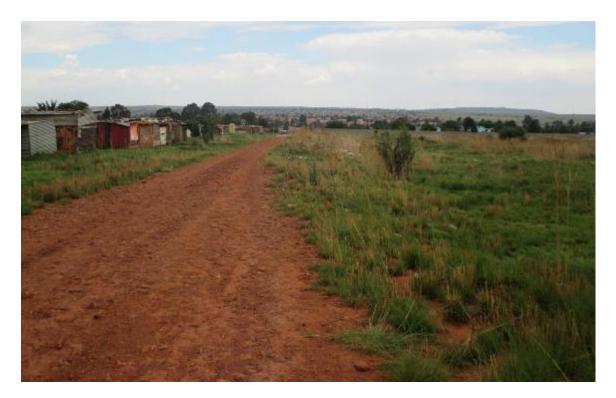
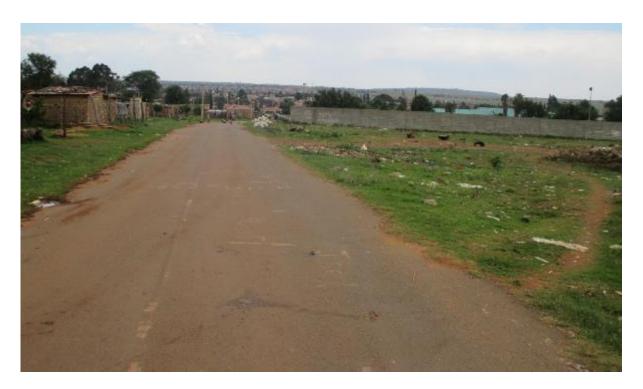
Figure 9: Scour pipeline Route 1 after Hospital Hill reservoir

Once the water supply terminates at the Hospital Hill Reservoir, Route 1 will skirt the reservoir terrain and then run alongside an existing road to Cosmos street where it will discharge into the

stormwater system. The road is bordered by an informal settlement as well as open areas that are disturbed (Figures 9 and 10).

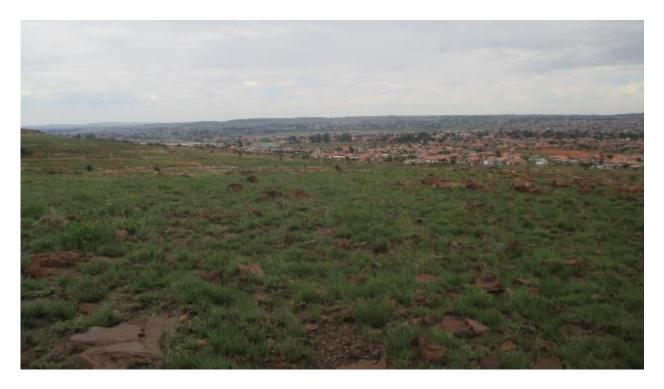
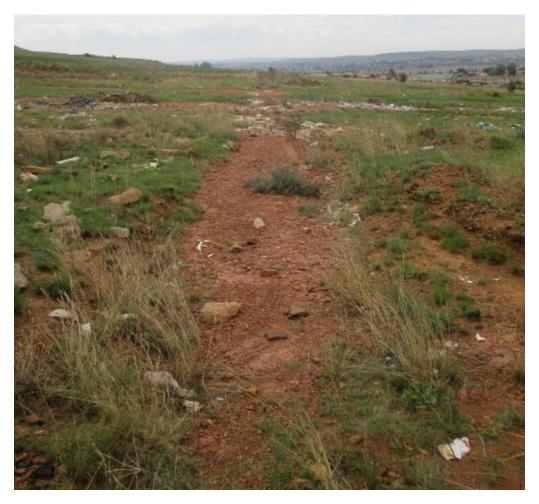
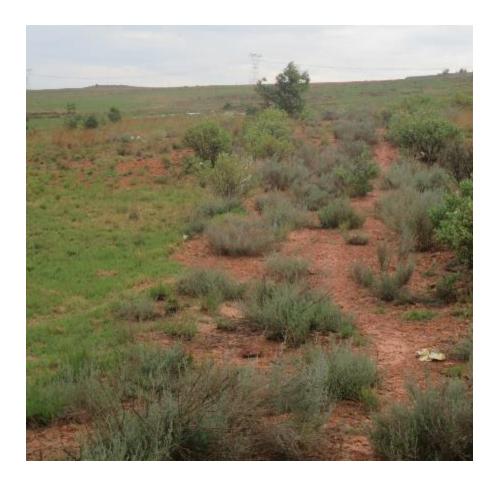
Figure 11: View along alignment of scour pipeline Route 2 looking south

The alignment of scour pipeline Route 2 runs for some distance along an existing vehicle track and through an area that is used to dump rubbish (**Figures 11 - 13**).

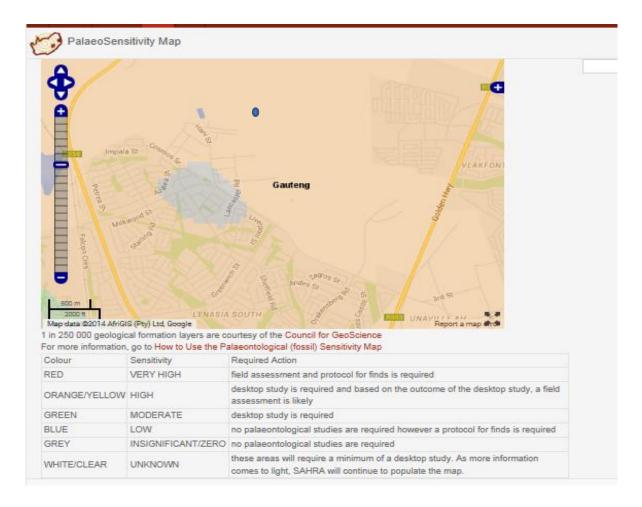
Figure 14: Fossil sensitivity of project area

The South African Heritage Resources Agency's (SAHRA) Fossil Sensitivity Map indicates that the project area is situated in an area of <u>high palaeontological or fossil sensitivity</u>. See **Figure 14** below. A palaeontological desk top study was undertaken and established that the dominant rocks in the region were those of the Chuniespoort Group (the Malmani Subgroup) and the Pretoria Group (Timeball Hill, Rooihoogte and Hekpoort Formations) and that these rocks are too old to contain fossils and are also not of the correct lithology.

The report concluded that since the rocks are too old (Archaean in age) to contain fossils it is extremely unlikely that any fossils will be found along the routes for the proposed water supply pipeline and scour pipeline.

As far as the palaeontology is concerned, the specialist recommended that the proposed development can go ahead due to the low probability of fossils been found in the area. It is recommended however that if, in the extremely unlikely chance of fossils being found during construction, a palaeontologist must be called to the site in order to assess the fossils and rescue them if necessary (with a SAHRA permit). The fossils must then be housed in a suitable, recognized institute.
