**PROPOSED CONSTRUCTION OF MTWALUME DAM,
HARRY GWALA DISTRICT MUNICIPALITY, KWAZULU-
NATAL**

Phase 1 Heritage Impact Assessment

June 2015

For: Nemaï Consulting

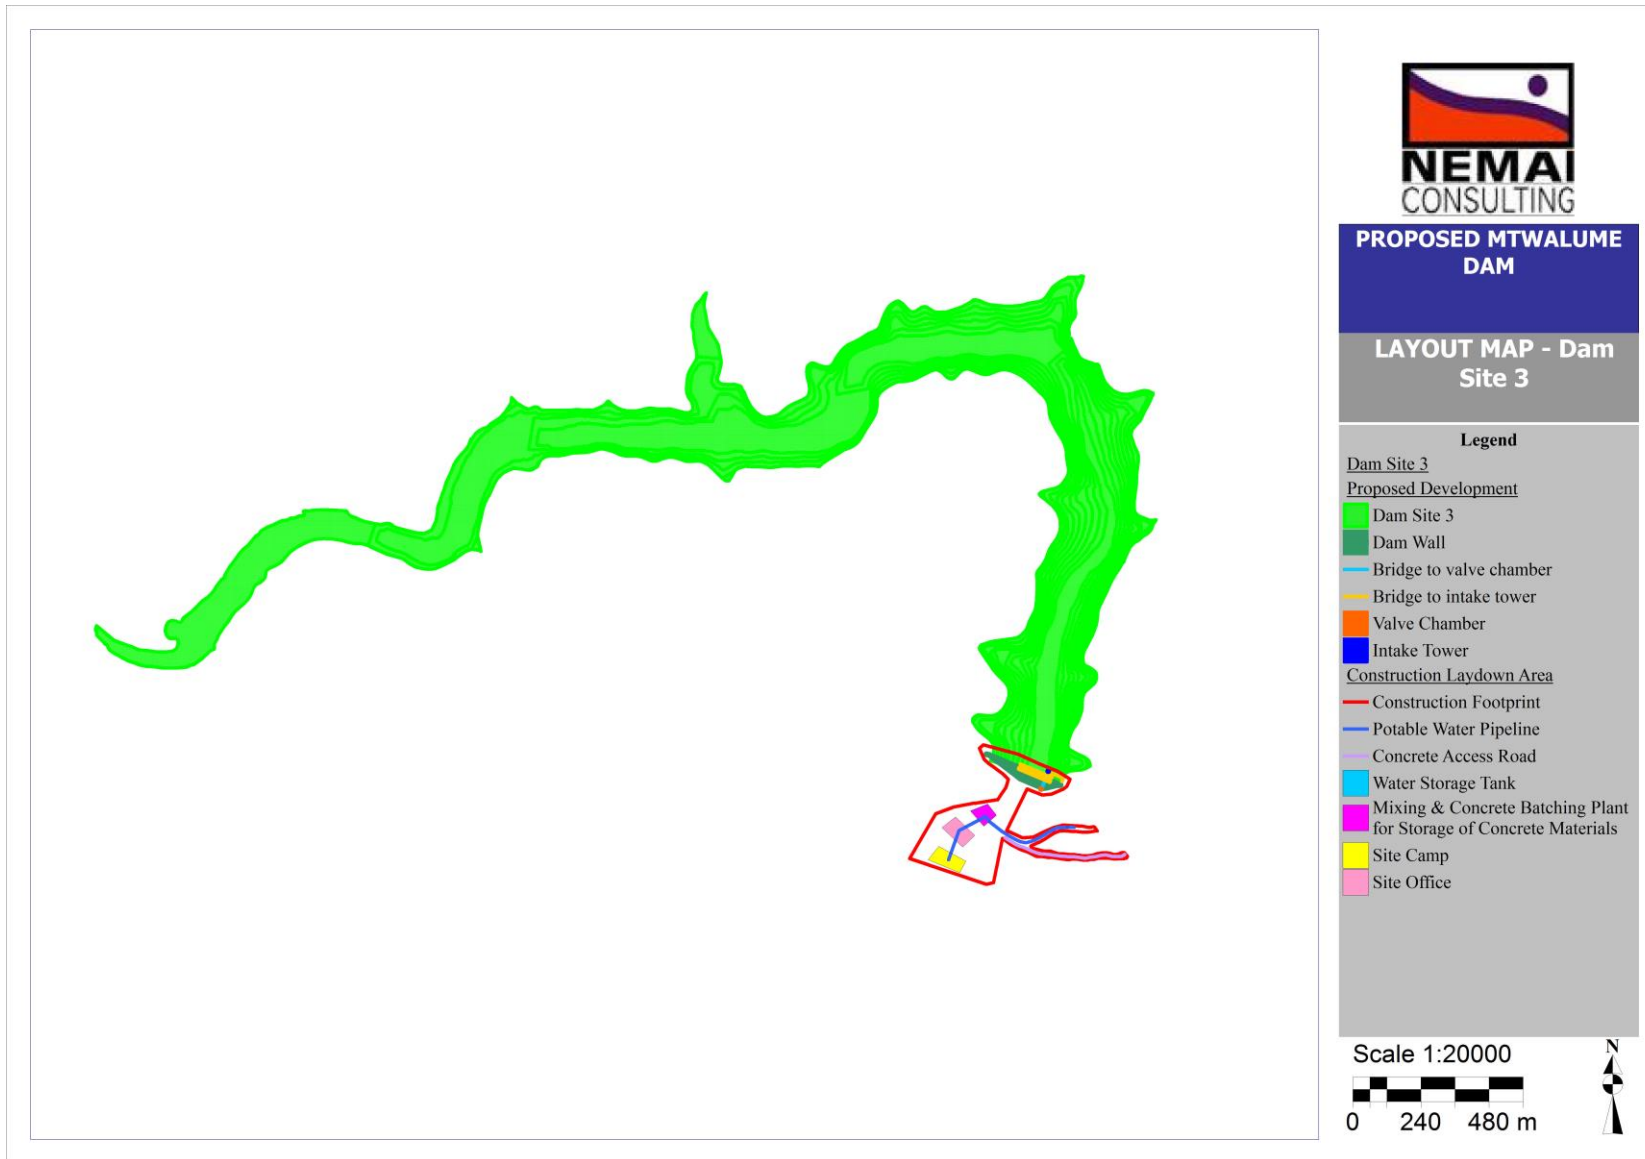
Figure 2: Dam Site 3 and construction laydown area

Sites that were found to be environmentally sensitive or contained poor founding conditions were discarded. Two sites were taken forward for the environmental authorisation process, namely Dam Site 3 and Dam Site 5. Their locations can be seen in Figures 2 and 3 provided below together with the components of the construction laydown area.

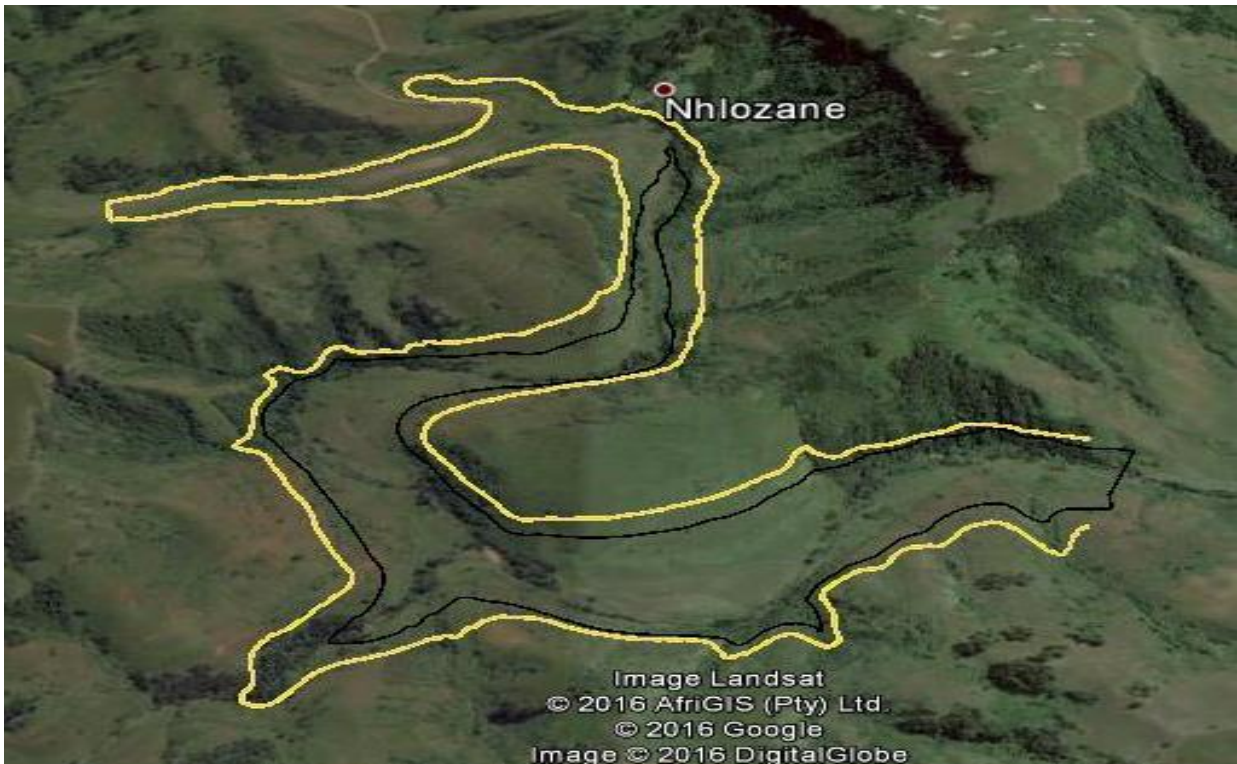
Figure 4: Google Earth image showing original and expanded inundation area of Dam Site 5

It should be noted that Figure 4 shows the original inundation area (outlined in black) and the proposed inundation area (outlined in yellow) of Dam Site 5. The new inundation area is bigger or larger than the original area of inundation.

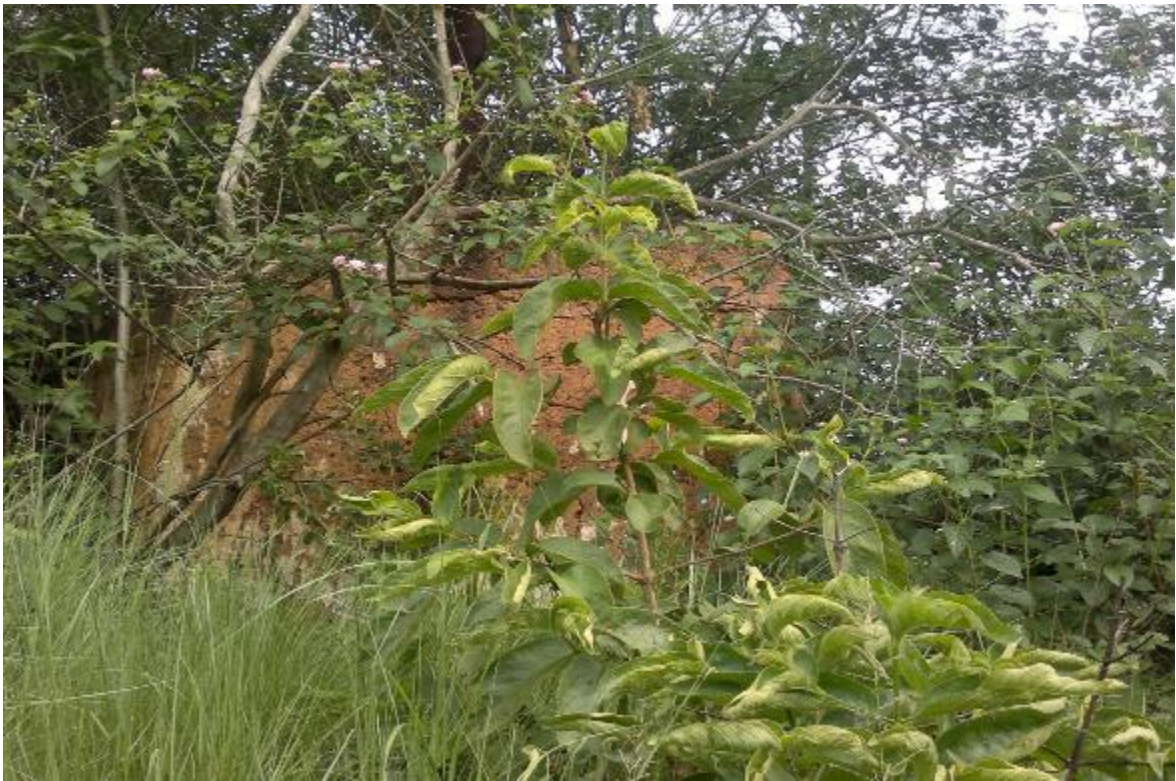
Figure 7: Abandoned dwelling above construction laydown area

There are a number of abandoned dwellings close to and possibly in the area where the construction laydown area is to be located for Dam Site 3. The mud walls of one of the dwellings is still visible. This dwelling is situated at 30°19'33.4"S; 30°19'25.6"E. See Figure 7 below. No visible graves were noted in the area of the dwelling. Although the remains are not regarded as significant, the site could be impacted by the proposed potable water pipeline or by the concrete access road, therefore, the area around the site needs to be checked for possible graves.

The remains of abandoned dwellings were found at 30°19'37.5"S; 30°19'24.4"E. The stone and mud walls of at least two structures remain and the area was thickly overgrown with vegetation. See Figures 8 and 9 below. No visible graves were found. This site could be impacted by the construction laydown area and the area around the remains must be closely investigated for the presence of graves.

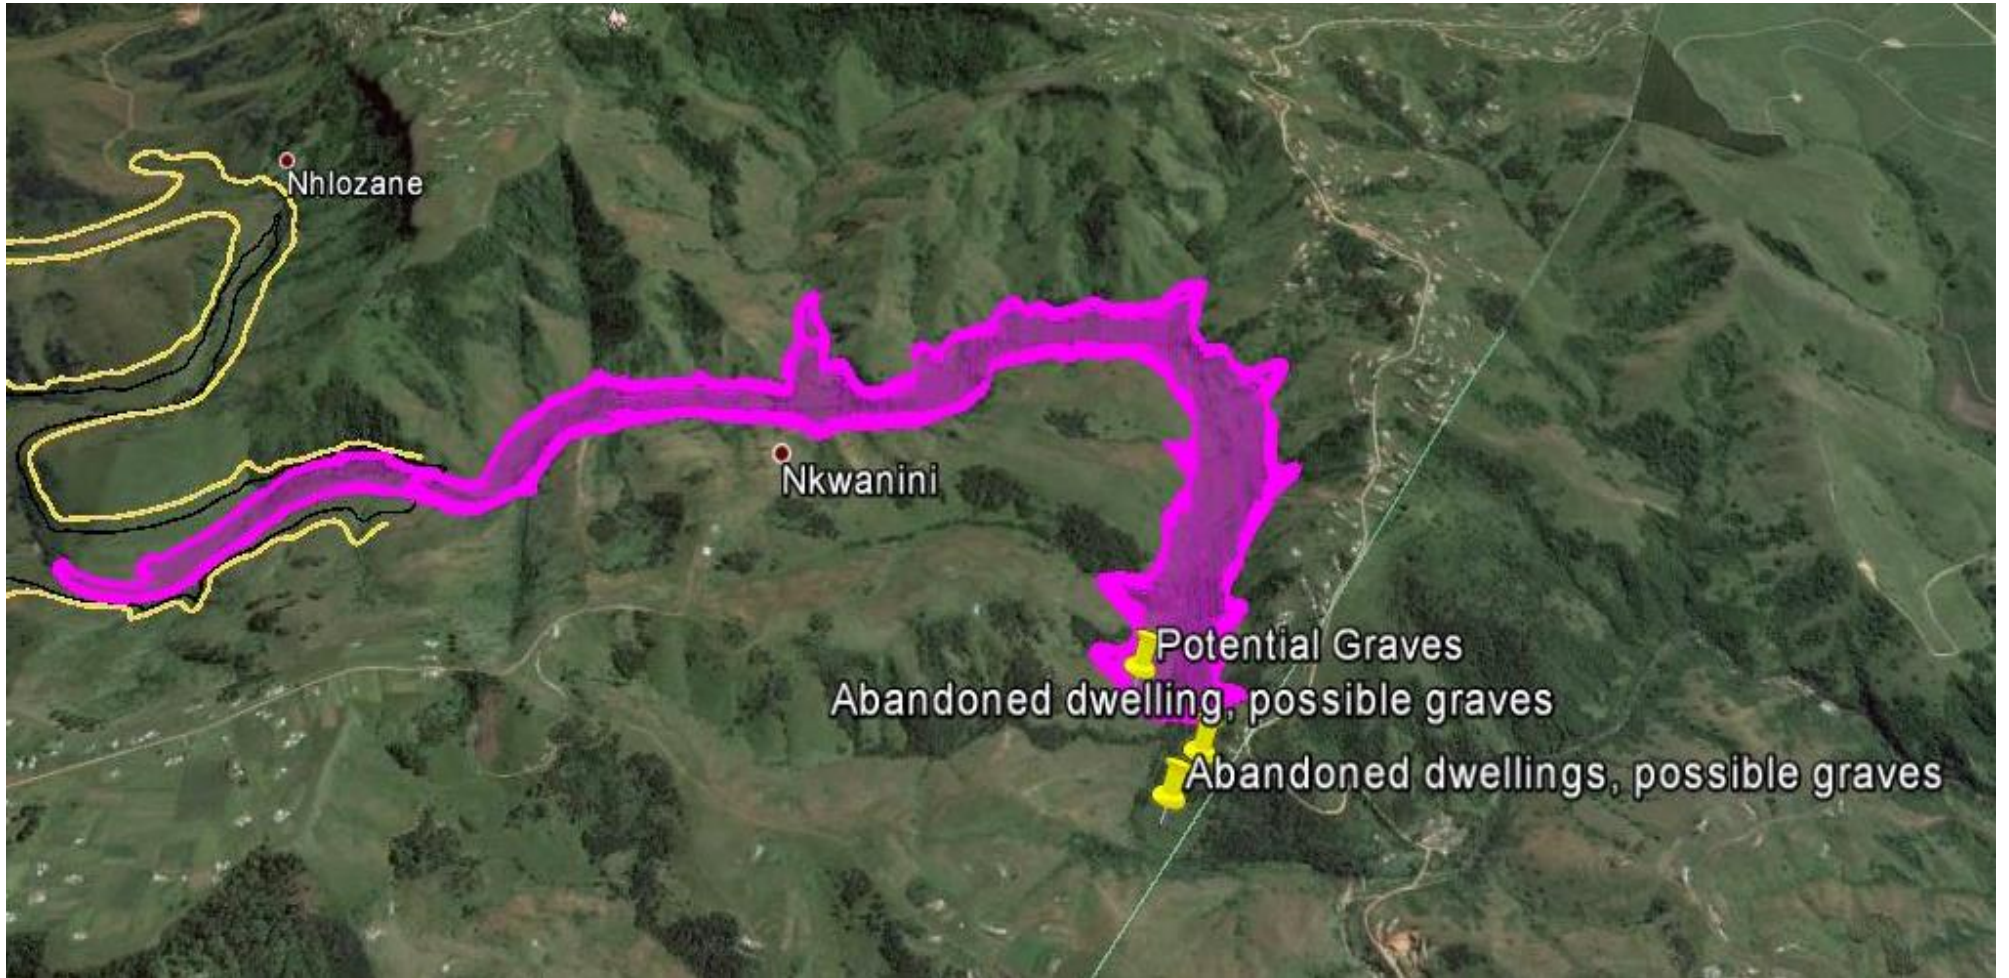
Figure 10: Heritage sites: Dam site 3

A Google Earth image below (Figure 10) indicates the location of potential heritage sites within Dam site 3.

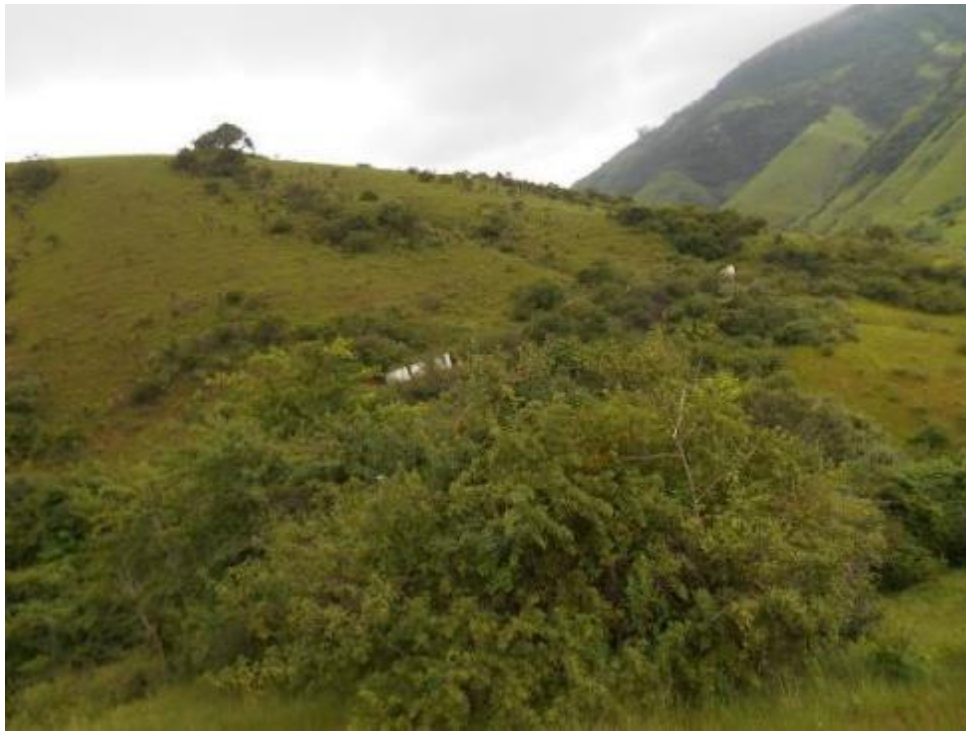
Figure 11: Abandoned homestead

A number of abandoned structures were noted above the area where the dam wall is proposed. No graves could be seen but the vegetation was dense making visibility poor. It appears as if the structures would fall outside the area of inundation of the dam.

However, the graves in the immediate vicinity of the structures could be at risk because of construction activities related to the building of the dam wall. Construction activities, including building of access roads and pipelines, should be kept well away from these abandoned structures. Alternatively a buffer of 10m should be imposed around the structures to avoid damage to potential grave sites.

There is the possibility of the existence of graves situated close to the abandoned homesteads found in the area above the site of the proposed dam wall. Damage to or destruction of these graves could occur during the construction of the wall through the construction of access roads and other activities taking place in the area. It is therefore recommended that construction activities should be kept well away from these abandoned structures. Alternatively a highly visible buffer of 10m should be placed around the structures to avoid to these sites.

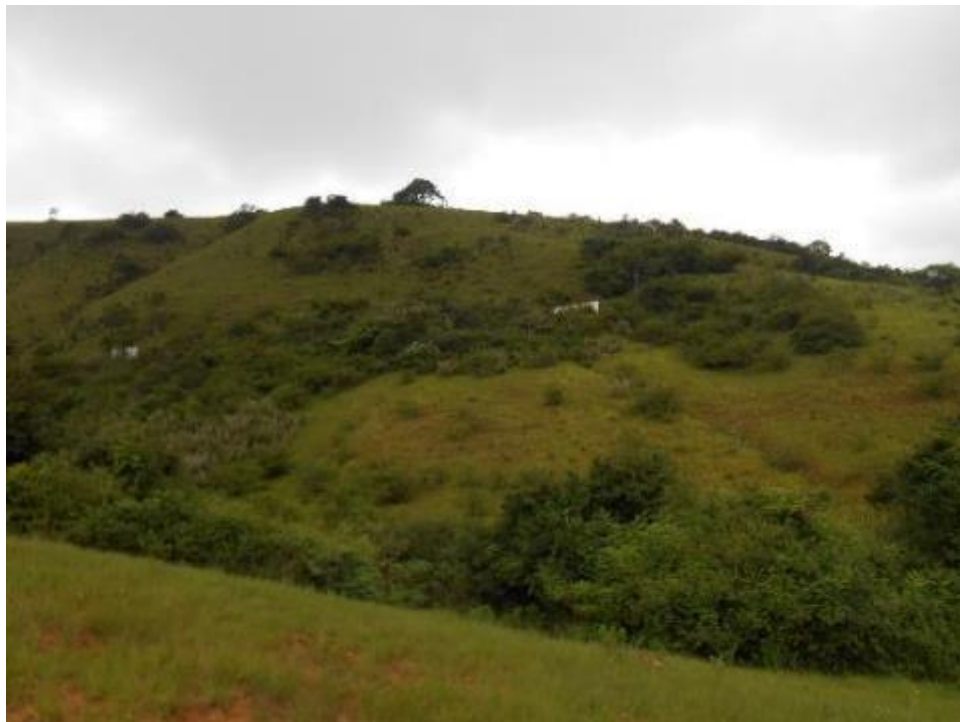
Figure 12: Abandoned homesteads

The valley that Dam Site 5 will inundate contains a fairly large amount of dwellings that appear to be abandoned. Most of these dwellings will be inundated by the new area of inundation of this dam. If Dam Site 5 is chosen for the project, a thorough examination of these dwellings must take place to locate grave sites (if any) and relocate them after consultation with family and/or community.

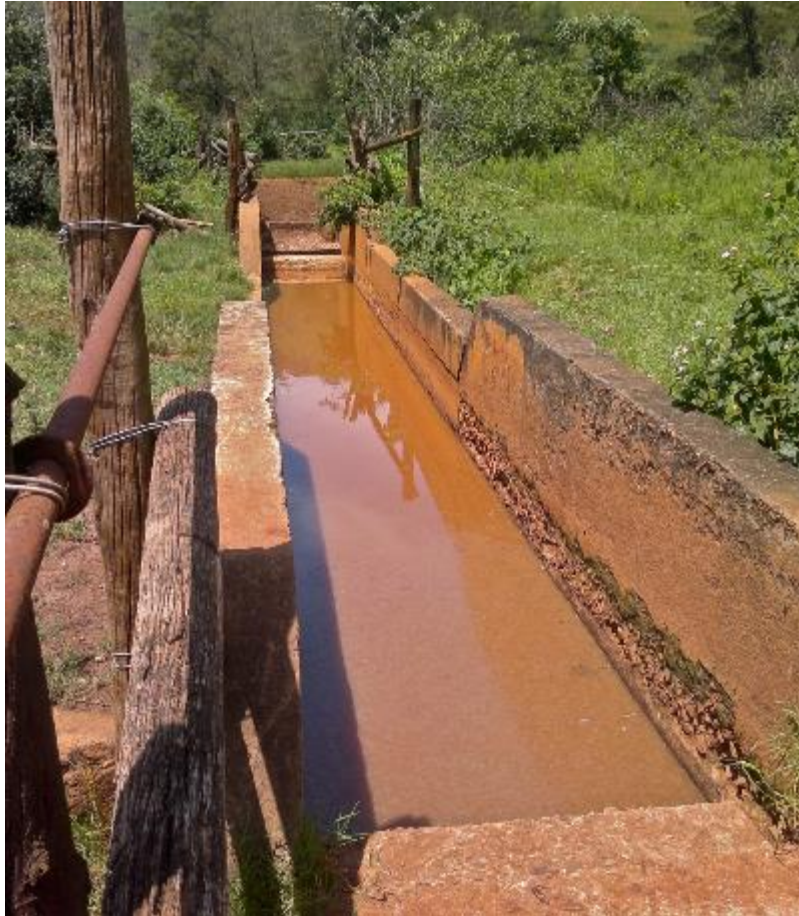
Figure 13: Cattle dip

The valley is used mainly for grazing of cattle and large numbers of cattle were noted during the site inspection. A cattle dip that appears to still be used is located at 30°19'06.5"S; 30°17'14.3"E. The age of the structure could not be determined.

The cattle dip found in the valley could be older than 60 years and appears to be utilised by the local land owners. It is therefore of importance to the surrounding community and if this site is selected, it is recommended that the Applicant provide another cattle dip in consultation with the landowners.

If Dam Site 5 is chosen as the preferred dam site, a complete photographic record of the cattle must take place prior to inundation of the valley. A permit must be obtained from Amafa in

accordance with Regulation 2 of the 2012 Heritage Regulations prior to inundation. The specialist is uncertain of the age of the structure hence it is recommended that application is made to Amafa to ensure that all legislative requirements are met. Regulation 2 relates to the destruction of structures that may be reasonably expected to be older than 60 years.

The cattle dip will also be inundated by the dam. It is regarded to have medium to high significance as it is still in use. It is therefore recommended that if Dam Site 5 is chosen, the Applicant consider providing a cattle dip in an area outside the inundation area of the dam in consultation with affected farmers. If the cattle dip is to be inundated, then a complete photographic record must be taken of the structure. Application for its destruction must be made to Amafa.

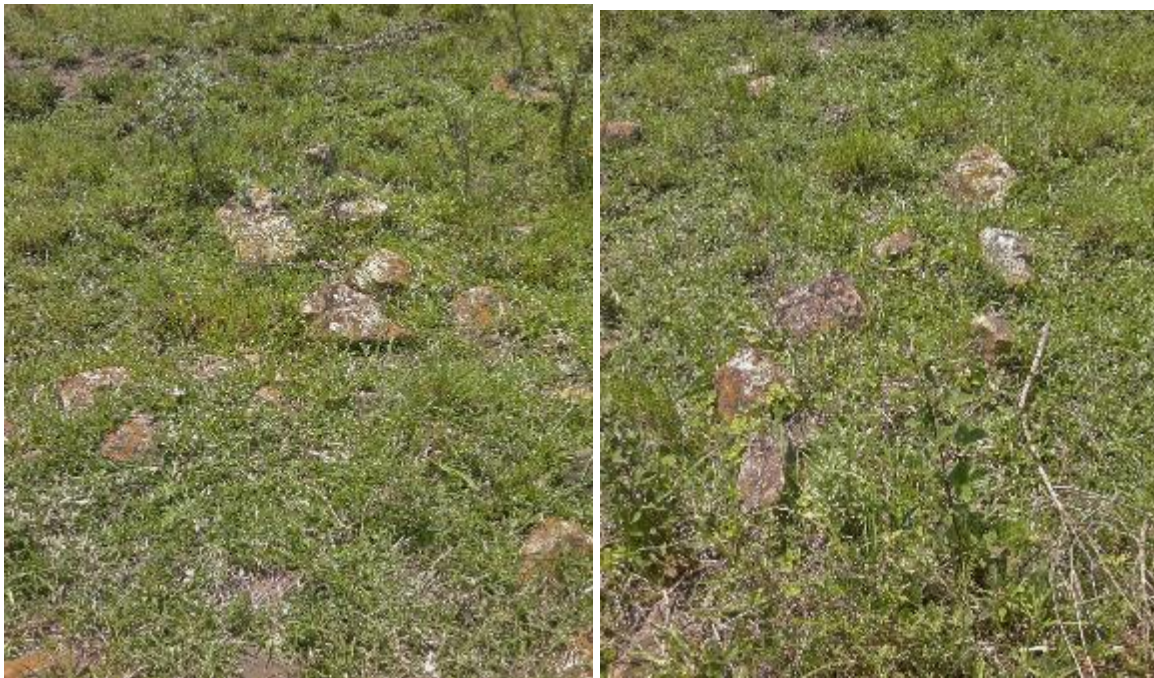
Figure 14: Graves

As many as 5 grave sites were found at 30°18'33.6"S; 30°17'29.5"E in the valley that will be inundated by the dam. There appears to have been dwellings in the immediate area of the graves but the only evidence of this is a thickly vegetated area and the graves. The graves are indicated as slightly raised mounds of stone and are unmarked. The graves appear to be older than 60 years hence they are protected by section 36 (3) (a) (b) of the NHRA that states that:

The inundation of the dam will cover these graves therefore if Dam Site 5 is chosen, the relocation of these graves will have to take place in consultation with the affected family or community and once the required permission has been received from Amafa.

The graves found in the area of inundation of Dam Site 5 will have to be relocated if this dam is chosen. Relocation must follow the requirements as set in the KZN Heritage Regulations.
