HERITAGE IMPACT ASSESSMENT

Divisional Road 1660 South Cape
Uniondale - Eden District Municipality, Western Cape

Aurecon South Africa (Pty) Ltd appointed *vidamemoria* to conduct a heritage impact assessment for a expansion of an existing borrow pit located along Divisional Road 1660 15km southwest of Uniondale in the Eden District Municipality, Western Cape. *vidamemoria* appointed Dr John Almond (Natura Viva CC) to conduct necessary palaeontological specialist study (dated March 2012). Heritage impact assessment is submitted for comment in terms of Section 38(8) of the NHRAct as a component of an Environmental Management Programme (EMProg in terms of Mineral and Petroleum Resources Development Act 49 of 2008) to be submitted to the Department of Mineral Resources (DMR).

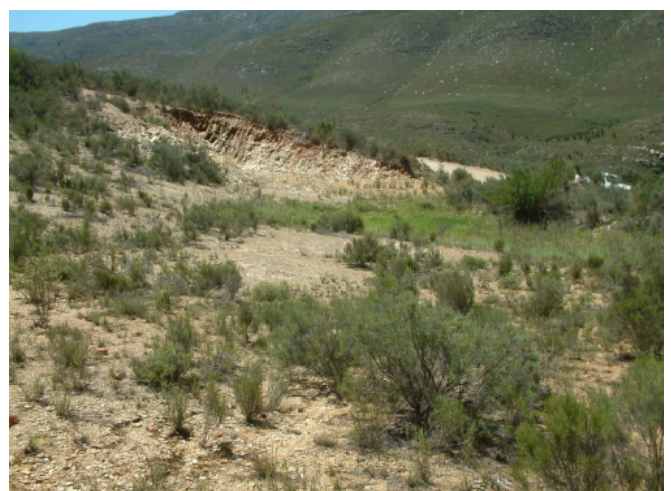
Surrounding land use includes agriculture. Site is located within the Klein Langkloofberge with a gentle gradient to the south. The land on which the borrow pit is located is not being actively used and there are no buildings on site. Geology is dominated by shale of the Gydo Formation (Bokkeveld Group, Cape Supergroup) deemed suitable as gravel wearing course (Galliers Jan, 2011).

Figure 2: View towards existing borrow pit

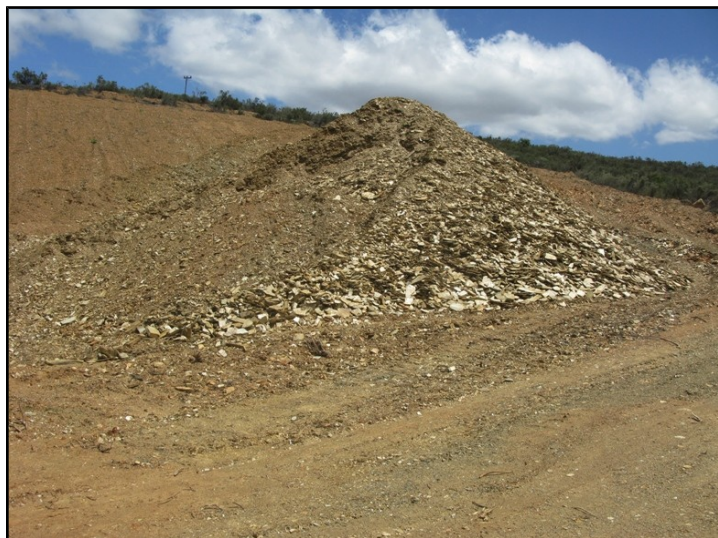
Figure 4: Heap of excavated Gydo Formation mudrocks in existing borrow pit (Almond, March 2012)

Dr John Almond conducted a palaeontological field assessment and provided a report outlining geological context, palaeontological heritage and palaeontological sensitivity. Refer to Annexure D report dated March 2012. Site investigation revealed that Bokkeveld mudrocks exposed are highly cleaved and deeply weathered. It is likely that most or all the fossils originally present within these rocks have been completely destroyed by cleavage and weathering. Those that have survived will be highly distorted and poorly preserved, with high levels of disruptive secondary mineralisation. Palaeontological sensitivity is correspondingly very low.

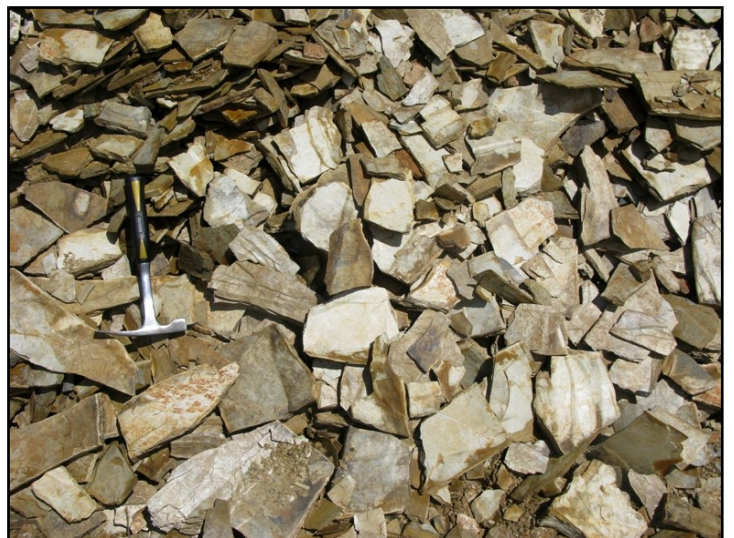
Figure 5: Close-up of platy (flat) cleavage blocks of weathered Bokkeveld mudrocks in borrow pit (Almond, March 2012)

A previous desktop assessment site assessed palaeontological heritage sensitivity as high due to presence of potentially fossiliferous mudrocks of the Lower Bokkeveld Group (Almond, 2012: 1). The site however is excavated into mudrocks of the lower Gydo Formation that elsewhere is well known for its rich fossil heritage especially shelly invertebrates from the Devonian Period. The Bokkeveld mudrocks have been found to be highly cleaved and palaeontological sensitivity is rated as very low (Almond, 2012: 6).

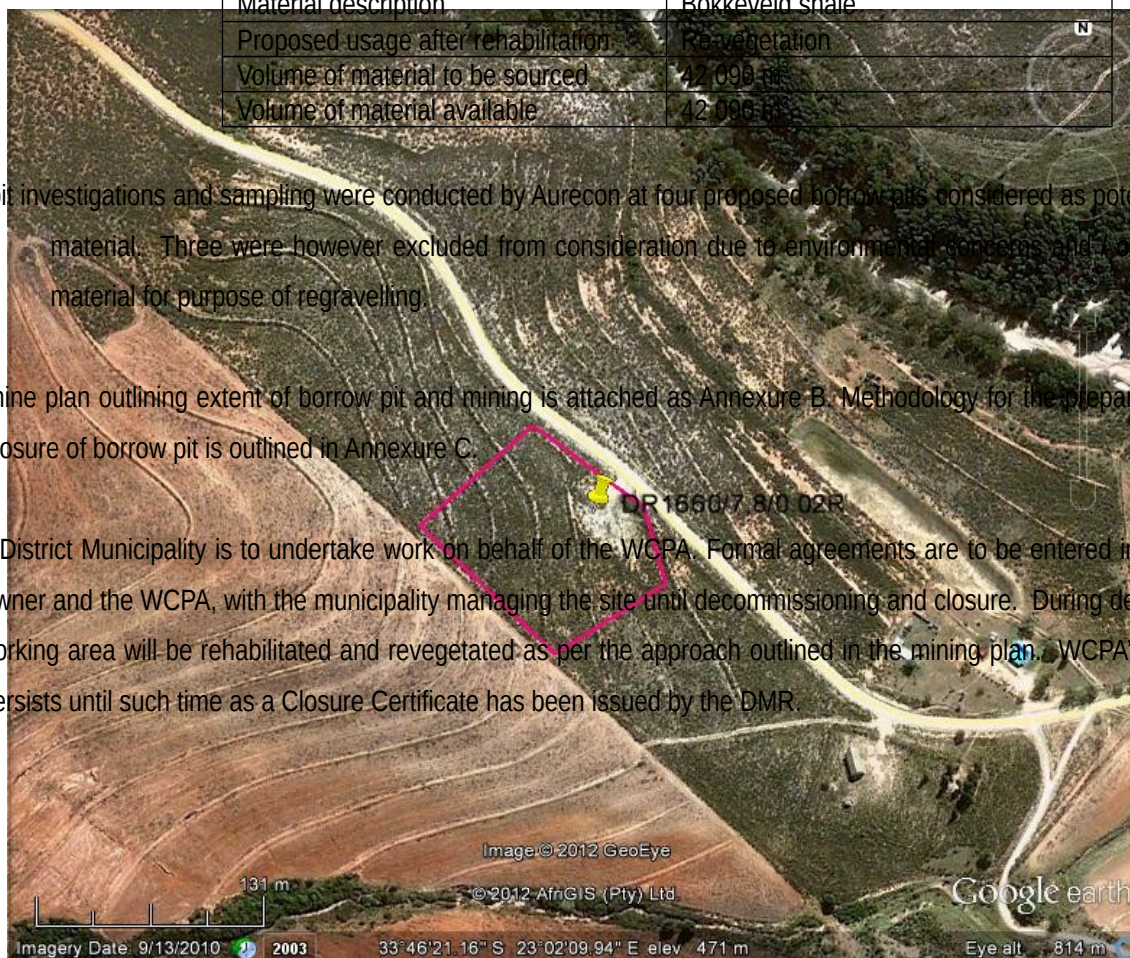
Summary of borrow pit	
Borrow pit area	4 700 m ²
Expropriation area	13 610 m ²
Maximum depth	14m
Material description	Bokkeveld shale
Proposed usage after rehabilitation	Re-vegetation
Volume of material to be sourced	42 090 m ³
Volume of material available	42 090 m ³

Figure 6: View of existing borrow pit and expropriation area

Site rehabilitation: It is expected that there should be an acceptable seed bank in the topsoil and this would be kept aside for rehabilitation. During rehabilitation, the topography would be finished off so that the sides of the borrow area are no steeper than 1:5. The slope changes would be finished off so that flowing curves that blend with the surrounding landscape are formed in preference to sharp angles. Topsoil and vegetation stripped during site clearance would be spread evenly across the borrow pit area. The area excavated as part of previous borrow pit activities would be ripped and also covered with a layer of topsoil.
