**HERITAGE IMPACT ASSESSMENT:  
PROPOSED LOXTON WIND ENERGY FACILITY 2,  
CARNARVON AND VICTORIA WEST MAGISTERIAL  
DISTRICTS, NORTHERN CAPE**

Required under Section 38(8) of the National Heritage Resources Act (No. 25 of 1999)

SAHRA Case ID: 20118

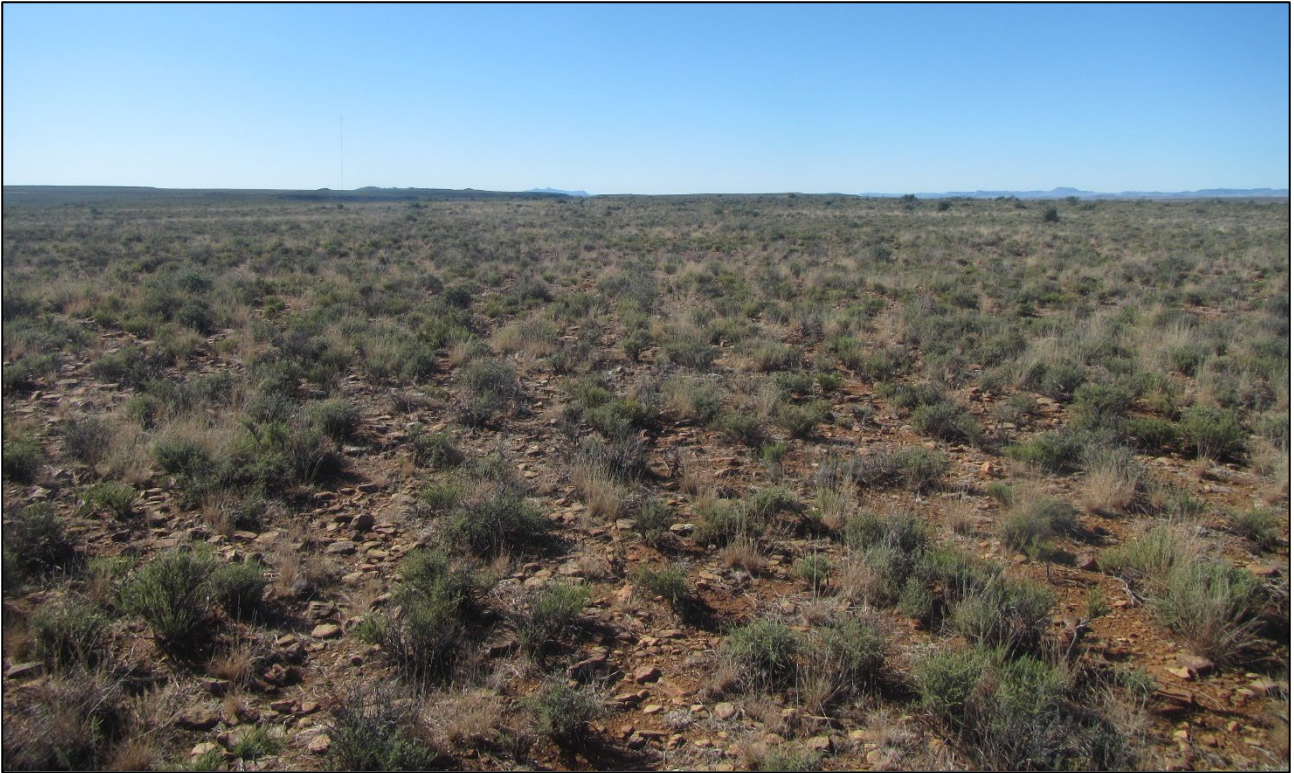
**Figure 9:** Looking towards the east along a turbine row in the central part of the WEF site and showing a gravel substrate.

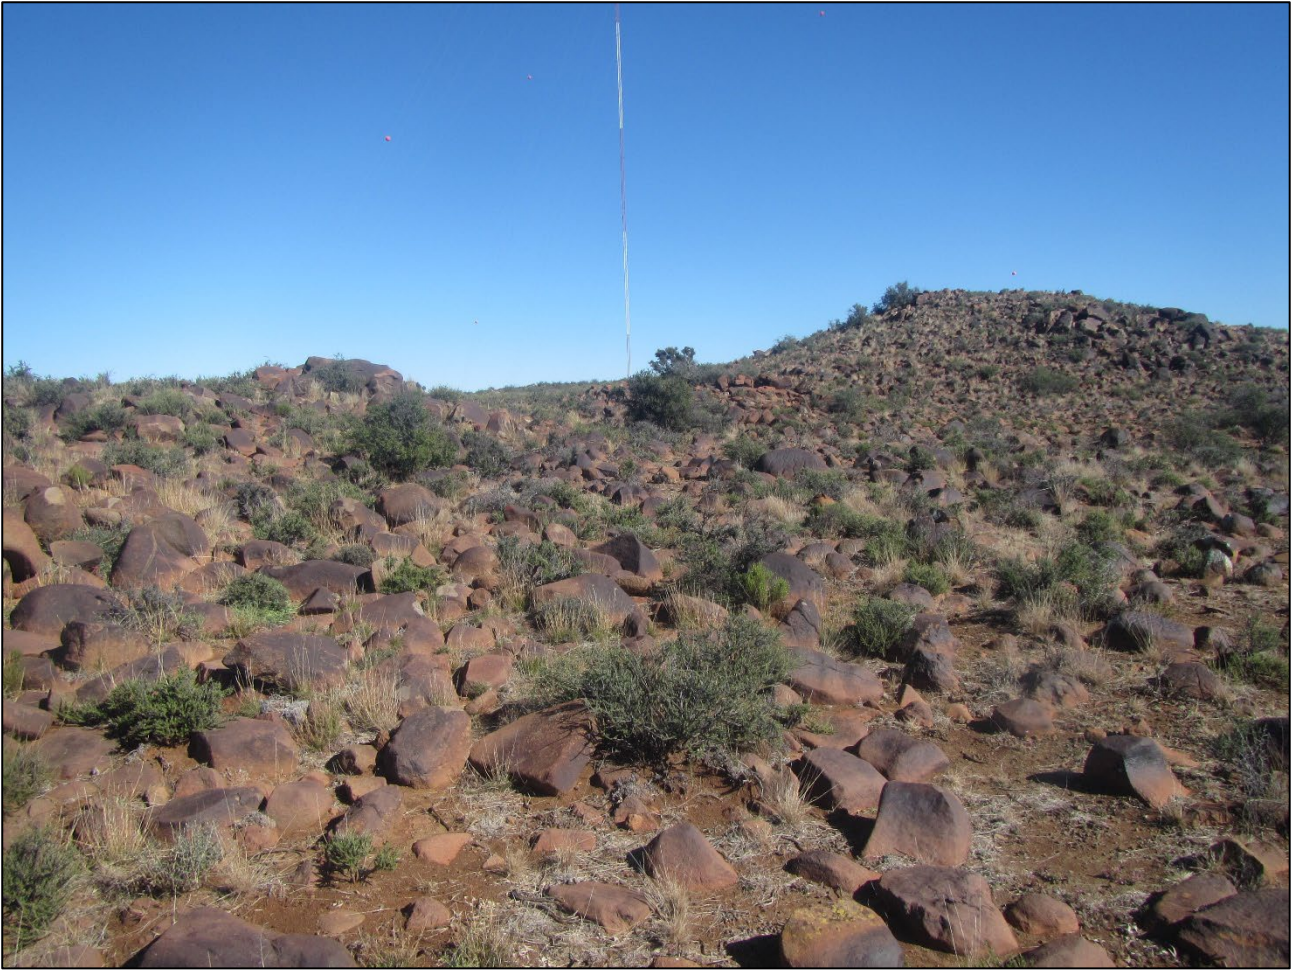
**Figure 11:** Looking towards the southwest along a turbine row in the central part of the WEF site and showing a dolerite dyke (with a wind measuring mast in view).

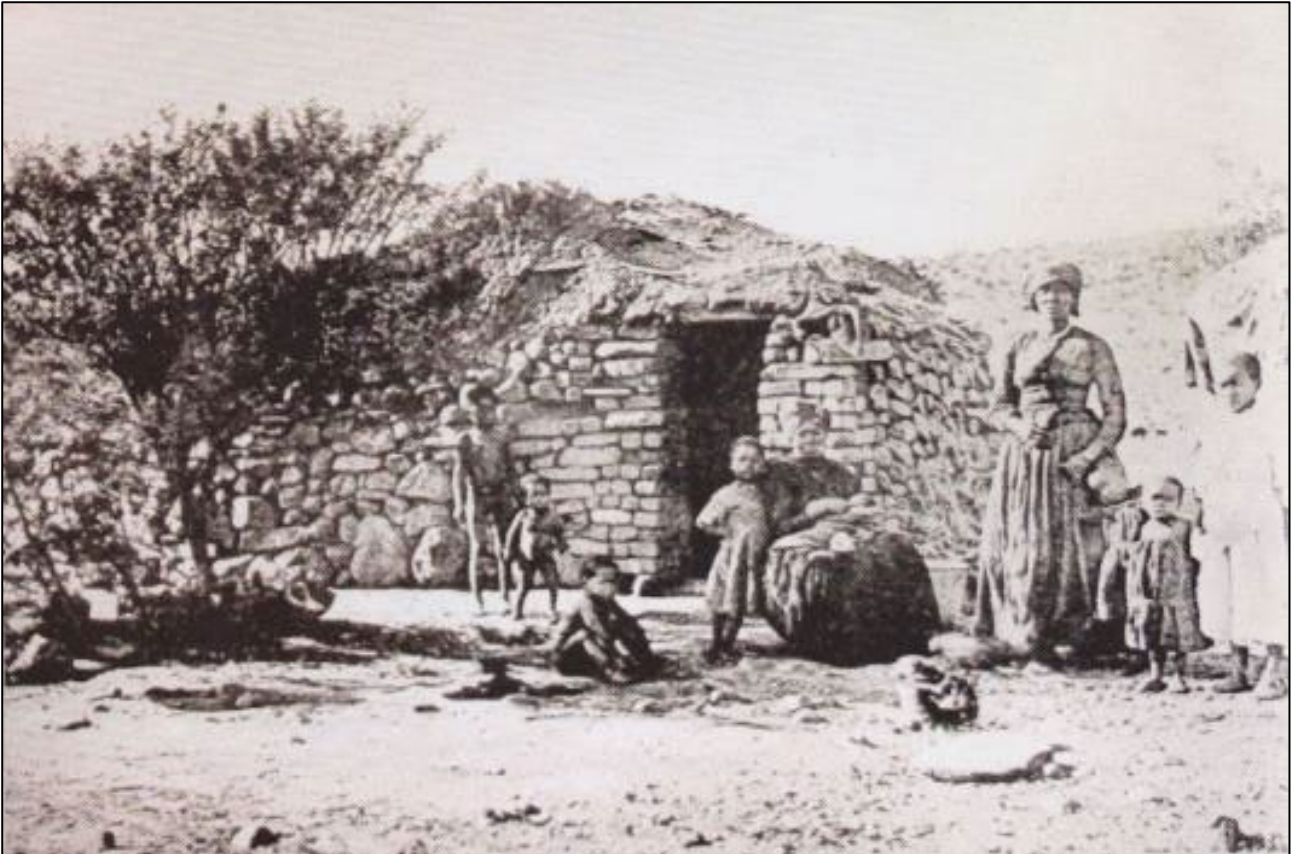
**Figure 14:** A shepherd's hut photographed near Beaufort West in the early 20th century. Note the low, narrow doorway and informal roof structure. Source: Schoeman (2013:48).

These early packed stone structures are invariably collapsed reducing them to archaeological sites in terms of the NHRA definitions. While some with taller walls may have had a formal or informal and/or temporary roof over them, others may have been hartebeeshuise with A-frame-type roofs made of branches and reeds placed above low stone or mud walls. Governor van Plettenberg, during his travels east to inspect the Colony, noted near the Sneeuwberg Mountains that the houses of the colonists consisted only of one room structures with low walls and straw roofs (Theal 1896-1911 cited in Böeseken 1975). In 1811 William Burchell illustrated a trekboer farmhouse (Van Zyl 1975), while Schoeman (2013) shows an image of such a historical stone dwelling still in use in the early 20th century (Figures 13 & 14).

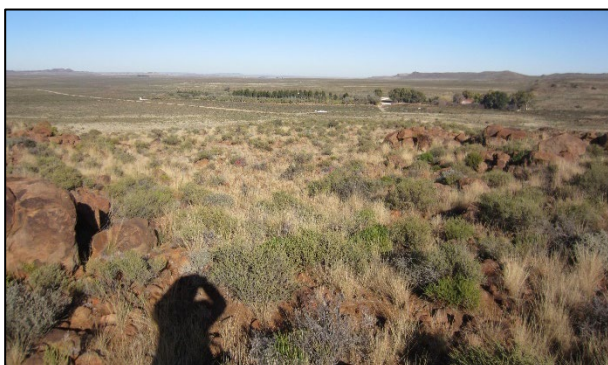
Stone Age materials were rarely found. No ESA artefacts were seen and MSA artefacts were restricted to rare background scatter items. One LSA site was found at waypoint 1988. The site lies on an open sandy patch atop a dolerite dyke and is some distance from the nearest river (Figure 15). The artefacts were on hornfels and chert (Figure 16). Many pieces of ostrich eggshell were also seen.

**Figure 15:** The location of the LSA site at waypoint 1988. The river is visible in the background.

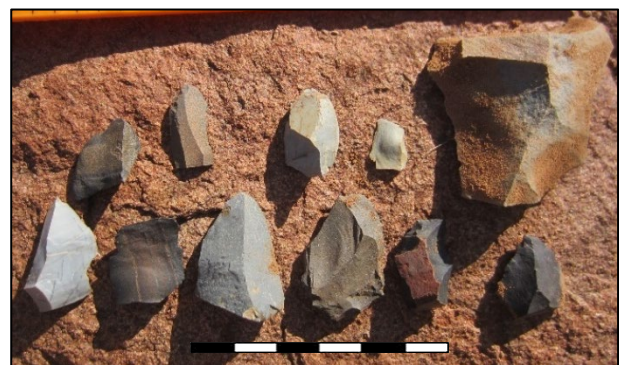
**Figure 16:** Stone artefacts on hornfels and chert from waypoint 1988. Scale in cm.

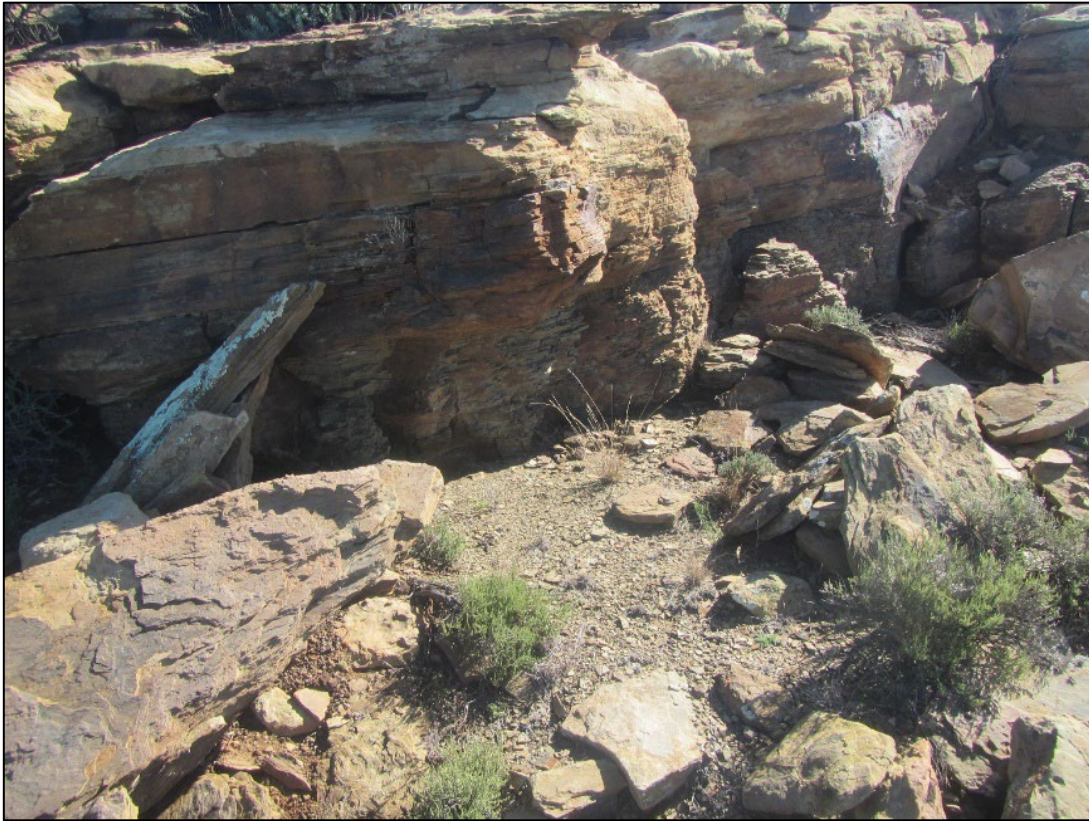
A few historical archaeological sites were also found. These ranged from very ephemeral alignments of stones to ruined formal structures. The tiny, semi-circular feature at waypoint 1237 (Figure 17) is an example of the former and several other small stone features of indeterminate function were noted in other places.

**Figure 17:** *The ephemeral, semi-circular stone feature at waypoint 1237. The alignment is not clearly visible in the photograph but on site it was clear that stones had been moved into position.*

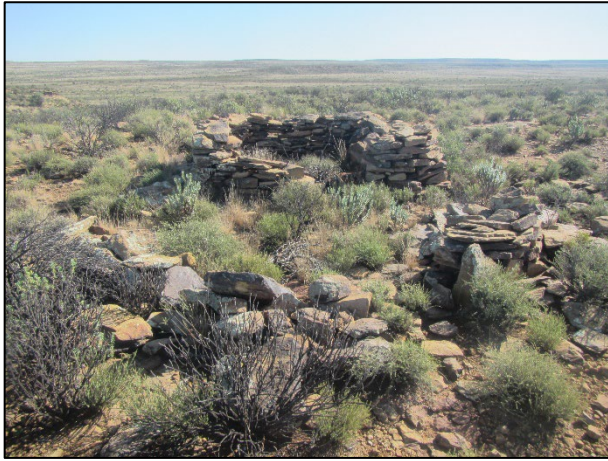
Slightly more formal was a stone walled structure that must have been a shepherd's hut at waypoint 1272 (Figure 18). The main room of the structure was about 2 m by 2 m but a 3 m diameter and opens into a slightly less formally built vestibule that lies to the south. A few historical items were noted in the area (Figure 19).

**Figure 18:** Stone-walled hut in the background with a vestibule in the foreground at waypoint 1272.

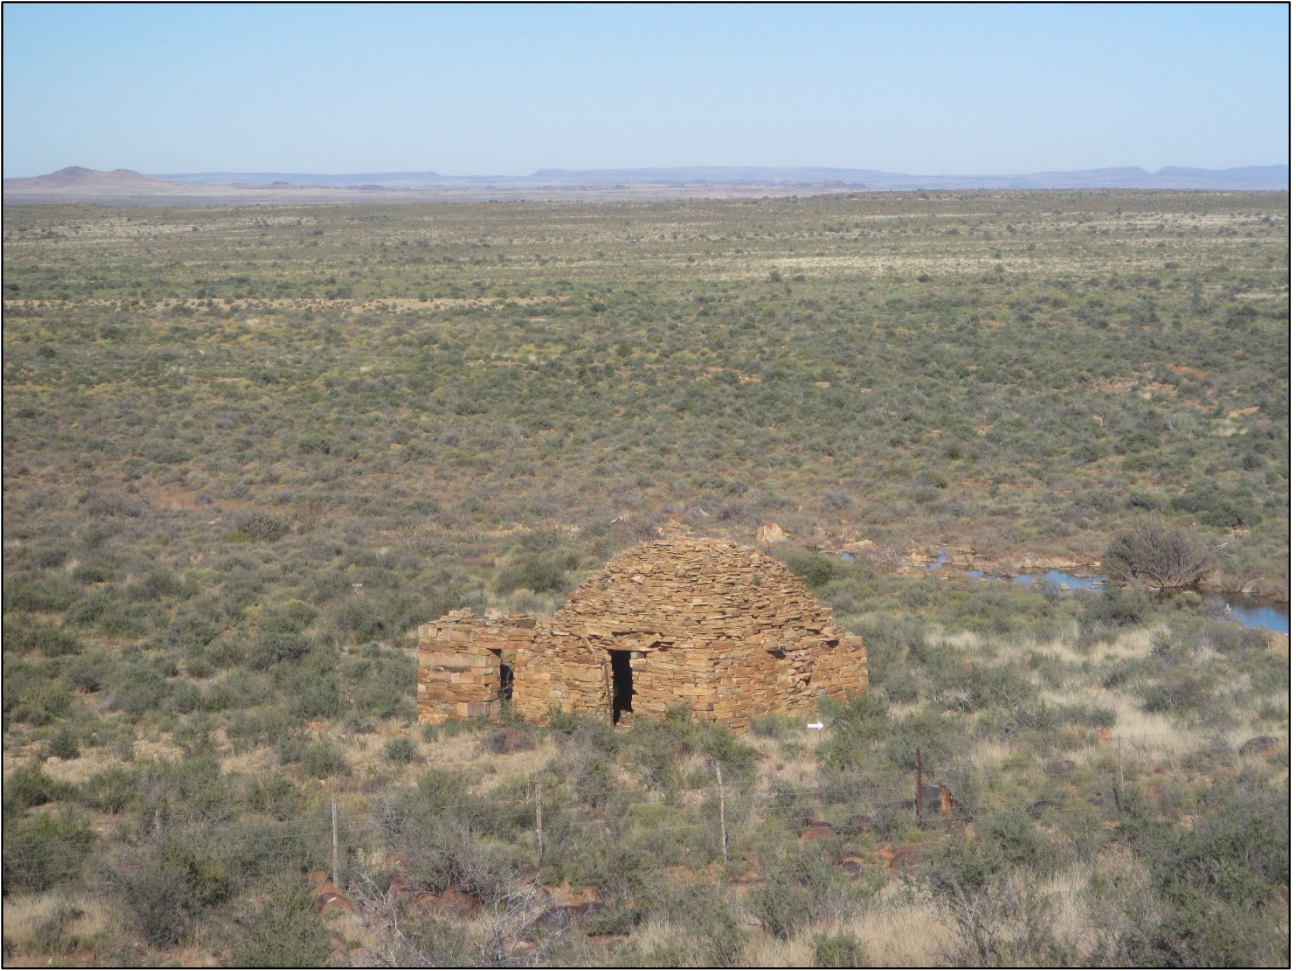
The most important site located during the survey was a corbelled building at waypoint 1270 (Figure 20). Although it lies just outside the study area, it has been illustrated here because of its significance. It is also on the borderline between the legal definitions of archaeology and built environment, but because of clearly archaeological features associated with it, it has been included under archaeology. The structure is a square-based structure with a round dome. It originally had doors to the east (Figure 21) and north, but the northern one has been closed up (Figure 22). A window to the west has also been closed up (Figure 23), while a rectangular, flat-roofed addition (also opening to the east and with a window facing west) has been made to the southern side (Figure 21). Internal features of the main building include some pierced wooden blocks with pegs through them set into northern wall above the closed-up door (Figure 24) and a corner shelf in the south-eastern corner (Figure 25). The top of the dome has been closed by two thin rock slabs (Figure 26). This site was recorded by Kramer (2012) but the floor plan she provides is incorrect in that the southern addition stops short of the western wall of the main structure (Figure 27). To the east are several stone-walled features. One is clearly the remains of a kraal, while others are of indeterminate function. Kramer (2012) noted a feature she thought might be a threshing floor to the southeast of the house. On aerial photography it looks to be about 12 m in diameter which is consistent with a threshing floor. This feature was not seen during the survey. Artefactual materials were also seen in the area and seem to be typical late 19<sup>th</sup> century materials (Figure 30). Kramer (2012) noted the dump to have been to the west of the house, but it is not known whether this was a proper dump or just an area of dense artefact scatter since no proper dump was seen there during the survey. The site lies adjacent to a river which flows through a small poort in dolerite dyke, but the poort has been dammed.

**Figure 20:** East and north sides of the corbelled building at waypoint 1270 and recorded as Ystervarkspoor 2 by Kramer (2012).

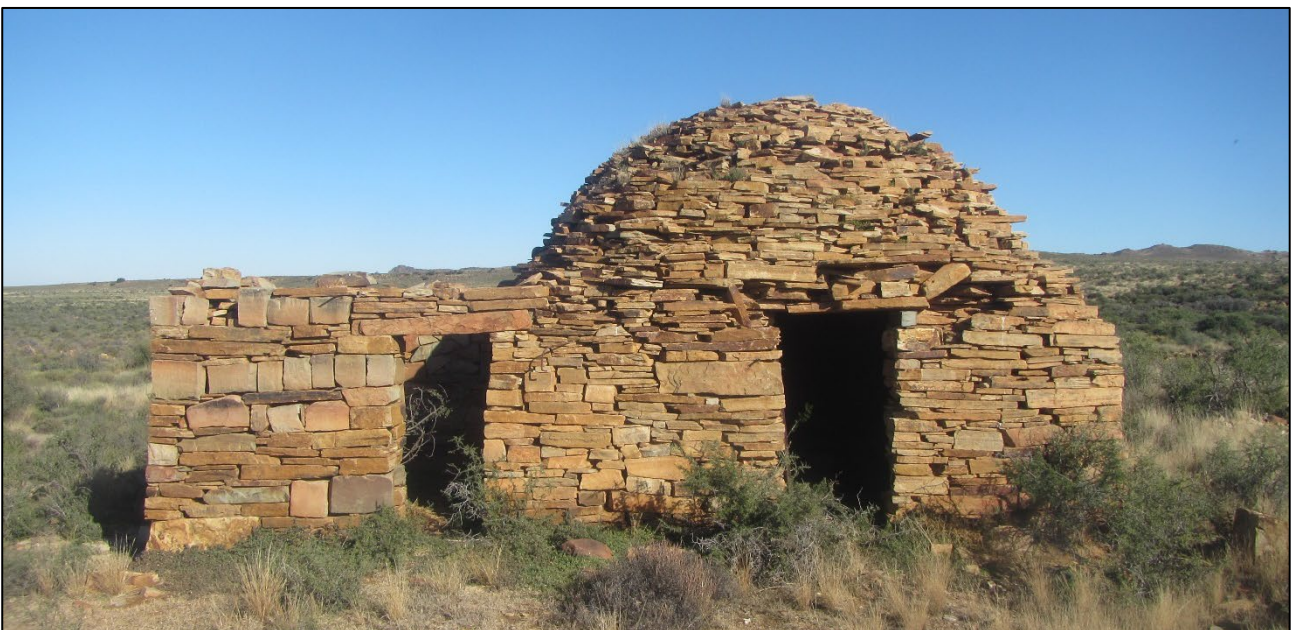
**Figure 21:** East and north sides of the corbelled building at waypoint 1270.

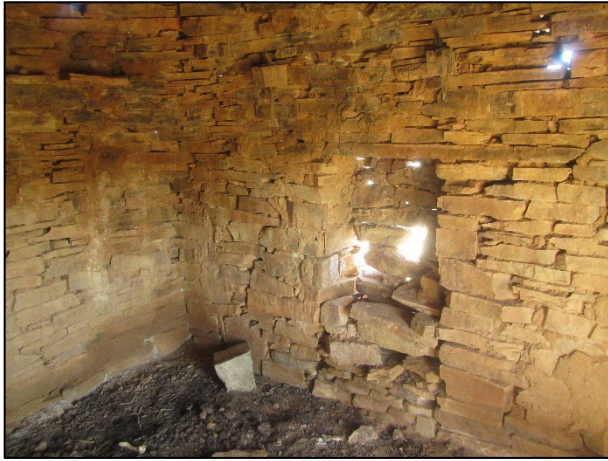
**Figure 22:** Closed up door in the north wall of the corbelled building at waypoint 1270.

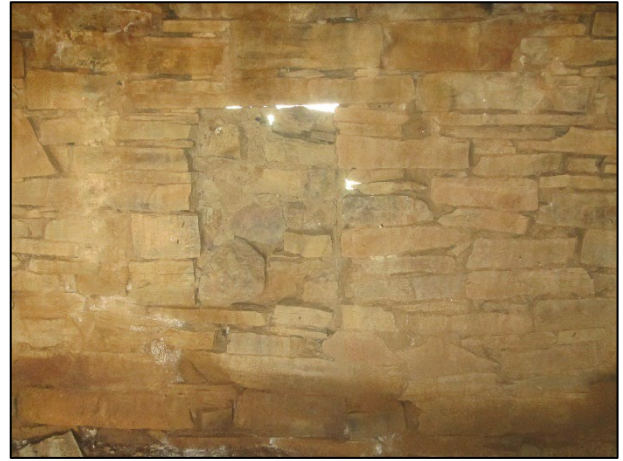
**Figure 23:** Closed up window in the west wall of the corbelled building at waypoint 1270.

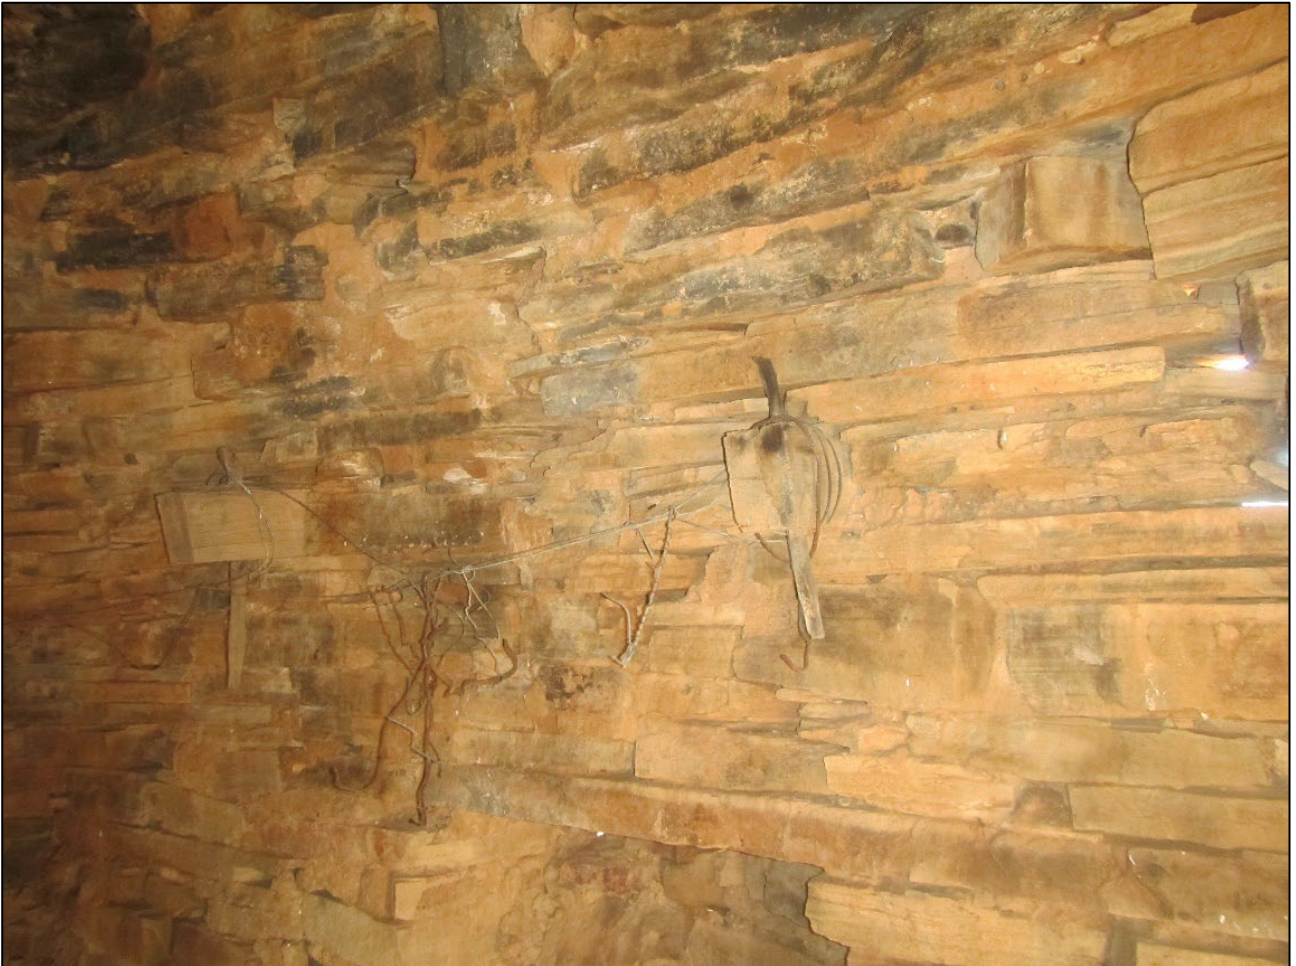
**Figure 24:** Internal features of the corbelled building at waypoint 1270. Two pierced wooden blocks with pegs through them are visible in the wall above the lintel of the now closed up northern door. Some wire has been fastened to the wooden blocks.

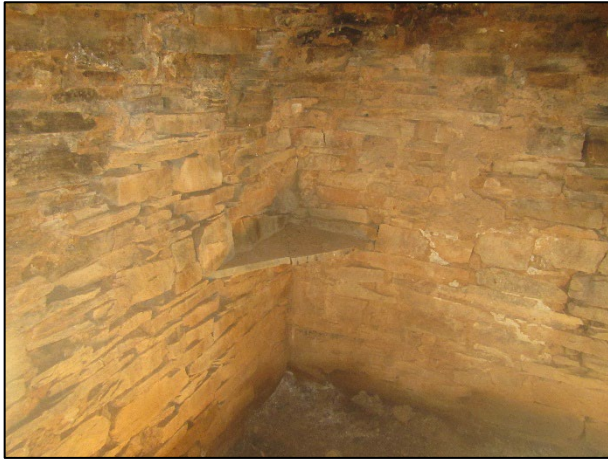
**Figure 25:** Internal corner shelf in the corbelled building at waypoint 1270.

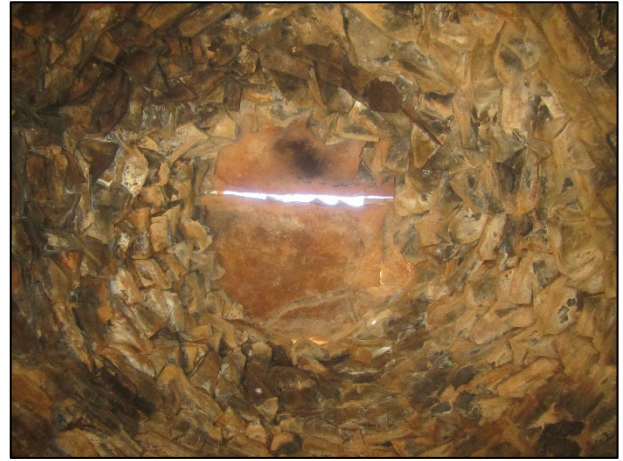
**Figure 26:** The inside of the dome in the corbelled building at waypoint 1270 showing two large slabs closing the top.

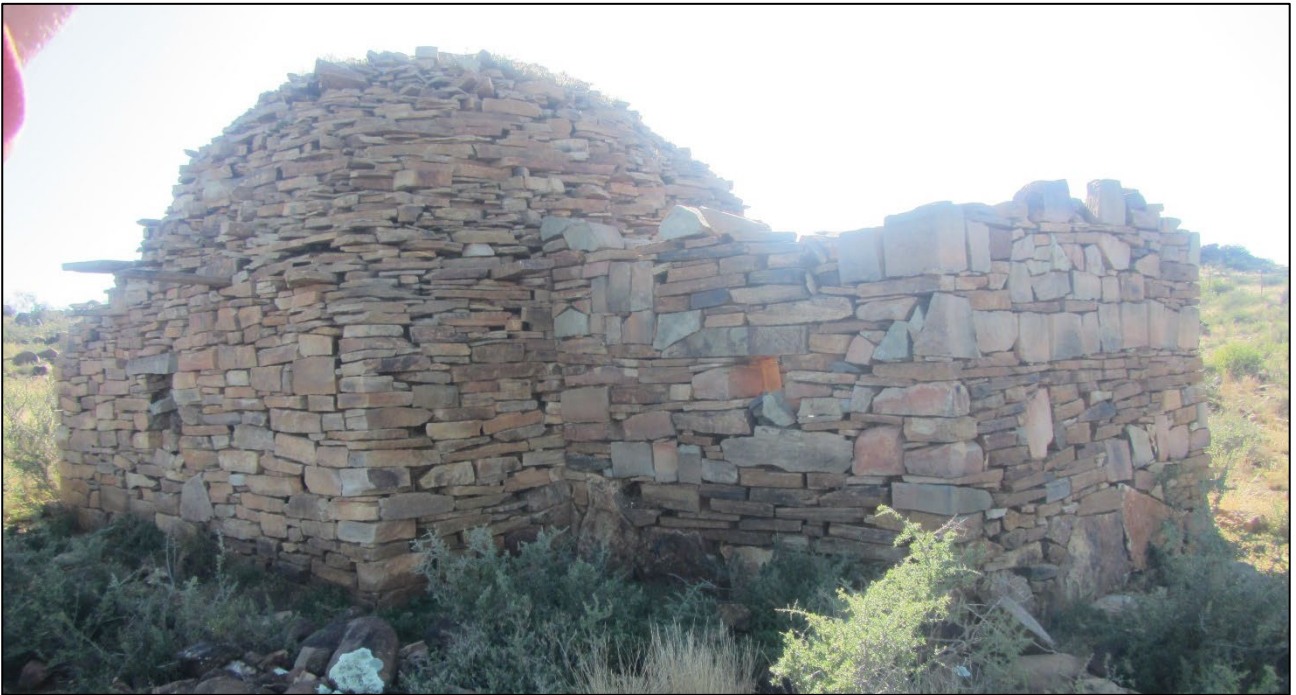
**Figure 27:** West and south (with added flat-roofed room) faces of the corbelled building at waypoint 1270.

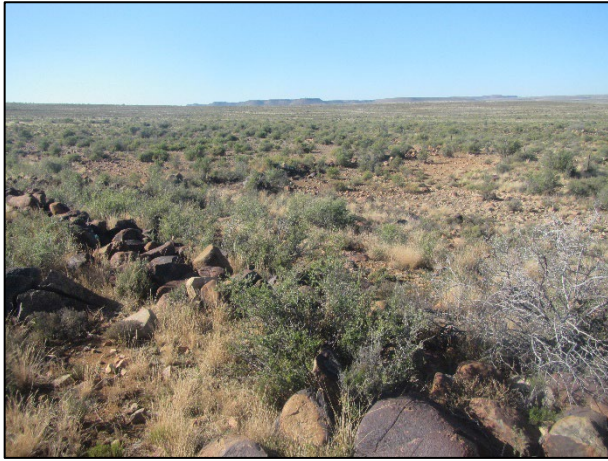
**Figure 28:** Stone-walled kraal at waypoints 1268-9.

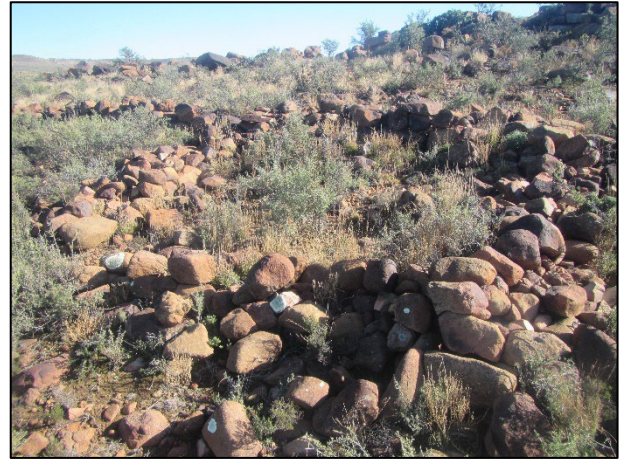
**Figure 29:** Stone-walled feature at waypoint 1269.

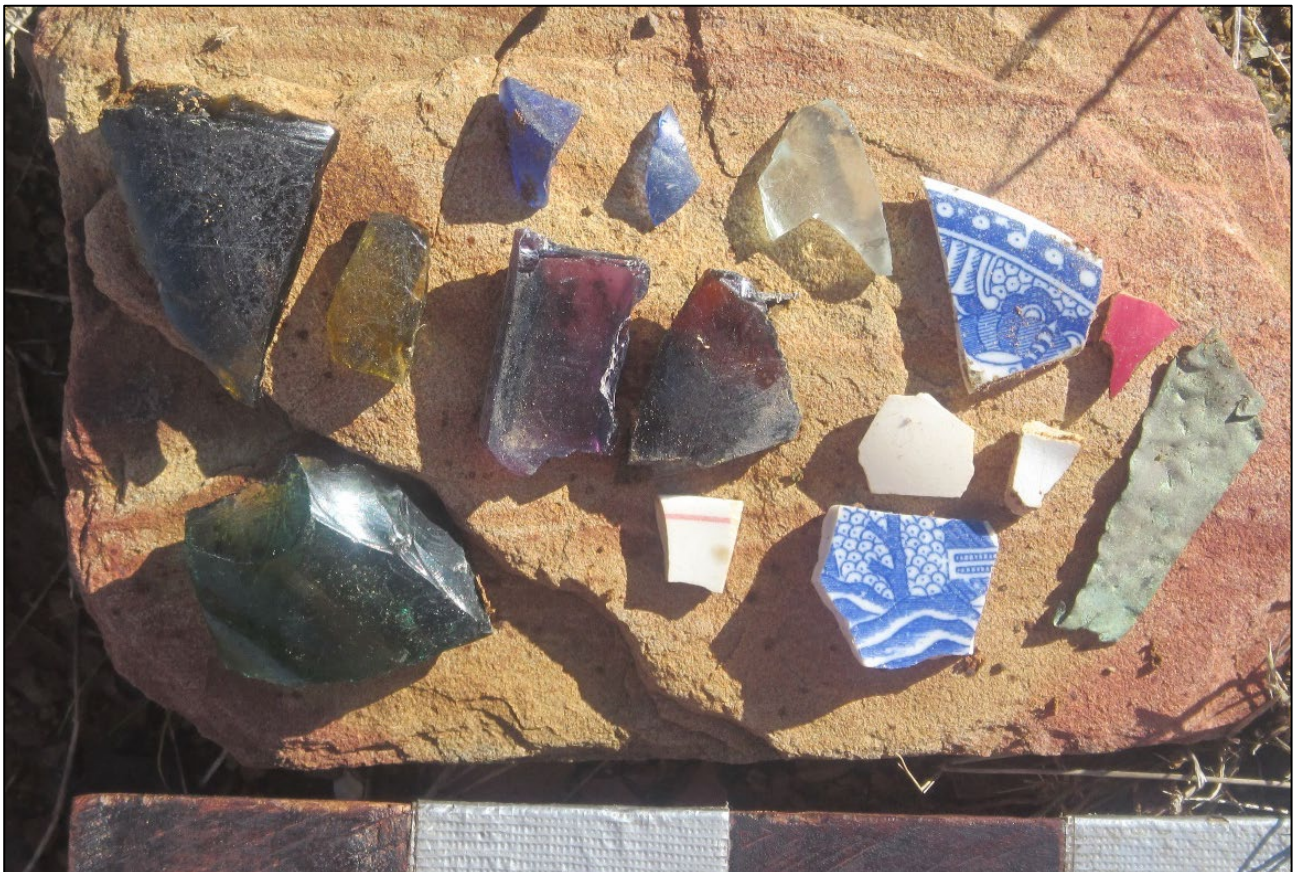
**Figure 30:** Historical materials from outside the corbelled building at waypoint 1270.

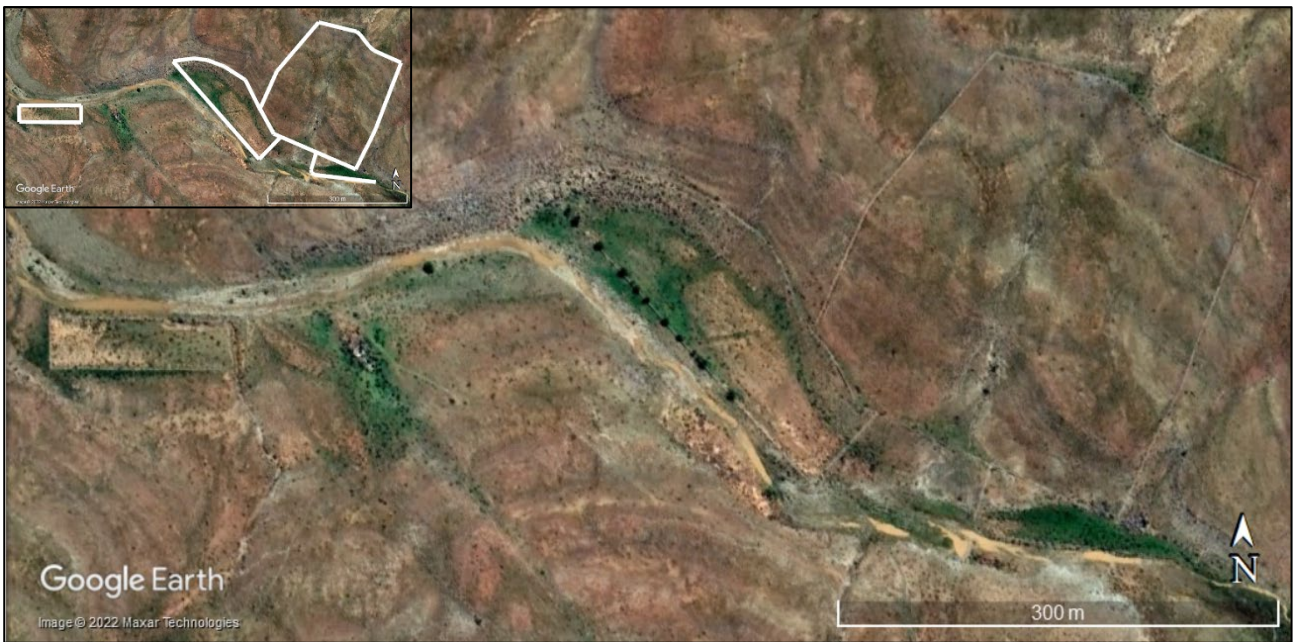
Further archaeological features were seen on aerial photography. Most impressive was a series of large walled features to the west of the Aarfontein farm complex. While two are clearly garden areas because they lie on the river floodplain, one of far larger and extends up the hill to the north of the river (Figure 33).

**Figure 33:** Aerial view of the stone-walled features at waypoints 013 (left) and 014 (right). The inset shows the exact same view but with the walling highlighted.

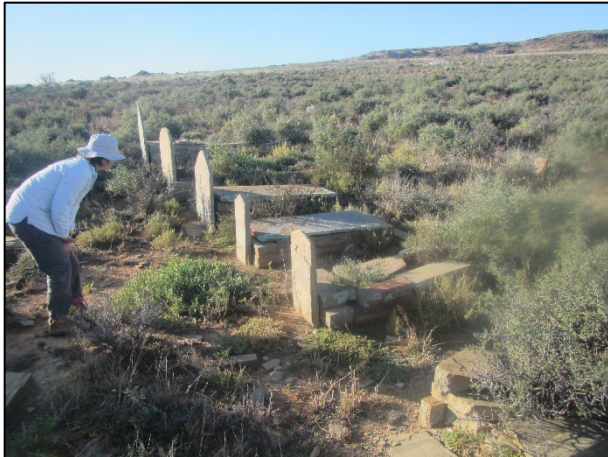
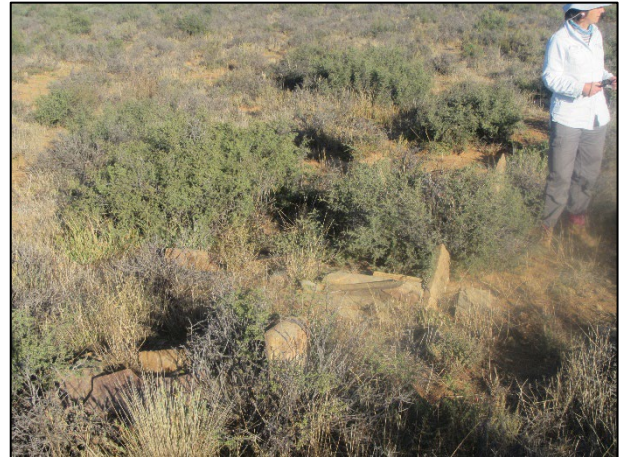
No isolated graves were seen during the survey but a graveyard was found in the Ystervarkspoor farm complex.

**Figure 34:** Graveyard at waypoint 1281 in the Ystervarkspoor farm complex.

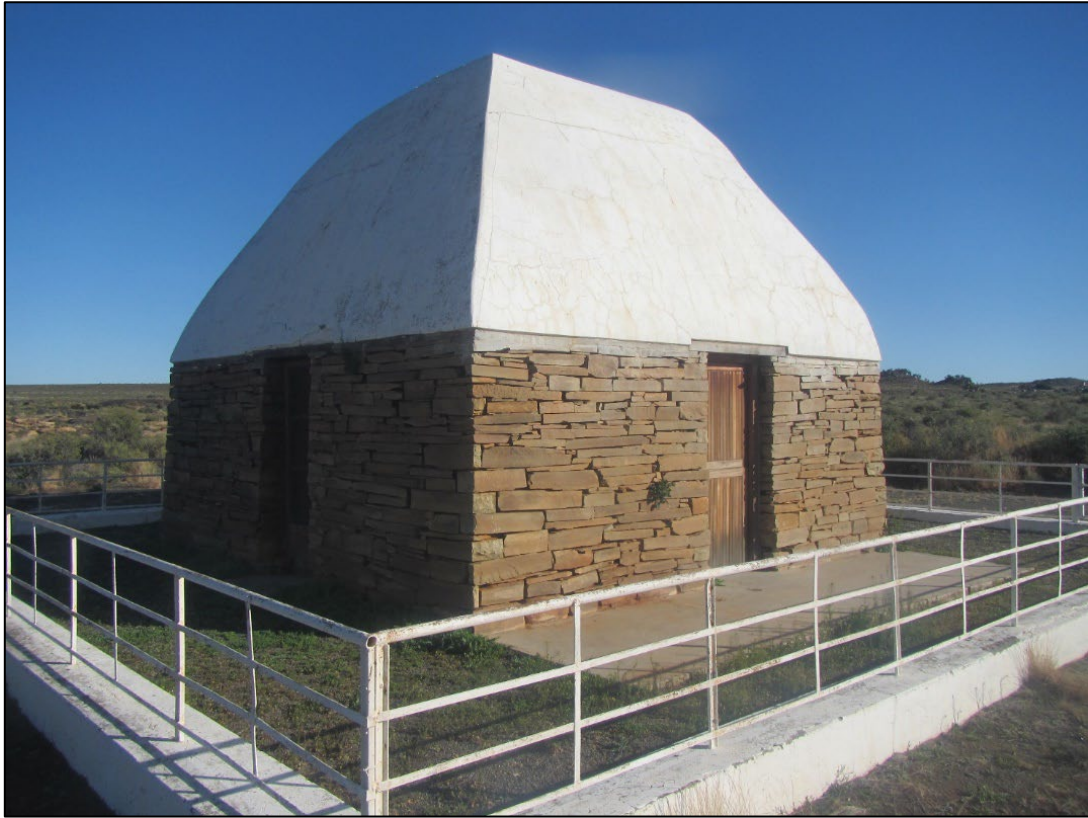
**Figure 38:** The corbelled building at waypoint 1265 and recorded as Ystervarkspoort 1 by Kramer (2012).

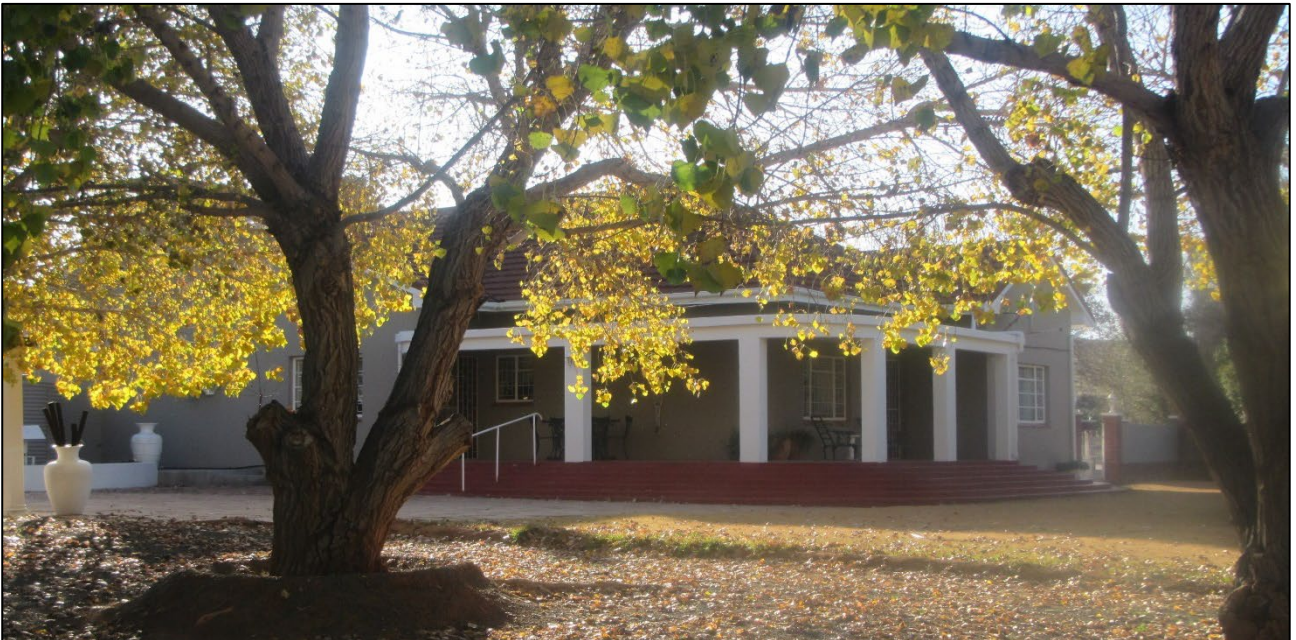
**Figure 39:** The current main farmhouse at the Ystervarkspoort farm complex at waypoint 1264.

Historical and built heritage resources all occur along river valleys and they are generally few and far between. Only one farmstead was visited during the survey and this was that at Ystervarkspoort in the east. There are two generations of farmhouses with the oldest being a corbelled building that has been renovated and maintained. Although it has lost its charm by having its corbelled dome plastered and painted, the overall structure will certainly last longer (Figure 38). The current farmhouse appears to date to the mid-20<sup>th</sup> century (Figure 39), and seemingly after 1960 (Figure 40). Another structure on the farm may have served as a house in between. Other features include a stone-walled kraal complex which, according to the evidence of Figure 40, has been partly dismantled sometime during the last 60 years. The remaining section, however, is well-preserved and well-maintained (Figure 41).

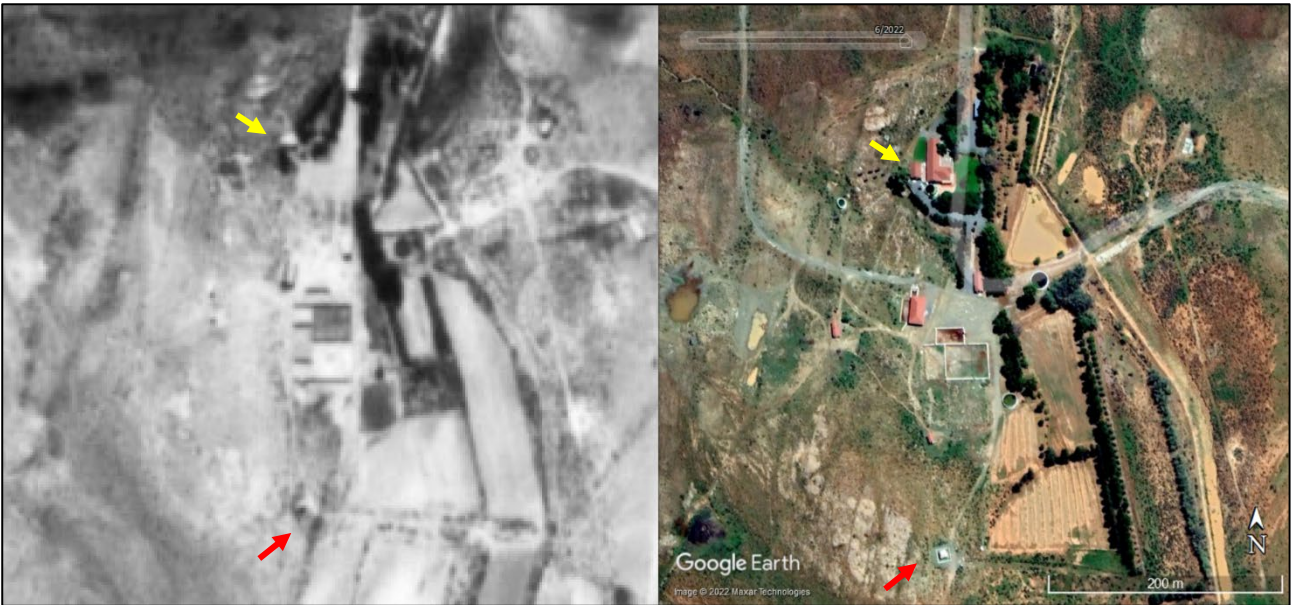
**Figure 40:** Historical aerial views from 1960 (434\_005\_02986) and today (Google Earth) of the Ystervarkspoort farmstead. Arrows show the corbeled building (red) and small outbuilding (yellow) behind the current farmhouse which does not seem to have been present in 1960.

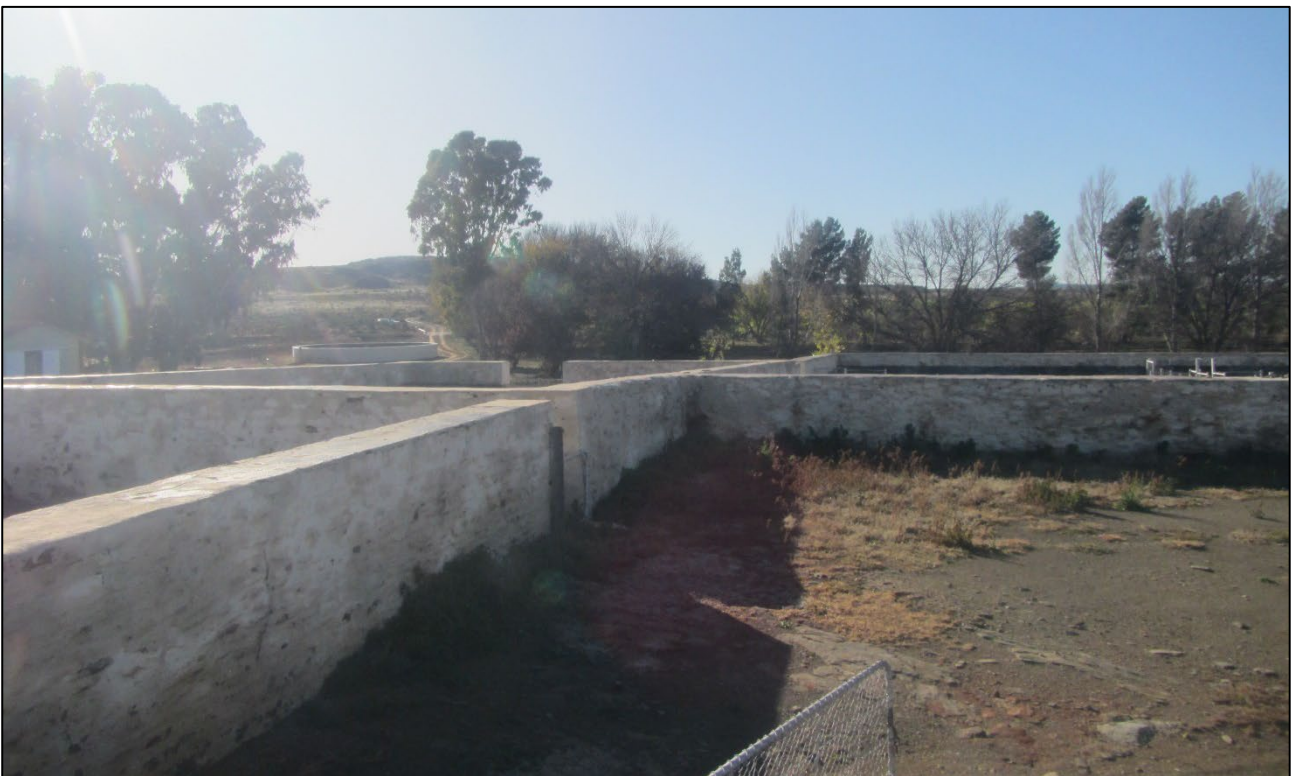
**Figure 41:** The well-preserved remaining section of the stone-walled kraal complex at waypoint 1264.

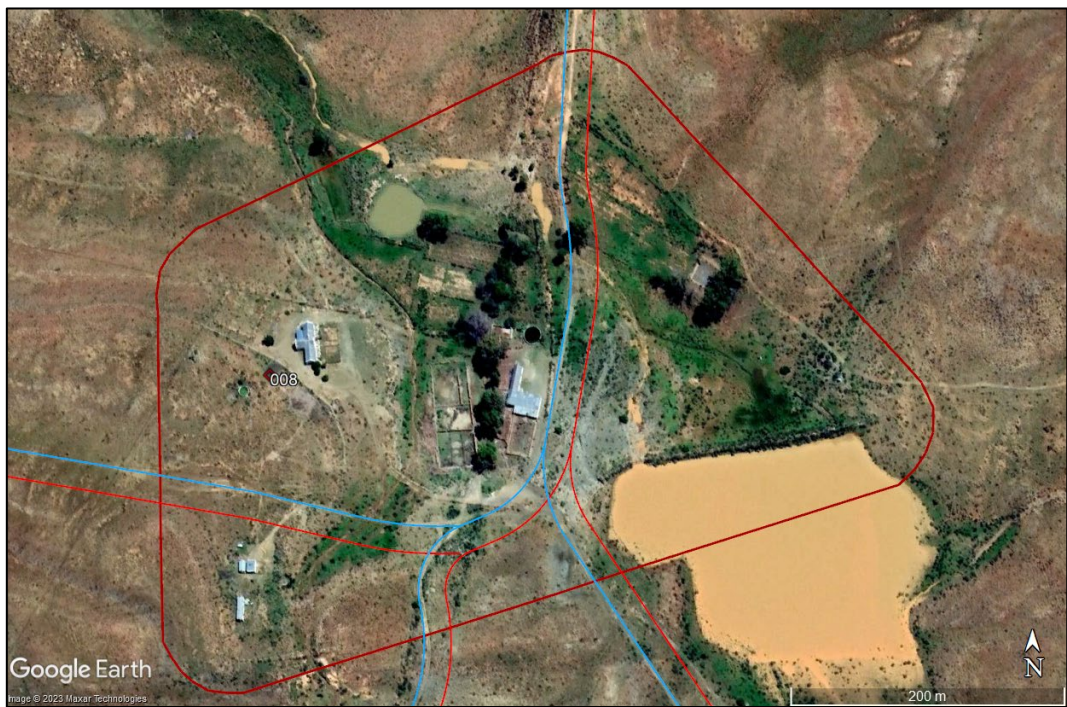
**Figure 44:** Aerial view showing project roads (blue) and cables (red) passing through the site at waypoint 003.

Table 8 provides project responses to the heritage indicators with mapping shown in Figures 44 to 46 where needed. The main concern relates to the site at waypoint 1238 which would require avoidance or mitigation as noted in Table 8. In other places where existing roads are being reused the heritage resources can be protected through clear No-Go signage and monitoring.

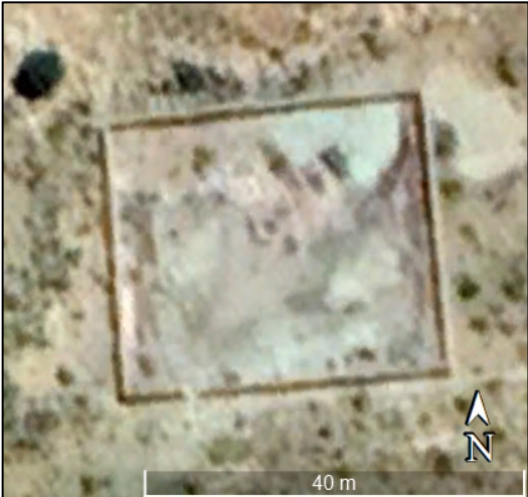
1		1217	S31 16 26.8 E22 21 59.7	<p>A three-roomed kraal built below a scarp and incorporating the scarp as the back wall of the one room. There are a few small sections that have tumbled, but the rest is otherwise quite well preserved.</p>

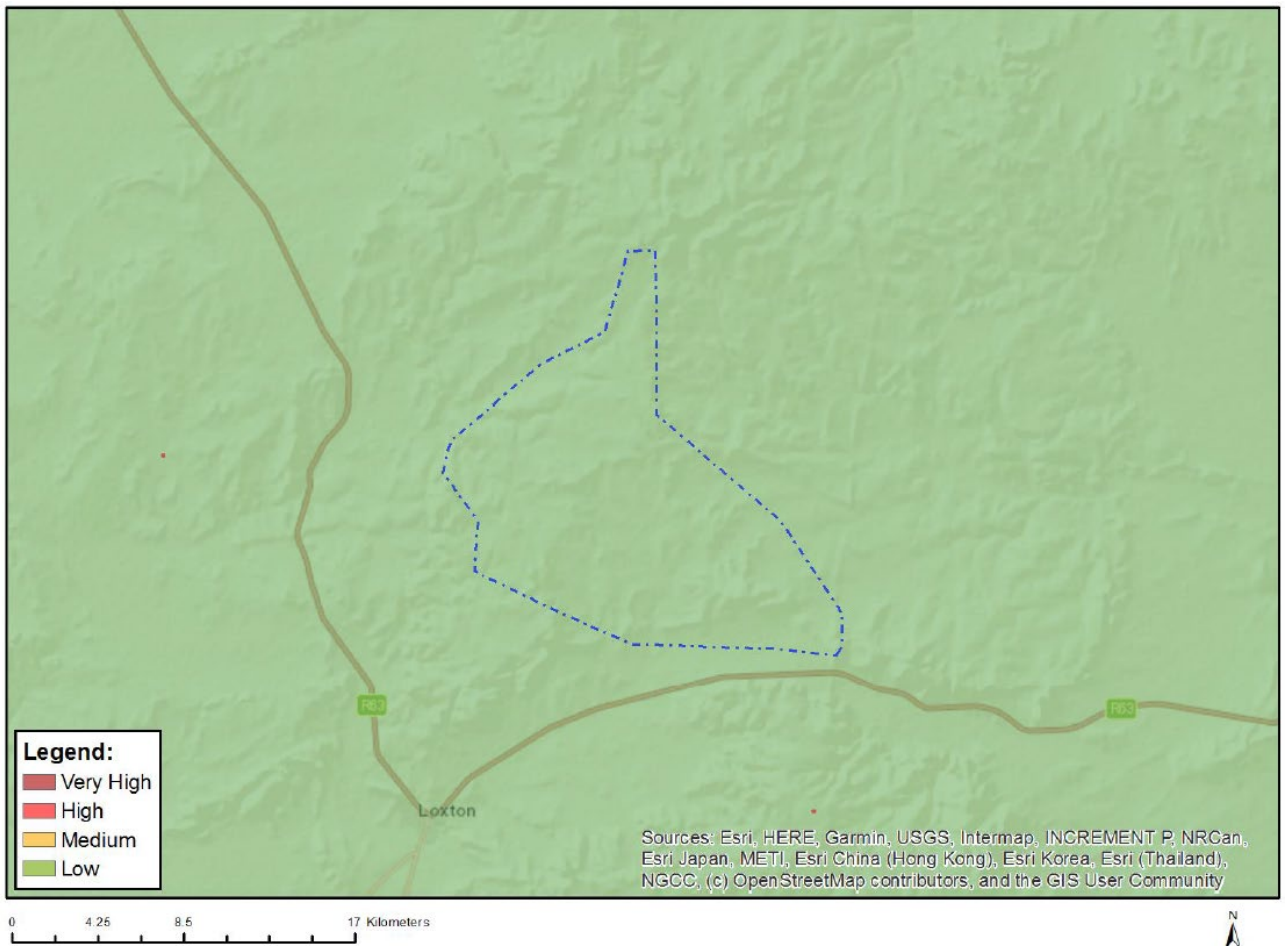
The map below is extracted from the screening tool report and shows the archaeological and heritage sensitivity to be low throughout the study area. The site visit showed that in fact the majority of the site is of low sensitivity with only small pockets (where heritage resources occur) considered to be of higher sensitivity. Figure 42 (in the HIA above) shows the areas considered to be sensitive from a heritage point of view. The main concerns are the farm complexes (inhabited and abandoned/archaeological) since these have high densities of heritage resources and are considered locally significant cultural landscapes. These tend to be in river valleys, while the ridges targeted for development have almost no traces of heritage. A photographic record and description of the relevant heritage resource is contained within the impact assessment report. The heritage specialist thus disputes the uniform low sensitivity, noting that several pockets of medium to high sensitivity are also present in the area.
