Site Management Memorandum

PROPOSED REHABILITATION OF NATIONAL ROUTE R56 SECTION 8, MATATIELE LOCAL MUNICIPALITY IN THE ALFRED NZO DISTRICT MUNICIPALITY, EASTERN CAPE PROVINCE

Prepared for: SANRAL

Date: 2023/01/26

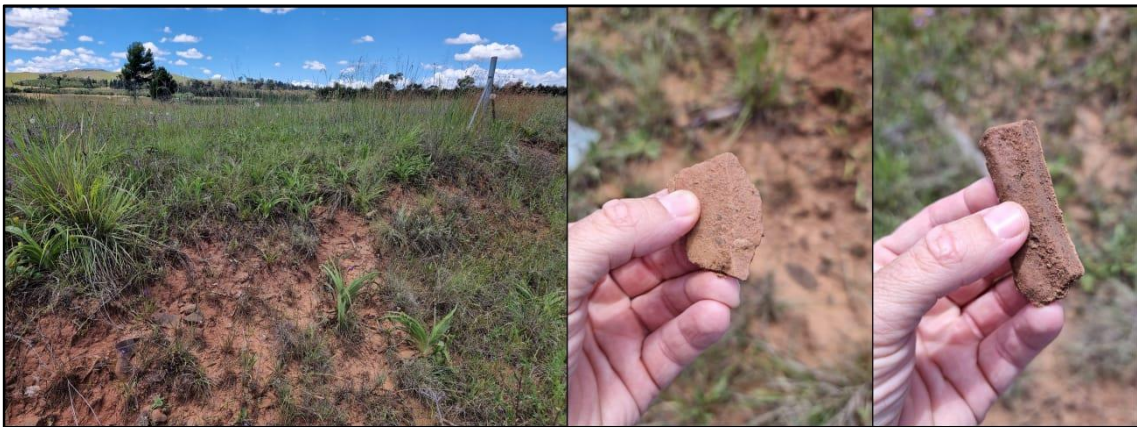
During the updated site survey (2022) some but not all of the lithics initially documented by PGS were located but the site seemed heavily eroded exposing subterranean stone tools. The site significance grading (Medium Significance) is maintained due to the underlying deposit potentially informing on MSA developments in the region.

Figure 2: General view of MAT 1 (left) and lithics observed at the site (centre and right) at the time of the site survey for this Memorandum.

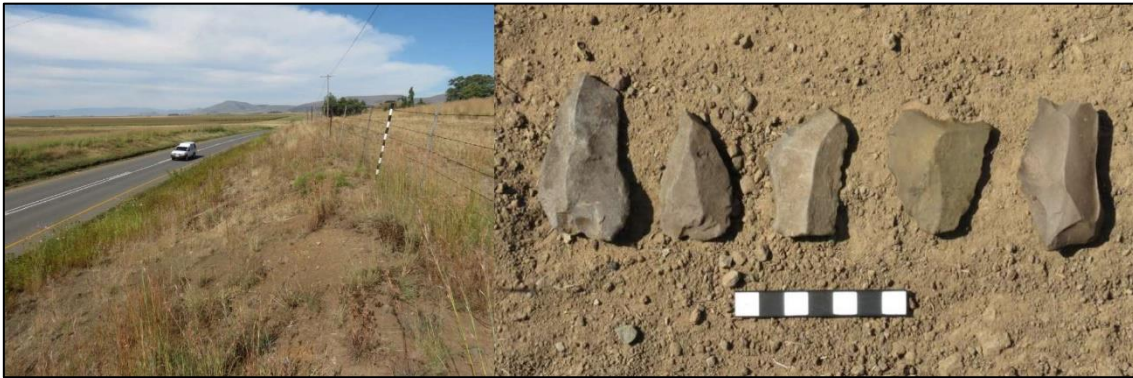
PGS noted a low density surface scatter of MSA lithics which extends approximately 40m along the side of the road. The highest density of lithics that could be observed at the site was 2 lithics per/m², whereas the overall number of lithics observed on the site was low. The lithics were evidently exposed during the construction of the road, when a road cutting was made into a low hill. Subsequent erosion may have exposed more lithics. However, no evidence for an in situ lithic concentration could be seen. The lithics observed on the surface of the site comprise flaked blades and triangular flakes produced on prepared cores. Some specimens exhibit utilisation marks. In terms of raw material use, fine-grained

quartzite and hornfels appears to have been preferred. The lithics from the site has a low density and is of small number. PGS graded the site to be of Low Significance.

Figure 3: General view of MAT 2 (left) and lithics observed at the site (right) at the time of the PGS HIA study.

PGS Site Code:	MAT 2
Coordinates:	S 30.37465 E 28.91934
Significance Rating (PGS):	Low Significance Generally Protected
Mitigation (PGS):	No Mitigation Required
Updated Mitigation Opinion:	Initial mitigation recommendations applicable. The ECO should provide a Close-Out Report after construction to review management procedures and ensure that effective measures were implemented.

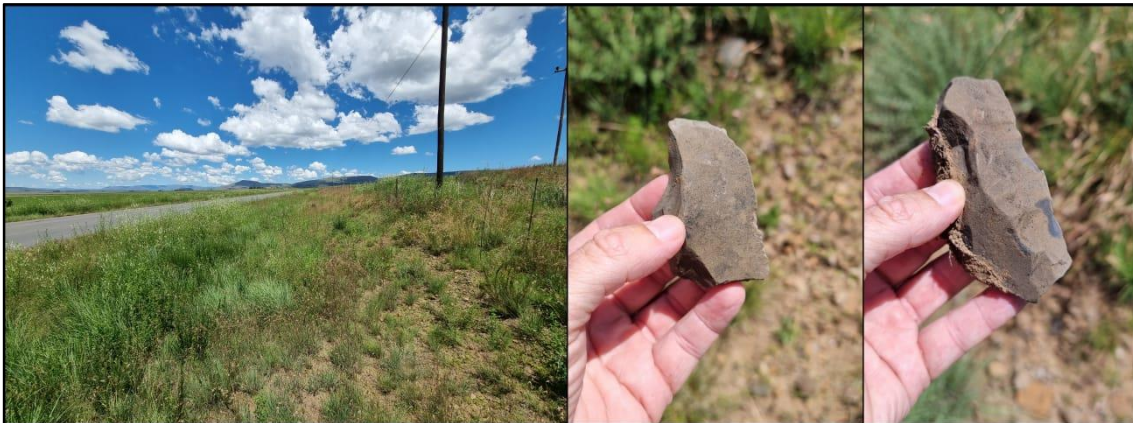
During the updated site survey (2022) some but not all of the lithics initially documented by PGS were located but the site seemed heavily eroded and the site significance grading (Low Significance) is maintained.

Figure 4: General view of MAT 2 (left) and lithics observed at the site (centre and right) at the time of the site survey for this Memorandum.

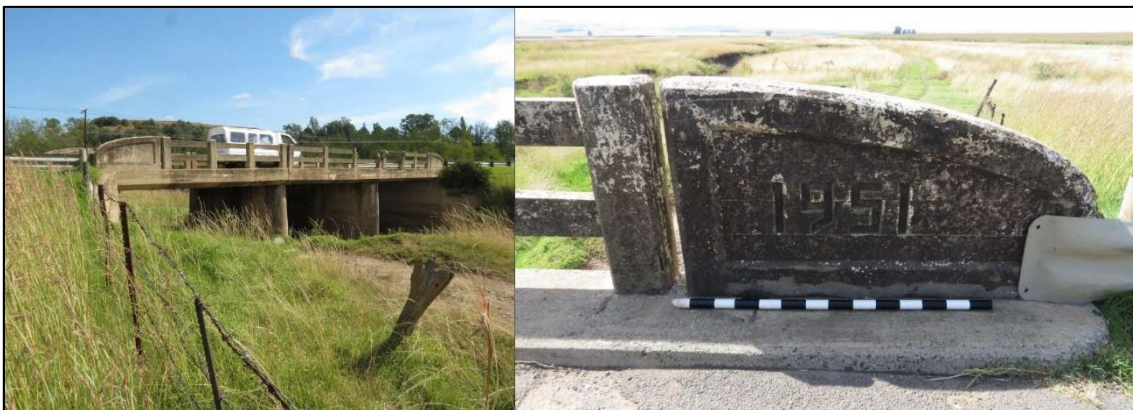
PGS documented a slab type low level reinforced concrete bridge over the Edendale Stream. The structure is a three-span concrete bridge which has a very narrow pedestrian sidewalk on each side and is roughly 20 m by 7 m in extent. The condition of the bridge is not pristine, and a section of the precast concrete handrails on the northern end of the bridge had been severely damaged by presumably a vehicle or truck. The construction date “1951” appears on the north-eastern end of the bridge. According to information found in the Western Cape Archives (TBK, PAA (A-WS), M/190, MT4/E), the bridge was known as the “Edendale Sluit Bridge” and was designed to have three 20-foot-long spans, a roadway width of 22 feet and 12 inch sidewalks on either side with precast concrete handrails. The earliest record relating to the bridge was found in letter by the District Roads Engineer for Umtata written during December 1948. By 20 June 1949 the specifications for the construction of the bridge had been finalised, whereas the bridge was completed in November 1951. The construction of the bridge cost an estimated £2,500 to complete. The completion date obtained from the archival information (November 1951) supports the construction date (1951) which appears on the bridge, and both indicate that the bridge is 65 years old. According to the archival information obtained from the Western Cape Archives, the bridge was completed at roughly the same time as the so-called “Commonage Bridge”. It is not presently known where this bridge is located. A stone and concrete drift is located a short distance south of the bridge with evidence for a road continuing in a western direction from this drift before joining the modern tar road. It is possible that this concrete drift and road formed part of the construction of the slab type bridge at MAT 3, or alternatively that the drift and road represent tangible remains of the earlier road and crossing point over the stream. The bridge is certainly more than 60 years old. PGS graded the site to be of Medium Significance.

Figure 5: General view of the bridge at MAT 3 at the time of the PGS HIA study.

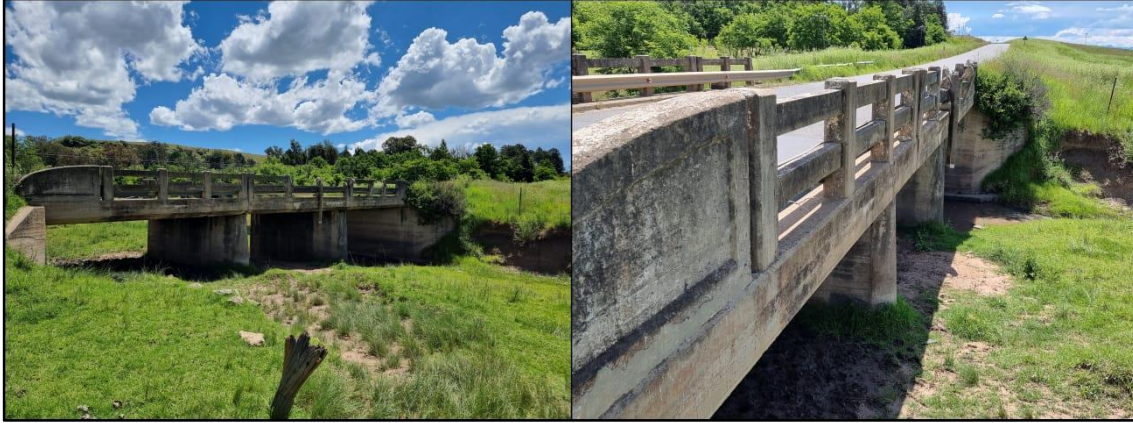
During the updated site survey (2022) it was noted that the bridge was more or less in the same state of preservation with minor structural deterioration as a result of natural elements. The site significance grading (Medium Significance) is maintained.

Figure 6: General view of the bridge at MAT 3 at the time of the site survey for this Memorandum

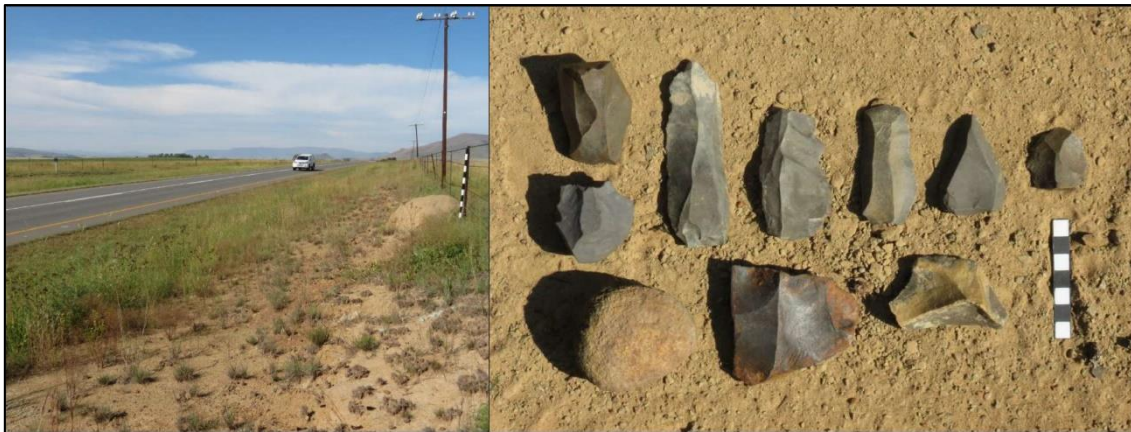
PGS noted another concentration of MSA lithics was identified here. The lithics extend over a distance of approximately 100m along the southern side of the road. Only one lithic was identified on the northern end of the road. The highest density recorded was 7 lithics per/m². Furthermore, a large number of lithics were observed on the surface of the site. The lithics were revealed when a road cutting was made during the construction of the road. Subsequent erosion activity may have further facilitated this process. Based on the sample that was identified, a high frequency of blades and triangular flakes seems evident. Several cores and a quartzite hammer stone suggest *in situ* stone knapping activities at this particular locality. The range of raw materials used includes hornfels and fine-grained Cryptocrystalline Silicas (CCS). Hornfels and CCS materials were extensively used in lithic assemblages from the Kwazulu-Natal region in particular. The raw materials are derived from the Drakensberg volcanics and were sourced by the prehistoric hunting and gathering communities from river systems and outcrops. The evidence for stone tool manufacture at this site is important in the context of the importance of the MSA and the presence of Anatomically Modern Humans with complex cognition and innovative technologies that form the focus of southern African MSA research (Wadley 2013, 2015). Therefore, PGS graded the site to be of Medium significance.

Figure 7: General view of MAT 4 (left) and lithics observed at the site (right) at the time of the PGS HIA study.

PGS Site Code:	MAT 4
Coordinates:	S 30.38558 E 28.95260
Significance Rating (PGS):	Medium significance Generally Protected B
Mitigation (PGS):	Small-scale archaeological excavation work which adheres to standard practice and method.
Updated Mitigation Opinion:	Initial mitigation recommendations applicable. Should the site be maintained <i>in situ</i> a temporary construction barricade should be erected around the occurrence for the duration of construction. The ECO should provide a Close-Out Report after construction to review management procedures and ensure that effective measures were implemented.

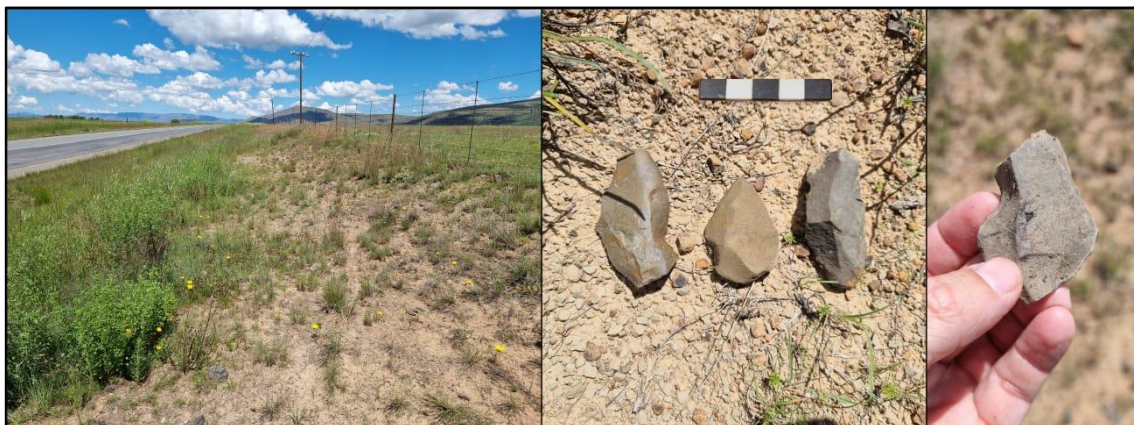
During the updated site survey (2022) some of the lithics initially documented by PGS were located but the surface artefact densities seemed lower. This might be the result of erosion and surface wash displacing stone tools or even collection of

artefacts from the surface. The site significance grading (*Medium Significance*) is nonetheless maintained due to the site potentially being a manufacturing area of MSA tools.

Figure 8: General view of MAT 4 (left) and lithics observed at the site (centre and right) at the time of the site survey for this Memorandum.

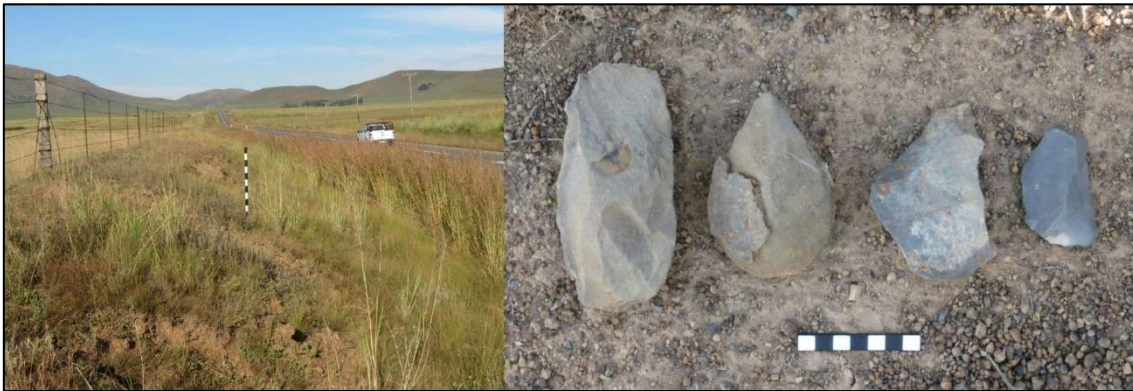
A small number of lithics were identified by PGS along the northern end of the road. As is the case with most of the other Stone Age sites, these lithics were exposed when a road cutting was made during the construction of the road. The highest density of lithics that could be identified here, was 2 lithics per/m². The lithics identified here include typical Large Cutting Tools (LCTs) associated with the ESA, including a cleaver and a handaxe. Whereas the density of lithics is low, this is the only occurrence of ESA tools that has been recorded during the survey. Therefore, PGS graded the site to be of Medium Significance.

Figure 9: General view of MAT 5 (left) and lithics observed at the site (right) at the time of the PGS HIA study.

PGS Site Code:	MAT 5
Coordinates:	S 30.44292 E 29.19011
Significance Rating (PGS):	Medium Significance Generally Protected B
Mitigation (PGS):	Archaeological monitoring of sites during construction phase. Should any significant deposits or artefacts be exposed, small-scale archaeological excavation work will be required which adheres to standard practice and method.
Updated Mitigation Opinion:	Initial mitigation recommendations applicable. Should the site be maintained <i>in situ</i> a temporary construction barricade should be erected around the occurrence for the duration of construction. The ECO should provide a Close-Out Report after construction to review management procedures and ensure that effective measures were implemented.

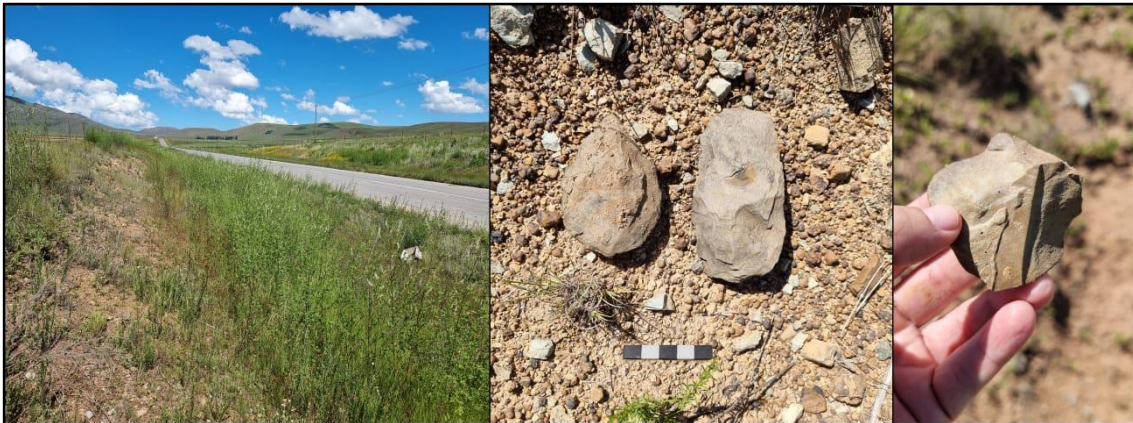
During the updated site survey (2022) many of the LCTs initially documented by PGS were located on eroded surfaces and the site significance grading (Medium Significance) is maintained for this unique ESA occurrence.

Figure 10: General view of MAT 5 (left) and lithics observed at the site (centre and right) at the time of the site survey for this Memorandum.

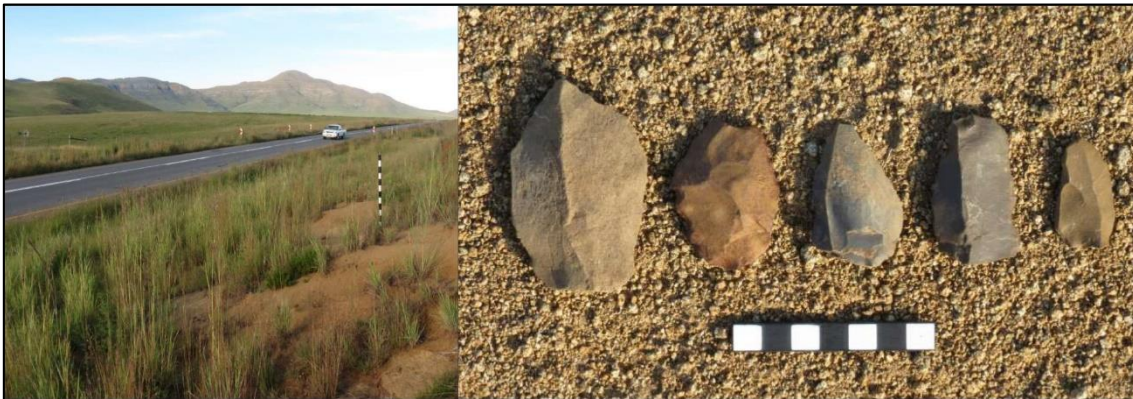
PGS identified a MSA site extending approximately 40m along the southern side of the road where it was exposed by a road cutting during the construction of the existing road. A very low density of 1 lithic per/m² has been established. The raw materials used for the stone tools include quartzite and hornfels. In view of the very low density of the lithics, PGS graded the site to be of Low significance.

Figure 11: General view of MAT 6 (left) and lithics observed at the site (right) at the time of the PGS HIA study.

PGS Site Code:	MAT 6
Coordinates:	S 30.44201 E 29.18297
Significance Rating (PGS):	Low significance Generally Protected C
Mitigation (PGS):	No Mitigation Required
Updated Mitigation Opinion:	Initial mitigation recommendations applicable. The ECO should provide a Close-Out Report after construction to review management procedures and ensure that effective measures were implemented.

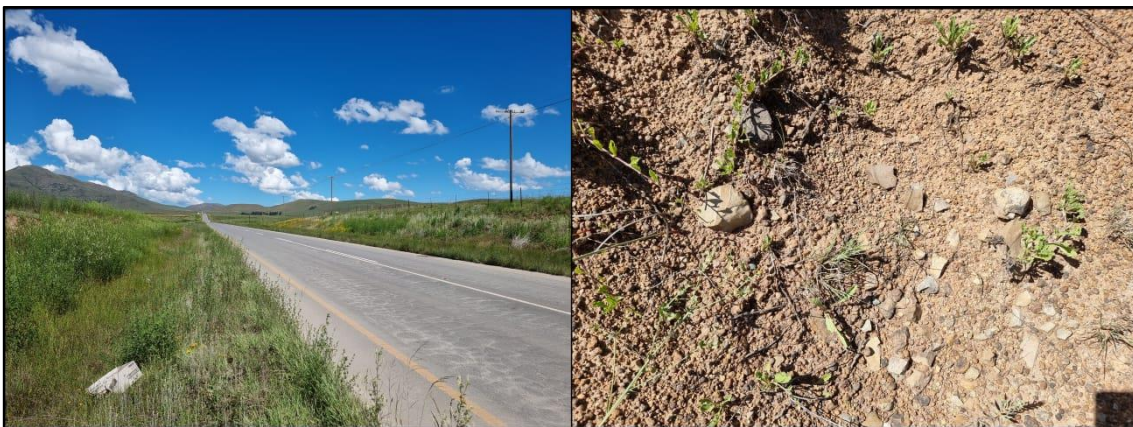
During the updated site survey (2022) some but not all of the lithics initially documented by PGS were located but the site seemed heavily eroded and the site significance grading (Low Significance) is maintained.

Figure 12: General view of MAT 6 (left) and lithics observed at the site (centre and right) at the time of the site survey for this Memorandum.

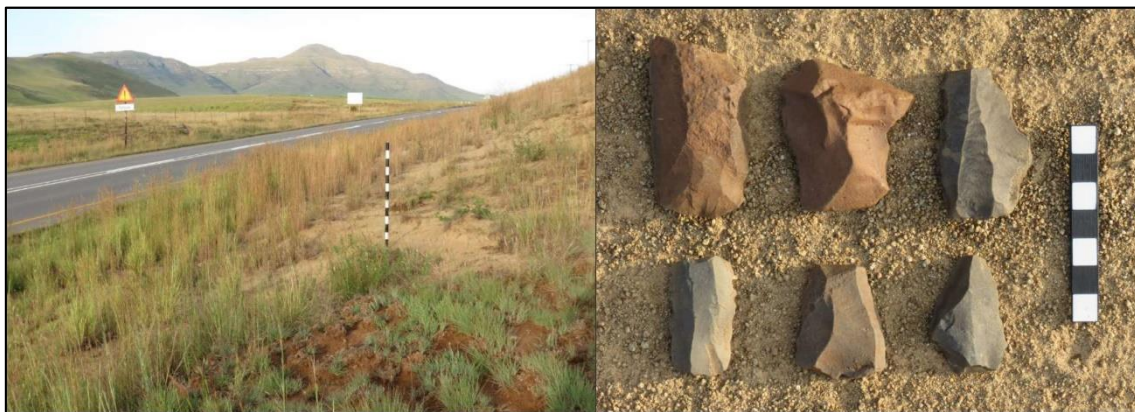
A low density scatter of MSA lithics that extends approximately 25m along the southern side of the road was documented by PGS. The locality was exposed by a cutting during the construction of the existing road. A very low density of 1 lithic per/m² was established. A similar range of raw materials for stone tool manufacture was used as found at the other sites, including the use of hornfels and quartzites. The convergent flakes and blade flakes were mostly produced on prepared cores. Evidence for utilization could be observed on some of the lithic specimens. Due to the very low density of the lithics, PGS graded the site to be of Low Significance.

Figure 13: General view of MAT 7 (left) and lithics observed at the site (right) at the time of the PGS HIA study.

PGS Site Code:	MAT 7
Coordinates:	S 30.44174 E 29.18128
Significance Rating (PGS):	Low Significance Generally Protected C
Mitigation (PGS):	No Mitigation Required
Updated Mitigation Opinion:	Initial mitigation recommendations applicable. The ECO should provide a Close-Out Report after construction to review management procedures and ensure that effective measures were implemented.

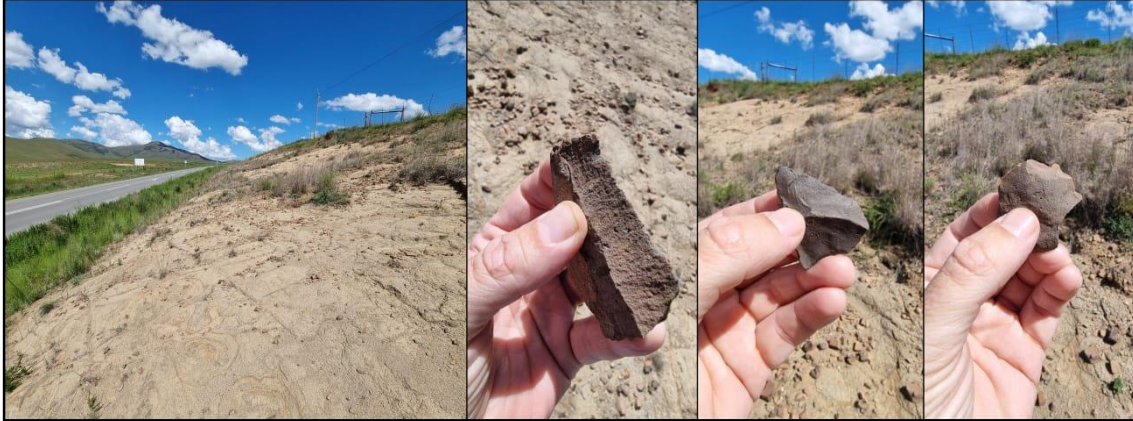
During the updated site survey (2022) some but not all of the lithics initially documented by PGS were located but the site seemed heavily eroded and the site significance grading (Low Significance) is maintained.

Figure 14: General view of MAT 7 (left) and lithics observed at the site (centre and right) at the time of the site survey for this Memorandum.

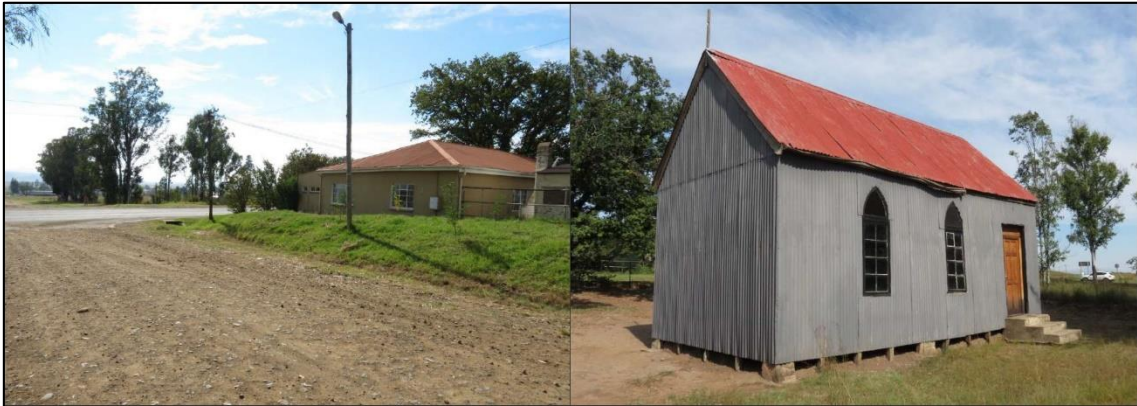
PGS noted that, according to the road reserve provided by the client, the proposed development footprint on the western side of Cedarville ends directly adjacent to an old house. This house is located on the southern side of the existing road. It was also noted that the road reserve ends against the stand of an old church on the northern side of the road. Although the church is located on the eastern end of the stand (with no structures or buildings evident on the remainder of the stand), this old corrugated iron church building has significant historical value and is located only 48m from the point where the road reserve ends. The house on the southern side of the road is certainly older than 60 years, and a number of outbuildings are associated with it, including a rondavel. The old church building is in all likelihood even older, and may very well be older than 100 years. The church appears to be the St. Michael Anglican Church (www.artefacts.co.za), but the exact history or age of this church building is not presently known. An area of roughly 100m by 100m incorporates both the old house and its stand, as well as the old church and its stand. Both buildings are older than 60 years, with the church quite likely older than 100 years as well. As a result, PGS graded the site to be of Medium Significance.

Figure 15: General view of MAT 8 at the dwelling (left) and the old church (right) at the time of the PGS HIA study.

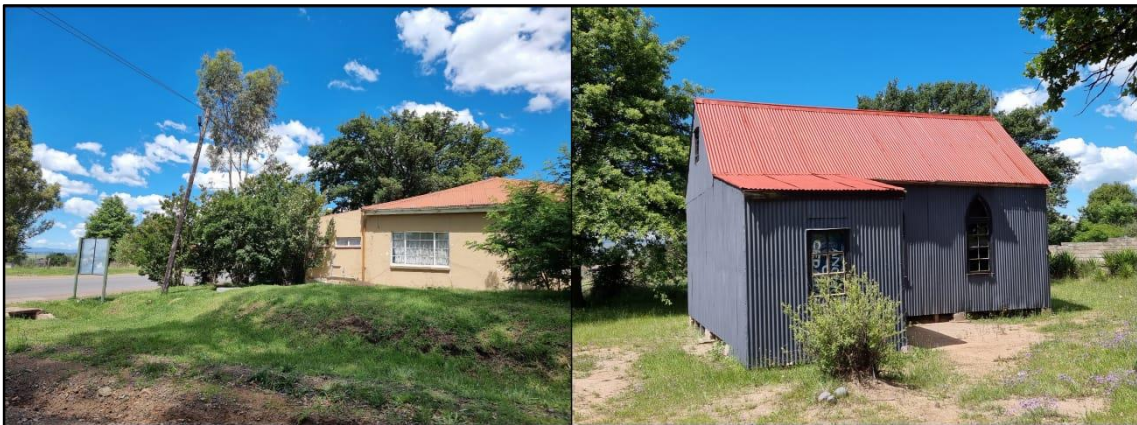
During the updated site survey (2022) it was noted that the dwelling and the church remains more or less in the same state of preservation and the site significance grading (Medium Significance) is maintained.

Figure 16: General view of MAT 8 at the dwelling (left) and the old church (right) at the time of the site survey for this Memorandum.

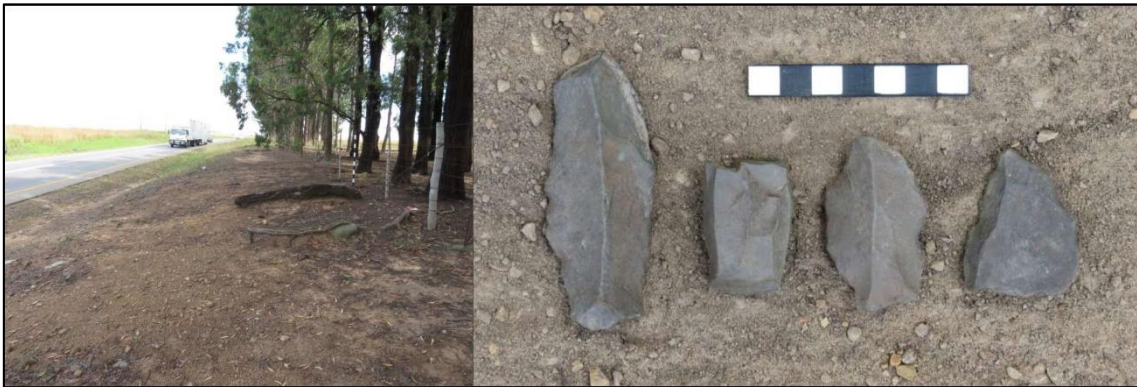
Another MSA site was identified by PGS. While widely scattered lithics of very low density were observed over an area that extends approximately 30m along the northern side of the road, the highest density recorded at the site was 5 lithics per/m². This latter concentration of lithics was found to be highly localised and seems to have been the result of the

excavation of a drainage channel next to the tar road. It is clear therefore that the lithics from the site are all in secondary context. The sample of lithics observed at the site contains typical MSA tool types such as blades and a convergent flake, again produced on prepared cores. Several of the stone tools exhibit utilization marks. In view of the secondary context of the lithics as well as the relatively low density of lithics found across the site, PGS graded the site to be of Low Significance.

Figure 17: General view of MAT 9 (left) and lithics observed at the site (right) at the time of the PGS HIA study.

PGS Site Code:	MAT 9
Coordinates:	S 30.38759 E 28.96879
Significance Rating (PGS):	Low Significance Generally Protected C
Mitigation (PGS):	No Mitigation Required
Updated Mitigation Opinion:	Initial mitigation recommendations applicable. The ECO should provide a Close-Out Report after construction to review management procedures and ensure that effective measures were implemented.

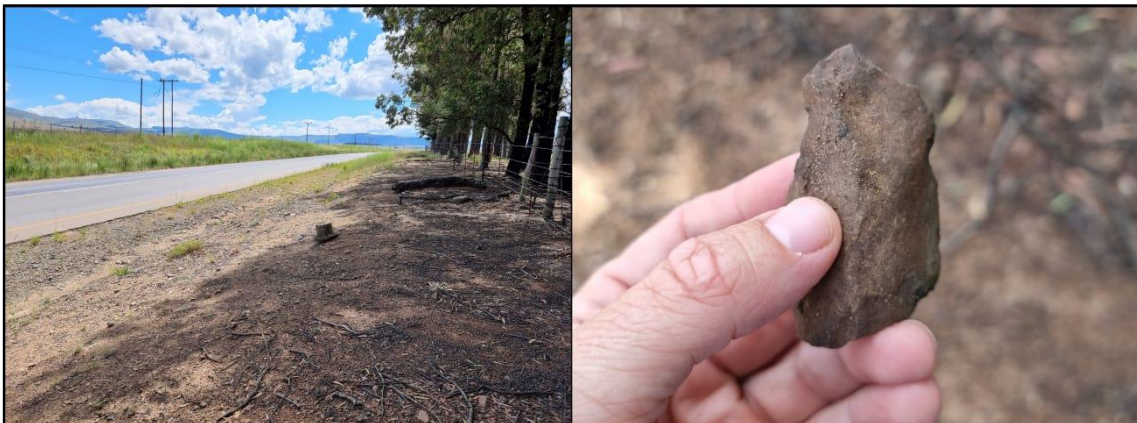
During the updated site survey (2022) none of the lithics initially documented by PGS were located and the site seemed heavily eroded. The site significance grading (Low Significance) is maintained.

Figure 18: General view of MAT 9 (left) and lithics observed at the site (centre and right) at the time of the site survey for this Memorandum.

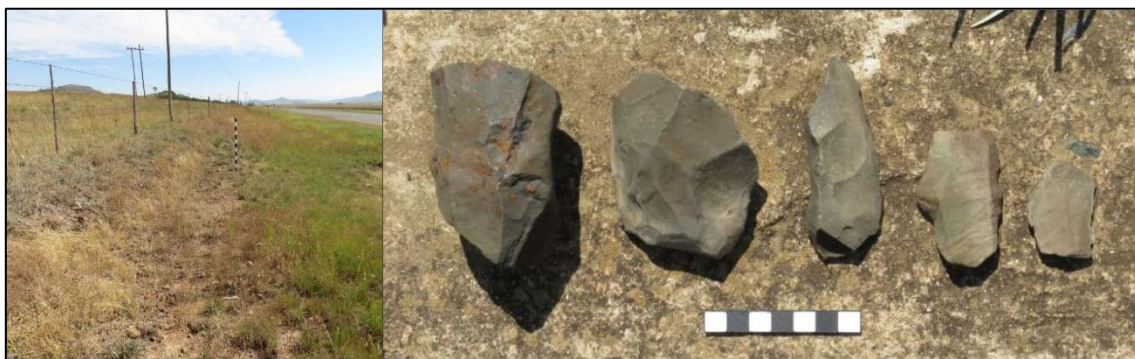
PGS noted another MSA site over an area that extends approximately 30m along southern side of the road where the stone tools were exposed by a cutting made during the construction of the road. The highest density of lithics observed at the site is 3 lithics per/m². The sample of lithics observed at the site includes typical MSA cores and blade flake forms. Even though the site exhibits a relatively low density of lithics, the presence of some cores resulted in PGS grading the site to be of Medium significance.

Figure 19: General view of MAT 10 (left) and lithics observed at the site (right) at the time of the PGS HIA study.

PGS Site Code:	MAT 10
Coordinates:	S 30.38100 E 28.93091
Significance Rating (PGS):	Medium significance Generally Protected C <i>A downscale of the site significance grading from Medium Significance to Low Significance should be considered.</i>
Mitigation (PGS):	Archaeological monitoring of sites during construction phase. Should any significant deposits or artefacts be exposed, small-scale archaeological excavation work will be required which adheres to standard practice and method.
Updated Mitigation Opinion:	It should be considered to downscale initial mitigation recommendation to general site monitoring with small-scale archaeological excavation work which adheres to standard practice and method, should any significant deposits or artefacts be exposed. The ECO should provide a Close-Out Report after construction to review management procedures and ensure that effective measures were implemented.

During the updated site survey (2022) only a few of the lithics initially documented by PGS (and no cores) were located and the site seemed heavily eroded. A downscale of the site significance grading from Medium Significance to Low Significance should be considered due to the low density of lithics and the general absence of formal tools.

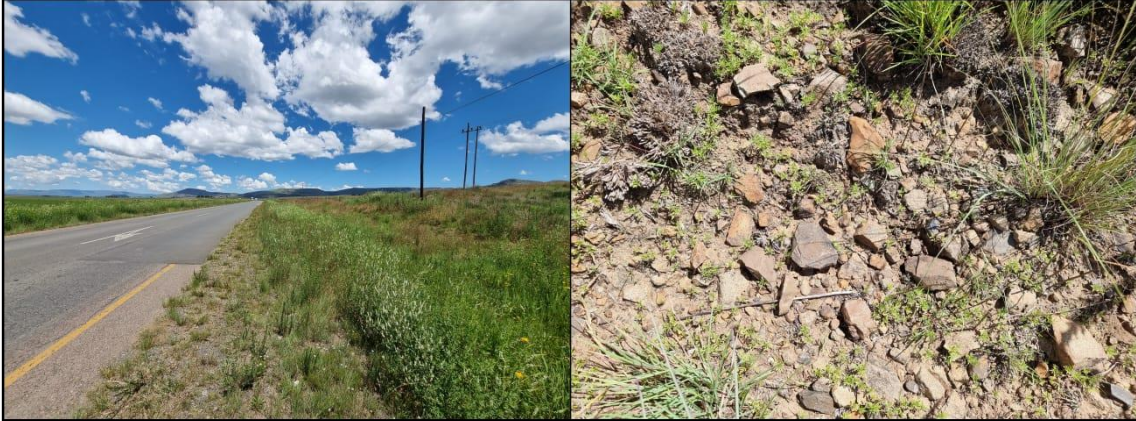
Figure 20: General view of MAT 10 (left) and lithics observed at the site (centre and right) at the time of the site survey for this Memorandum
