HERITAGE IMPACT ASSESSMENT

27 February 2013

DR 01458 Cape Winelands

Prince Alfred – Cape Winelands District Municipality, Western Cape

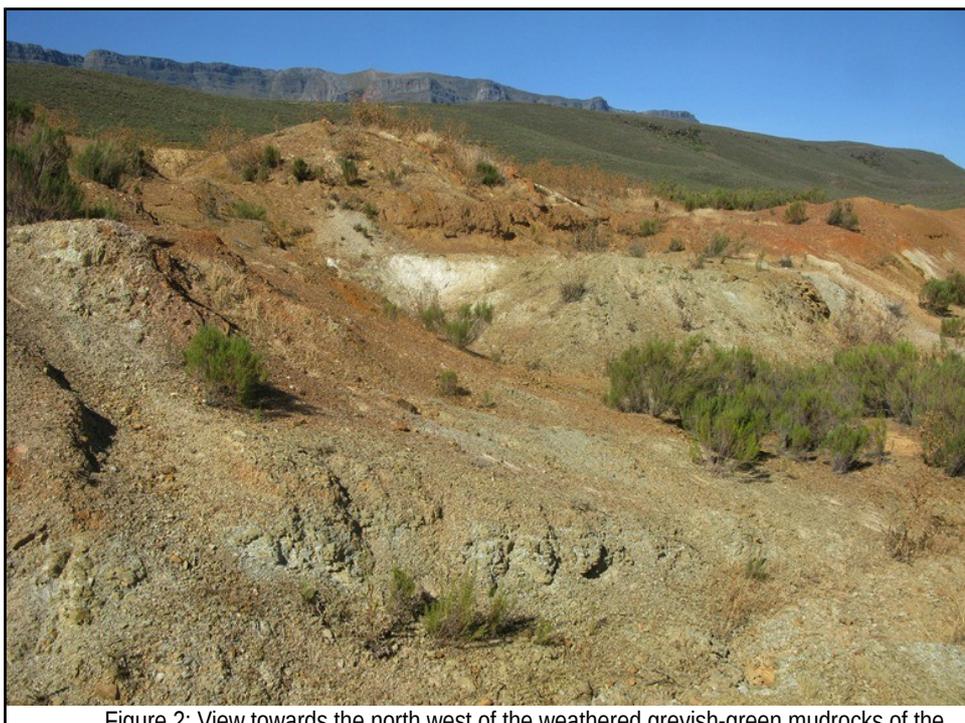
Figure 2: View towards the north west of the weathered greyish-green mudrocks of the Tra Tra Formation (Almond 2013: 4)

Dr John Almond conducted a palaeontological field assessment and provided a report outlining geological context, palaeontological heritage and palaeontological sensitivity. The small borrow pit overlies Middle Devonian marine mudrocks of the Tra Tra Formation (Bokkeveld Group, Ceres Subgroup). This formation has yielded assemblages of shelly invertebrate fossils elsewhere in the Warm Bokkeveld region (e.g. Waboomberg / Theronsberg Pass area northeast of Ceres), but only sparse, small nuculid bivalves and possible vertical burrows are recorded from the Prince Alfred Hamlet area.

A previous desktop basic assessment of the borrow pit site assessed palaeontological heritage sensitivity as moderate due to the presence of potentially fossiliferous sediments of the Lower Bokkeveld Group (Ceres Subgroup). However, Due to extensive chemical weathering of the bedrocks the palaeontological sensitivity of the study site is rated as low (Almond, 2012: 6).

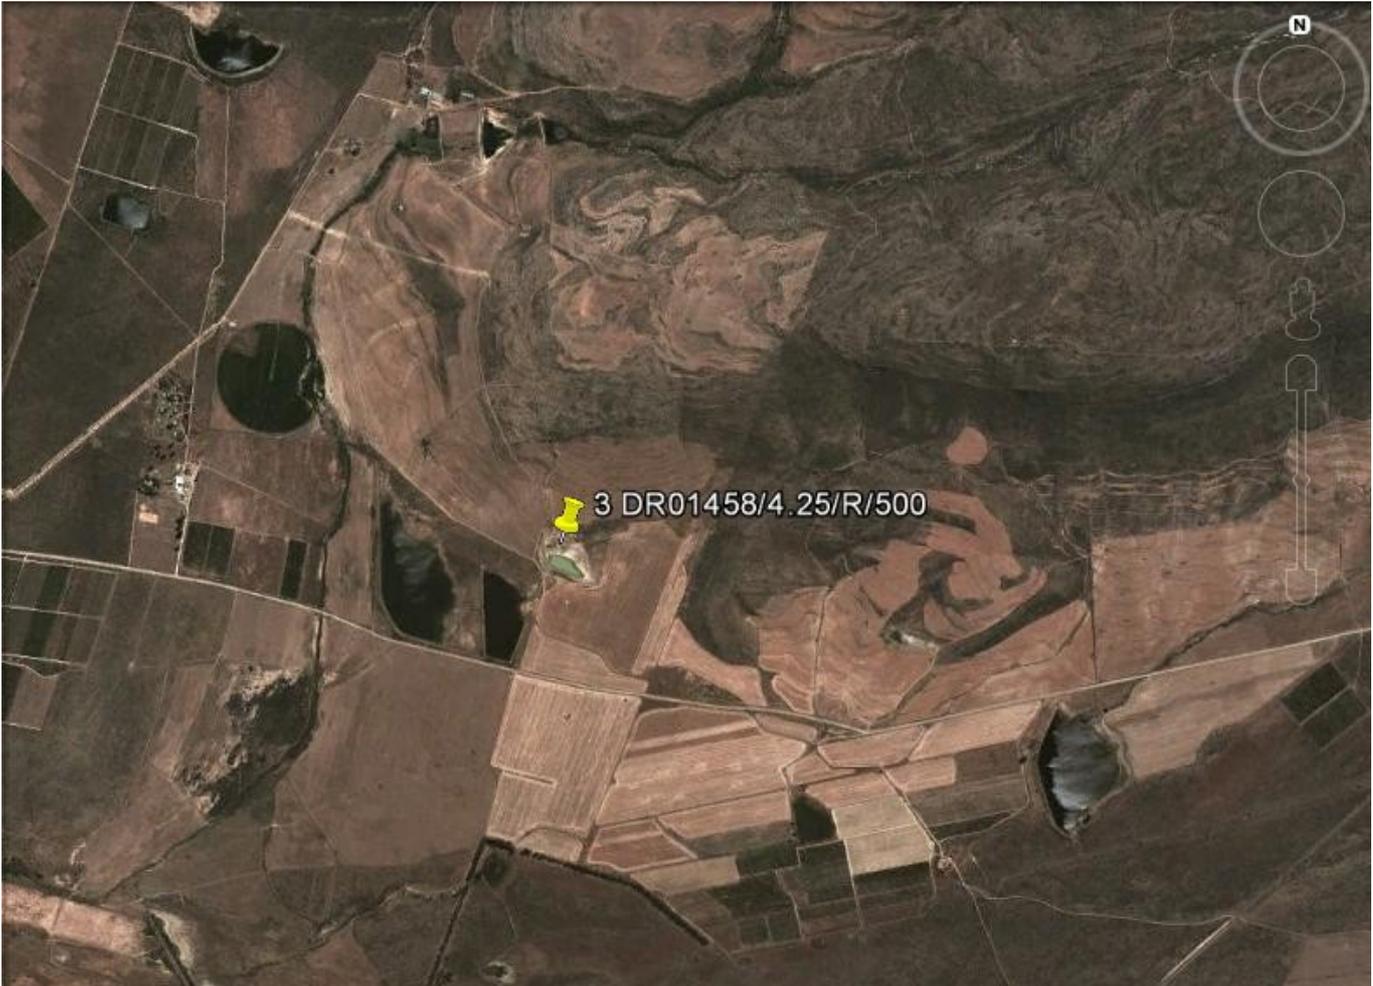
Figure 3: Aerial view of potential borrow pit location (Google earth image, February 2013)
