HERITAGE IMPACT ASSESSMENT

27 February 2013

DR01457 Cape Winelands

Touwsrivier – Cape Winelands District Municipality, Western Cape

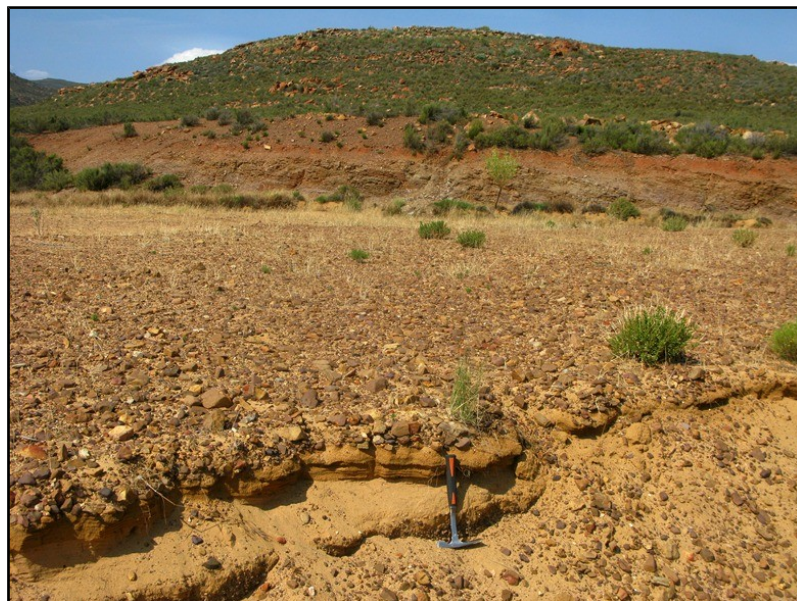
Figure 2: View northeastwards across borrow pit whose floor is largely mantled by sandy and gravelly alluvium (Almond 2013: 5)
