HERITAGE IMPACT ASSESSMENT

DR 02244 Cape Winelands

Ceres – Cape Winelands District Municipality, Western Cape

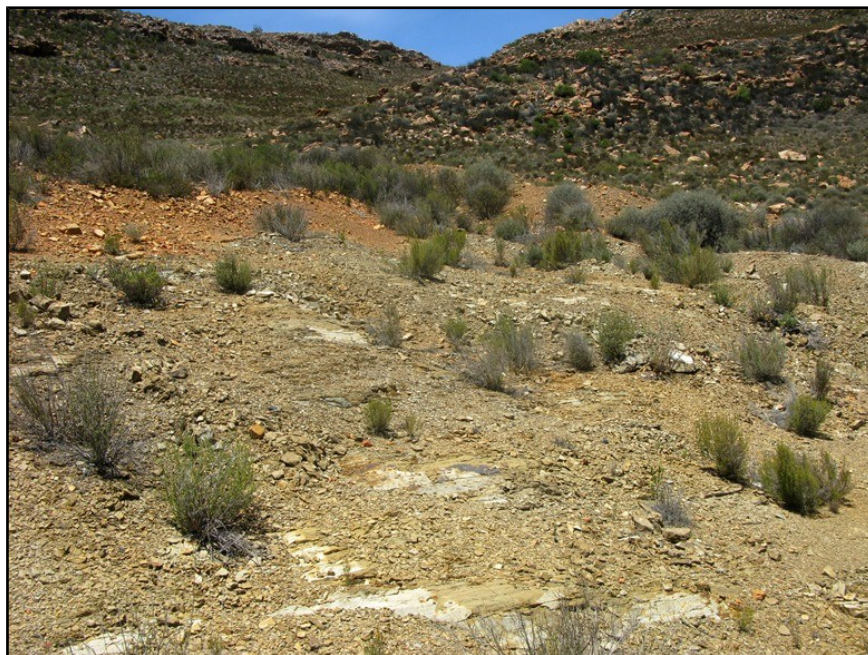
Figure 2: View towards the NE across borrow pit (Almond 2013: 5)

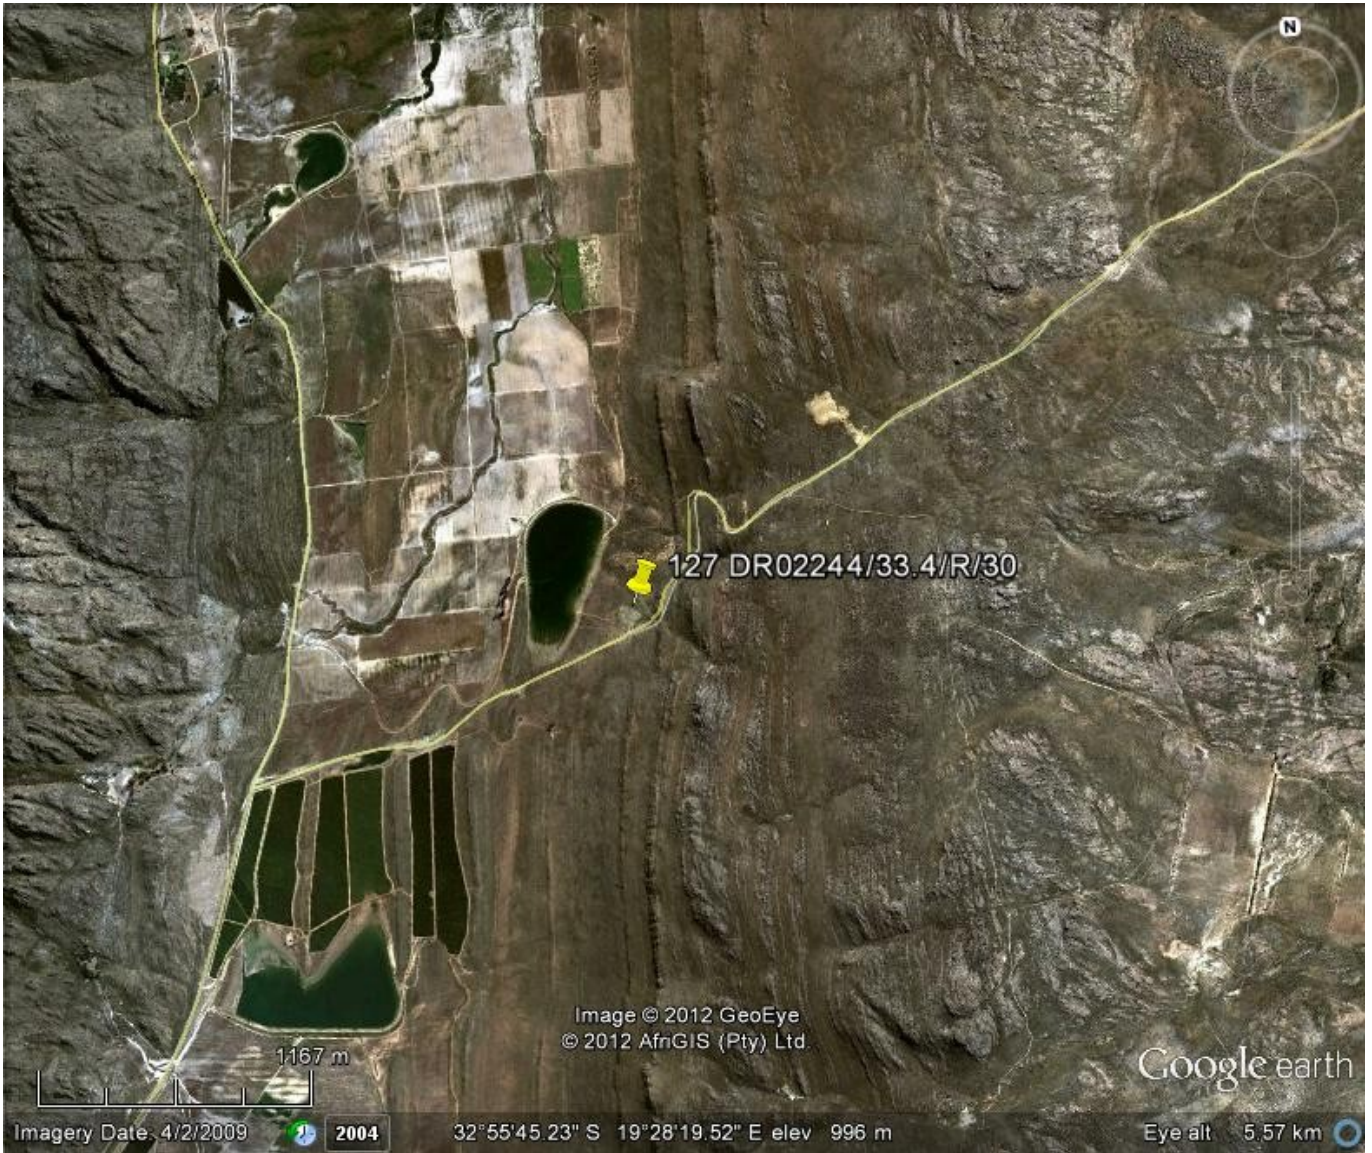
Figure 3: Aerial view of existing borrow pit location (Google earth image, February 2013)
