# HERITAGE SPECIALIST STUDY:

## Scoping and Environmental Impact Assessment (EIA) Processes for the Proposed Development of a Solar Photovoltaic Facility (Kudu Solar Facility 3) and associated infrastructure, near De Aar, Northern Cape Province

SAHRA Case ID: 20338

Final report: 23 May 2023

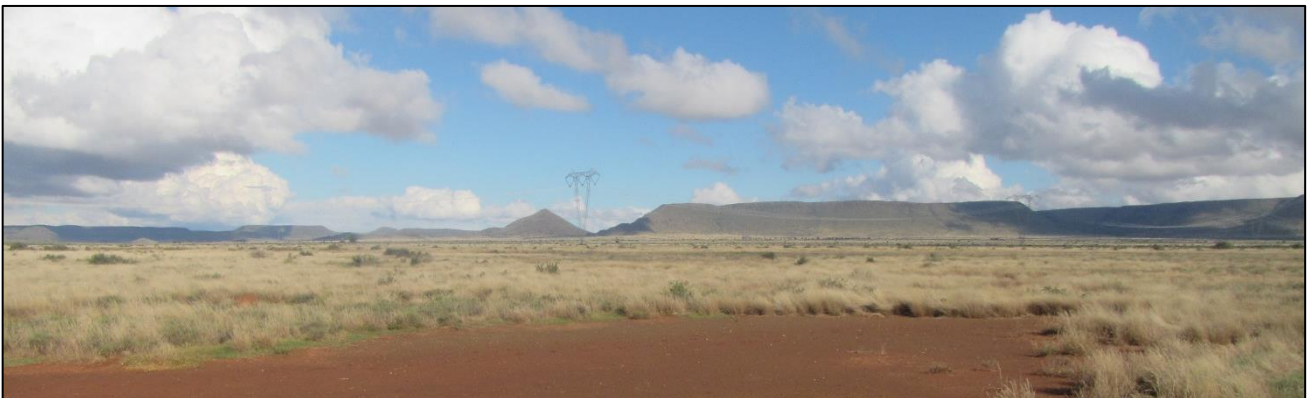
The Kudu PV3 facility study area is flat, open grassland and lacks any features. The nearest dolerite hill is just over 1.2 km to the northeast. Figure 9 shows a view across part of the PV3 area but taken from just outside the footprint in an area excluded from development.

**Figure 9:** View towards the south over the western part of the PV3 footprint but taken from outside the site.

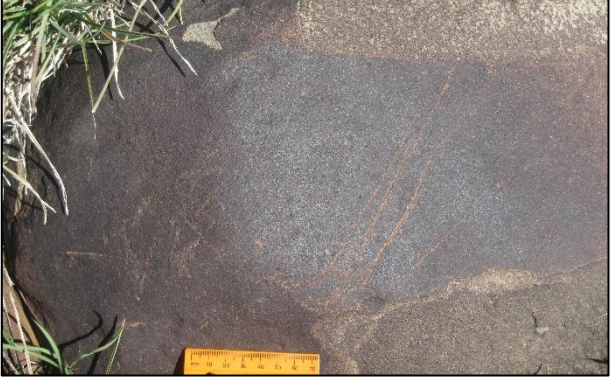
959	S30 07 53.1 E24 24 52.6	This point is at the northern end of the wall recorded under waypoint 957.		High IIIB
960	S30 07 53.3 E24 24 52.0	A dolerite rock with some scratches on it.

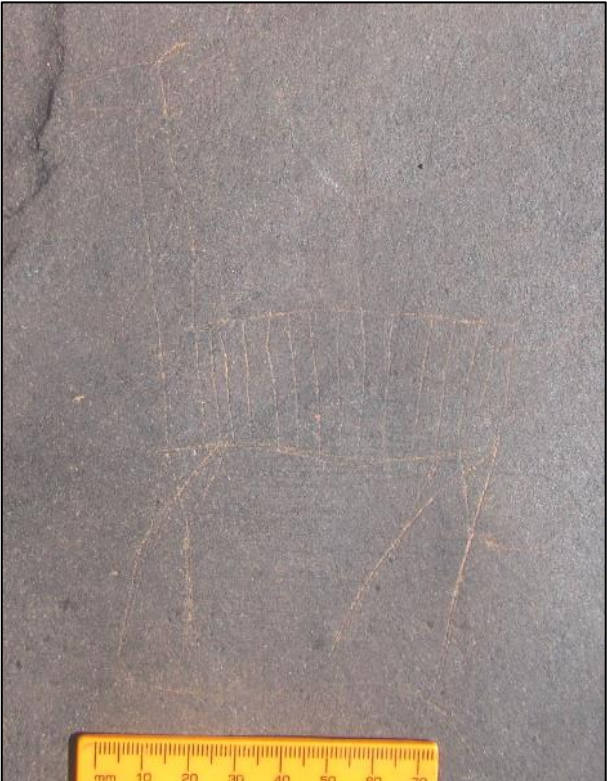
961	S30 07 53.4 E24 24 51.9	<p>Two historical scratched horse engravings and a few other images. The horses are identical in design, but the one is far smaller (and clearer) than the other. The large one is above the scale in the photograph below, while the smaller is indicated by the yellow arrowed. There is also a patch of multiple parallel lines that is very well patinated and must be far older (red arrow).</p>

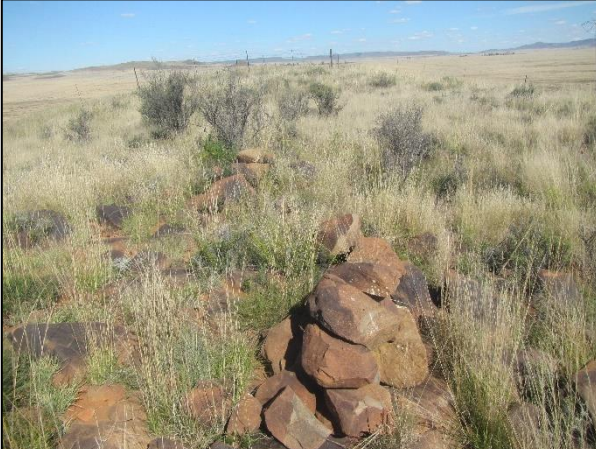
977	S30 09 21.7 E24 23 25.1	A small stone cairn. Feature apparently related to the ABW.

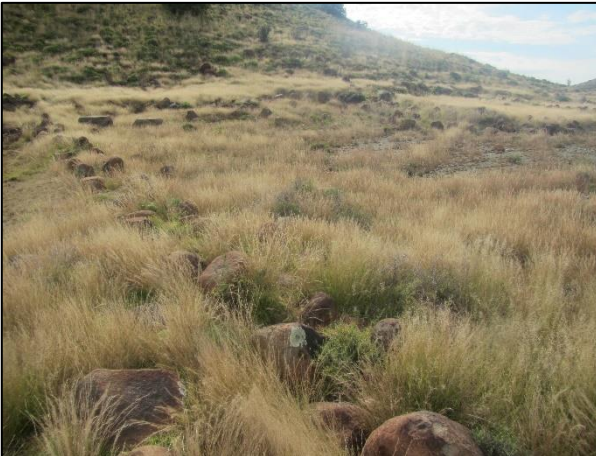
Very low GPC
985	S30 11 10.5 E24 23 53.6	The poorly preserved remains of a stone-walled kraal measuring about 18 m by 37 m and located on the foot of a dolerite hill. Although the site was not examined in detail, some glass, ceramics and metal fragments were seen.

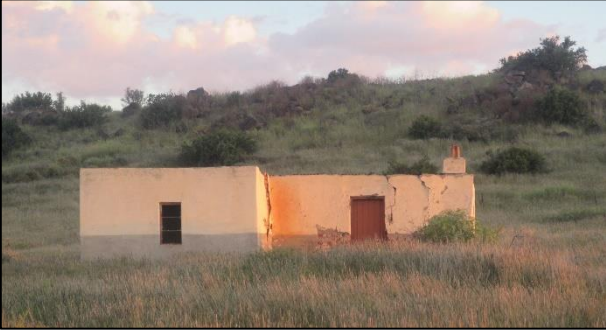
1008	S30 14 30.9 E24 19 35.9	The oldest-looking of a set of three different labourers' cottages. It is in poor condition and is probably early-mid-20 <sup>th</sup> century.

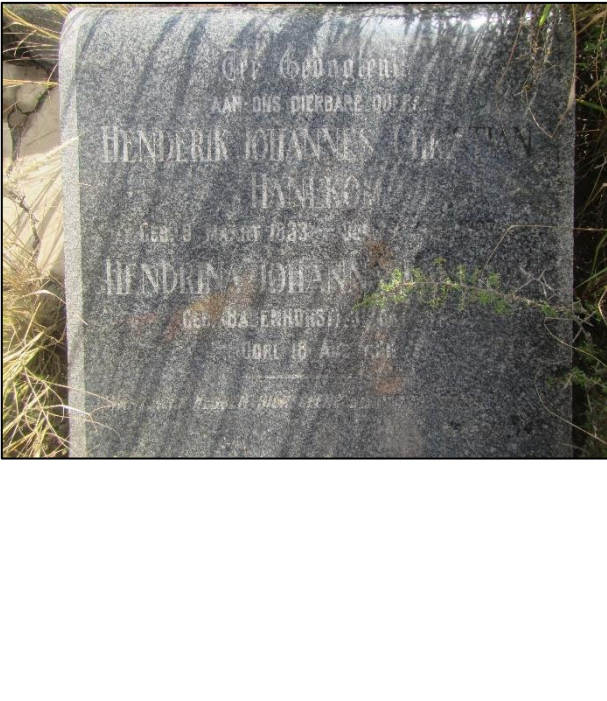
Very low GPC
1038	S30 14 26.7 E24 19 17.1	A heavily overgrown (with grass) but fenced (with a now derelict wire fence) graveyard to the west of the Basberg fam complex. It is impossible to count the graves. There is one double grave for “HENDRIK JOHANNES CHRISTIAN HANEKOM” who lived from 1833 to 1907 and his wife “HENDRINA JOHANNA” who died in 1901 (birth date illegible) and whose maiden name was Badenhorst. These may be the parents of the Badenhorst who left his name at waypoint 1016. Another grave has a stone lying loose on top of it with much cursive writing on it. It is very difficult to read but bears dates that look like 1826 and 1891 near the base. The name “Badenhorst” also appears near the top and at the very base of the stone. There are several graves that only have dolerite cobbles packed over them.

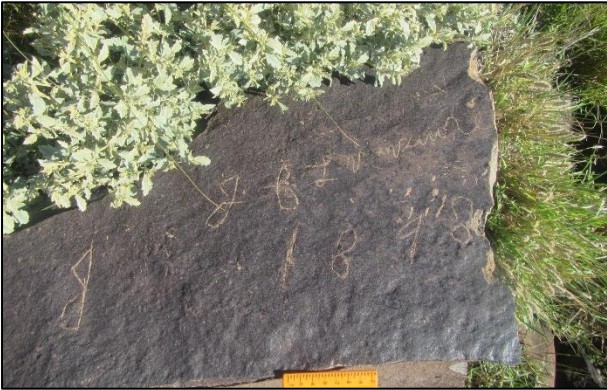
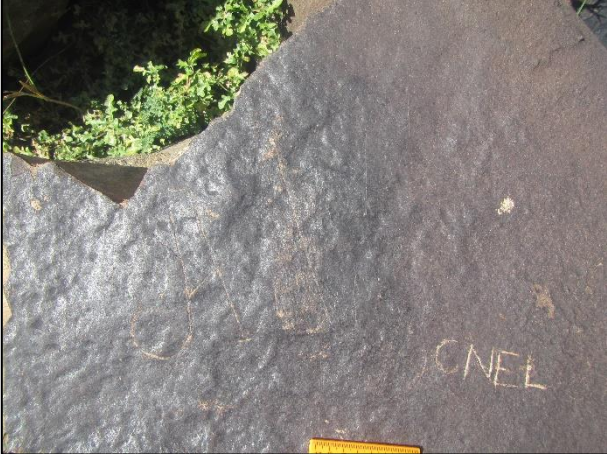
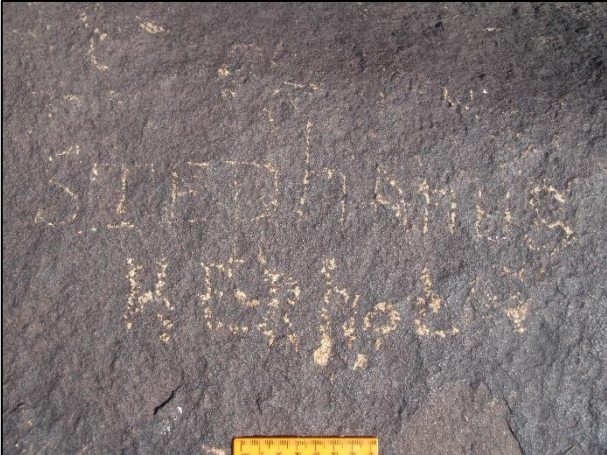
Medium GPA
1057	S30 11 46.4 E24 17 44.3	<p>Four boulders on a dolerite hill with various inscriptions as follows: "STEPHANUS", "CNEL", "J.C.L. v. Vuure..." (middle initial uncertain and right hand end of rock broken) with "1898" below it and another name on a broken rock that includes "VAN VUU...". Some other graffiti is unclear.</p>

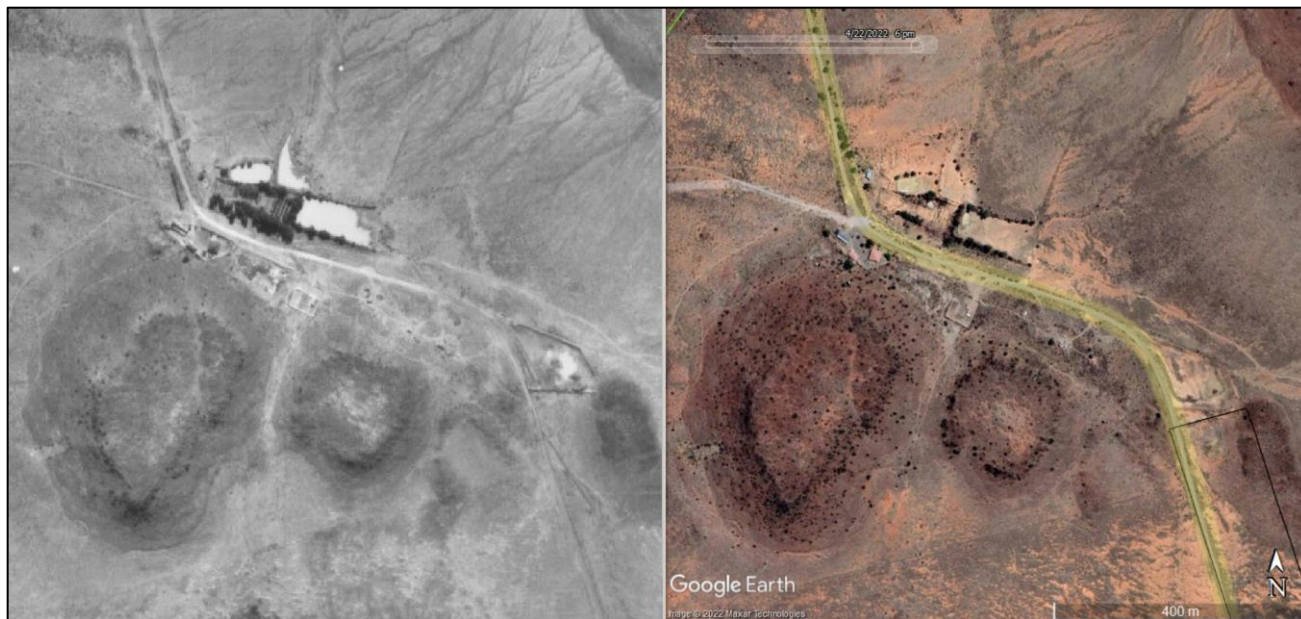
**Figure 14:** 1974 (738\_025\_12970) and modern (Google Earth) views of the Basberg farm complex (on Portion 3 of Basberg 88). All structures present today were present in 1974 as well (waypoint 1008).

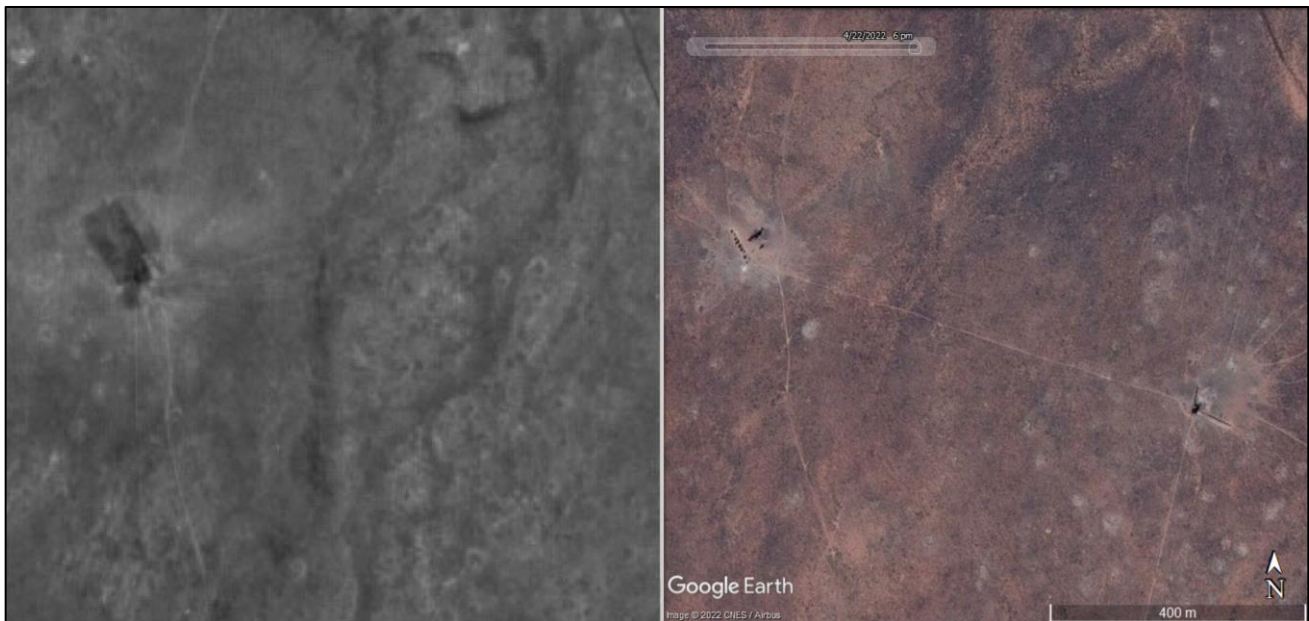
**Figure 16:** 1968 (611\_012\_00356) and modern (Google Earth) views of two watering points on Portion 1 of Annex Wolwe Kuilen 41. It is evident that there was more activity at the western one in 1968, while the eastern one was not yet present at that time. These are close to PV11 and are illustrated here as an example.
