HERITAGE WALKDOWN REPORT

**for the approved Brandvalley WEF near Matjiesfontein in the Western and
Northern Cape**

CTS HERITAGE

September 2021

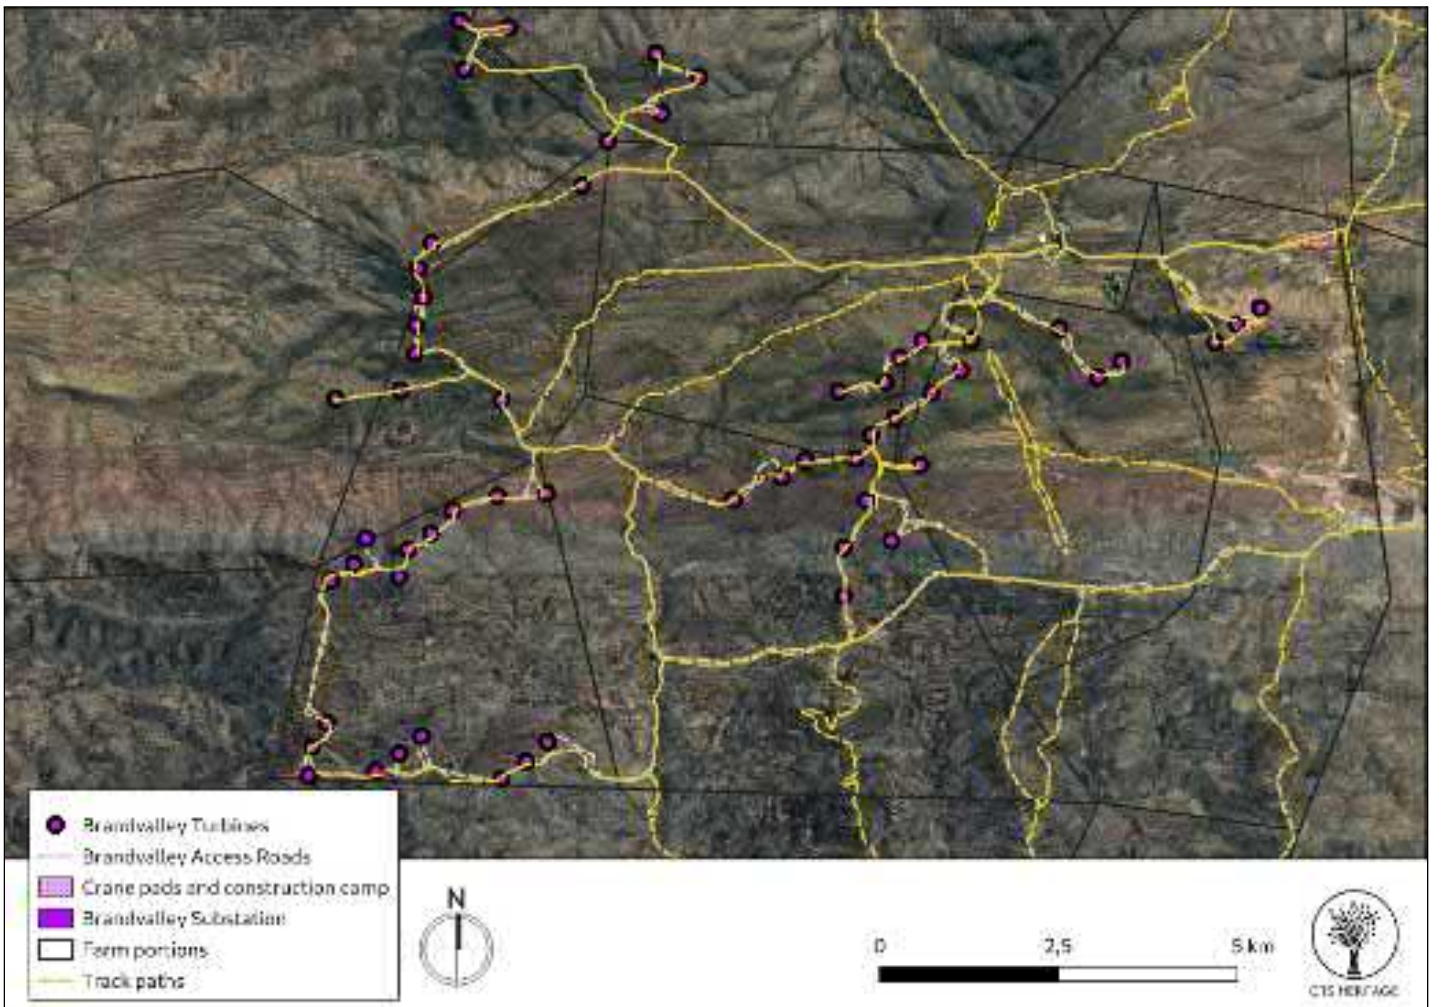
Figure 6.: Overall track paths of foot survey
