Heritage Report

of 32/34 Buiten Street, Erf 3114, Bokaap, Cape Town

22 January 2013

compiled by Till Manecke - Architect

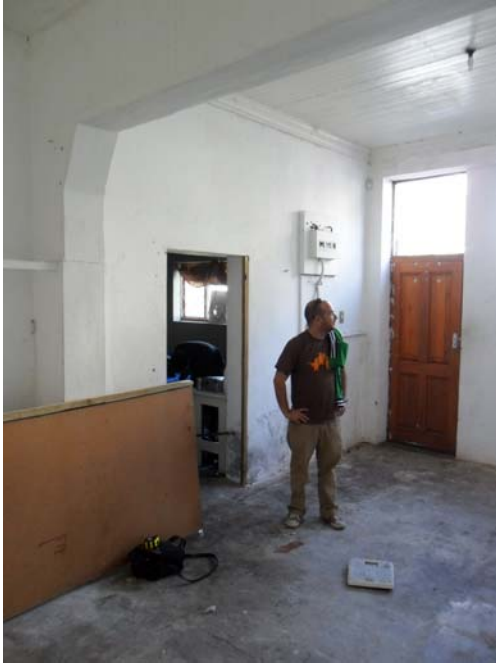
Room 1 & 2

The interior of the ground floor has been modified and changed and apart from the staircase, one door frame/architrave, some ceilings and the position of the main walls, not much of the original fabric is obviously apparent. Only room 7 still has timber floors.

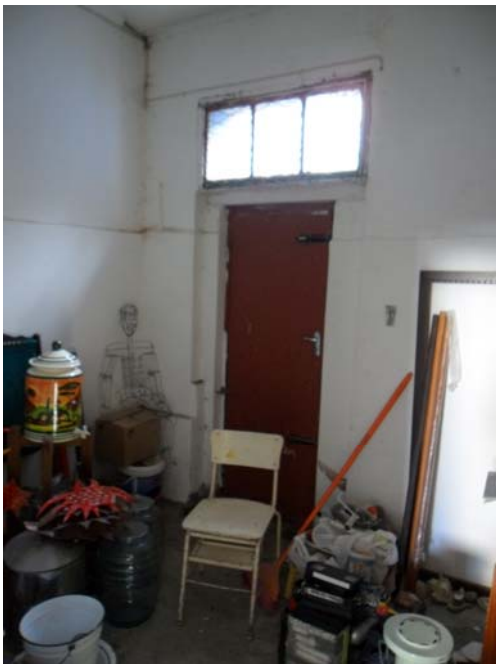
The window & door openings have mostly been changed and in some cases the previous positions are partly visible (see Room 3 door above).

Where the walls between room 3 & 7 and towards 1 & 8 are to be removed, their previous existence will remain evident, by brick down stand 'beams' coming down from the ceiling, under which steel beams will carry the structure to a central steel column. This way the original structure of the building will remain evident. The timber floors above remain intact and are not affected by this change.

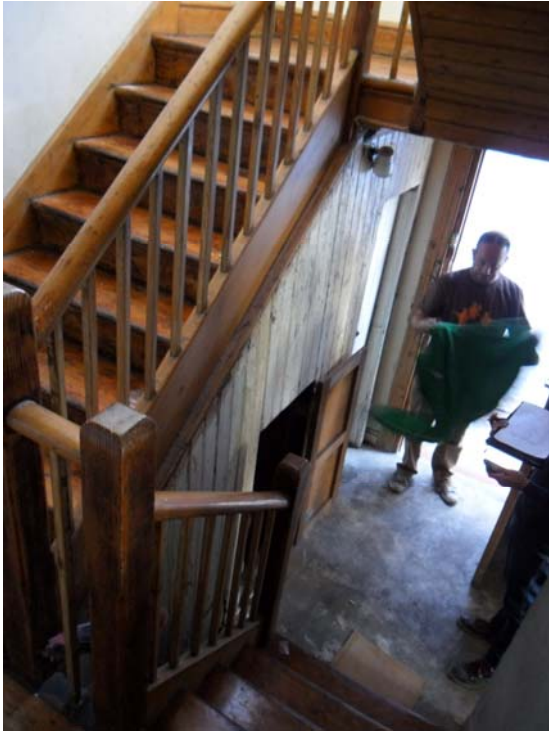
Room 6 stairwell

The first floor, on the other hand is in relatively good condition and the interior reflects the common Victorian style. Wide Oregon pine floorboards & skirtings, Oregon architraves & door frames as well as t&g ceiling boards & cornices. Only the facades and window openings have been altered and changed in an unsympathetic manner.

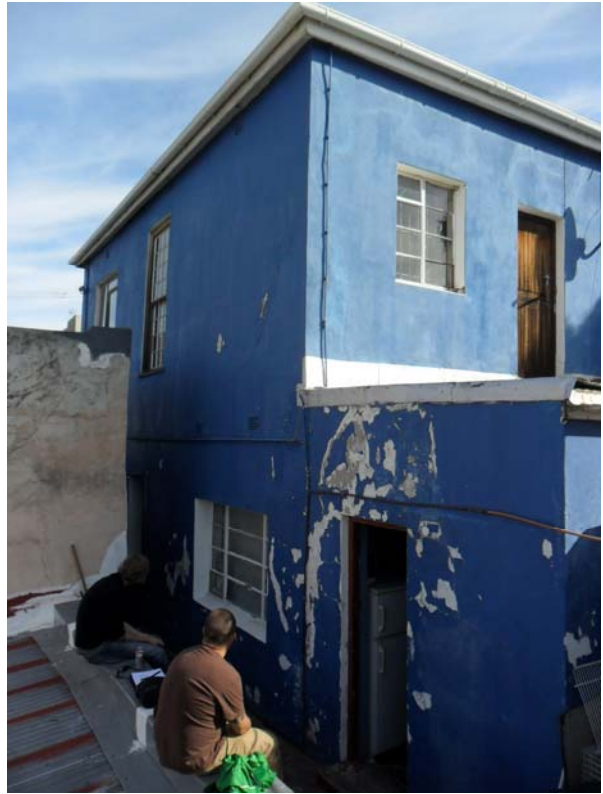
The windows would have been timber sash windows, but only one with cottage pane subdivision remains in the stairwell. It doesn't seem like an original window either, given its good condition. The rest have been replaced by steel & timber windows and the original window proportions have not been kept.

East & part North elevation

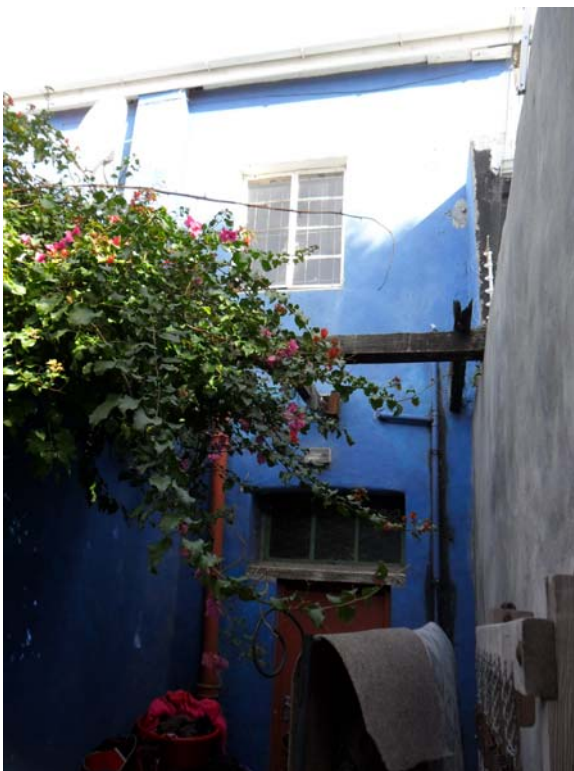
Part North elevation

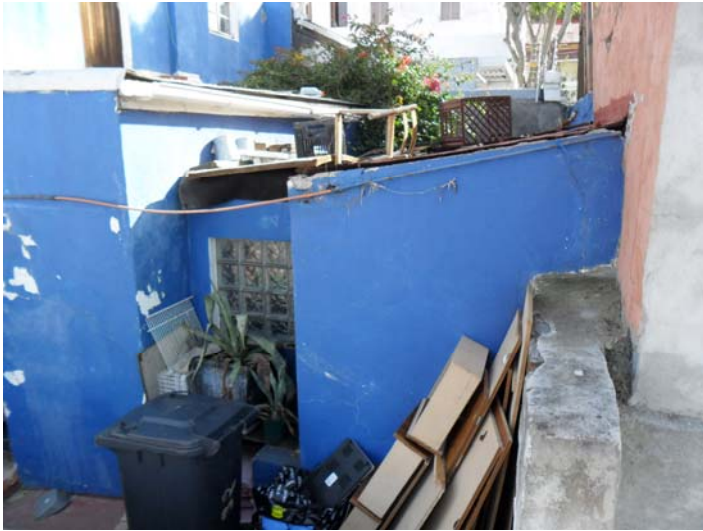
Out house connected to rear of building

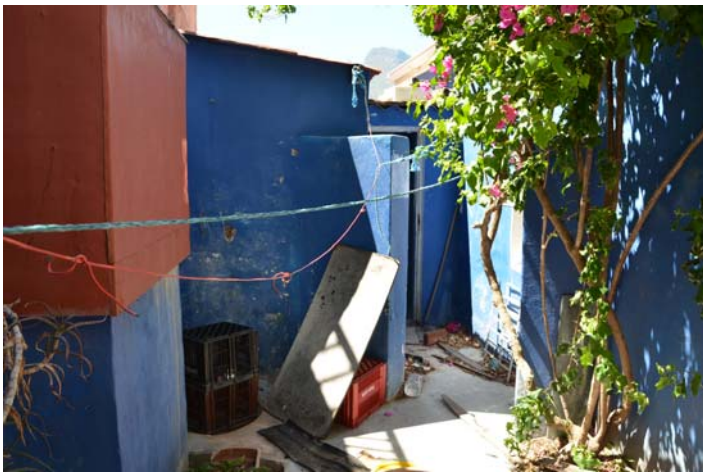
Back courtyard with out house

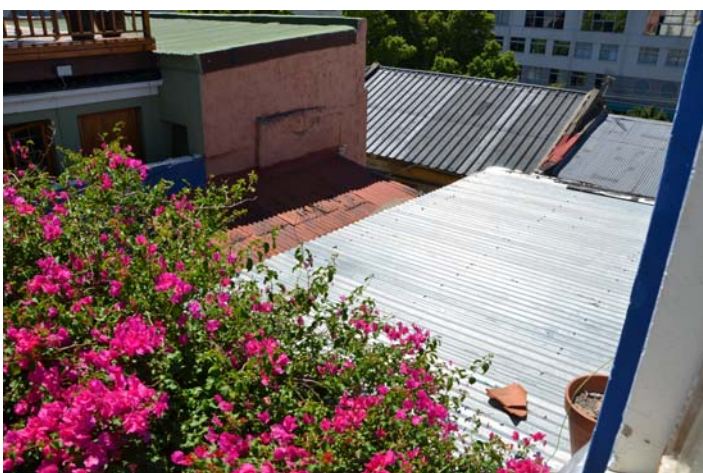
Courtyard & building seen from first floor

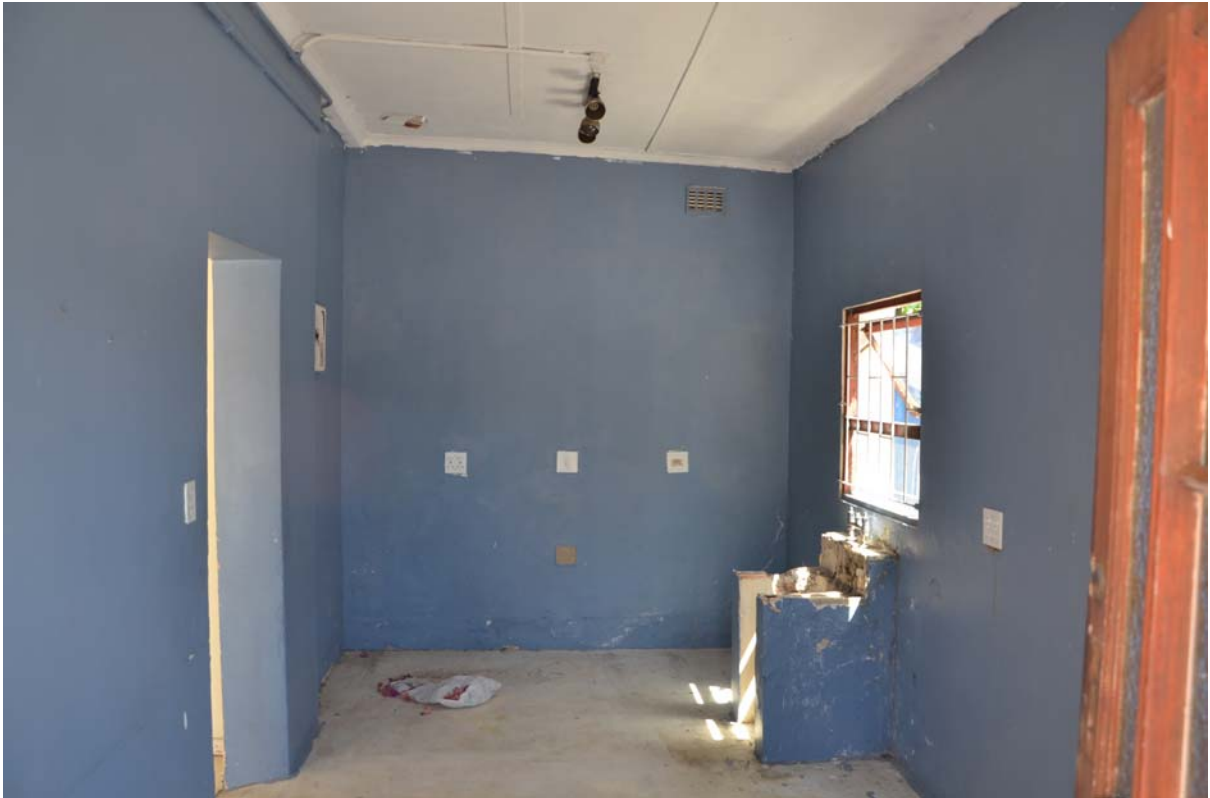
Room 8 (to be partially demolished) shows no traces of its age or time

The most significant changes to the existing building are the proposed demolition of the outbuildings and part of the lean to ground floor back of the house. The intention is to reduce the width of the lean to back section of the house and incorporate it into the living area, that is going to be created out of the rooms 3 and 7 and part of 8. This creates a external courtyard and an internal living area that are wide enough to function properly. Both room 8 and the out house room 10 have no externally visible features that show their age and any significance. Their removal (and that of the other elements in the courtyard from 1954) will reveal the packed stone wall/foundation that forms the northern boundary of the courtyard, which is both attractive and part of the character of the area.

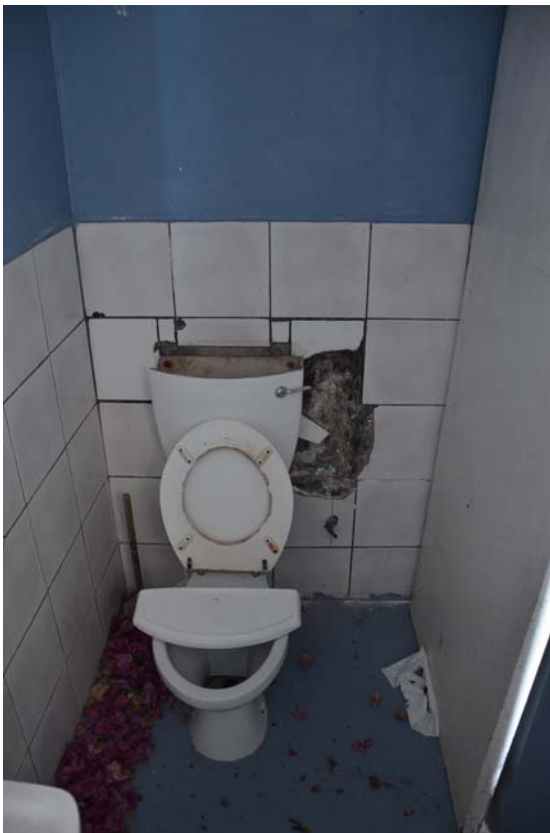
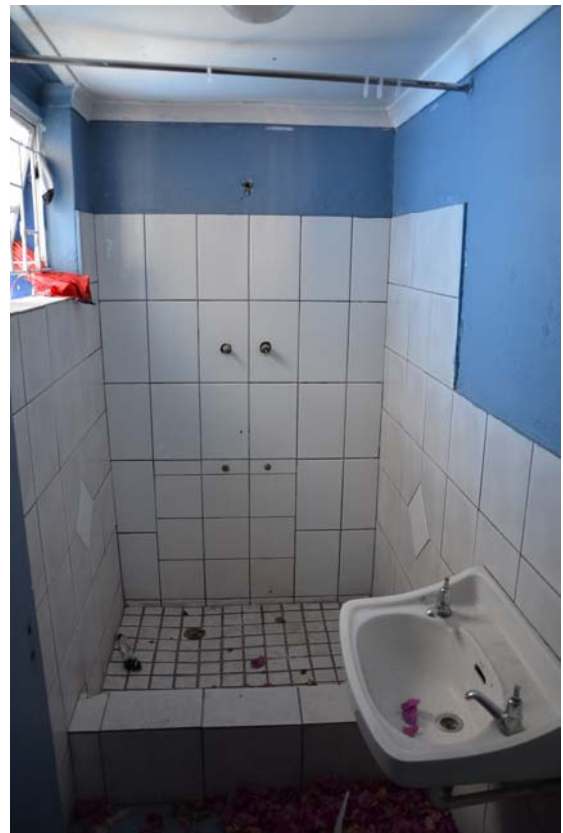
The out house (room 10 to be demolished) similarly shows no traces of its age or time

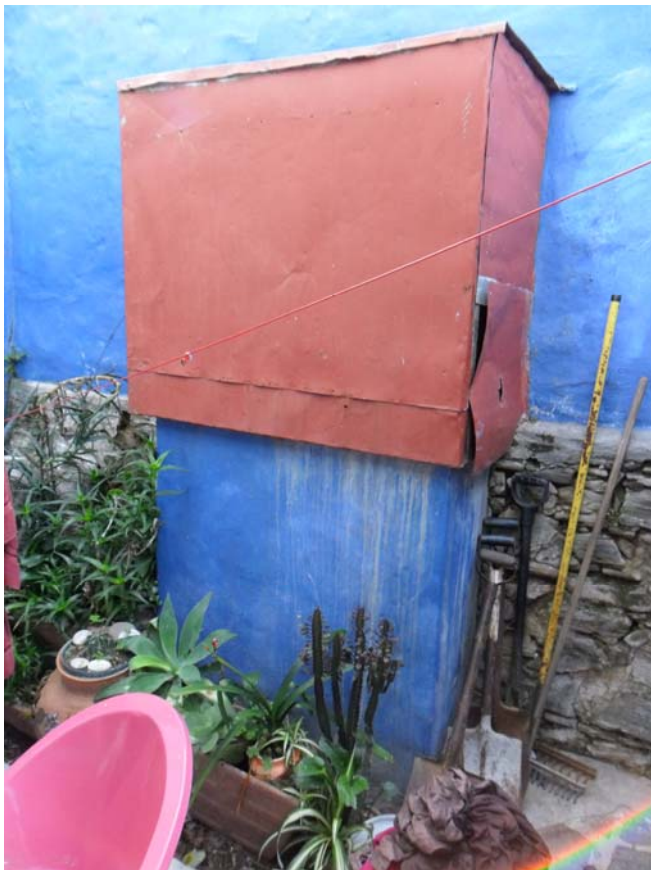
The packed stone wall that will be revealed after the proposed demolition
