ANNEXURE A

DROSTDY AND STRETCH'S COURT FABRIC ANALYSIS

DROSTDY FABRIC ANALYSIS METHODOLOGY

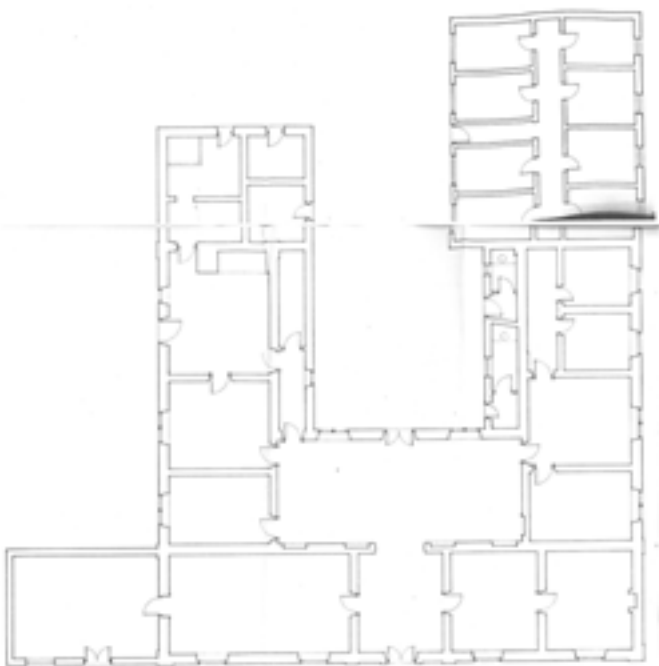
FIGURE 3: Drosty Hotel Victorian additions c. 1879 [SAHRA: 3/K/Graaff/1]

A set of floor plans were drawn up for the various stages of intervention and styles which the building had been exposed to from 1804 to the time of the restoration. These are illustrated in figures 1, 2, 3 and 4 on the following pages.

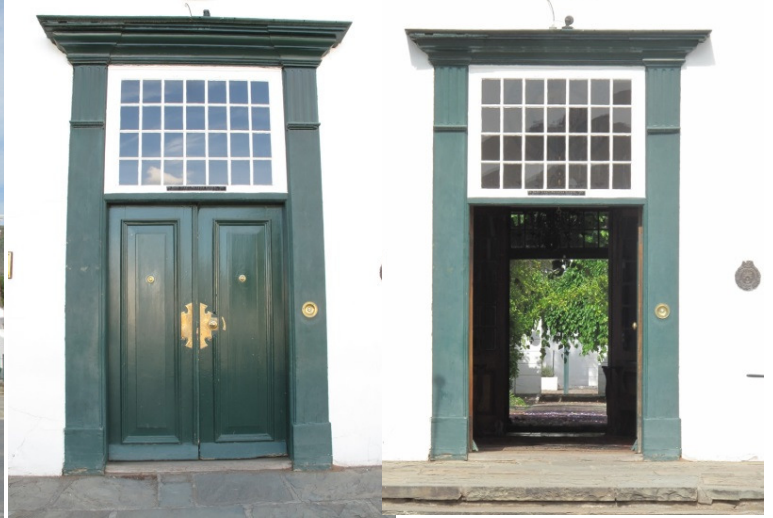
Front door detail [east elevation]

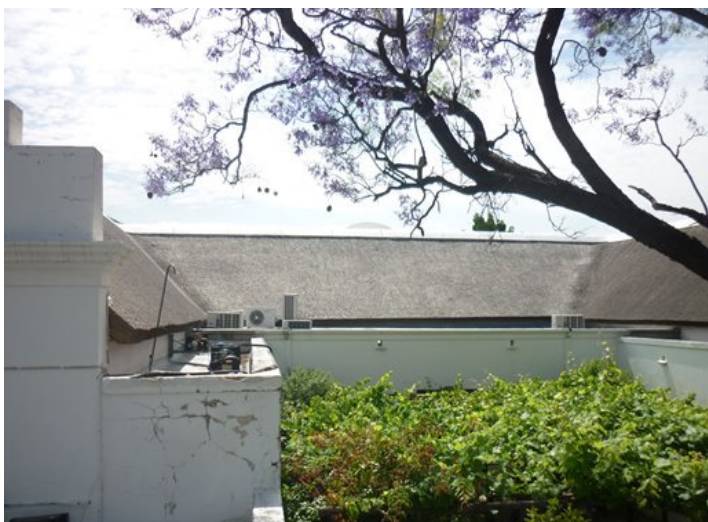
Roof structure [facing east]

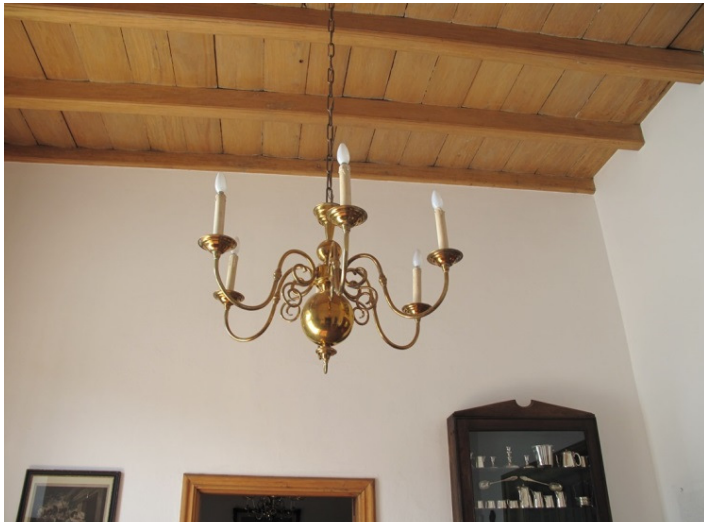
Typical ceiling and light fitting detail [entrance foyer to dining hall]

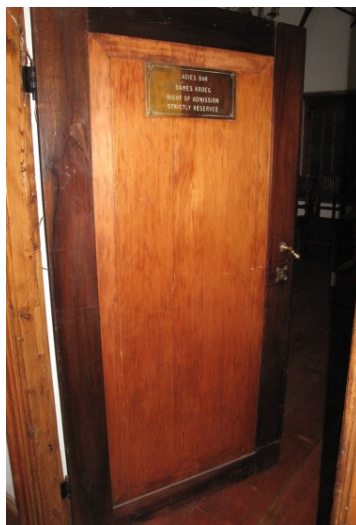
Interior door detail [to ladies bar]

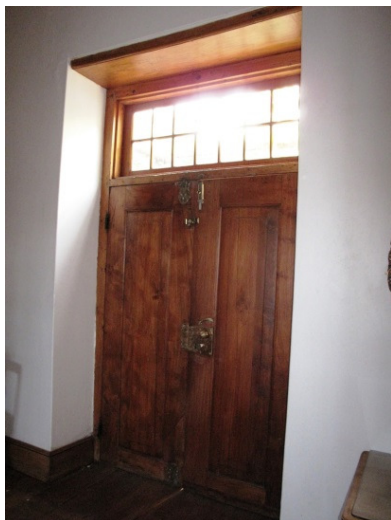
Lounge door to courtyard detail

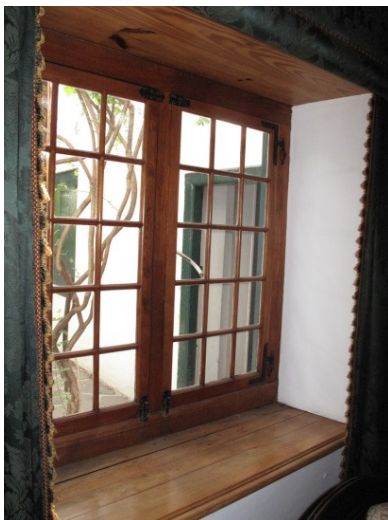
Lounge window to courtyard detail

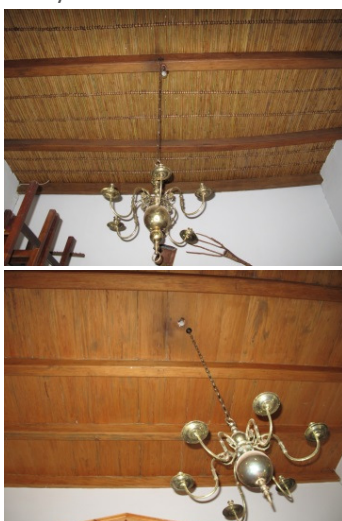
Ladies bar ceiling detail [reed in hearth room]
