HERITAGE IMPACT ASSESSMENT

DR01662 Eden

Dysseldorp – Eden District Municipality, Western Cape

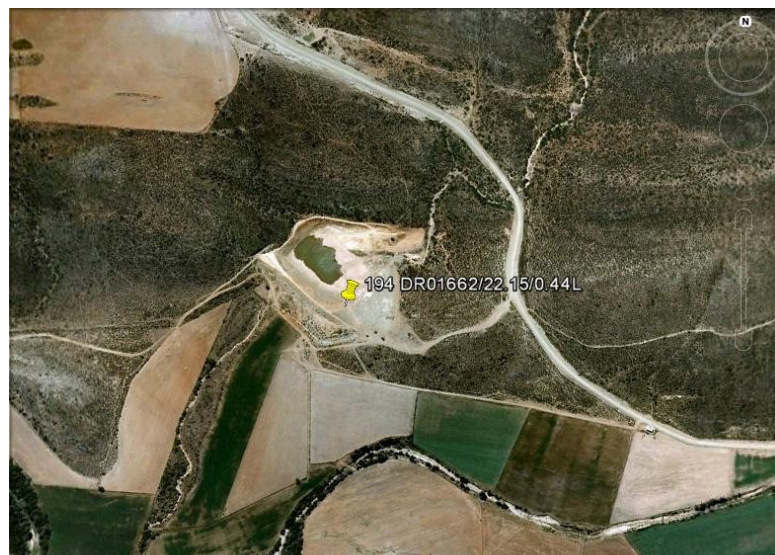
Figure 4: Aerial view of existing borrow pit (Google earth image, July 2012) 3

It is proposed to expand an existing borrow pit **DR01662/22.15/0.44L** for road material situated approximately 14 km south east of Dysseisdorp, Eden District Municipality, Western Cape. The previously used borrow pit was a source of wearing coarse gravel and lies to the left of DR1662, on a northwest-facing hillslope. The former pit now forms a dam and all that remains of the borrow pit is an area of cleared vegetation that was the turning area for lorries carting the gravel. The former pit is fully hidden from road-users' view, as would be any further/future of excavations. Vegetation is uncultivated natural veld with small to medium shrubs and some indigenous grasses. Farm Leeuwen Blad 3 is in private ownership and borrow pit co-ordinates are 33° 39' 40.2"S, 22° 32' 30.4" E
