Appendix 1: Project Specific Results

Starling Grid connection

Project number 2259

February 2023

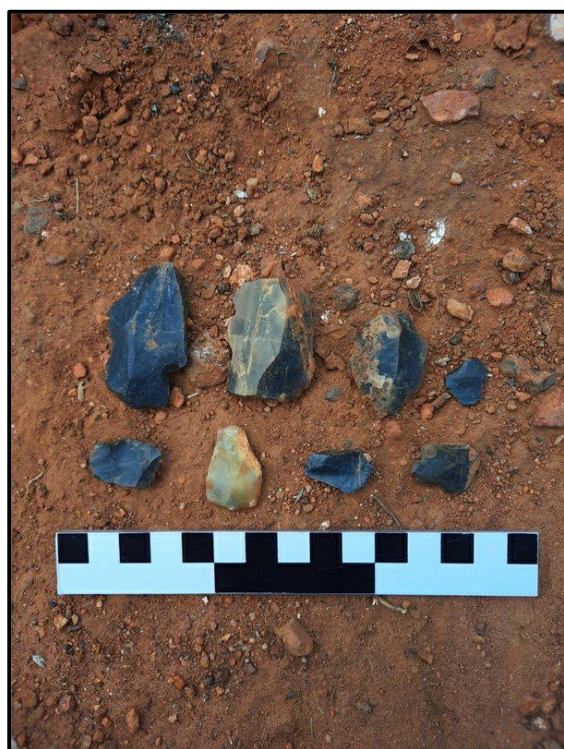
Figure 2.3. Artefact scatter at SF002.

The study area is rural in character and the impact area is undeveloped. The proposed site is covered in quaternary soils and used for grazing with no major focal points like rocky outcrops or pans that would have attracted human occupation in antiquity. Examination of historical topographic maps and aerial images also showed no structures or stone walled settlements in the study area and the impact footprint is considered to be of low archaeological potential. This was confirmed during the site visit finds were limited to a Stone Age scatter at SF002.

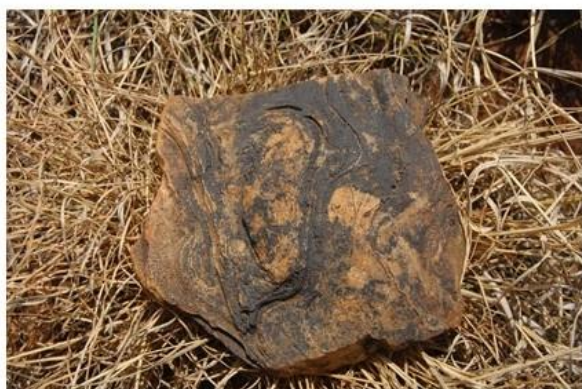
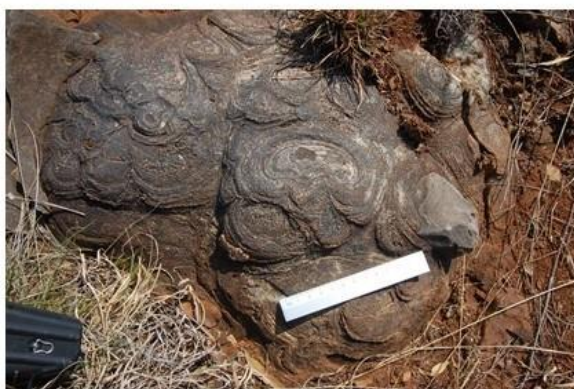
Figure 4.1: Photographs of stromatolites as seen in the field.

Weathering of dolomite

Small domal stromatolites

Side view of a stromatolite

Surface view of domal stromatolites

3. Photographs of similar fossils must be provided to the developer to assist in recognizing the fossil plants, vertebrates, invertebrates or trace fossils in the shales and mudstones (for example see Figure 4.1). This information will be built into the EMPr's training and awareness plan and procedures.
