Appendix 1: Project Specific Results

Swift Grid connection

Project Reference:

Project number 2259

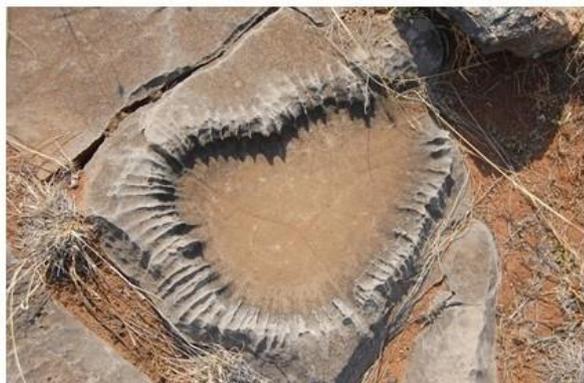
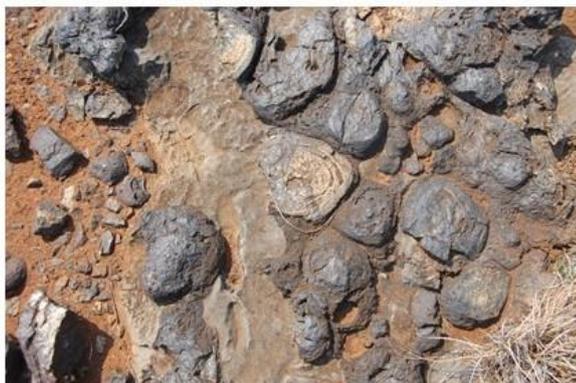
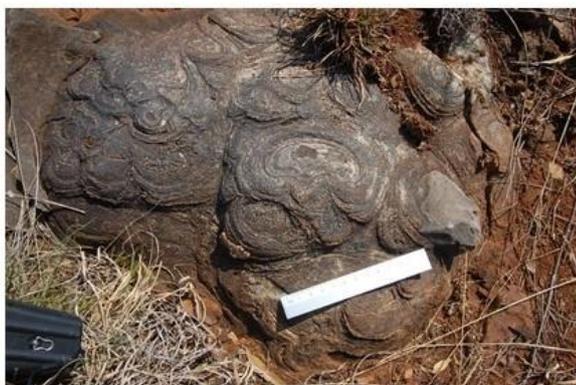
Figure 4.1: Photographs of stromatolites as seen in the field.

Weathering of dolomite

Small domal stromatolites

Side view of a stromatolite

Surface view of domal stromatolites

3. Photographs of similar fossils must be provided to the developer to assist in recognizing the fossil plants, vertebrates, invertebrates or trace fossils in the shales and mudstones (for example see Figure 4.1). This information will be built into the EMP's training and awareness plan and procedures.
