**HERITAGE IMPACT ASSESSMENT:
PROPOSED MURA 1-4 PV FACILITIES, BEAUFORT WEST
MAGISTERIAL DISTRICT, WESTERN CAPE AND VICTORIA
WEST MAGISTERIAL DISTRICT, NORTHERN CAPE**

Required under Section 38(8) of the National Heritage Resources Act (No. 25 of 1999)

HWC Case No.: 22101902AM1019E

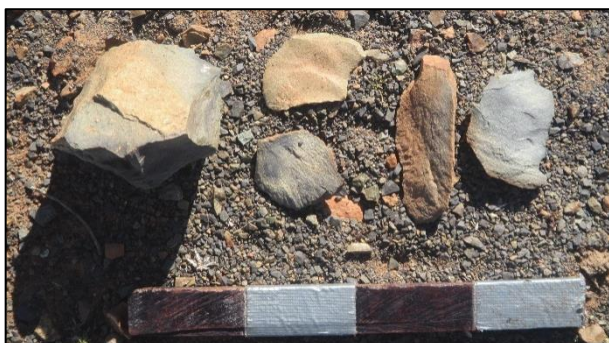
Figure 23: Stone artefacts from waypoint 1321. Scale = 20 cm.

In one area to the south of the Mura 1 footprint there was a very light scattering of artefacts that were only lightly patinated and may be from the LSA (Figures 23 & 24). There was nothing else associated with them. Elsewhere, Stone Age finds were limited to a few isolated background scatter artefacts of Pleistocene and/or Holocene age.

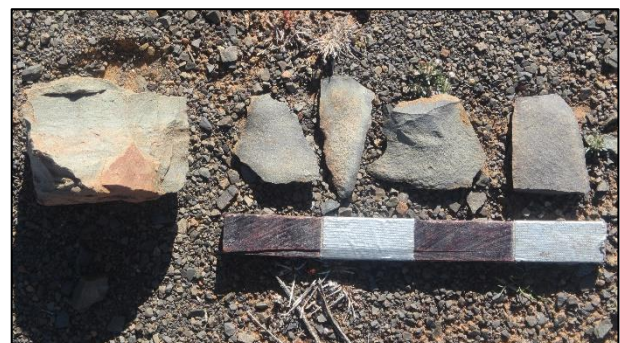
Figure 24: Stone artefacts from waypoint 1322. Scale = 20 cm.

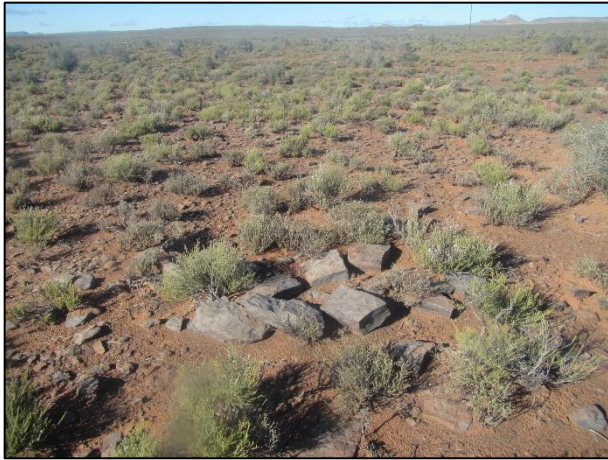
Figure 25: *Small stone cairn/feature at waypoint 1396. This is just within the Mura 2 study area.*

Historical archaeological sites were somewhat more common than Stone Age sites. The smallest sites were small clusters of rocks. These may have been cairns but otherwise their functions could not be determined. None seemed like graves and one of them had a wine bottle base located alongside it (Figures 25 to 28).

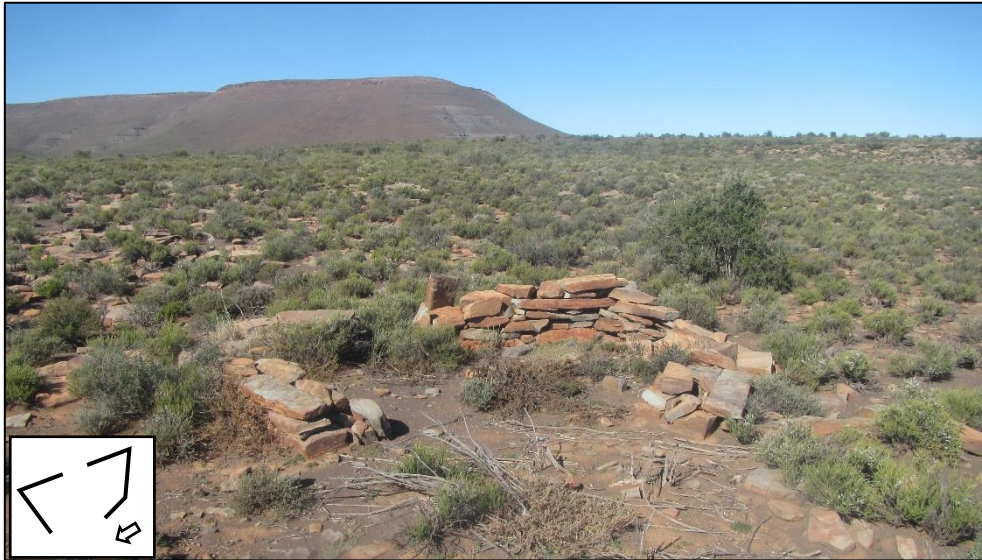
Figure 35: Small stone-walled feature at waypoint 1399 within the southern part of Mura 4. The inset shows a plan view orientated the same way as the photograph with arrow indicating north.

Another small stone-walled site was rather enigmatic due to its unusual shape (Figure 35). It had no associated artefacts and measured about 2 m by 4 m. Its function is unknown but the walls seem far too low to have served a residential function. The last historical site may not actually be archaeological in terms of its age. It comprises of a long line of slabs half buried in the ground and presumably had some sort of agricultural function (Figure 36).

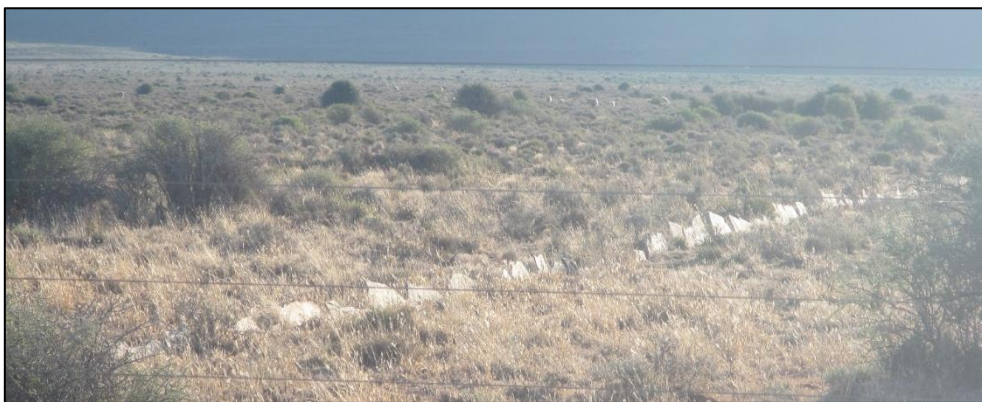
Figure 36: Line of planted stones at waypoint 1327 within the Mura 2 study area.

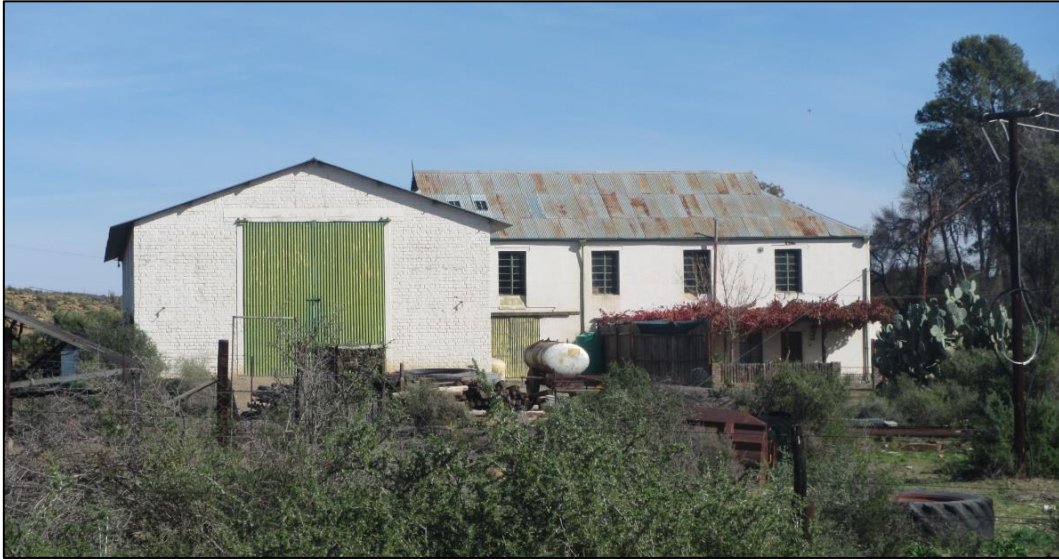
Figure 45: An unusual double story structure in the Boiskraal Farm complex at Waypoint 1794. Source: Orton (2021a: fig. 51).
