**Archaeological and Heritage Phase 2 EMP Walk  
down Report for proposed 765kv Umfolozi-  
Thetha powerline from Umfolozi Substation to the  
new Empangeni Substation in KwaZulu Natal  
Province.**

**DRAFT REPORT**

**September 2013**

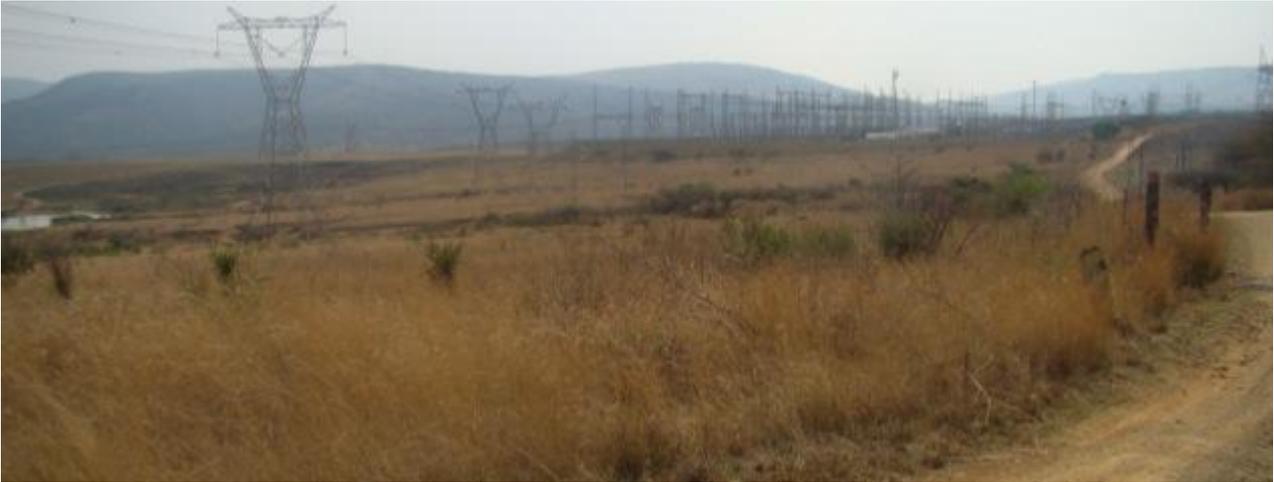
**Plate 1: View of Umfolozi Substation where the proposed powerline will T-off.**

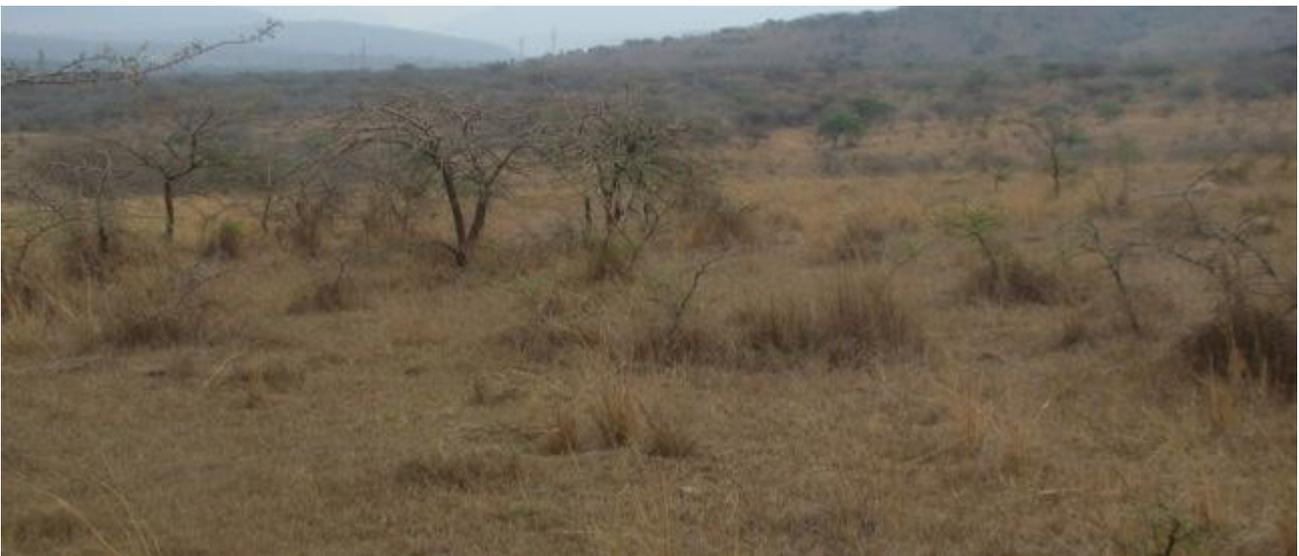
**Plate 2: The approved powerline will cut through previously cleared agricultural landscape with secondary vegetation currently used for livestock grazing.**

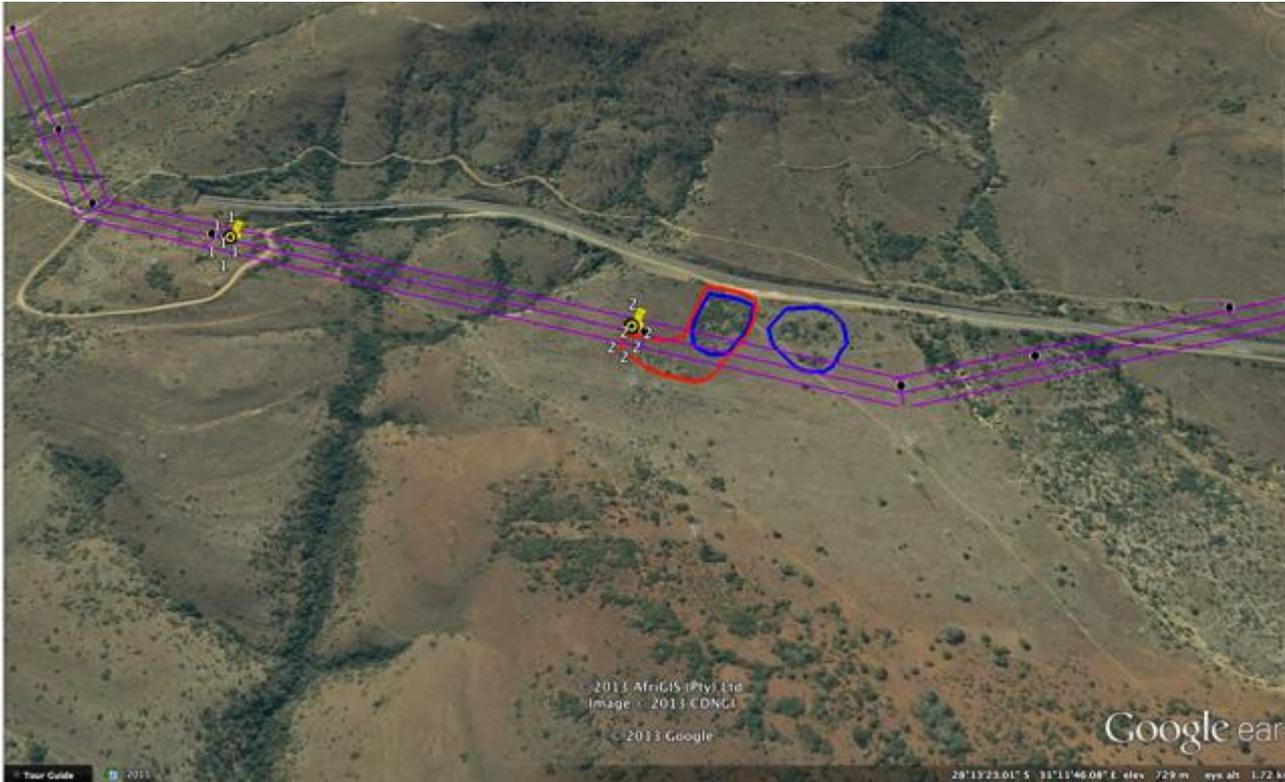
**Figure 1: Location of Historic archaeology sites associated with Tower 5 and 6. (Red marks the outer boundary; Blue marks the core of the sites).**

Monitoring is required during all stages of construction from excavation for tower foundations, erection of towers and stringing for Towers 5 and 6. Tower 5 is also associated with a grave. The grave should be marked and protected in situ during all construction activities on site. The rubble, litter and cable drum remains recorded in stone walls on the archaeological site near tower 10 should be cleaned up. The site should be protected from any future abuse by contractors when working in the project area. An archaeologist should monitor installation of Tower 10 during foundation excavations, erection and stringing. Although the archaeological stone structure and possible grave on tower 15 is now out of the tower construction impact zone, the site should be clearly marked and should be monitored during stringing. There is a high possibility of the site being interfered with during stringing because heavy construction machinery requires large space to operate. However, in the unlikely event that chance archaeological materials are disturbed at any of the

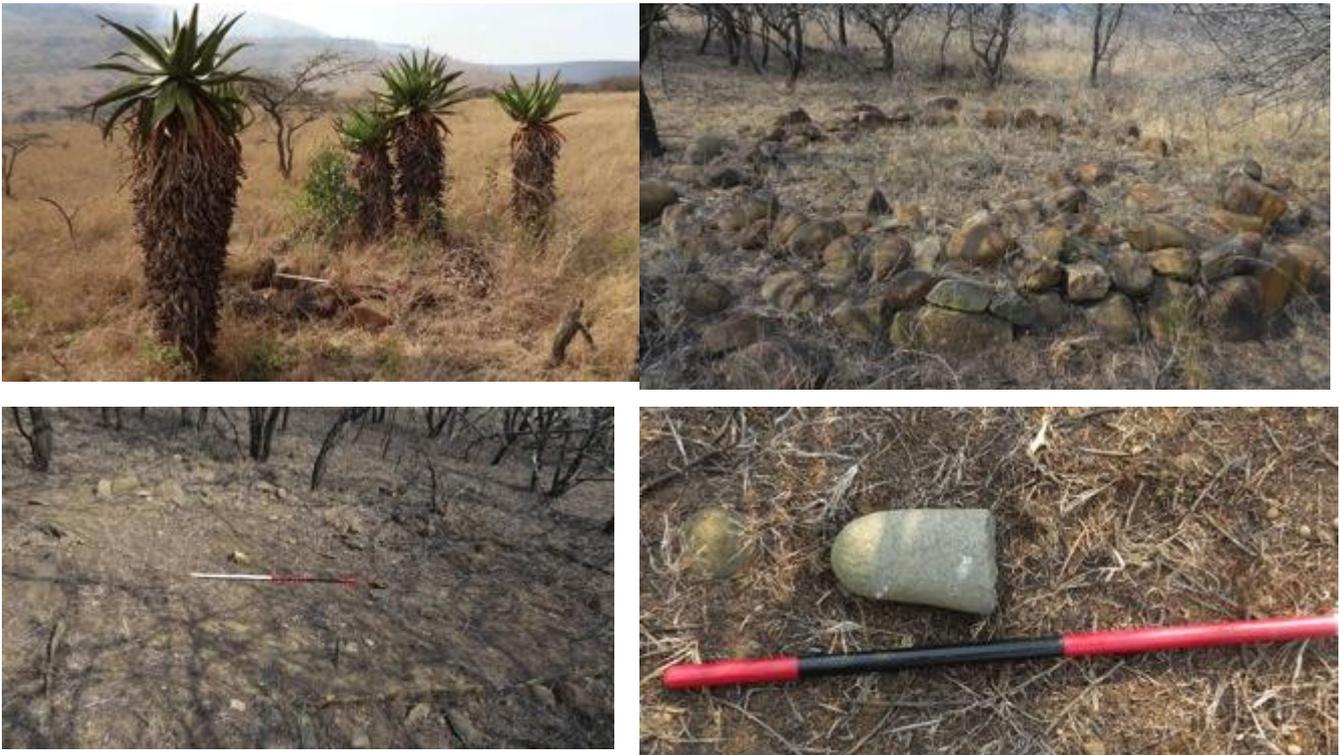
**Plate 3: Top Left - Grave situated close to tower 5 position within the historic archaeology site. Top Right – Stone wall remains on site. Bottom Left - Housing remains spread over the site. Bottom Left – artefact remains recorded on site.**

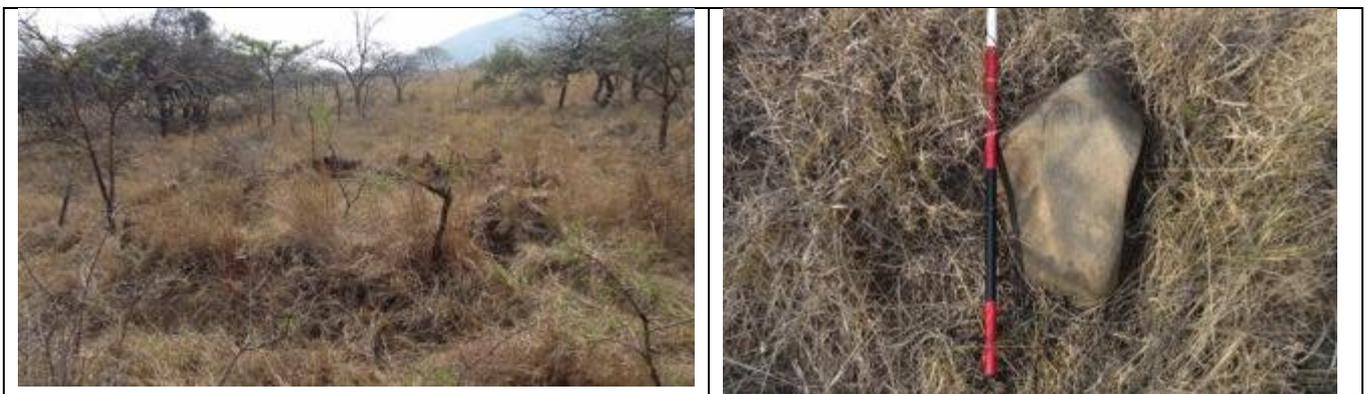
**Plate 4: Left - Stone wall feature on Archaeology site 2 situated between Tower 5 and 6. Right – Grinding stone recorded on site 2.**

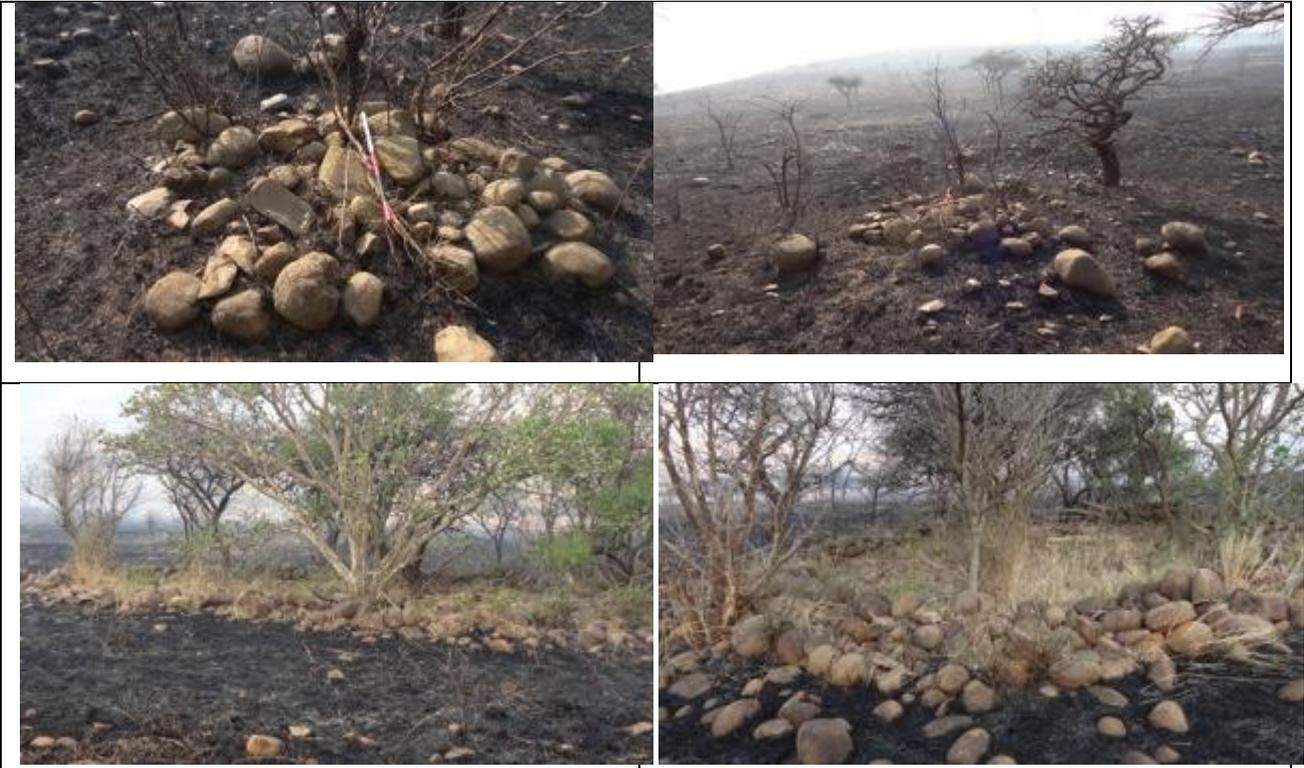
Plate 5: Top L&R – Graves on site associated with Tower 21. Nine graves were recorded on this site. Bottom L&R – Stonewall structure recorded on site. The site is associated with the gravesite previously described.

An archaeologist should monitor installation of Tower 21, 36, 38 and 40 during foundation excavations, erection and stringing. Special emphasis should be placed on tower 40 where an extensive Middle/ Later Stone Age site was recorded in the preliminary walk down survey and confirmed by Nzumbululo Specialists. Although it may be time consuming, the construction team should allow the monitoring archaeologist to conduct extensive search for stone artefacts during excavation for tower foundation. The findings if any should be well documented, classified and tagged. Provision for storage of possible finds should be made with the nearest museum prior to commencement of work. If the excavation yields significant Stone Age tools, further research should be commissioned to salvage the entire site. However, in the unlikely event that chance archaeological materials are disturbed at any of the remaining tower positions in this section, salvage and chance finds procedures should be implemented in line with the project HMP.

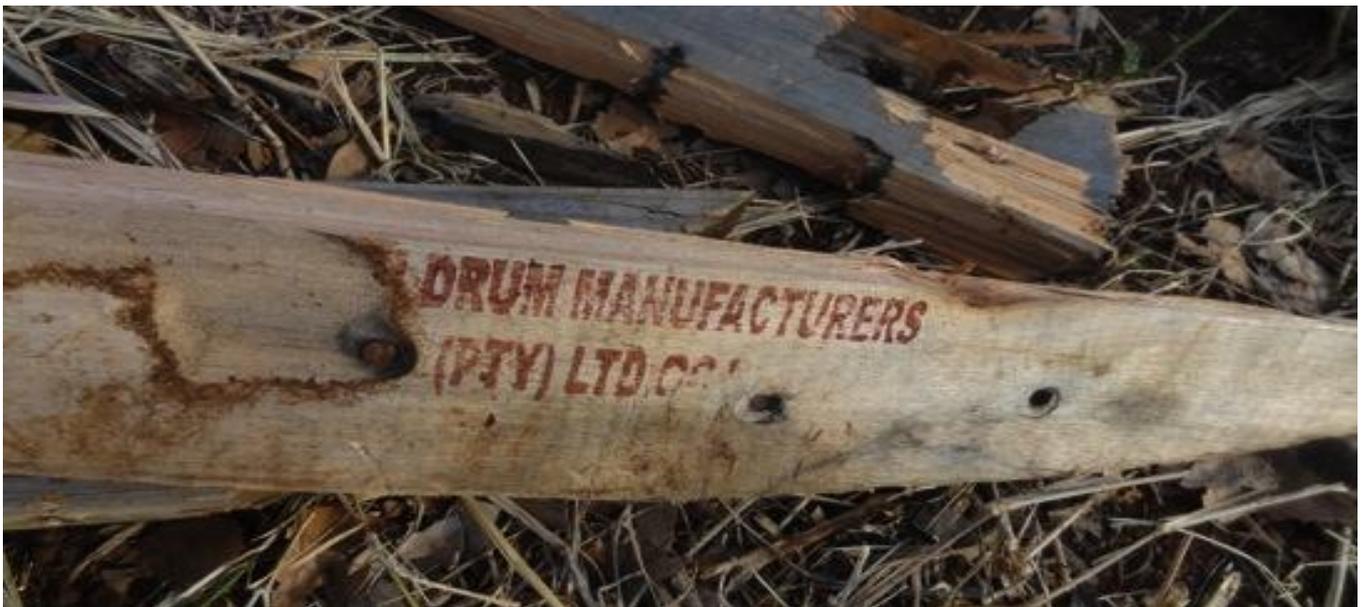
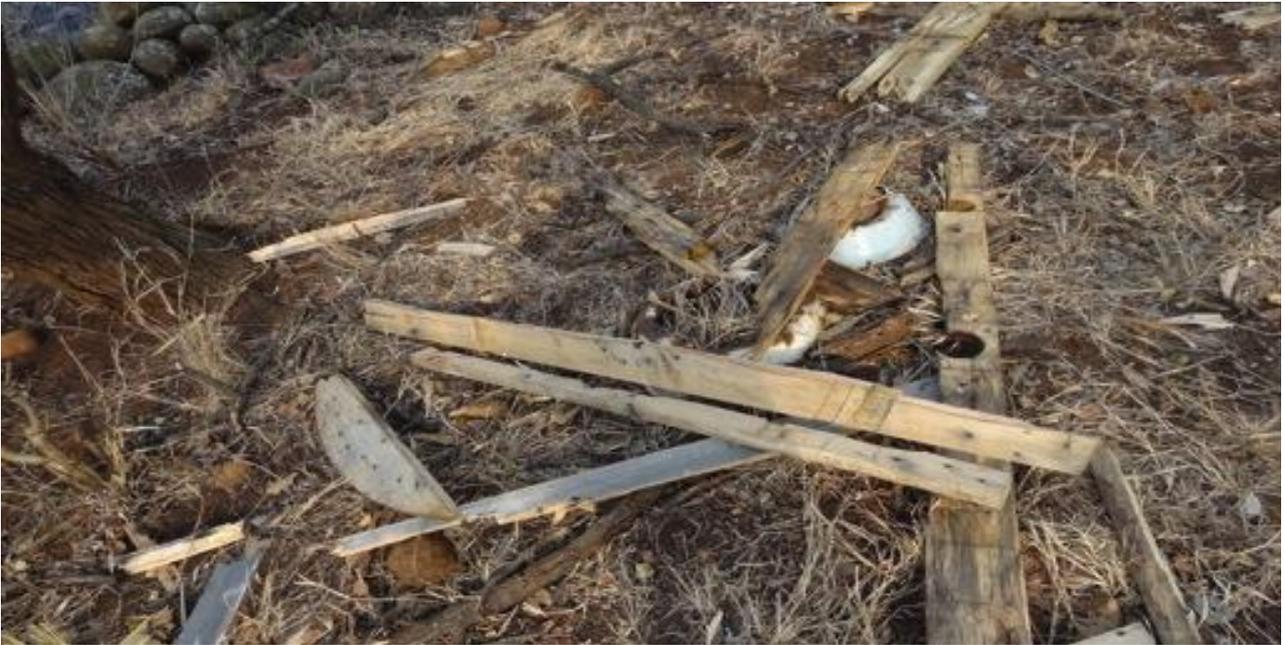
**Plate 6: Top & Bottom - rubble and cable drum remains left on archaeological site by previous Eskom Contractors. This site should be cleaned and all rubble and litter removed from area.**

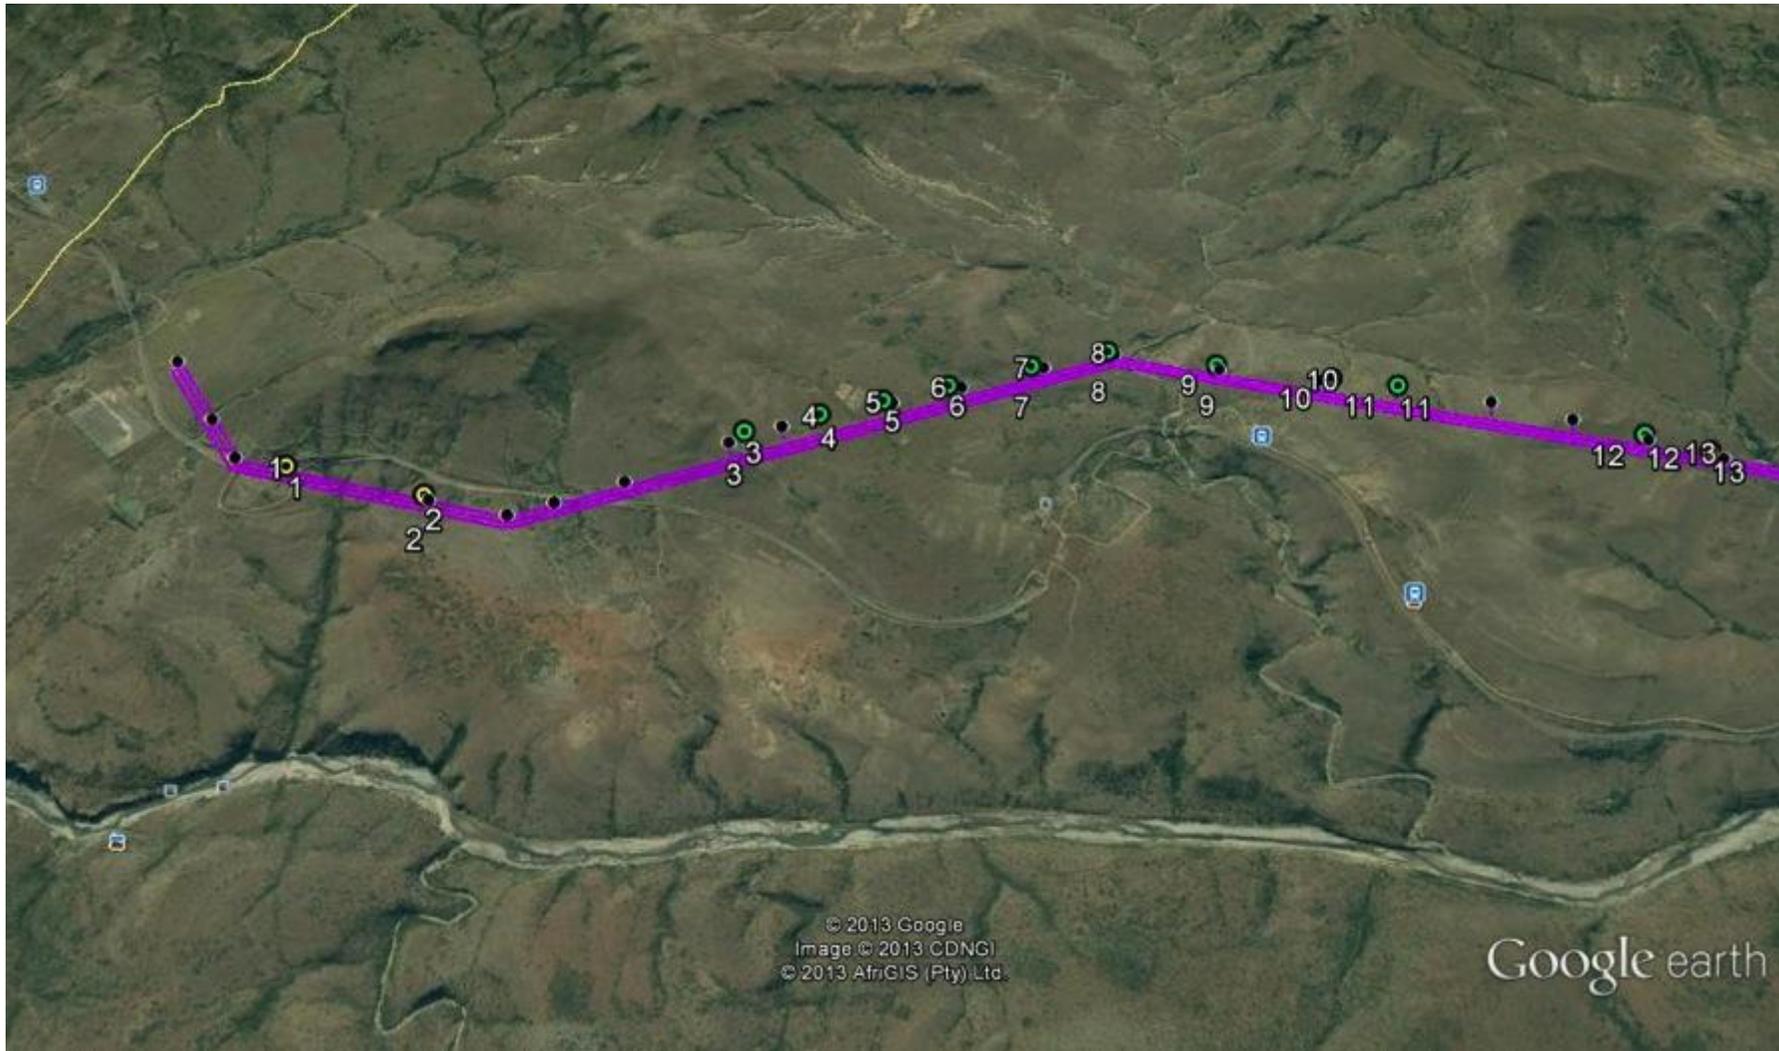
Structures 1 to 20 shown in Figure 2 are all situated on previously degraded and disturbed land portions where high voltage powerlines, railway line, minor reticulation powerlines and railway servitude roads and boundary fence lines already traverses along the powerline route. During the survey and verification exercise, the surveyed Pylon Structures positions 1 to 20 yielded an archaeological site on the direct path and vicinity of the tower positions 5 and 6. The preliminary walk down survey reported one grave at tower 5, but the verification exercise revealed that the entire section from tower 5 to 6 is an archaeological site. The archaeological site was initially not mentioned during the phase 1 HIA and preliminary walk

Figure 2: The powerline pylon positions follow the servitude that runs parallel to an existing high voltage powerline and railway line.

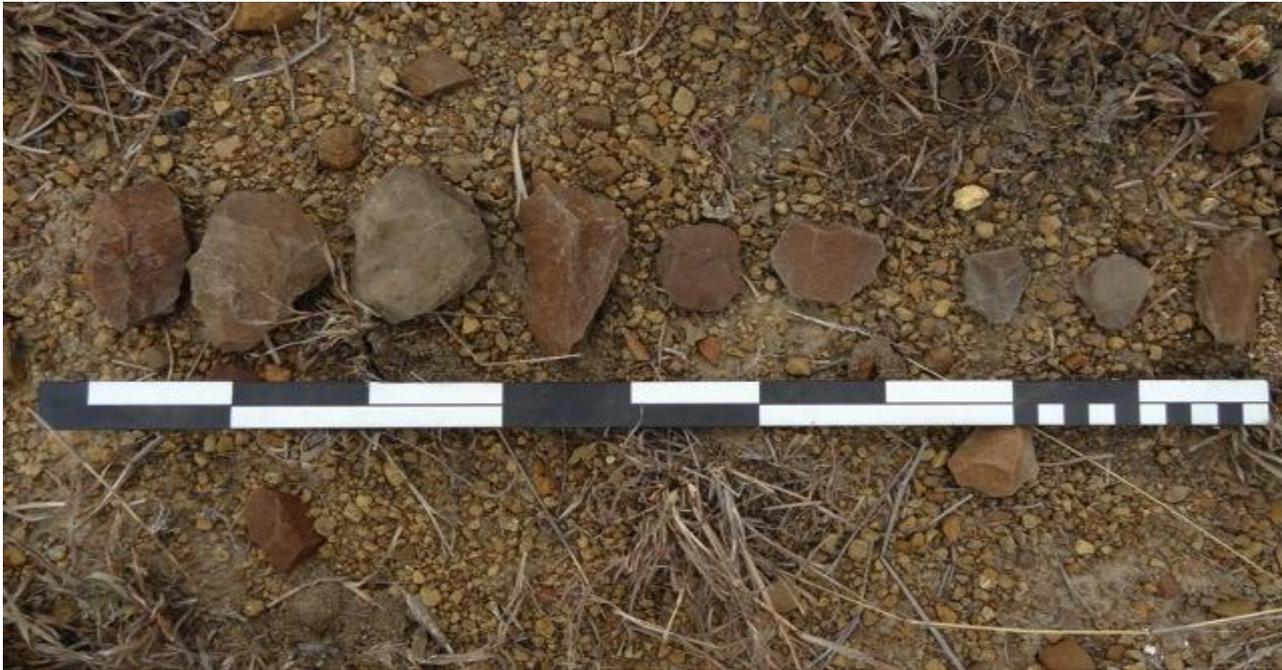
**Plate 7: A scatter of Middle Stone Age tools recorded in the vicinity of the powerline route. Such site should not be disturbed during the construction phase since they may be protected by the NHRA, Act 25 of 1999.**

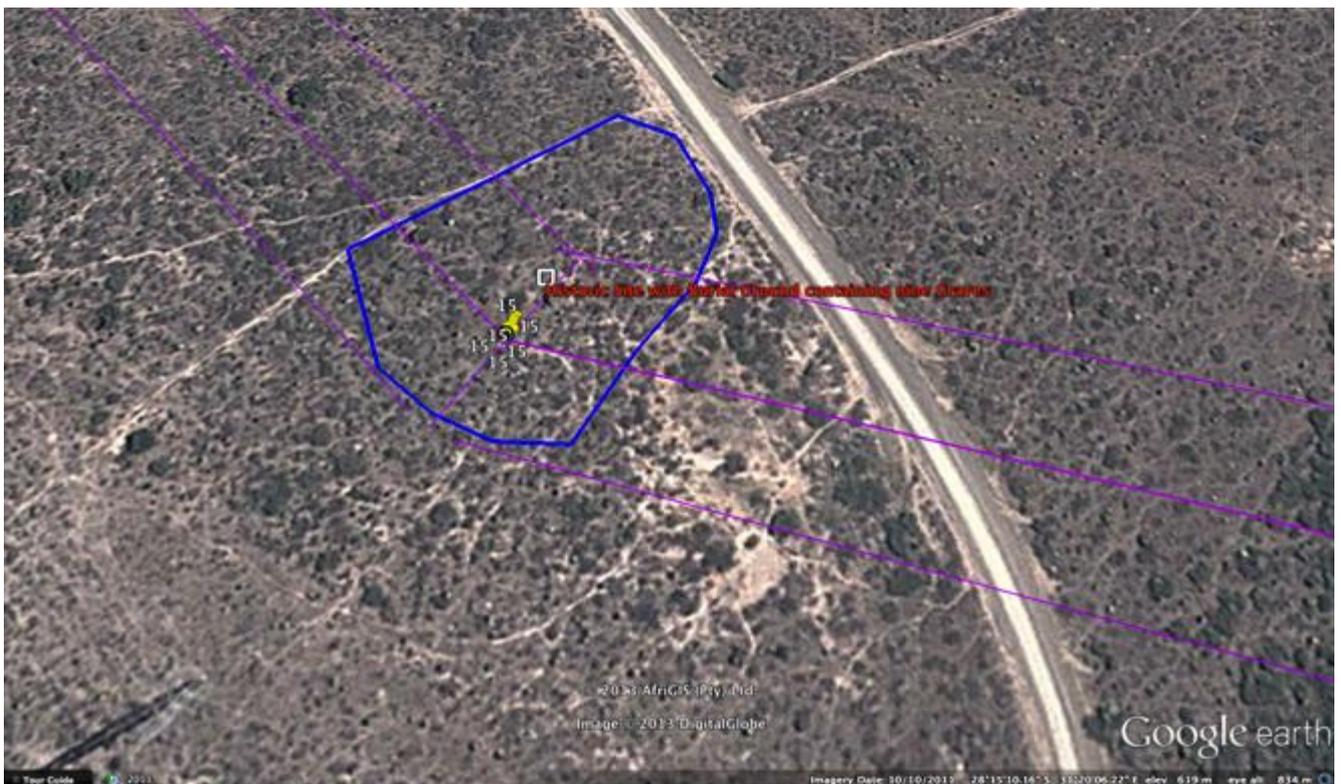
Figure 4: Historic site with a burial ground with nine graves. The site on direct path of Tower 42. The graves therefore should be relocated before construction work begins at Tower 42.

Eskom final tower position could not avoid the burial ground site at tower 42 because it will alter the alignment of the powerline route and it is surrounded by eroded and an existing local road nearby. From a technical point of view the tower position cannot be shifted. As such the nine burials on the direct path of tower 42 should be relocated in accordance with the relevant legislations. An archaeologist should monitor installation of Towers 42 during foundation excavations, erection and stringing to ensure that the solitary burial sites associated with the Mbatha homestead and remains of a historic homestead are not affected during construction and movement of heavy construction machinery. Subject to relocation of the burials, no further mitigation is required prior to construction phase. However, in the unlikely event that chance archaeological materials are disturbed at any of the remaining tower positions in this section, salvage and chance finds procedures should be implemented.

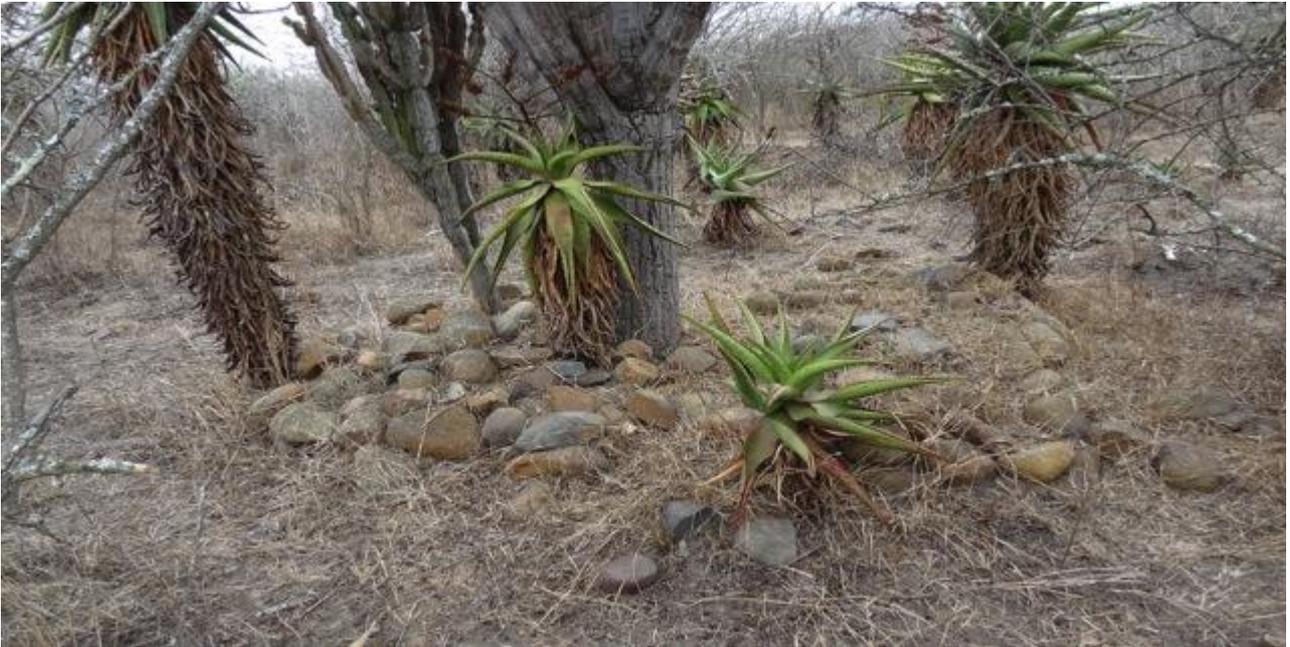
**Plate 8: View of nine graves recorded on the direct path of tower 42. Note that the site.**

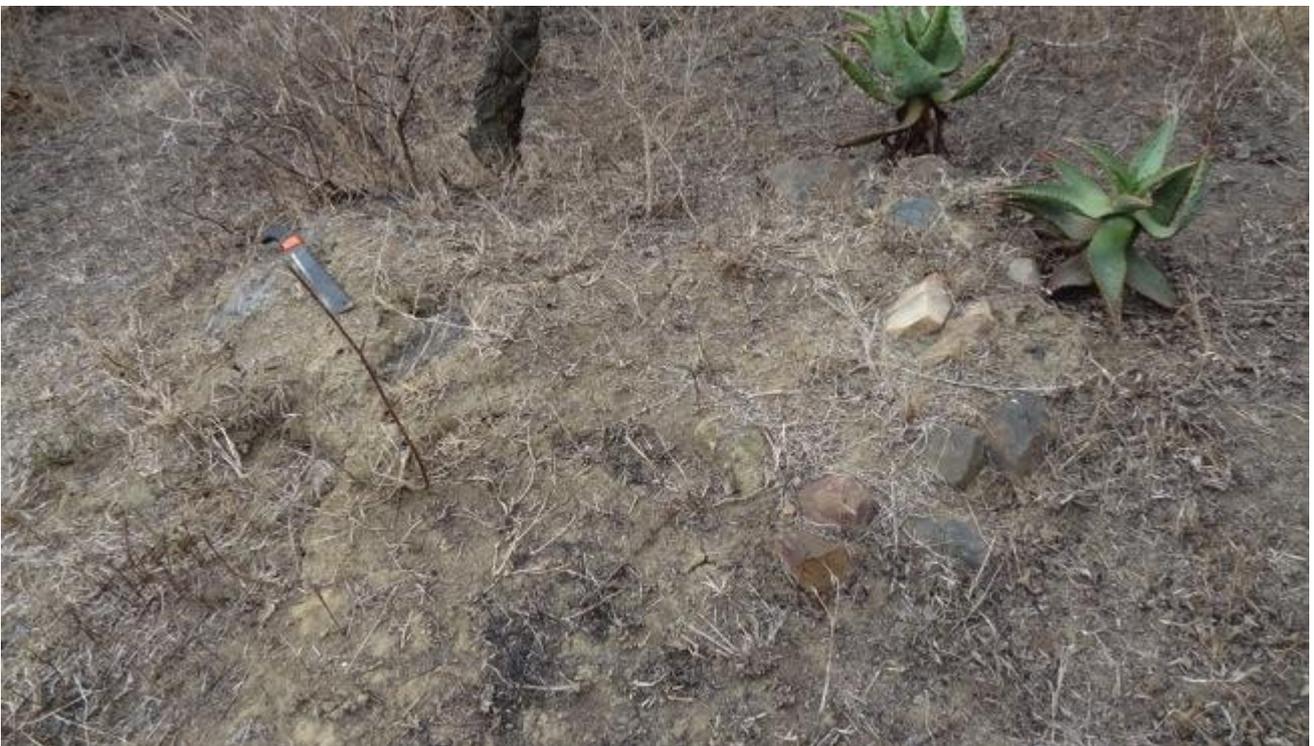
**Plate 9: View of burials at tower 42. Note the trees and vegetation growing on the graves, the custodians may have left the area long back.**

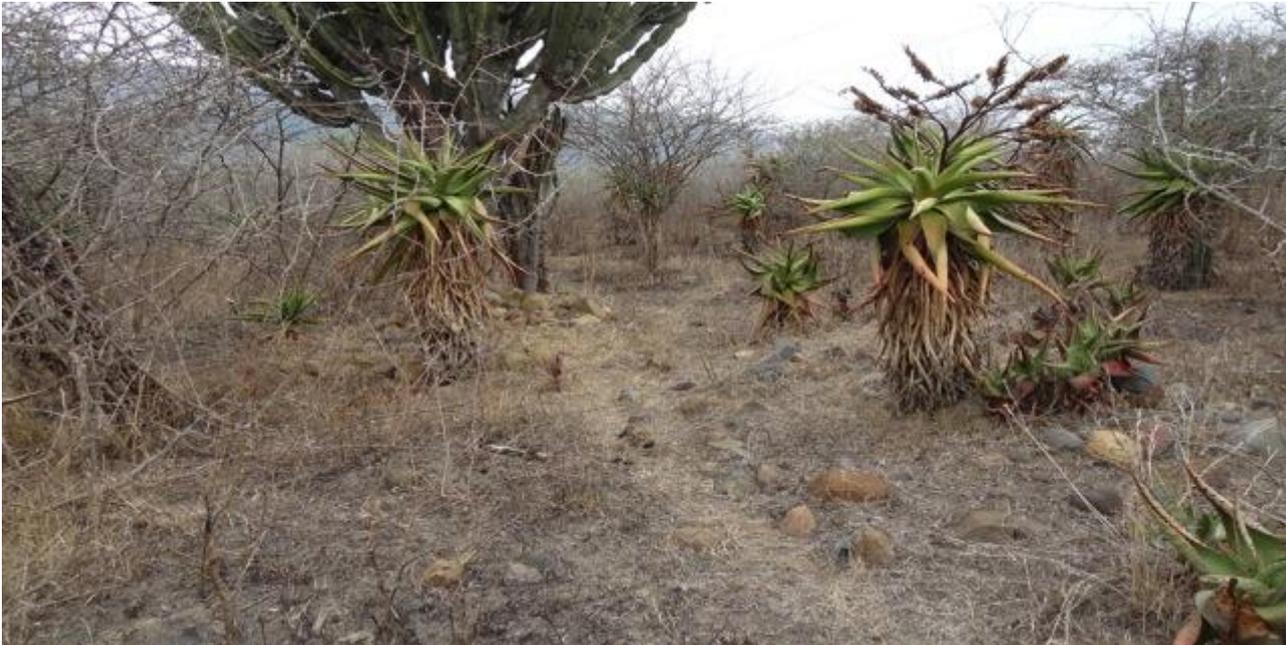
**Figure 10: Figure 5: Burial site at tower 42 trees and shrubs have been growing on top of the graves which may suggest that the custodians may be difficult to trace. Note that from a technical point of view the burial cannot be avoided therefore should be relocated.**

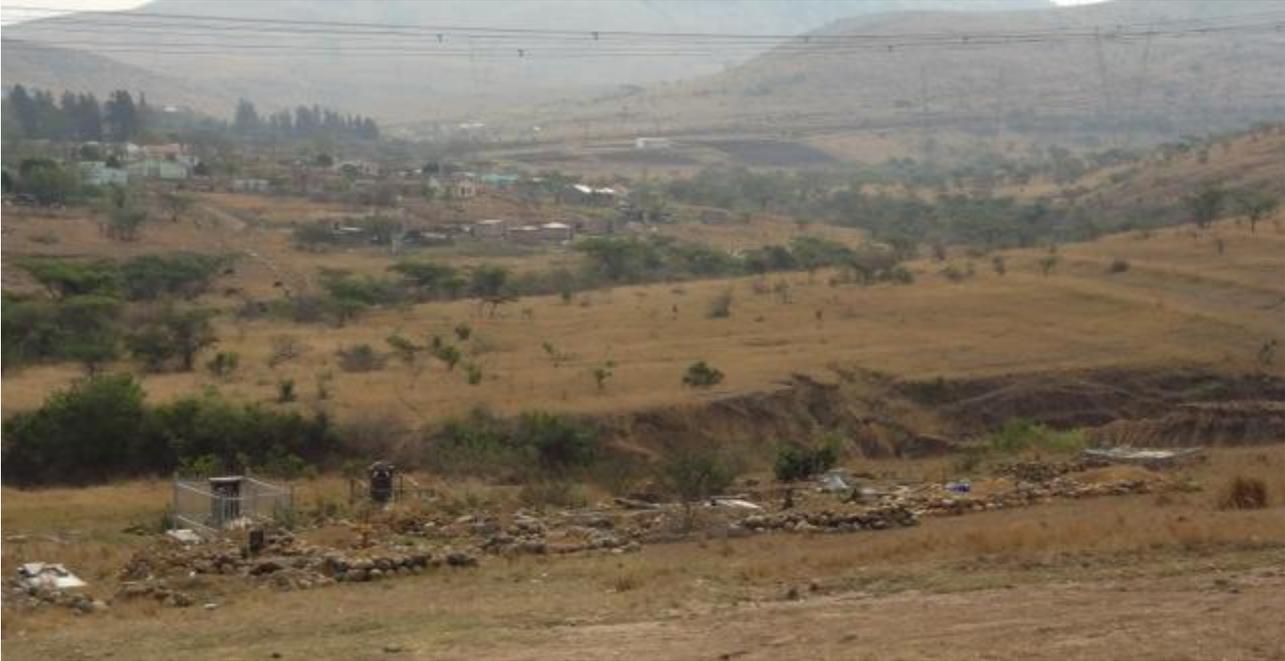
**Plate 11: A contemporary cemetery near tower 73 located in the outskirts of Ulundi D .The burial site is significantly away from the impact zone, however the construction team must exercise caution when working near the burial site.**

The sites must be monitored during installation of tower 66-67, 72, 73, 74 and 75 to avoid any interference with the contemporary cemetery and burial grounds recorded in the area. The construction team should avoid working near the contemporary cemetery during burial ceremonies. Heavy machinery should not be driven near the contemporary cemetery because they cause vibration, which may disturb the stability of burials and graves especially those with newly installed tombstones.

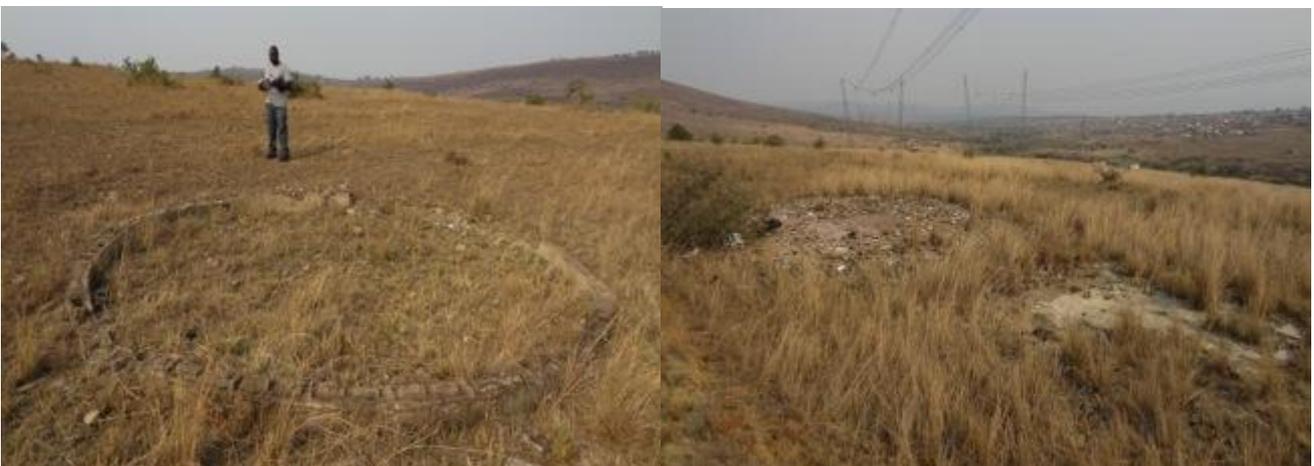
**Plate 12: Plate 13: Remains of a historical homestead near the tower 74.**

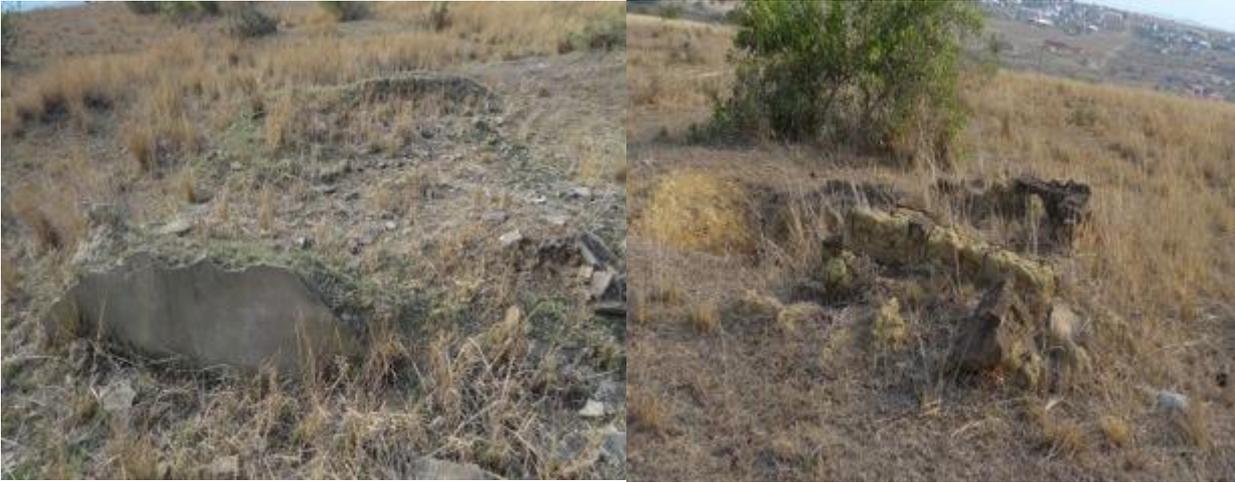
**Plate 14** Remains of a historical homestead in the vicinity of tower 75 near Ulundi section D

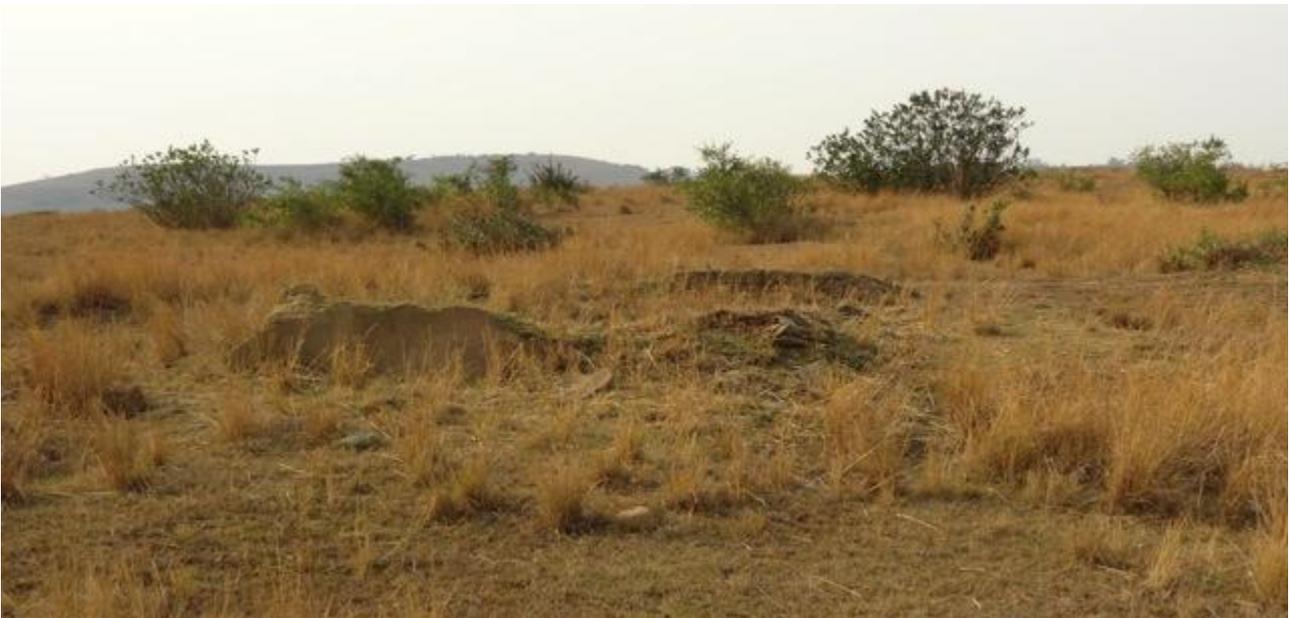
**Plate 15:** View of remains of a historical homestead located near tower 75. Note that the site is significantly far from the impact zone.

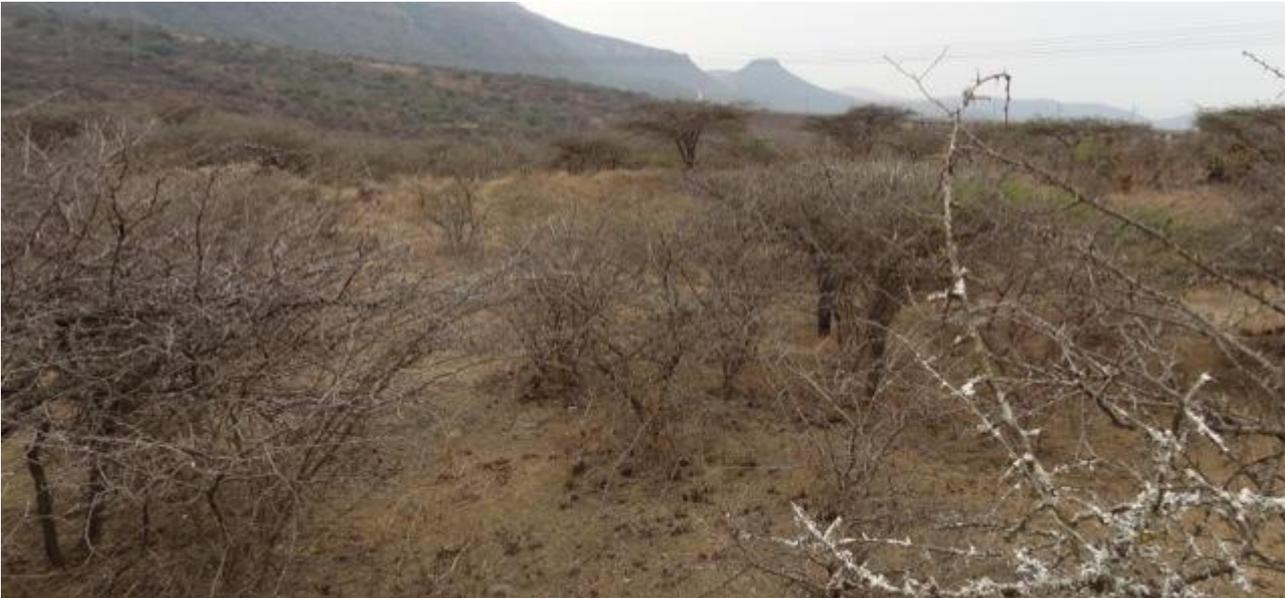
Plate 16: The proposed powerline cuts through sloppy and thickly vegetated areas.

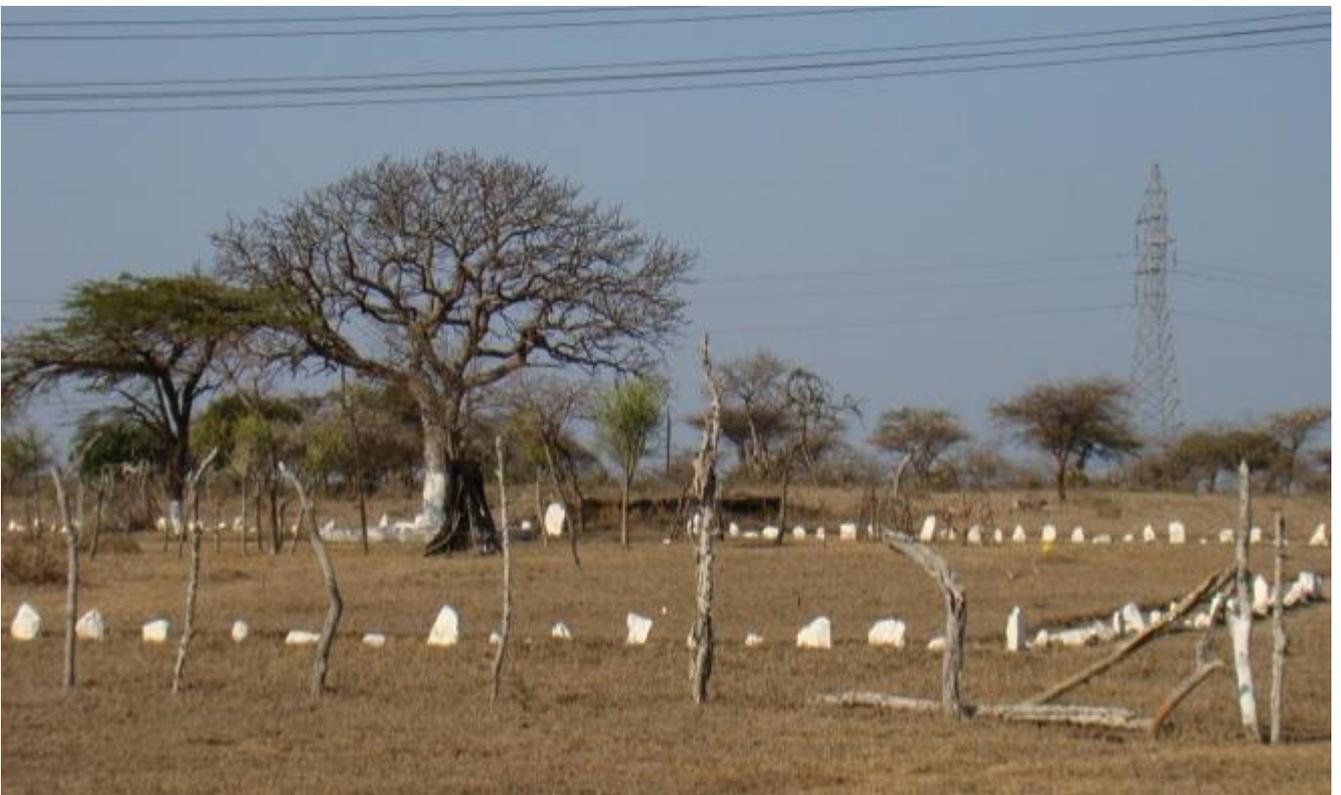
Plate 17: Shembe Church site located in vicinity of powerline development

An archaeologist should monitor installation of Towers 154, 157 and 159 during foundation excavations. These towers locations are associated with archaeological signatures which indicates potential to yield subsurface discernable archaeological remains that may require to be recorded. No further mitigation is required prior to construction phase on other tower positions. However, should chance archaeological materials are disturbed at any of the remaining tower positions in this section, salvage and chance finds procedures should be implemented. The construction team must exercise extreme caution when working near active burial sites and open-air places of worship such as the Shembe Church.

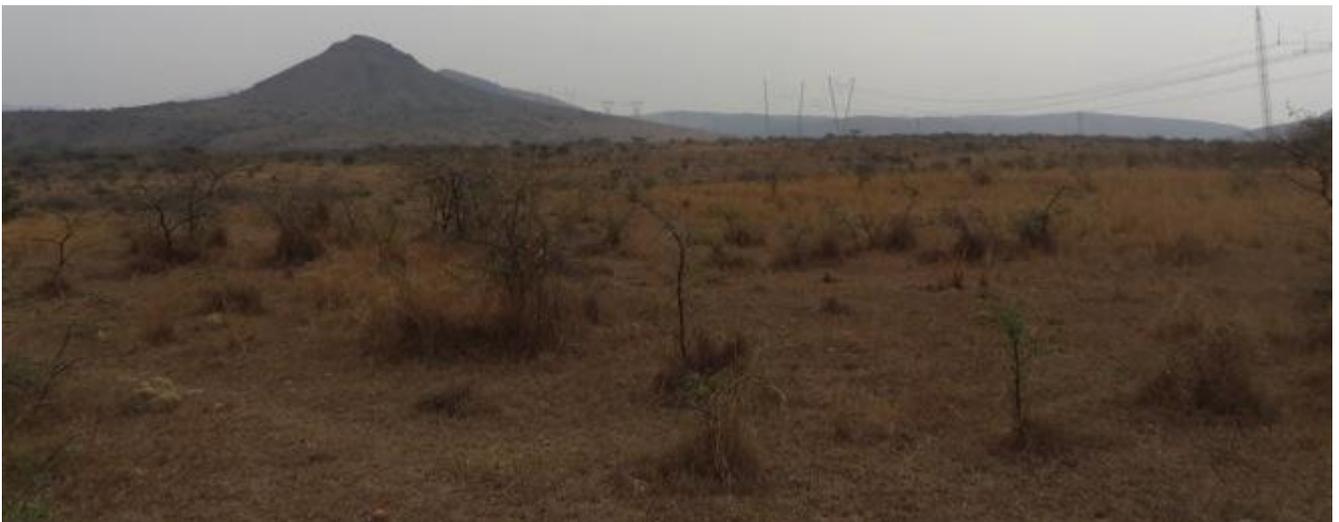
**Plate 18.** Typical landscape through which the powerline will traverse in section after Ulundi region. The powerline cuts through sloppy area with isolated farm or village settlements, agriculture fields and patches of grazing land.

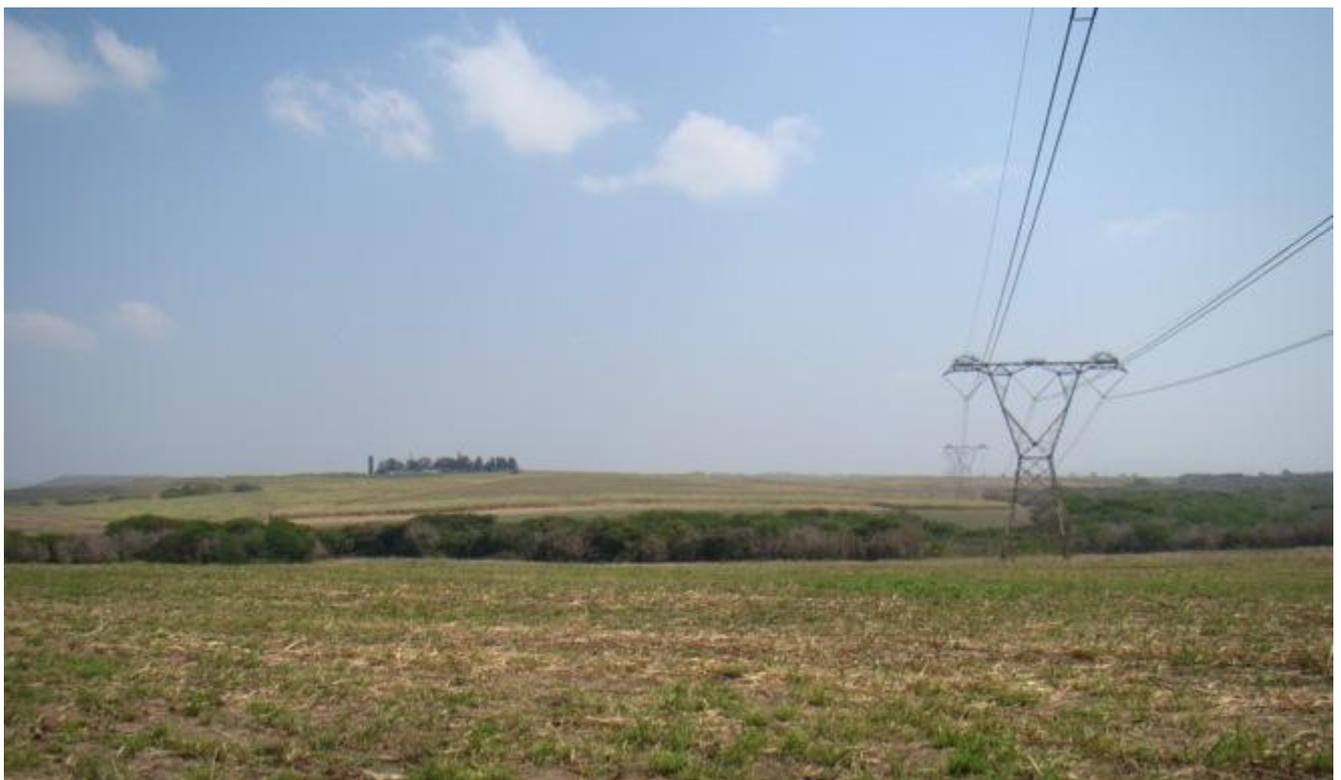
Plate 19: The powerline cuts through sloppy area with isolated farm settlements, agriculture fields and patches of grazing land.
