**ARCHAEOLOGICAL IMPACT ASSESSMENT
OF THE PROPOSED EXTENSION OF A BORROW PIT ON
MÔRESON (KYKOE 55) NEAR UNIONDALE,
EDEN DISTRICT, WESTERN CAPE**

(Assessment conducted under Section 38 (8) of the National Heritage Resources Act as part
of a Heritage Impact Assessment)

NOVEMBER 2013

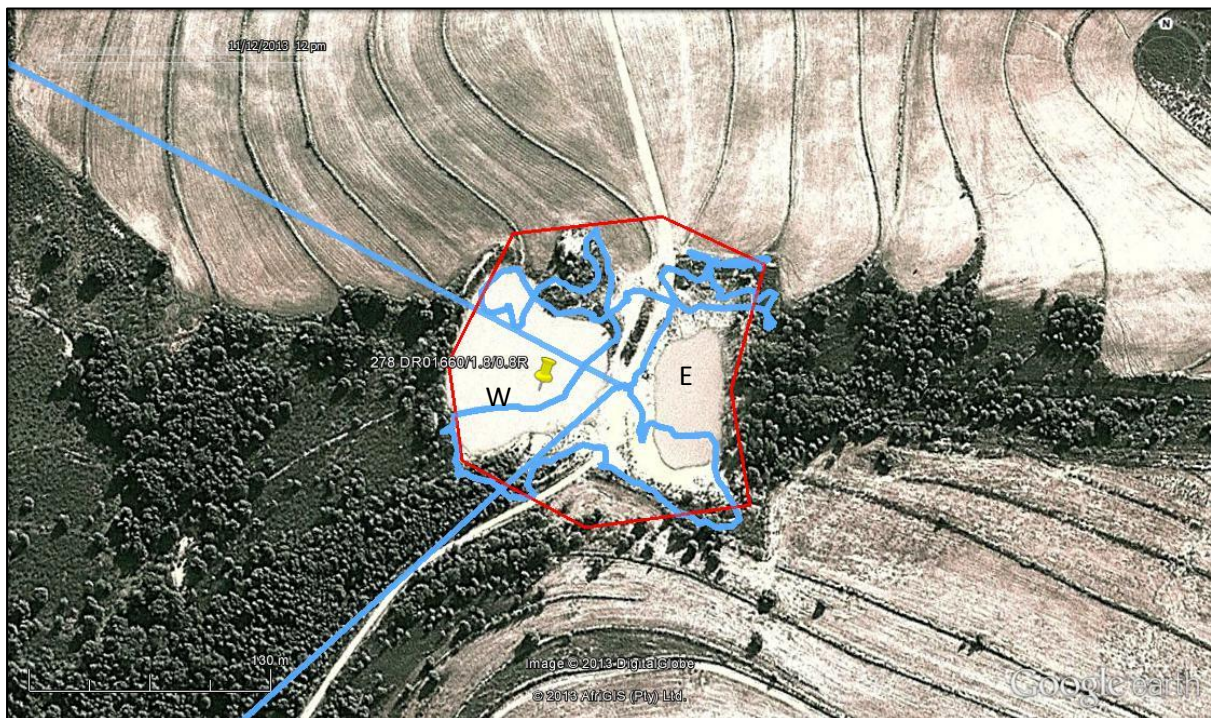
Figure 2: Google earth image showing the proposed extension to borrow pit 278, the eastern (E) and western (W) pits and the tracks of the field survey. Please note that the straight blue lines do not indicate survey tracks.

Fieldwork for the proposed pit extension was undertaken on 9 November 2013. A site plan indicating the affected area was provided by Aurecon for the Phase 1 survey. The area was covered on foot and the tracks were recorded by a Garmin GPSMAP 62s set on the WGS84 datum (Figure 2). The site was extensively photographed.

On the north-western side of the road (Figures 2, 6 and 7) two patches of leached quartzite cobbles were observed in the clump of black wattles (Figure 9). It seemed possible that these were the remains of local pediment gravels which had been cleared from the fields, but on further inspection they appeared to have been transported from elsewhere and dumped on top of the ferruginised gravels. The black wattles have probably grown subsequently. Heaps of smaller leached pebbles and gravel, tree stumps, plastic and some bricks are also associated with the cobbles and black wattles. Four quartzite artefacts of indeterminate age (Figures 12 and 13) were recorded to the west of the cobbles and black wattles. They were seen on a slope in the western pit and are not in a primary context (Figures 6 and 10).

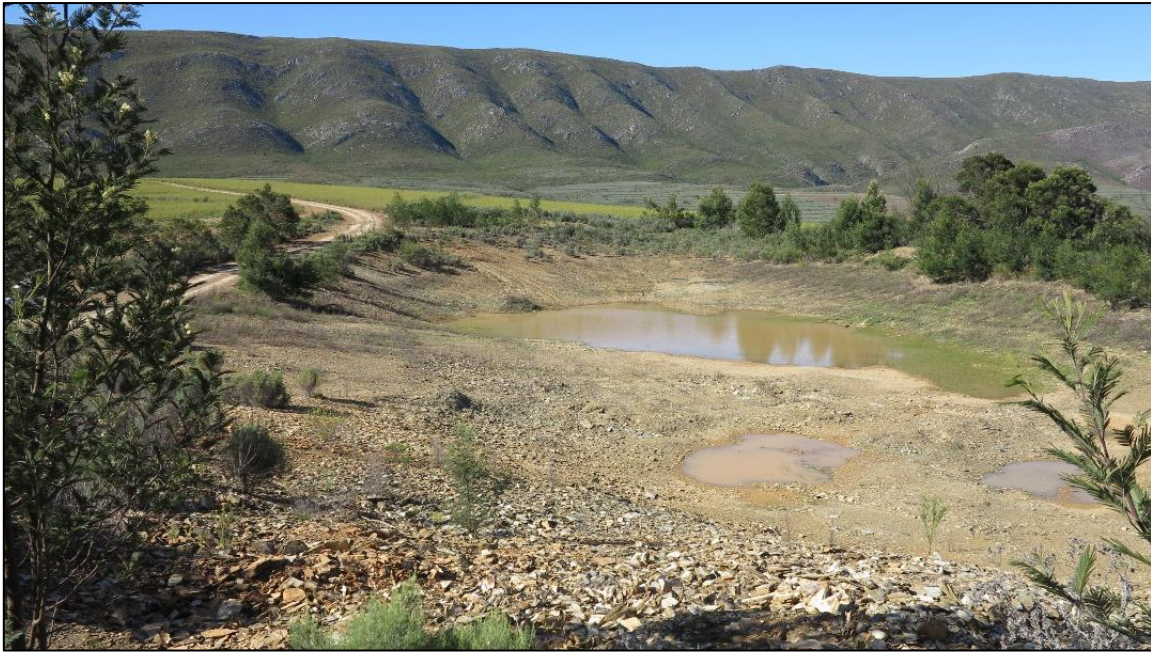
Figure 3: Eastern pit - view towards the north with Ghwerna se Berg in the background.

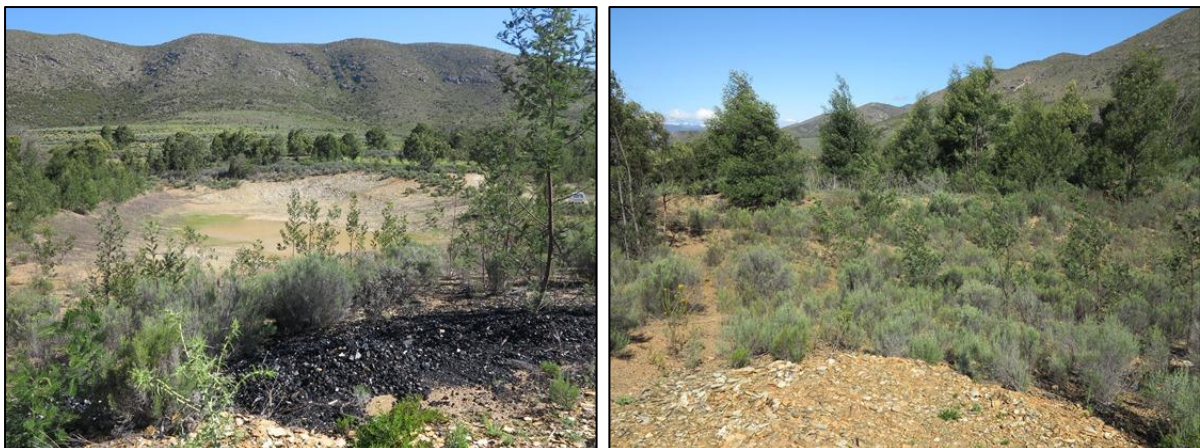
Figure 4: Eastern pit - view towards the south with one of the heaps of dumped charcoal in the foreground. Figure 5: View towards the east of the north-eastern part of the polygon showing the invasion of renosterveld vegetation by alien black wattle trees.

Attention was paid to the areas to the north and south of the dams where the ground was not disturbed by previous mining. During the survey it became apparent that most of the proposed extension area is in fact disturbed, either by digging, dumping or infestation by black wattles. The vegetation along the eastern boundary, between the eastern dam wall and fence, was particularly dense and this area was not surveyed. The part of the polygon with least disturbance, where some renosterbos (*Elytropappus* sp.) remains, is the northern area between the eastern pit and the field to the north (Figures 2, 3 and 5). With the exception of a quartzite flake (Figure 11), no archaeological remains of any sort were observed here. Several heaps of dumped charcoal were however noted (Figure 4).

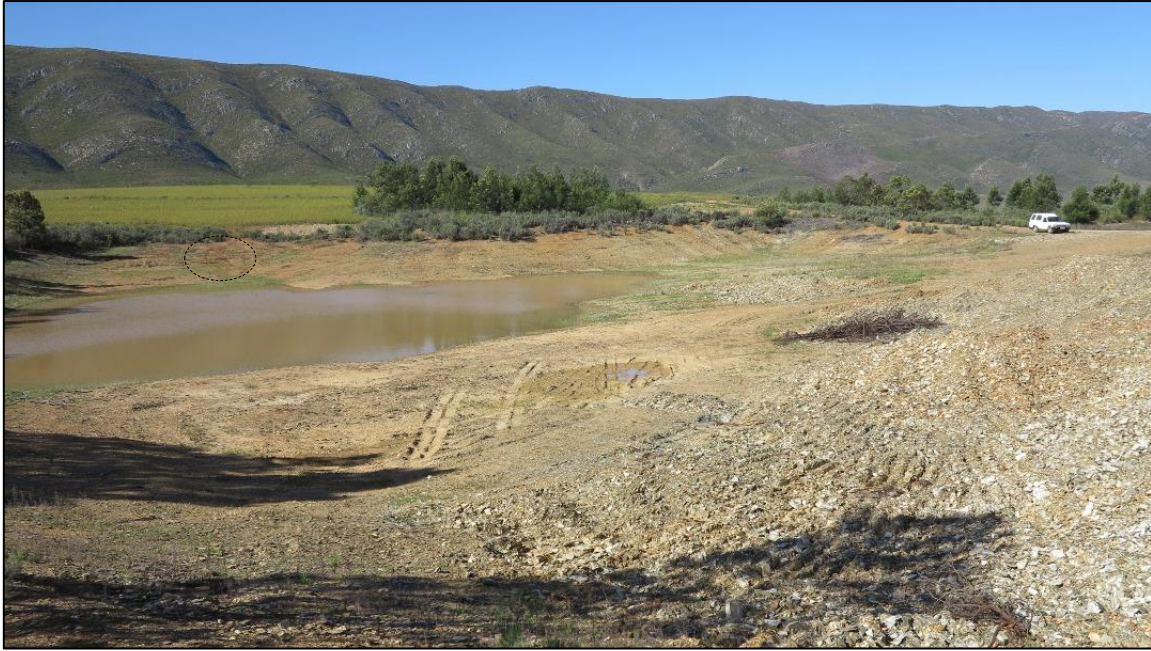
Figure 6: Western pit - view towards the northeast. The disturbed area with cobbles lies in the clump of black wattles on the northern side of the pit and the area where four quartzite artefacts were found is indicated by the black oval.

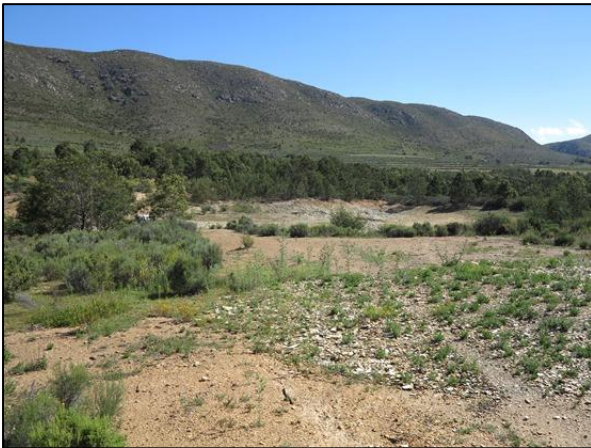
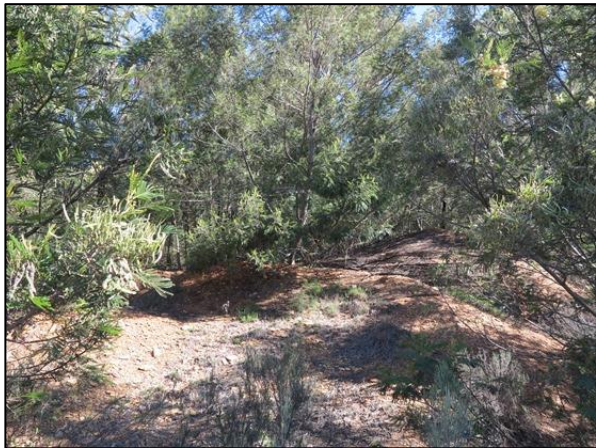
Figure 7: Western pit - view towards the southwest. Figure 8: Detail of the disturbed ground amongst the black wattles in the south-western part of the polygon.

No archaeological remains were seen in the areas to the south of both pits. Although the south-western part is heavily infested by black wattles, visibility of material on the ground was good as there is no undergrowth. The area has been greatly disturbed by digging (Figure 8).

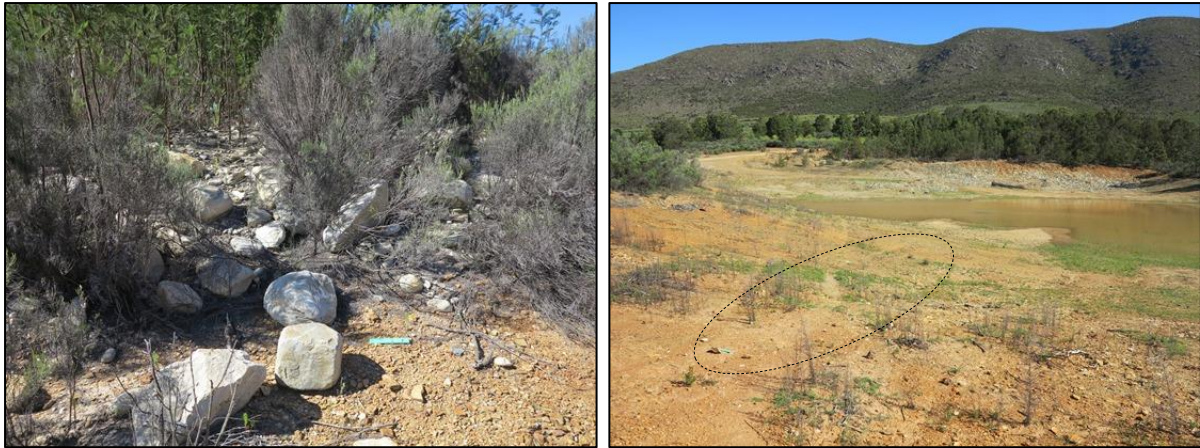
Figure 9: Detail of the leached cobbles dumped on top of the feruginised gravels amongst the black wattles to the north of the western pit. The ruler is about 15cm in length. Figure 10: Western pit - view towards the south with the disturbed black wattle forest evident. The area where four of the stone artefacts were seen is indicated by the black oval.

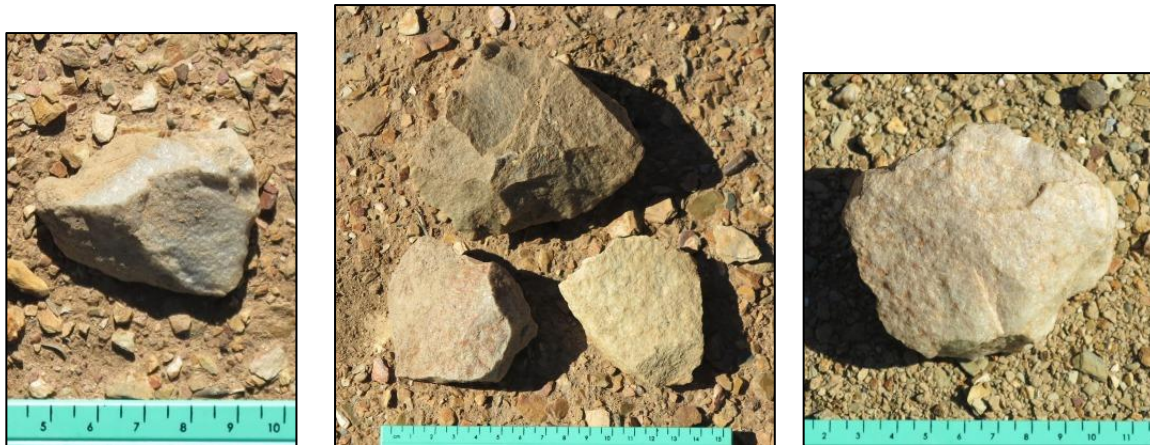
Figures 11, 12 and 13: Quartzite artefacts – flake; two flakes and a chunk; flake. The scale is in cm.

The only archaeological material observed was five quartzite artefacts of indeterminate age, found in a secondary context. No other archaeological remains, including structures, were seen.
