HERITAGE IMPACT ASSESSMENT

DR 01674 Eden

Calitzdorp – Eden District Municipality, Western Cape

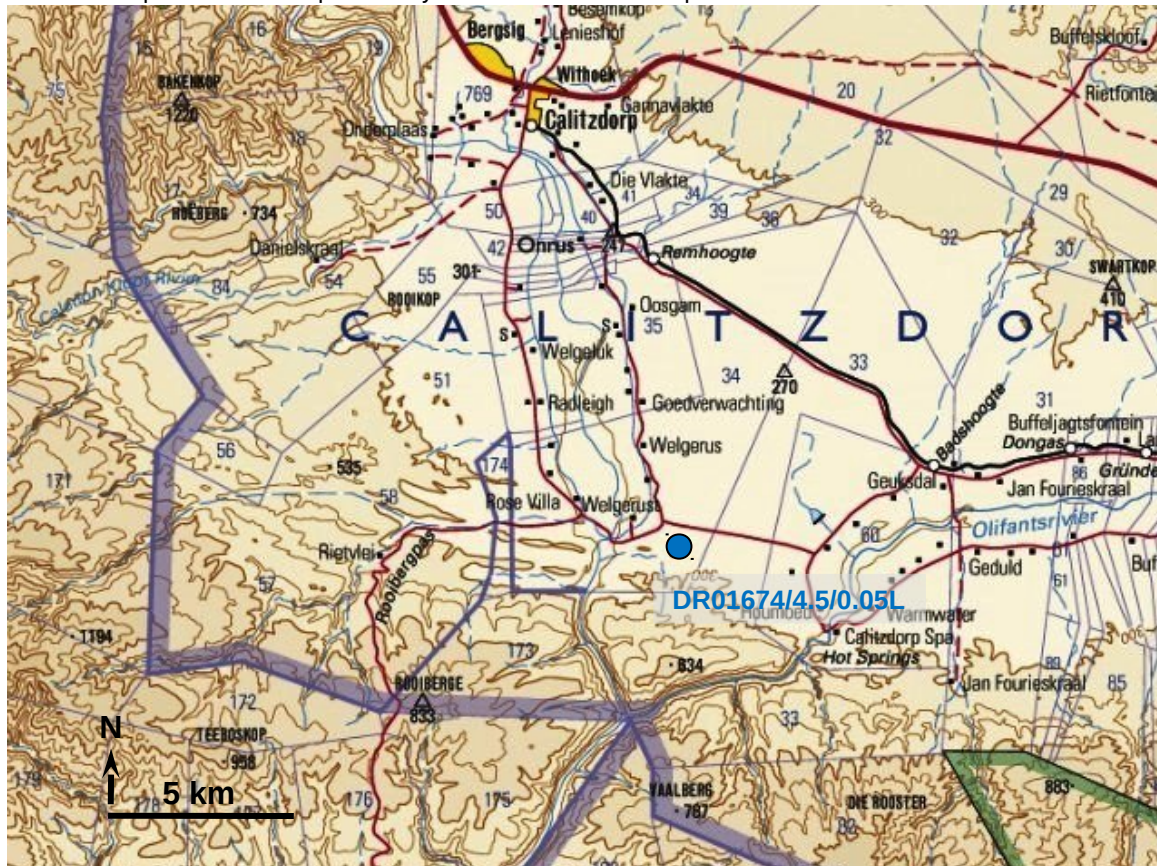
Figure 1: Extract from topographical sheets 3320(Dr John E. Amund 2014:2)

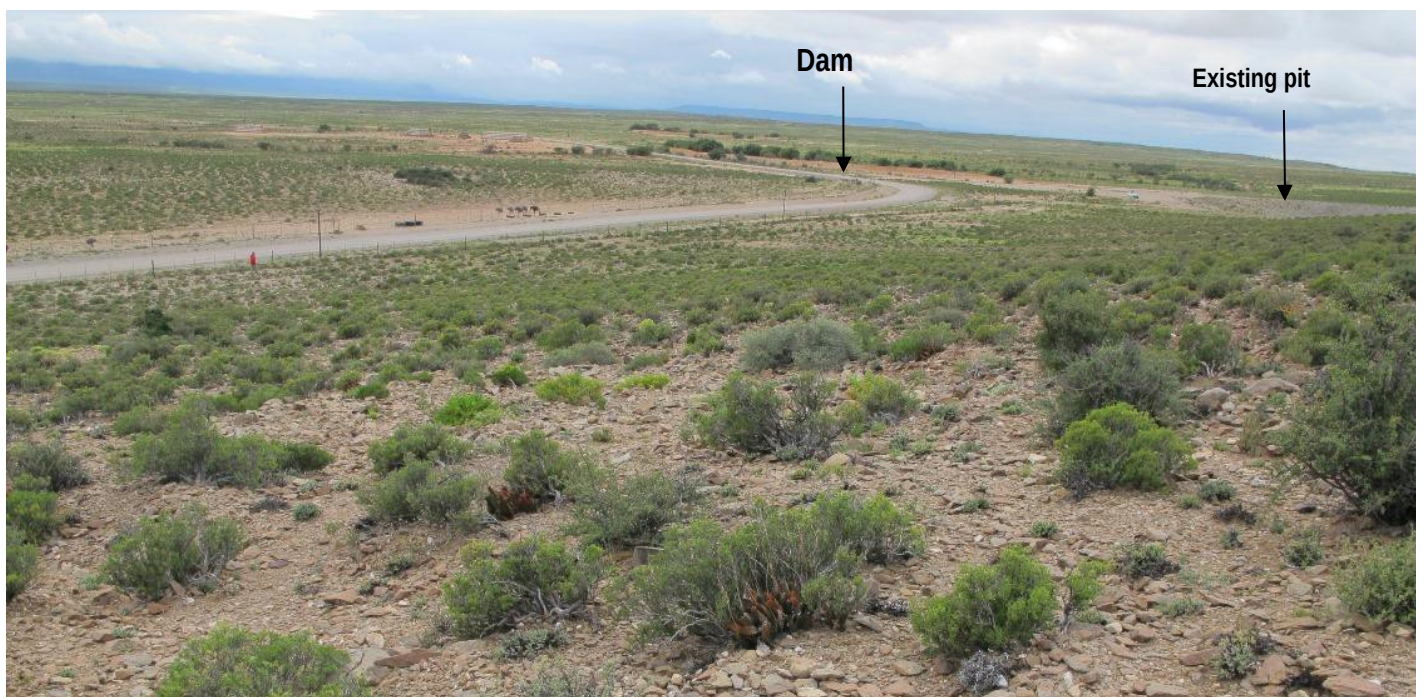
Figure 2: View towards the east of the existing quarry (Tusenius 2014: 7)

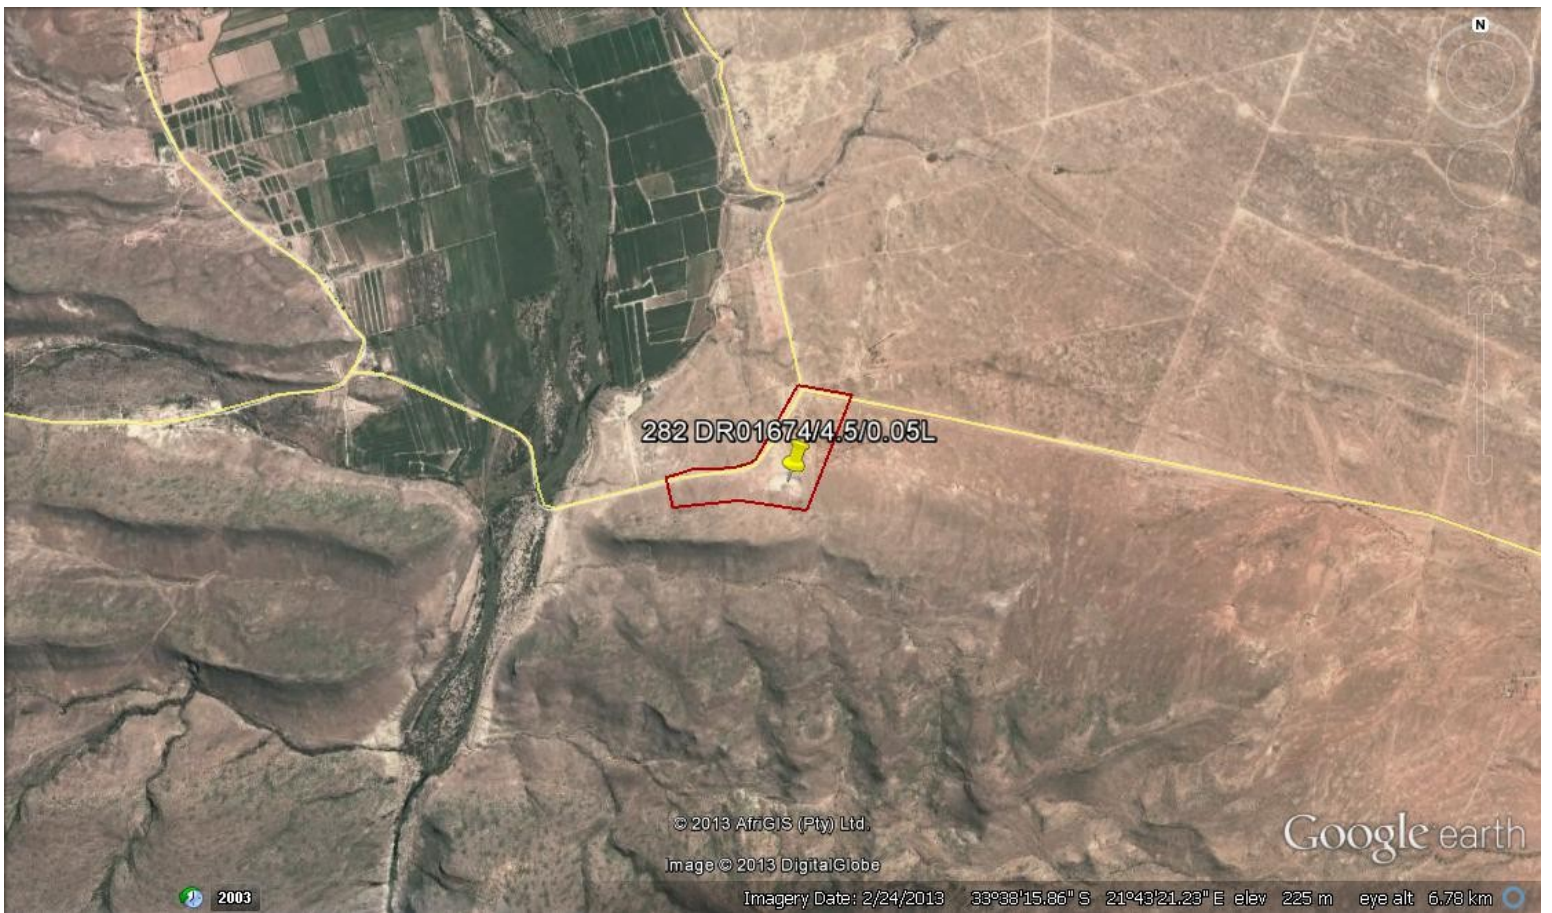
Figure 3: Site context and borrow pit location (Google earth, September 2013)

The potential source of a wearing coarse gravel pit site is located along the unpaved DR 1674/4.5/0.05L is accessed from the R62 southeast of Calitzdorp in Eden District, Western Cape. The proposed extension lies to the west of an existing borrow pit and the affected area is situated on the floodplain of the Gamka River at the foot of a hillslope where the Gamkaberg and Rooiberg meet. Uncultivated veld with mainly small indigenous xerophytic succulents and grasses surround the borrow pit. Farm Welgunst 394 is in private ownership of Mr Wynand Zaaïman. Borrow pit co-ordinates are 33°38'19.22"S and 21°43'24.21"E

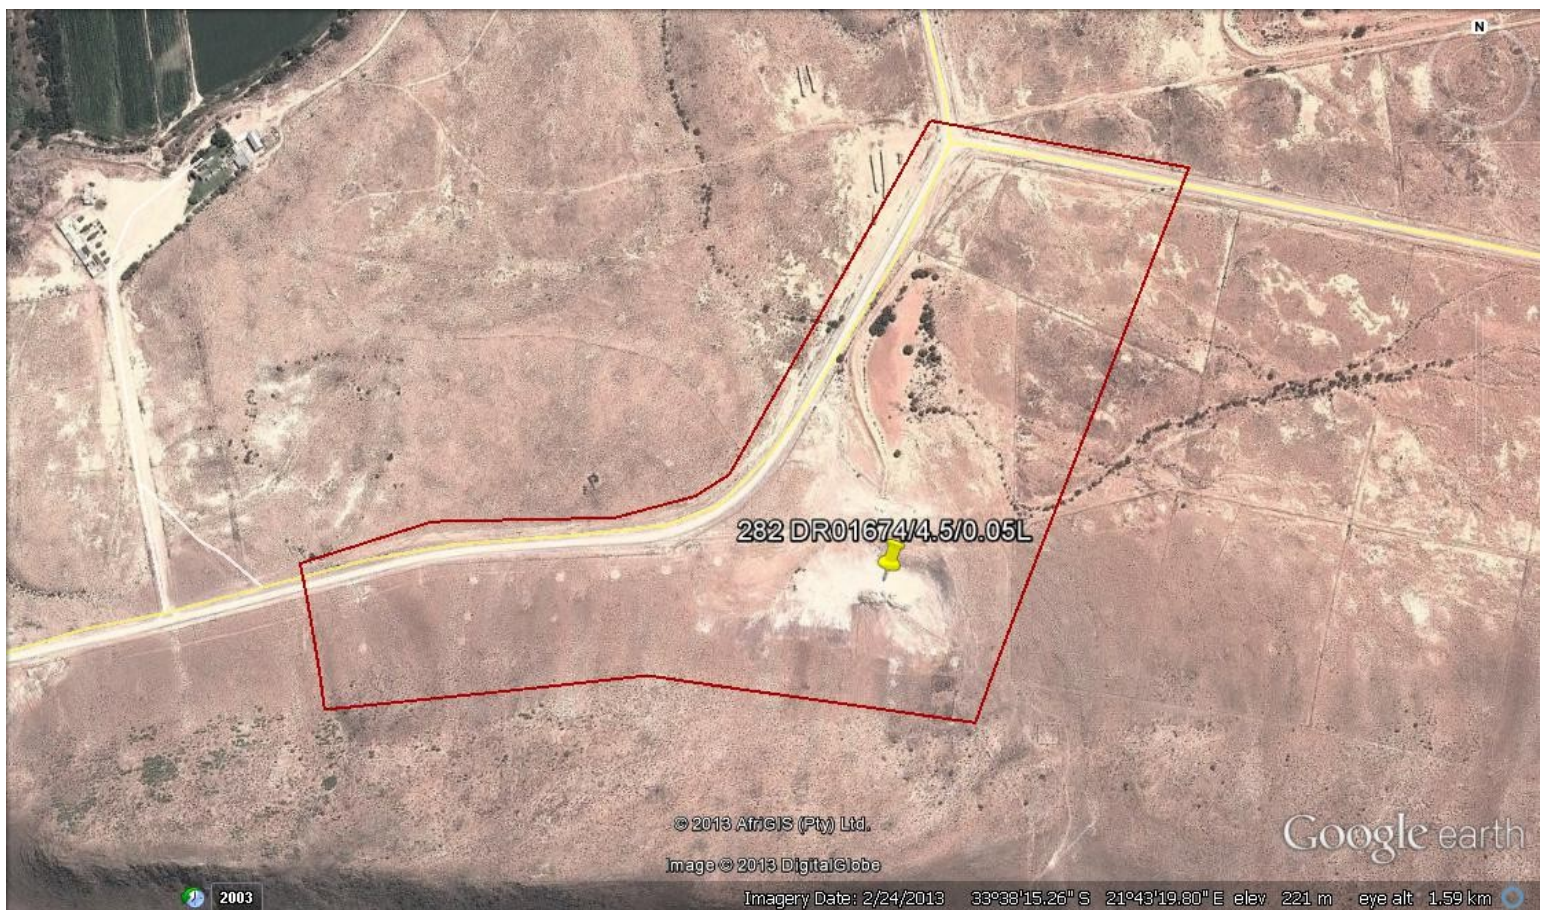
Figure 4: Aerial view of borrow pit and preliminary pit area (Google earth, September 2013)
