**ARCHAEOLOGICAL IMPACT ASSESSMENT
OF A PROPOSED BORROW PIT ON KLEINVLEI,
KLAARSTROOM, PRINCE ALBERT MUNICIPALITY,
WESTERN CAPE**

(Assessment conducted under Section 38 (8) of the National Heritage Resources Act as part
of a Heritage Impact Assessment)

MARCH 2012

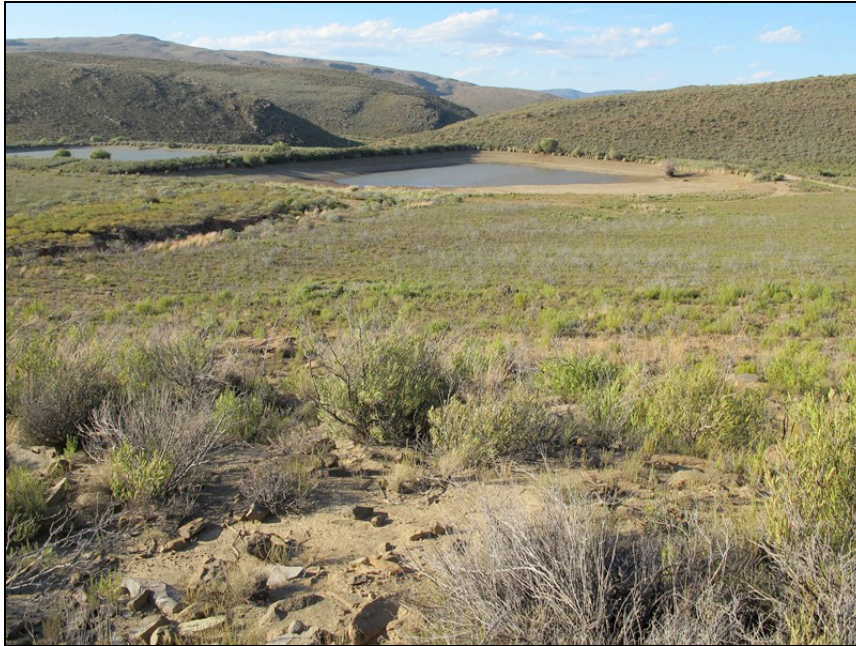
Figure 3: View across the affected area towards the dam in the north. The donga is visible on the left of the photo.

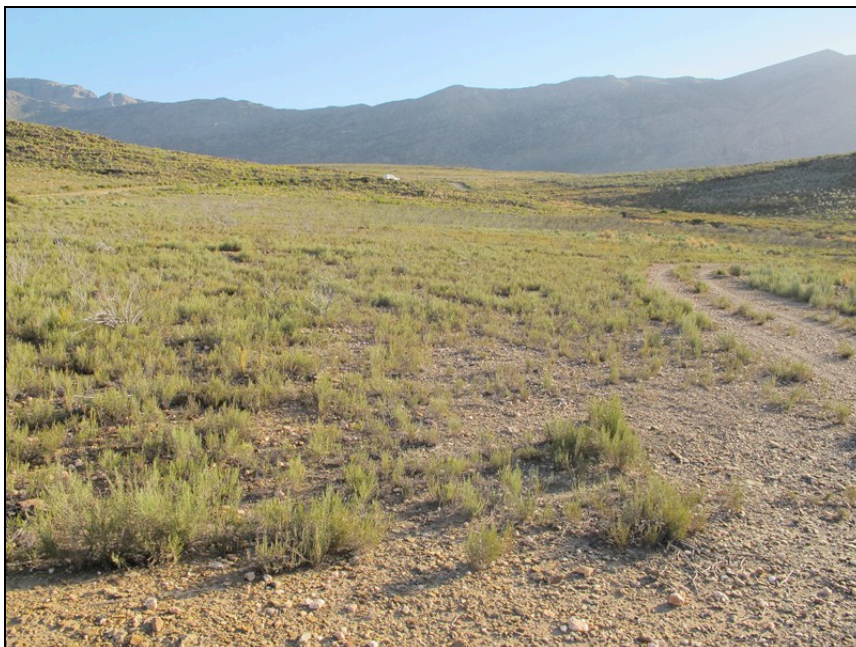
Figure 4: View of the affected area looking towards the Swartberg in the south. Low, fairly sparse vegetation covers the colluvial gravelly, silty sand on the surface here.

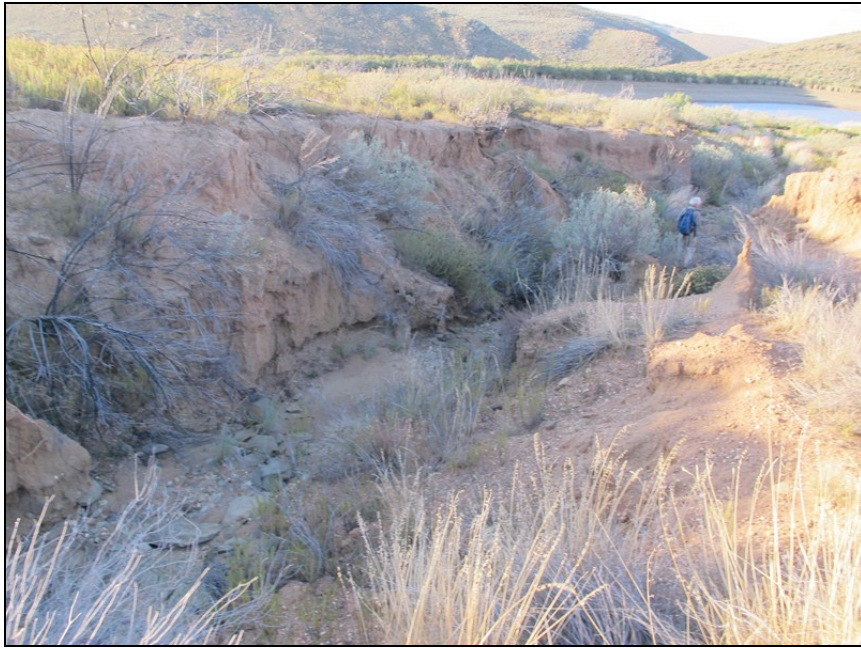
Figure 5: View northwards along the donga to the west of the affected area of pit 25. Slabs of weathered Bokkeveld shale are visible in the bottom of the donga.

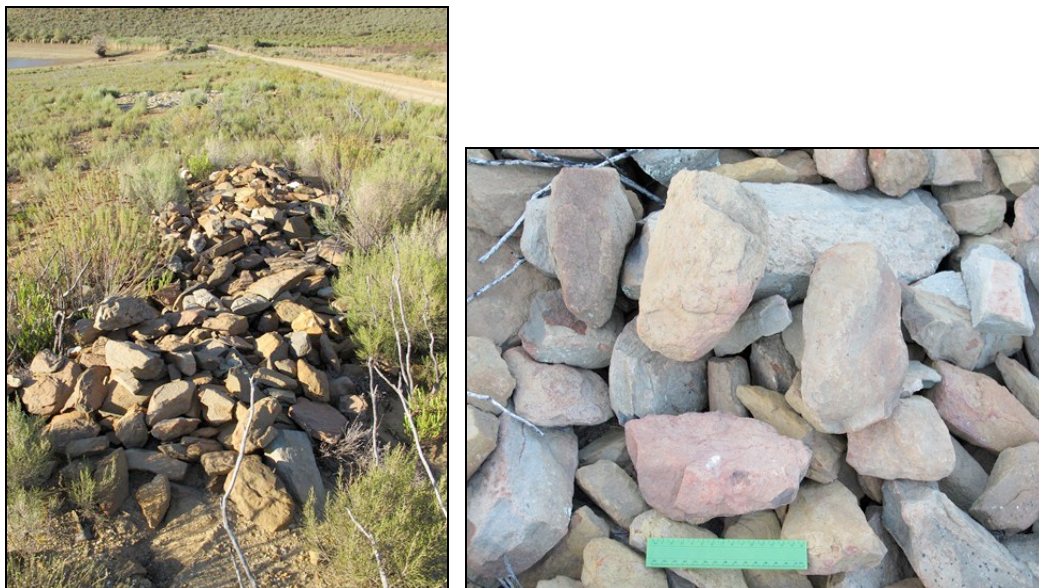
Figures 6 and 7: Heaps of stone from past ploughing in the foreground and from a geotechnical pit in the background; detail of some of the heaped rocks. The ruler is 15 cm in length.

Results of survey: The affected area and some land to the east of the road were surveyed (Figure 2). No archaeological remains were observed on the ground or in the heaps of rock. This was somewhat surprising given that Stone Age tools have been found in the general area (see section 5.1) and the fact that the quartzitic boulders, deriving from the old land surfaces, would provide a good source of raw material. Several quartzite exfoliation flakes, which could be confused with artefacts, were noted.

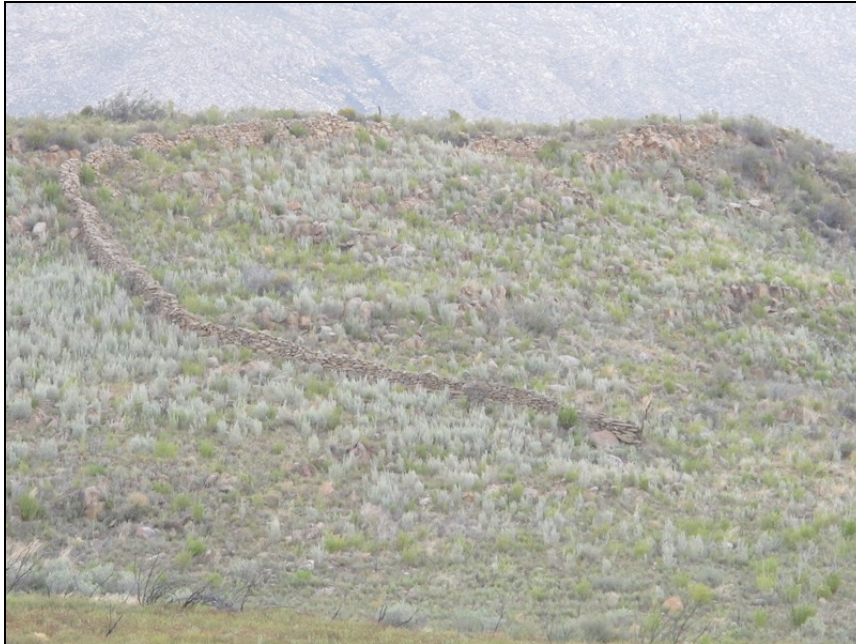
The only feature of historical interest observed lies outside the study area. It is a dry stone wall curving down from the crest of the little ridge to southwest of the donga (Figures 2, 8 and 9). The end of the wall which lies closest to the proposed pit is approximately 70 m away.

Figure 9: Close up of the dry stone wall viewed from the northeast.

No Stone Age or herder archaeological remains were observed in the area under consideration so the site is of low archaeological heritage significance. The dry stone wall observed lies outside the study area and there should be no direct impact on it, other than dust from the excavating activities. The proposed pit area is too far away from rocky outcrops where rock paintings may be found, so no impact on such heritage resources is predicted.
