**ARCHAEOLOGICAL IMPACT ASSESSMENT** **OF**  
**A PROPOSED BORROW PIT ON KLEINVLEI,**  
**KLAARSTROOM, PRINCE ALBERT MUNICIPALITY,**  
**WESTERN CAPE**

(Assessment conducted under Section 38 (8) of the National Heritage Resources Act as part  
of a Heritage Impact Assessment)

**MARCH 2012**

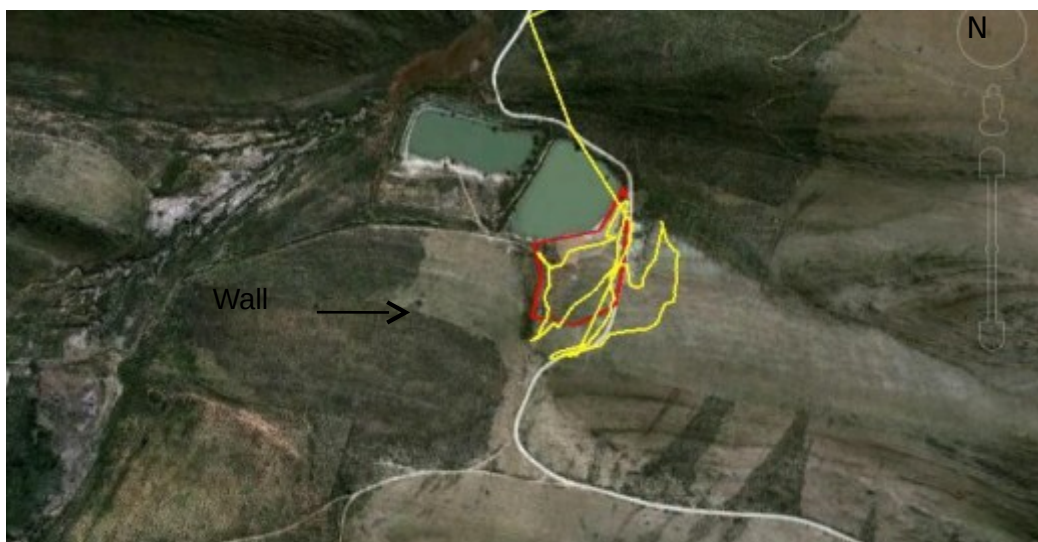
Figure 2: Google earth image showing the location of the proposed borrow pit 25 and the tracks recorded. The erosion gully (donga) lies immediately to the west of the study area and the closest end of the dry stone wall lies approximately 70 m to the southwest.

**Results of survey:** The affected area and some land to the east of the road were surveyed (Figure 2). No archaeological remains were observed on the ground or in the heaps of rock. This was somewhat surprising given that Stone Age tools have been found in the general area (see section 5.1) and the fact that the quartzitic boulders, deriving from the old land surfaces, would provide a good source of raw material. Several quartzite exfoliation flakes, which could be confused with artefacts, were noted.

The only feature of historical interest observed lies outside the study area. It is a dry stone wall curving down from the crest of the little ridge to southwest of the donga (Figures 2, 8 and 9). The end of the wall which lies closest to the proposed pit is approximately 70 m away.

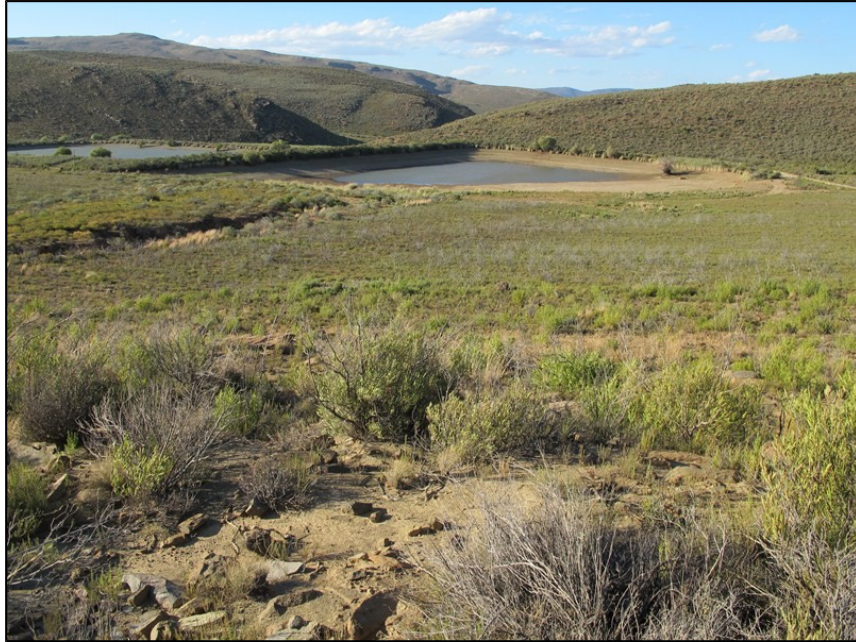
Figure 3: View across the affected area towards the dam in the north. The donga is visible on the left of the photo.

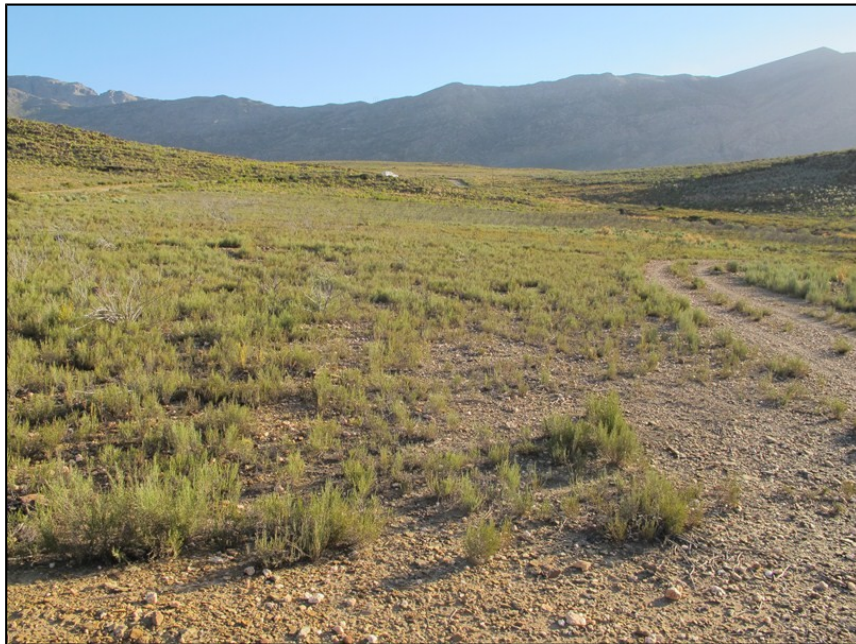
Figure 4: View of the affected area looking towards the Swartberg in the south. Low, fairly sparse vegetation covers the colluvial gravelly, silty sand on the surface here.

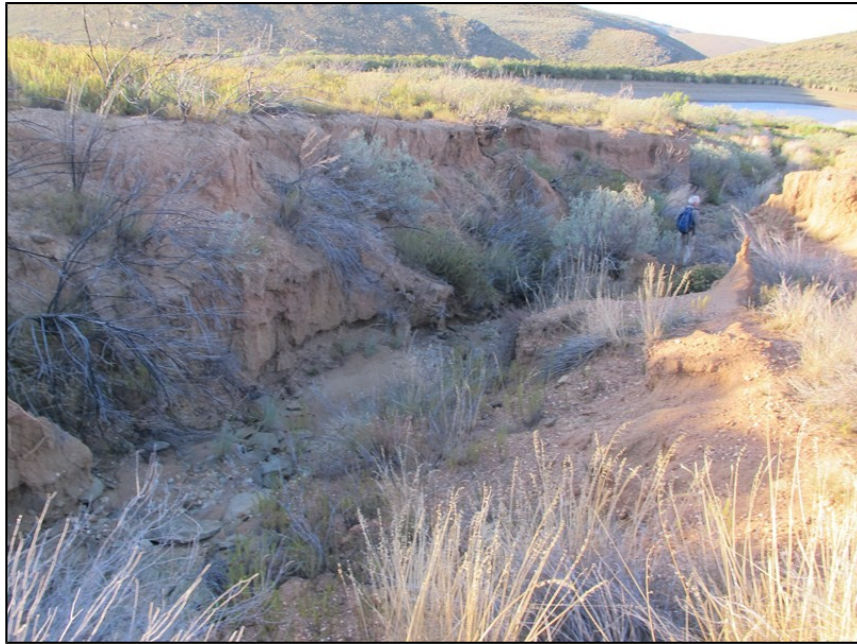
Figure 5: View northwards along the donga to the west of the affected area of pit 25. Slabs of weathered Bokkeveld shale are visible in the bottom of the donga.

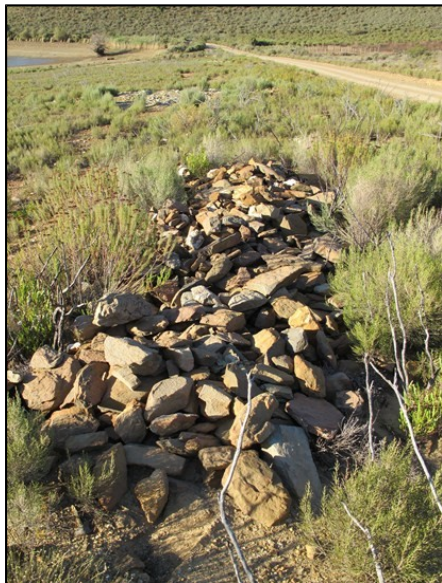
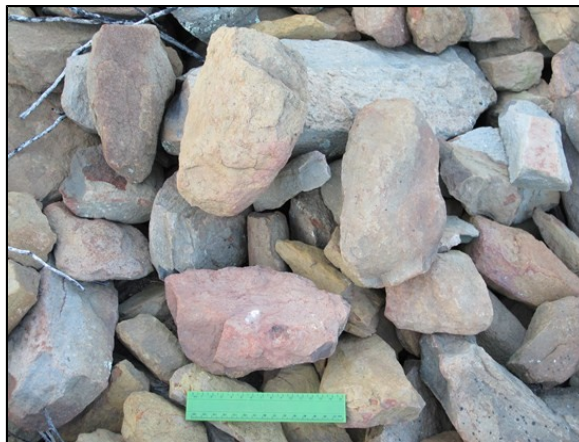
Figures 6 and 7: Heaps of stone from past ploughing in the foreground and from a geotechnical pit in the background; detail of some of the heaped rocks. The ruler is 15 cm in length.

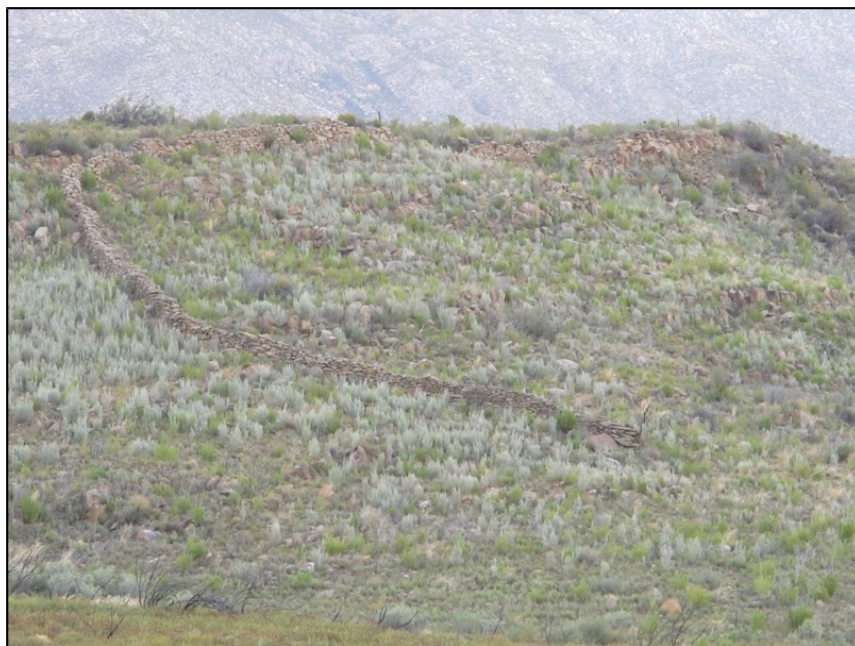
Figure 9: Close up of the dry stone wall viewed from the northeast.

No Stone Age or herder archaeological remains were observed in the area under consideration so the site is of low archaeological heritage significance. The dry stone wall observed lies outside the study area and there should be no direct impact on it, other than dust from the excavating activities. The proposed pit area is too far away from rocky outcrops where rock paintings may be found, so no impact on such heritage resources is predicted.
