# HERITAGE IMPACT ASSESSMENT

25 April 2012

Divisional Road 01721, Klaarstroom

Prince Albert – Central Karoo District Municipality, Western Cape

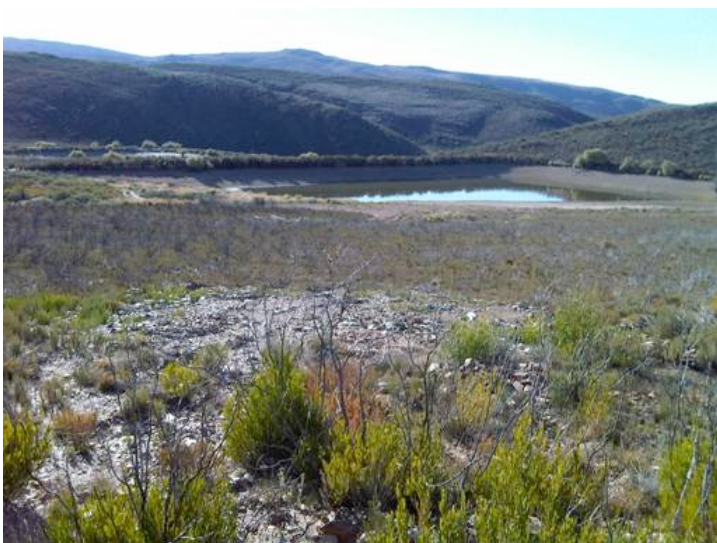
Figure 2: Looking northwest across the site of proposed expansion located between road DR01721 and existing dam (April 2011)

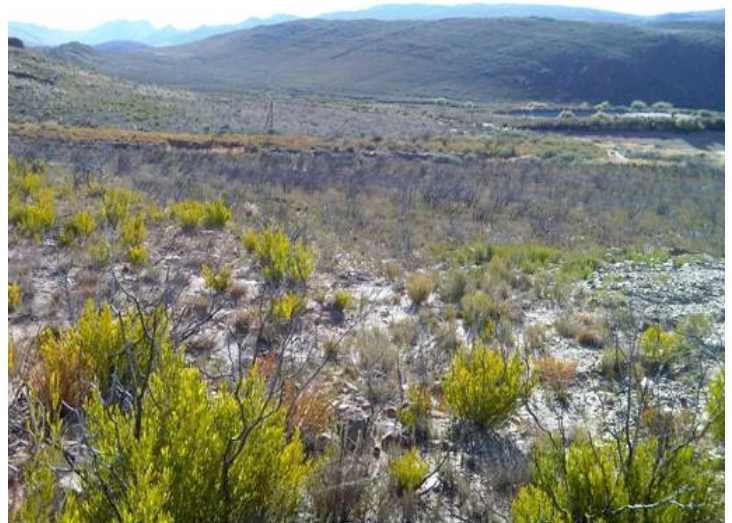
Figure 3: Looking west across site of proposed expansion located to the south and east of existing farm dam (April 2011)

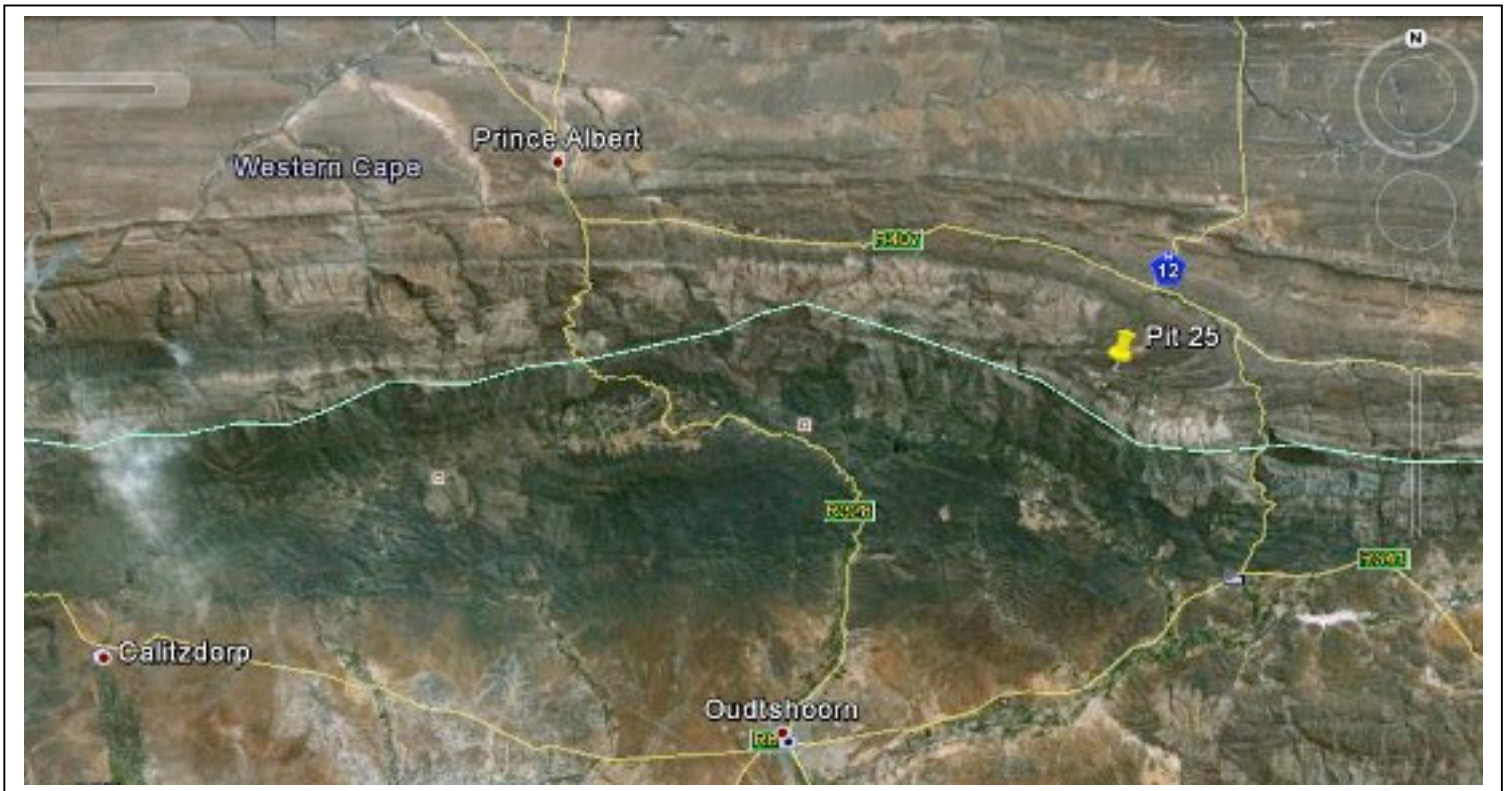
Figure 4: Aerial view of proposed borrow pit location (Tusenius, March 2012)

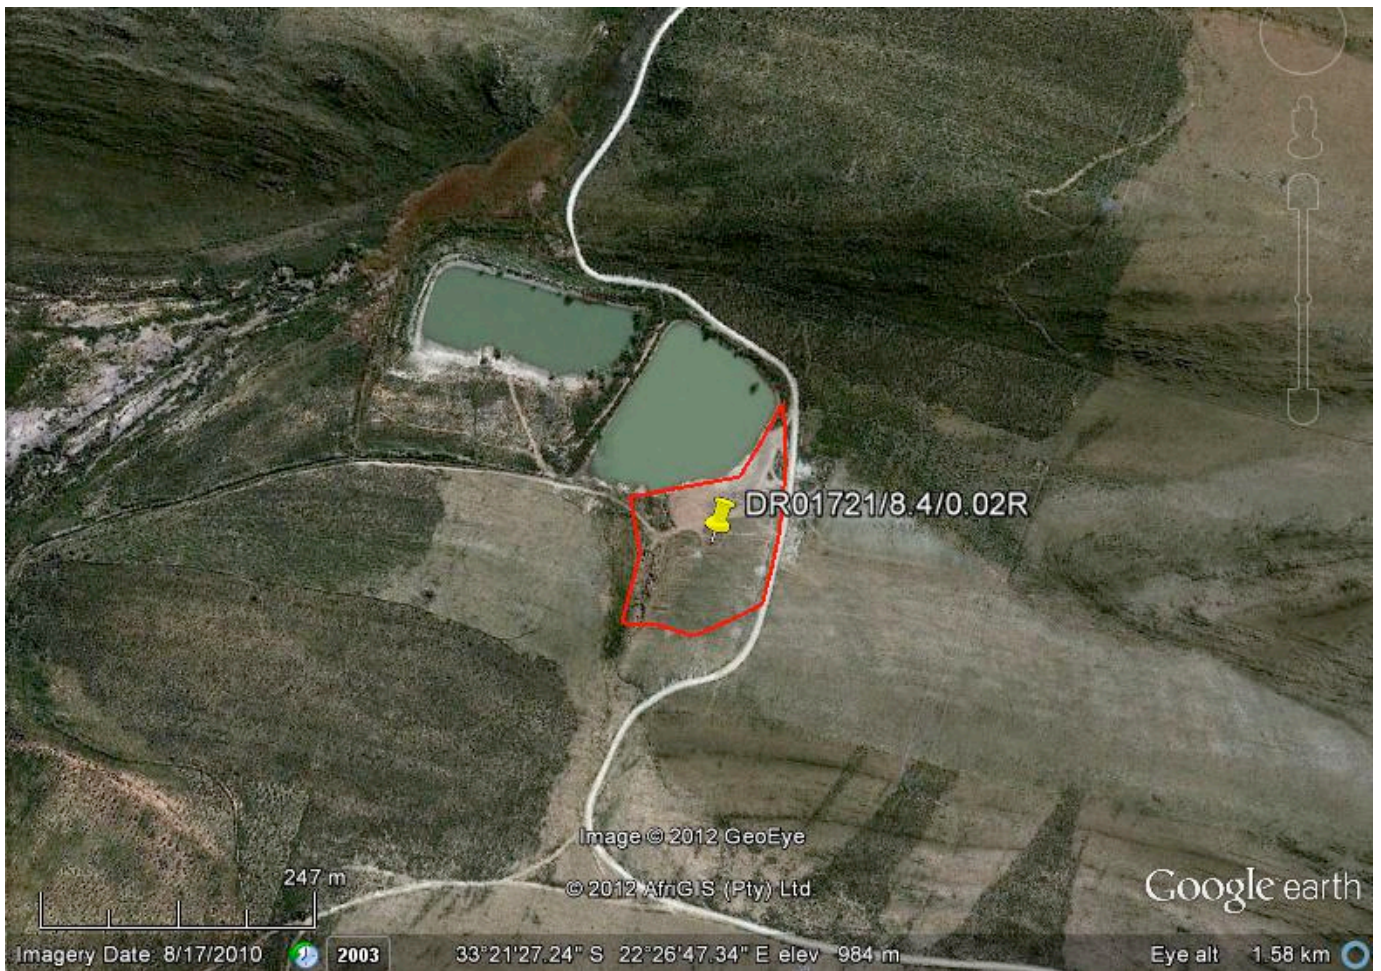
Figure 5: Aerial view of proposed borrow pit location (Google earth image, April 2012)
