# HERITAGE IMPACT ASSESSMENT: PROPOSED BORROW PIT ON THE FARM HOLTE 83, NAMAKWA MAGISTERIAL DISTRICT, NORTHERN CAPE

29 July 2021

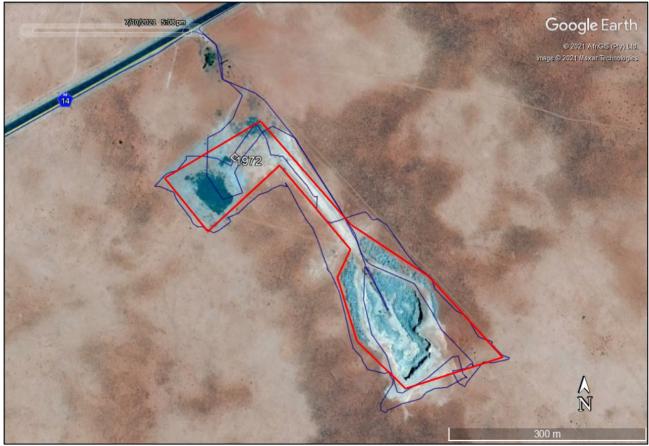
Figure 4: Aerial view of the study area (red polygon) showing the survey tracks (blue lines).

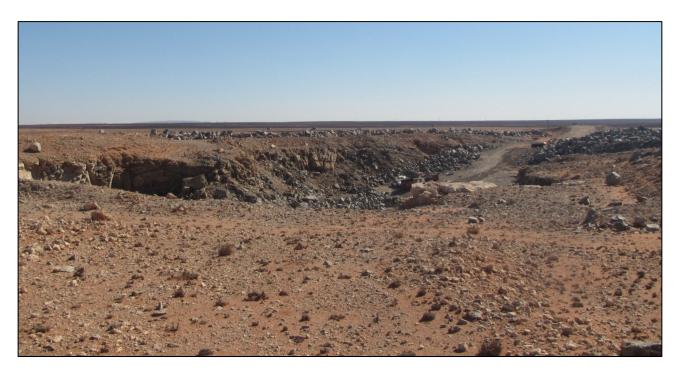
*Figure 5:* View towards the northwest from the south-eastern edge of the study area and showing the existing borrow pit in the southern half of the application area.

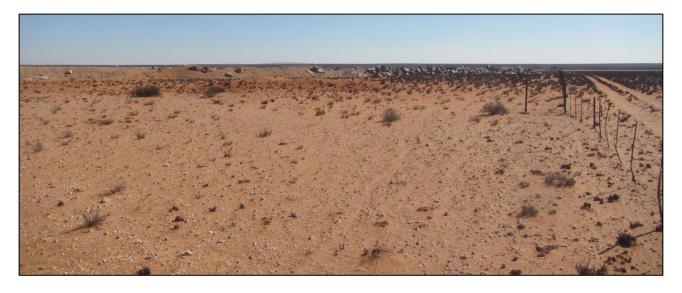
*Figure 6:* View towards the northwest from the south-eastern corner of the study area showing the largest undisturbed area with sand and calcrete nodules on the surface.

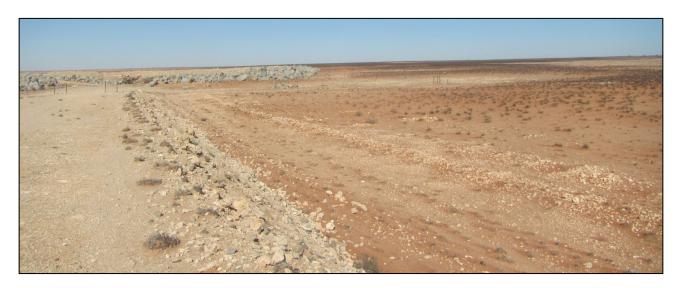
*Figure 7:* View towards the southeast along the existing road linking the northern and southern sections of the application area.

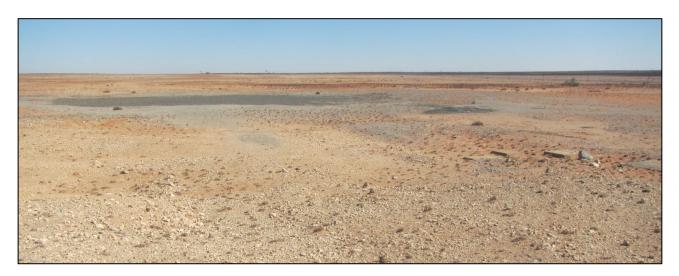
**Figure 8:** View towards the west across the northern part of the application area showing the gravelled surface. Some cement bases related to earlier gravel processing activities are visible to the right.

No archaeological materials were seen in the study area. A number of cement bases were noted in the northern part of the study area but they are modern, clearly associated with the borrow pit.

No historical materials were seen on the site. A number of cement bases related to the earlier quarrying activities were noted though. It is evident from the 1973 topographic map that the quarry was not yet present, although others did exist along the N14. The cement bases are thus not heritage resources.

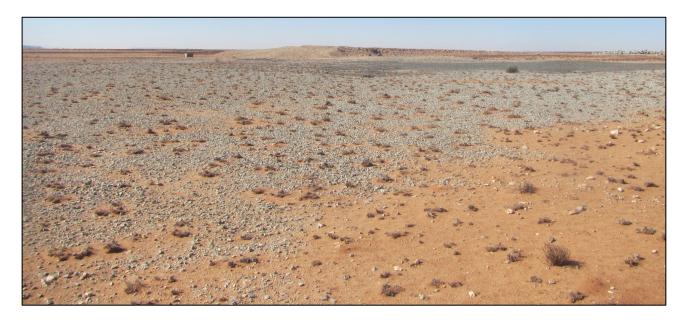
**Figure 9:** View towards the east from the western corner of the study area showing the calcrete gravel in the foreground and igneous gravel in the background.

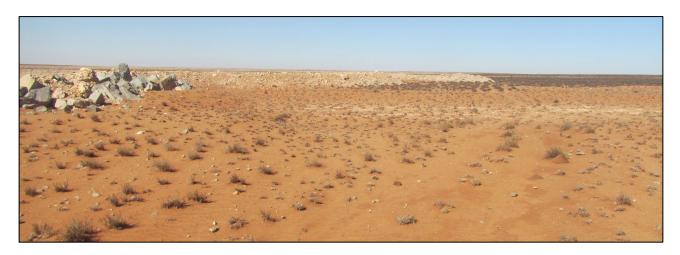
*Figure 10:* View towards the south along the western margin of the southern part of the study area showing a section of undisturbed ground just outside the application area.

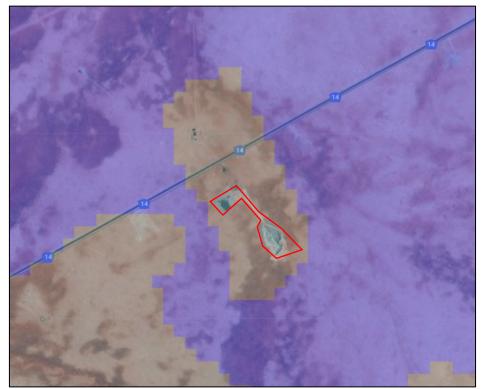
The proposed mining area is underlain by Mesklip Granite of the Little Namaqualand Suite. These rocks are entirely unfossiliferous (Almond & Pether 2009) as shown by the extract from the SAHRIS Palaeosensitivity Map shown in Figure 11.

**Figure 11:** Extract from the SAHRIS Palaeosensitivity map showing the entire study area and immediate surrounds to be of zero palaeontological sensitivity (grey shading). Areas of low sensitivity lie further afield (blue shading).

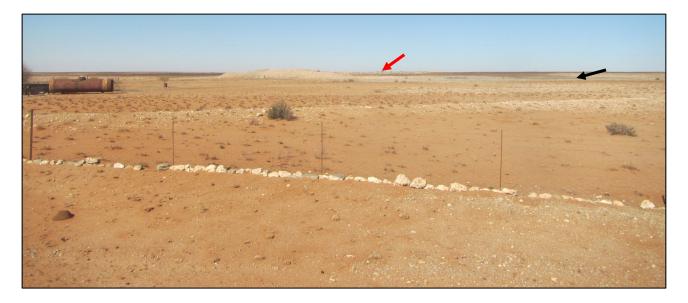
The dry parts of South Africa do hold a distinct aesthetic appeal. The N14 can thus be regarded as a scenic route. The current borrow pit is visible from the N14 (Figure 12) and will become far more visible once machinery is introduced and quarried rock is stockpiled there.

*Figure 12:* View towards the southeast from the N14. The stockpiling area in the north lies 200 to 270 m from the N14 (black arrow), while the mining area lies 470 to 670 m away on the skyline (red arrow).
