**MADRASSA AN-NOOR FACILITY FOR THE BLIND,
CEDARA, WARD 6, UMNGENI MUNICIPALITY
KWAZULU-NATAL**

Phase 1 Heritage Impact Assessment

August 2016

**Author: Jean Beater
JLB Consulting**

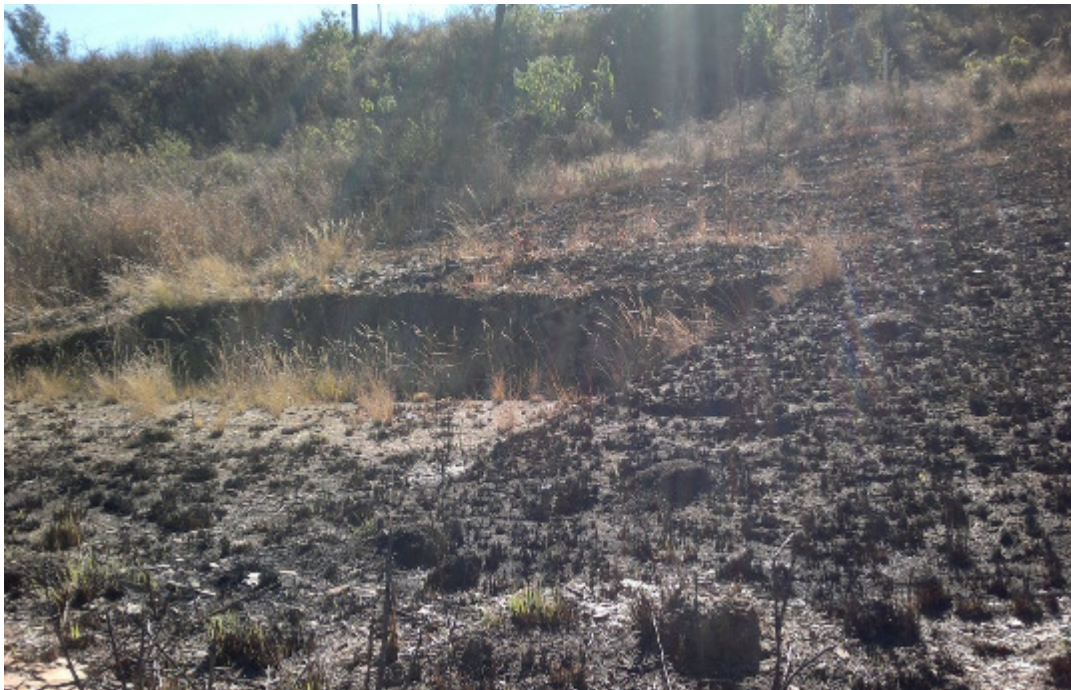
Mr Timol, project manager, stated that before the area was occupied by the facility, the area had been occupied by the inhabitants of an informal settlement. Remnants of this settlement are still visible in the project area where terraced areas are still visible where structures were built as well as refuse (litter) including bottles left by the inhabitants. The terraced areas are visible throughout the project area. Power lines also cross the project area.

Figure 3: Terraced area for placing of structures

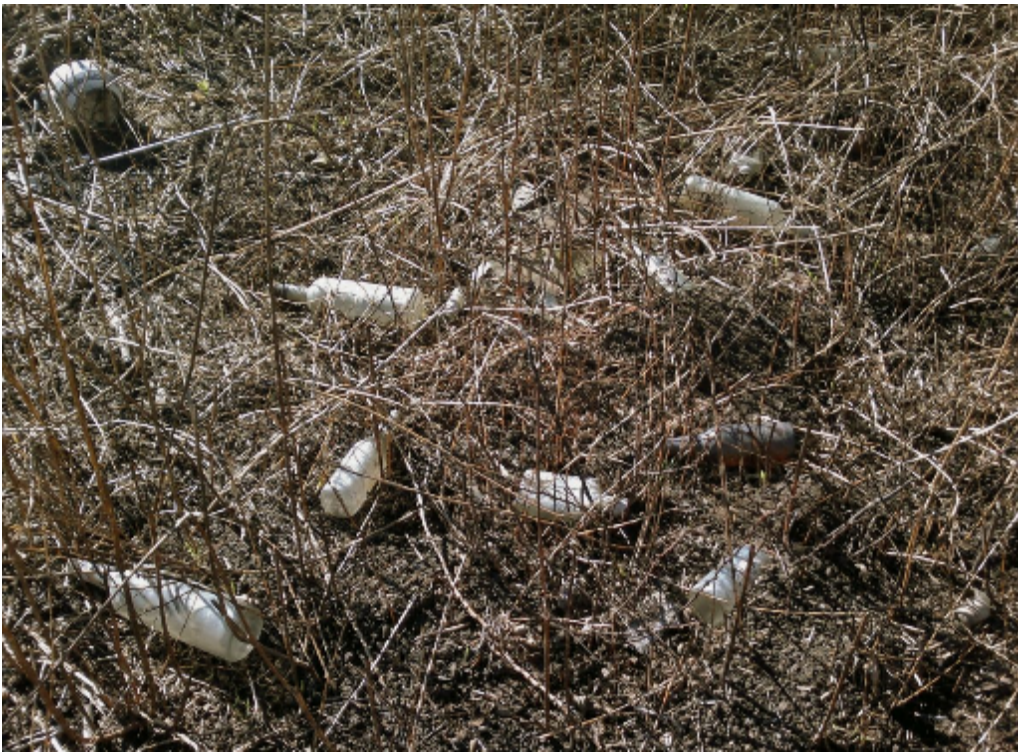
Figure 4: Bottles and other refuse

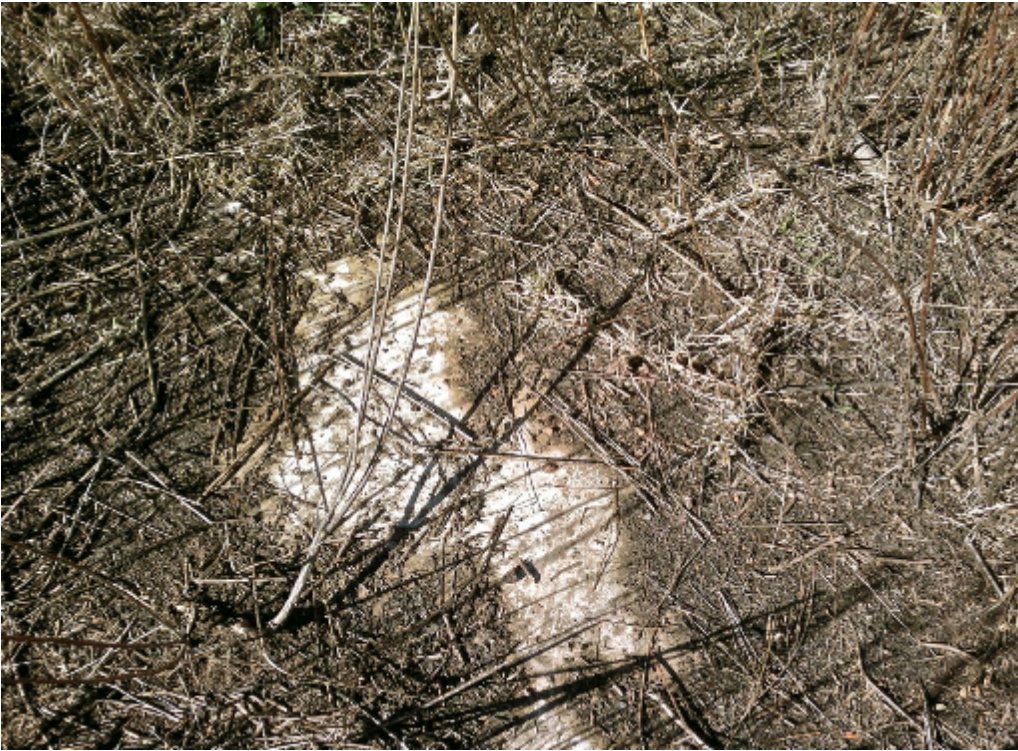
The remains of some floors of dwellings are still visible. Mr Timol mentioned that not all the structures in the informal settlement were shacks but that there were some cement structures as well. The remains of at least three such floors are still visible with some of the foundations still visible. Throughout the project area there are mounds of building rubble presumably left when the informal settlement was moved.

Figure 5: Remains of floor of structure

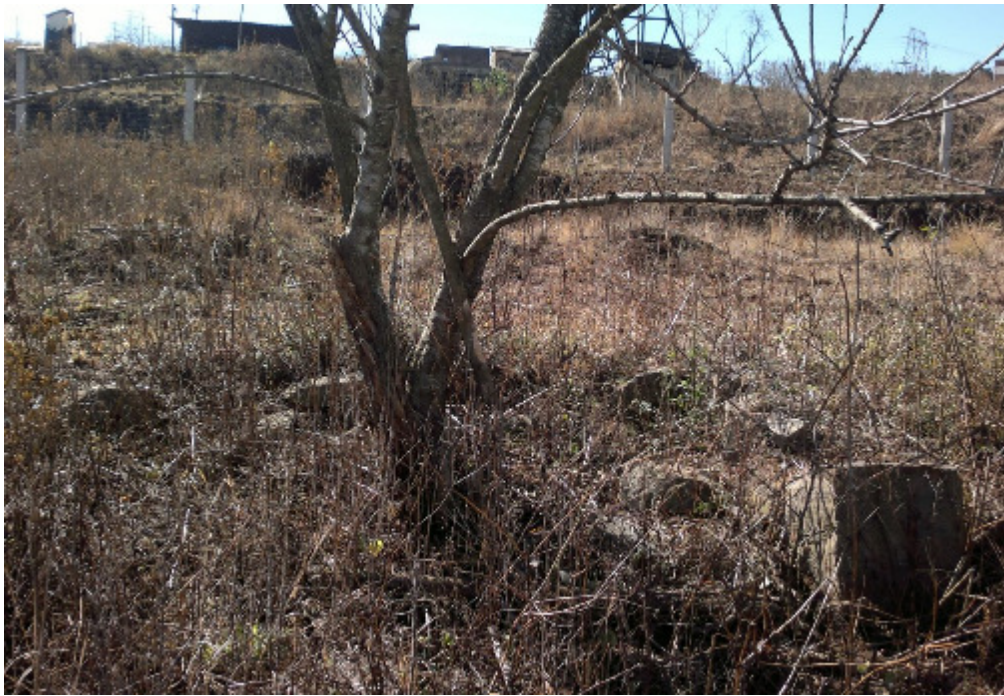
Figure 6: Remains of foundation / wall of structure

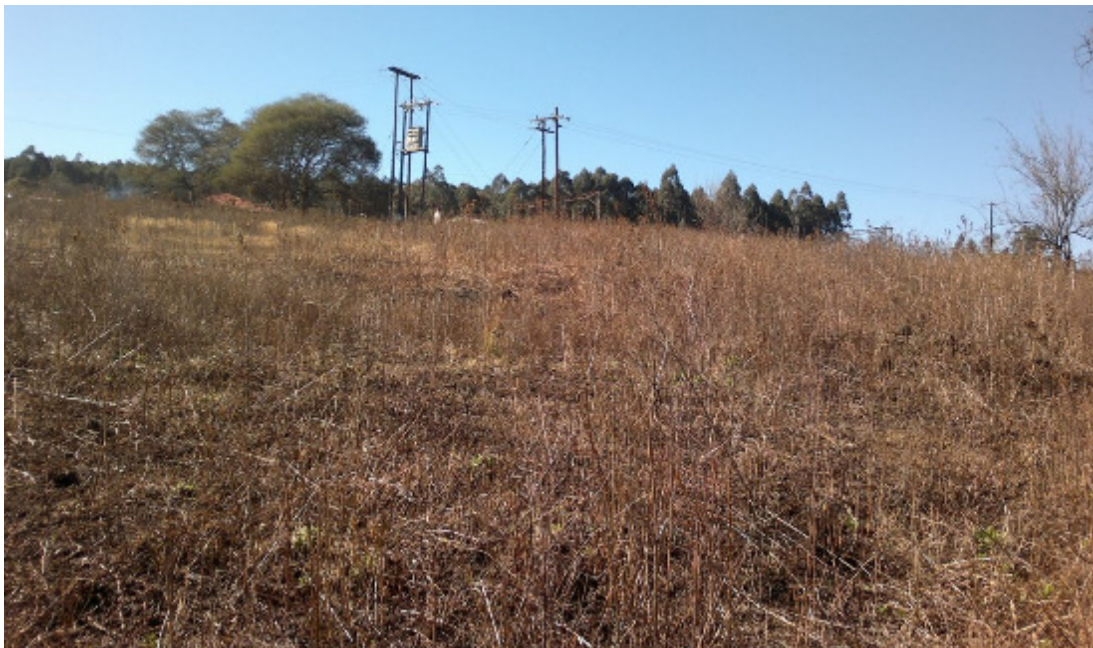
Figure 7: North eastern section of project area showing power lines

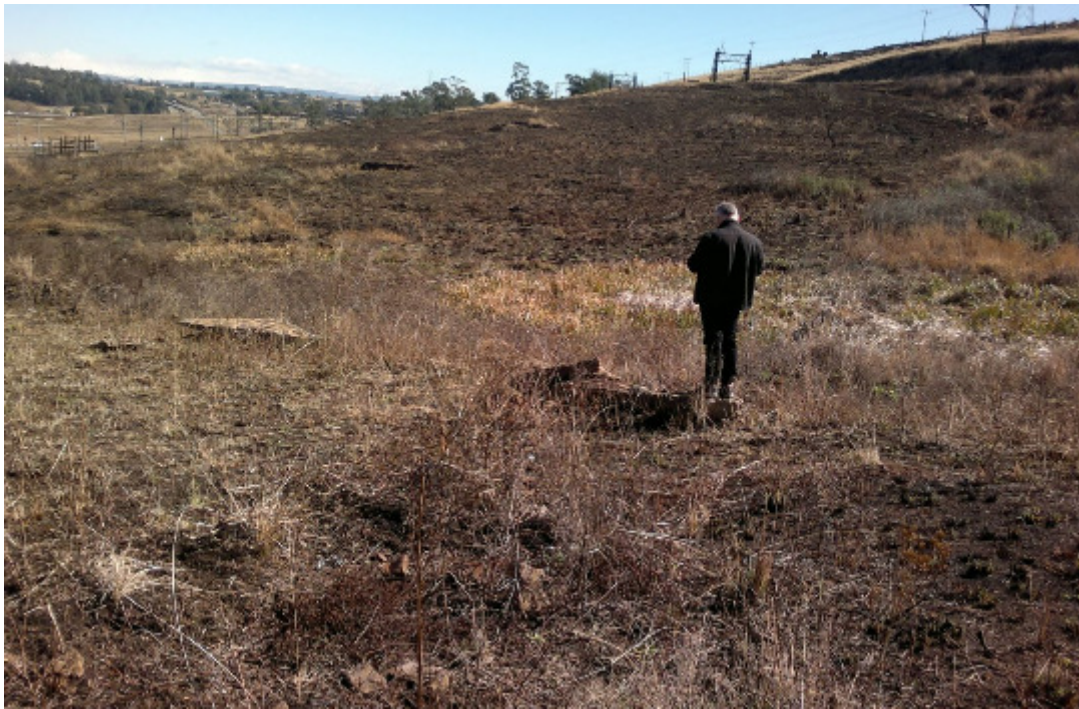
The western half of project area contains two wetlands that limit development in close proximity to these ecologically sensitive features. A man-made dam has been constructed below one of the wetlands for water storage. There are existing pipes running through this area but it is unclear what these are or were used for.

Figure 8: Western section of project area showing wetland in foreground

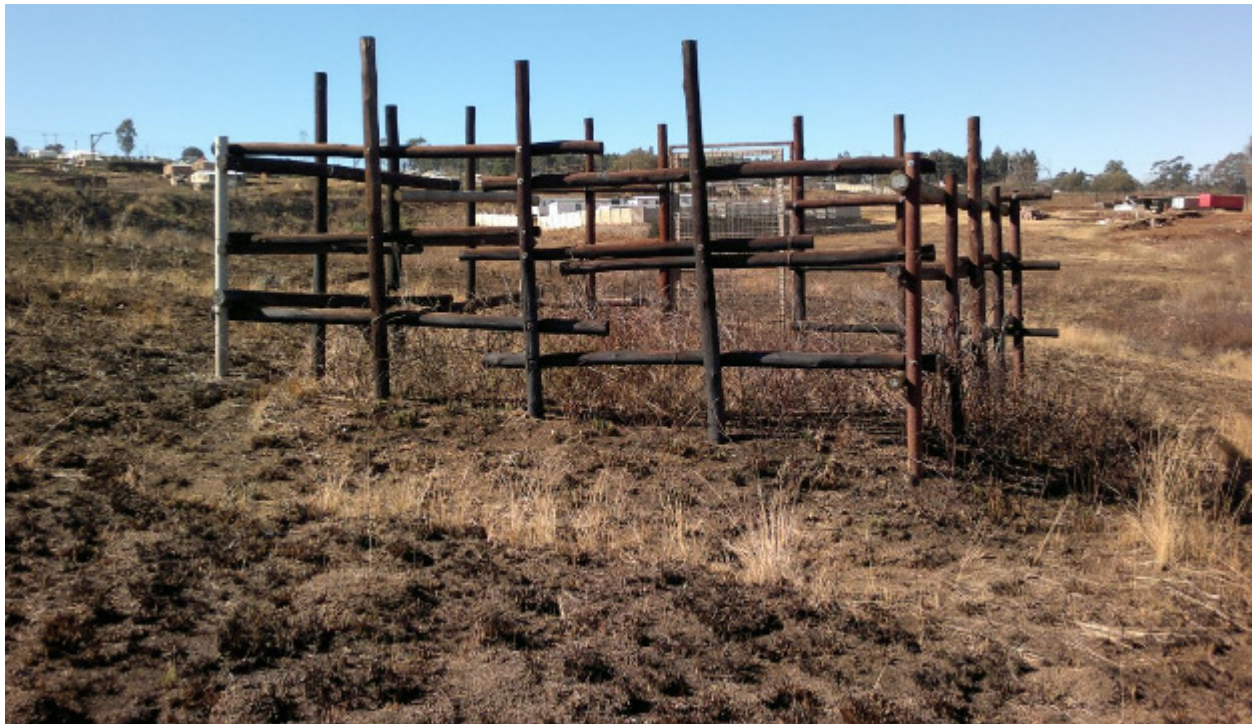
In the centre of the project area is a wooden structure that was used to keep animals therein. It appears to be currently unused.

Figure 9: Wooden structure used to keep animals

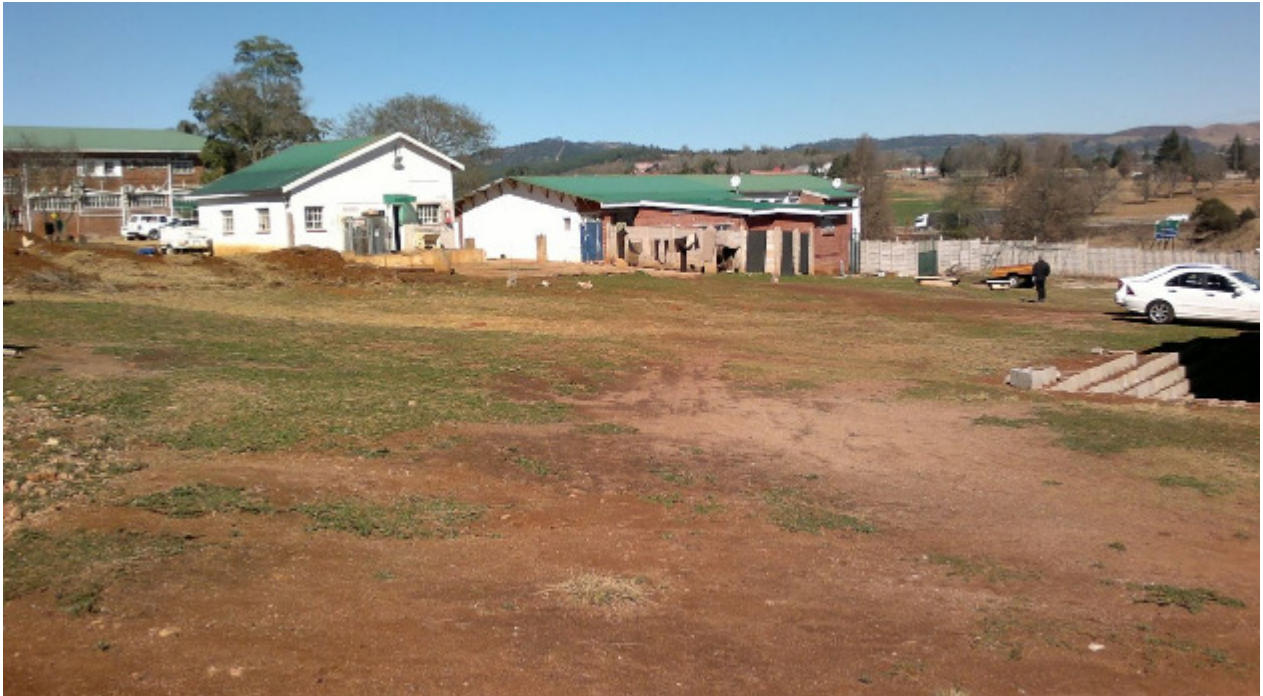
The existing structures exhibit no characteristics of historic significance or importance. The buildings are depicted below.

Figure 10: Existing structures
