**450MW**

**EMERGENCY RISK MITIGATION  
POWER PLANT (RMPP) ON LOTS  
1854 AND 1795, ALTON,  
RICHARDS BAY**

**PRELIMINARY SURFACE WATER  
ASSESSMENT REPORT**

18/3388-01A-SW

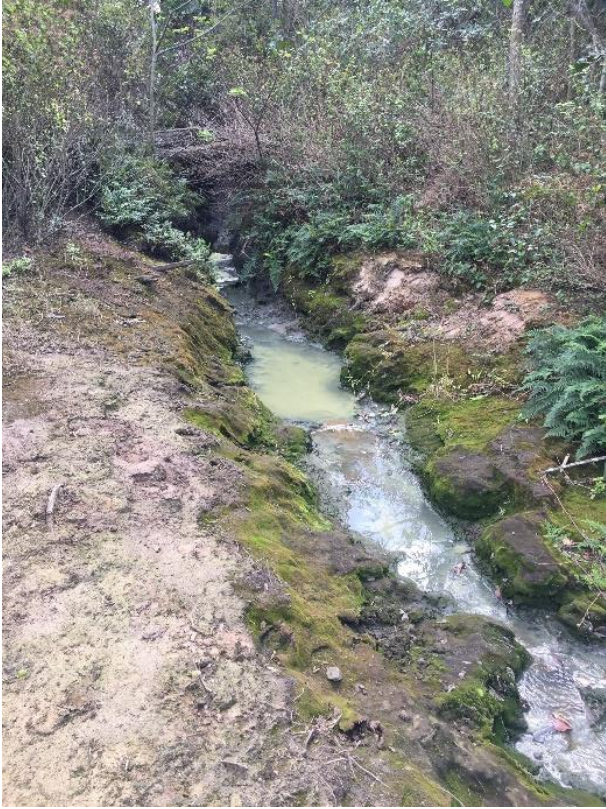
**Plate 5 : Upstream Sampling Location (WS04)**

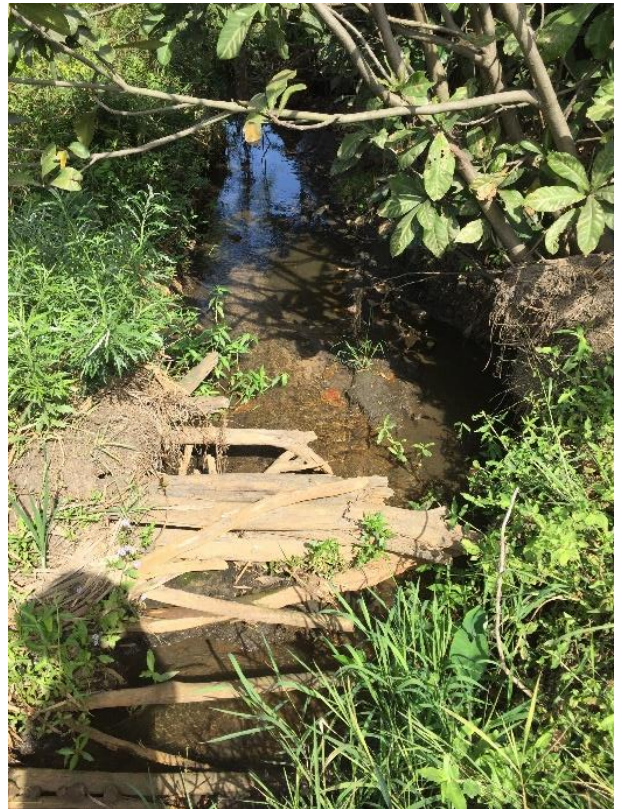
**Plate 6 : Downstream Sampling Location (WS05)**

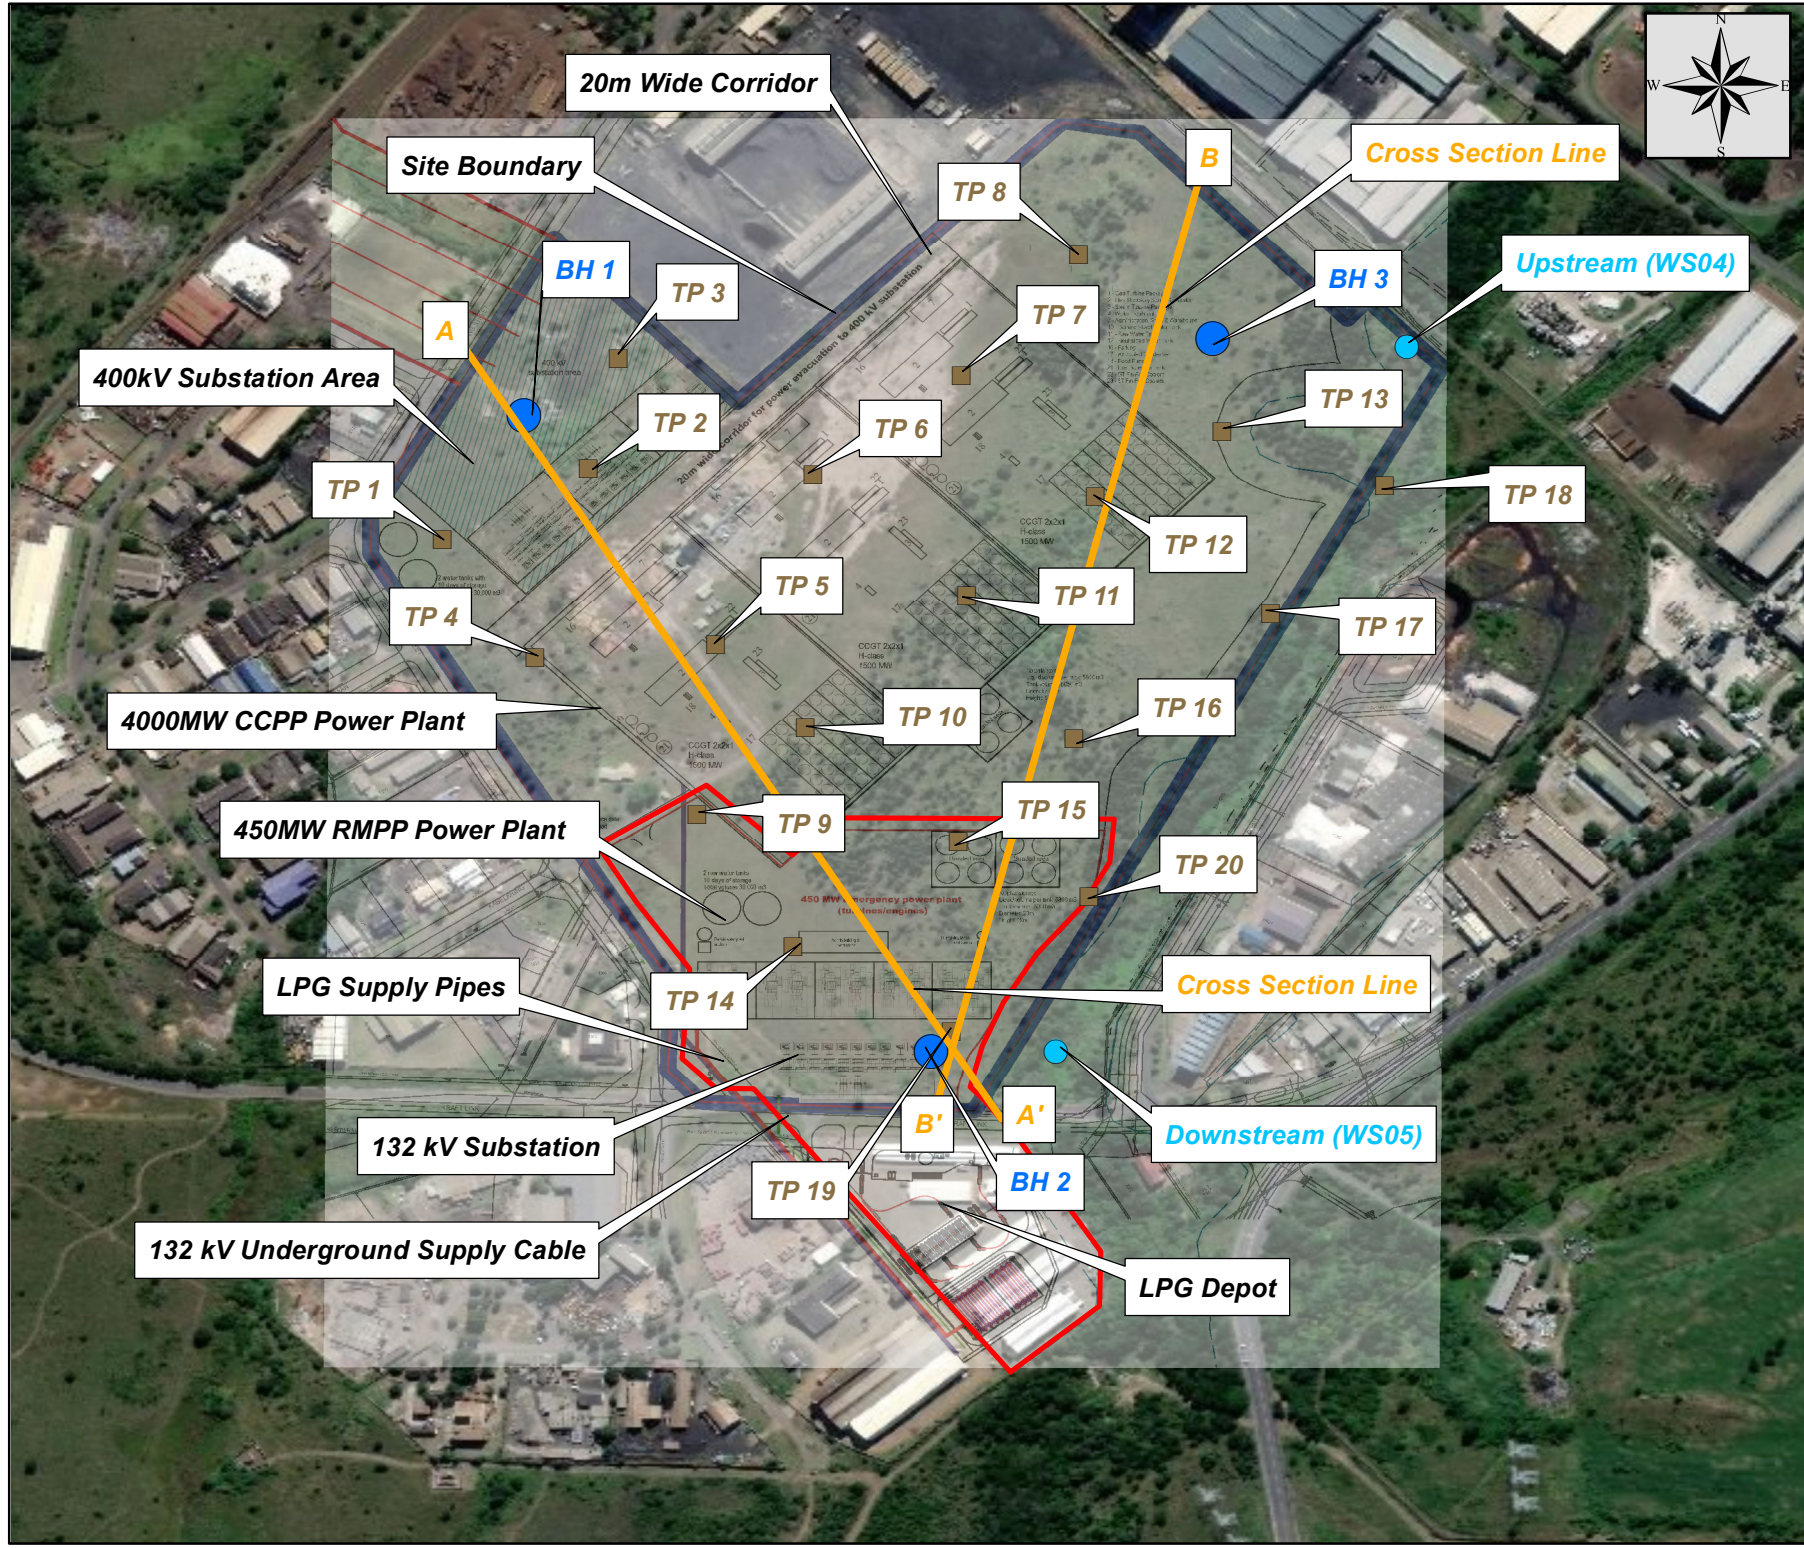
<b>JOB NO.</b> 18 / 3388 -01A - SW	<b>FIGURE NO.</b> FIGURE D2
--	--------------------------------

- LEGEND:**
- SURFACE WATER SAMPLE
  - GROUNDWATER SAMPLE
  - IP / DCP POSITIONS

**FIGURE TITLE:**  
**OVERALL SOIL, SURFACE WATER AND GROUNDWATER SAMPLING PLAN**
