**Heritage documentation of four bridges on a  
SECTION OF THE N11 NATIONAL ROUTE NORTH OF MOKOPANE,  
LIMPOPO PROVINCE**

**Report No:** 2012/JvS/036  
**Status:** Draft  
**Revision No:** 0  
**Date:** July 2012

This report presents the basic documentation of the four bridges.

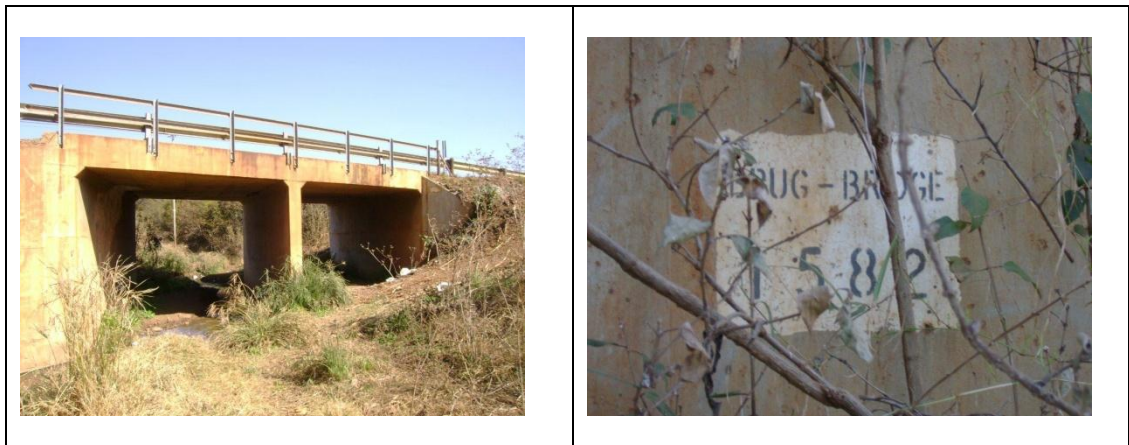
Fig. 5. Side-view of the bridge and its identification number.

This is a two span bridge of cast concrete. The bridge deck is supported by a single concrete column. The abutment and wing walls are all of concrete. The original railings are still in place and are now supported by Armco barriers. According to a panel on the bridge it dates to 1958.

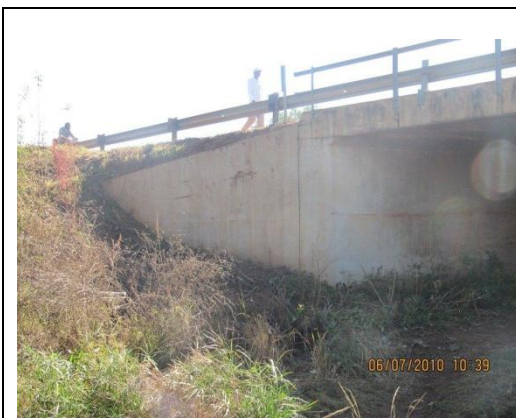
The walls are constructed from concrete that was cast in slabs. The abutment walls are currently below water level and most likely going down to the bedrock. The height of the abutment walls (to water level) is 3 m and it is 12 m wide.

Abutment wall, north-eastern side

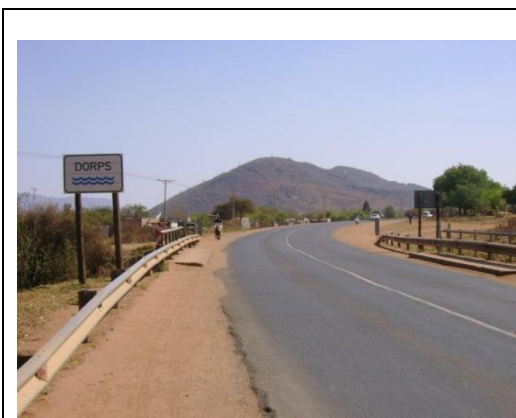
The approach road runs between Mokopane and the Botswana border and carries a large volume of traffic.

Approach road, travelling north

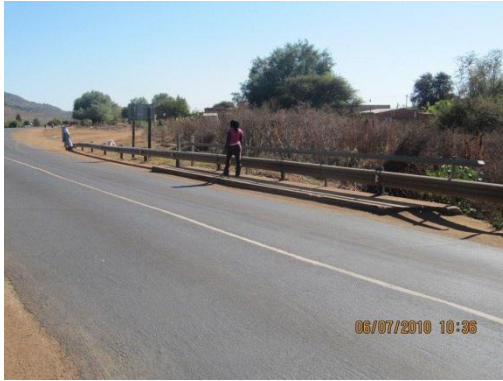
The bridge deck consists of concrete, which is also part of the construction of the bridge and is then covered with a layer of tarmac. The total length of the bridge deck is just over 12 m.

Bridge deck seen from the top

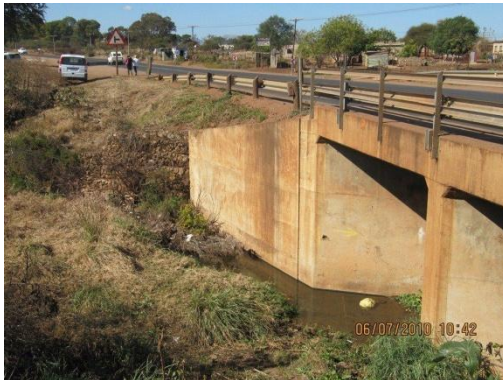
A single column supports the bridge deck. It is from cast concrete and is set at a slight angle to the bridge deck in order to be parallel to the stream bed.

The location of the column

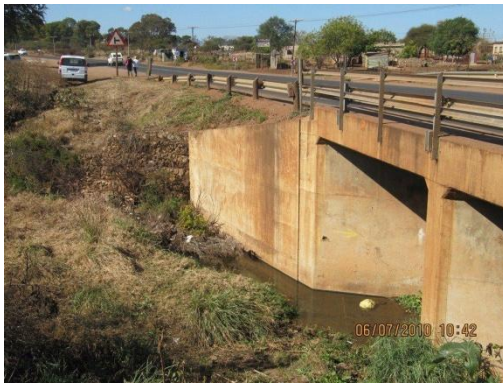
Formed by packing down soil to achieve the necessary height and then sloping down gradually the further away one moves from the river.

Showing the south-eastern embankment

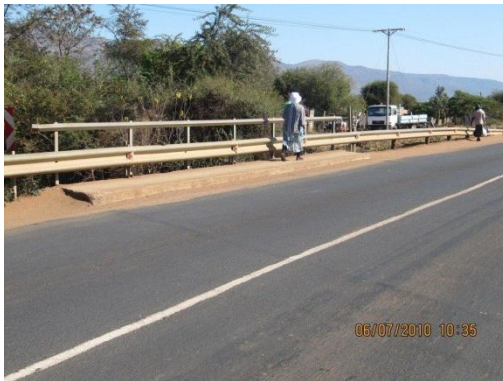
The guide rail is a raised platform of concrete, edged with angle iron that runs the length of the bridge. It is about 10cm high and about 30cm wide.

The guide rail

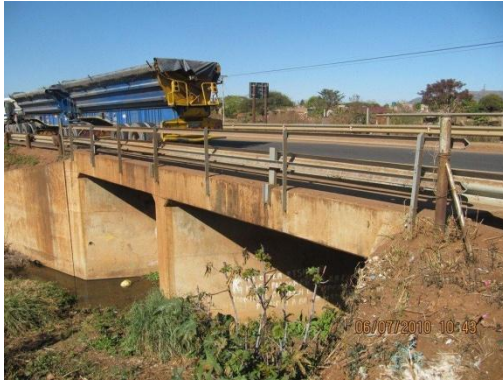
The original railings are made of six upright sections of pipe which supports two horizontal bars running the length of the bridge. The railings are now supported by Armco barriers

Railing on eastern side of bridge

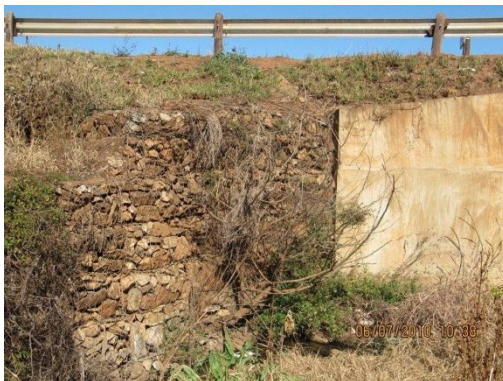
In the case of this bridge the revetments have at a later stage been strengthened by the installation of gabions.

South-eastern revetment

Apart from the embankments that had to be strengthened by the installation of gabions, this structure is still sound.

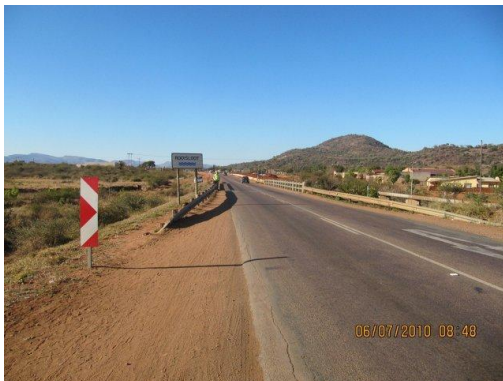
The approach road runs between Mokopane and the Botswana border and carries a large volume of traffic.

Approach road, travelling north

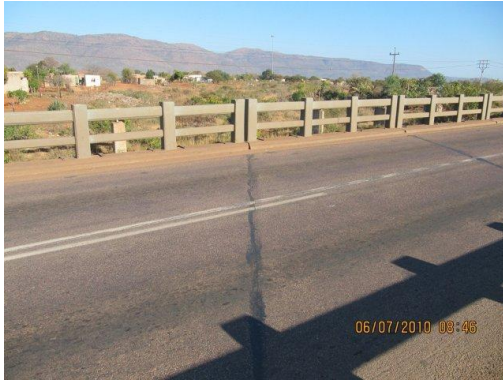
The bridge deck consists of six concrete sections reinforced by girders, which is also part of the construction of the bridge and is then covered with a layer of tarmac. The total length of the bridge deck is approximately 34 m.

Bridge deck seen from the top

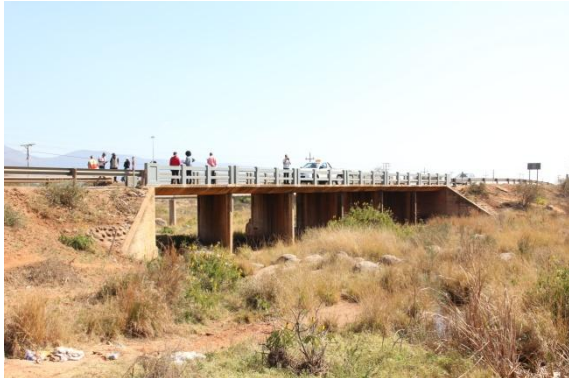
Formed by packing down soil to achieve the necessary height and then sloping down gradually the further away one moves from the river.

Showing the embankments on both sides of the bridge.

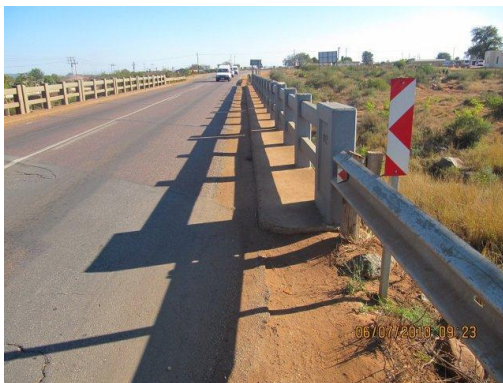
The guide rail is a raised platform of concrete, edged with angle iron that runs the length of the bridge. It is about 10cm high and about 30cm wide.

The guide rail

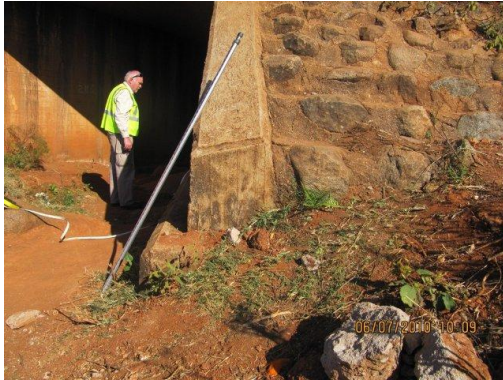
The revetment walls are constructed from large stones that have been cemented into place.

South-eastern revetment

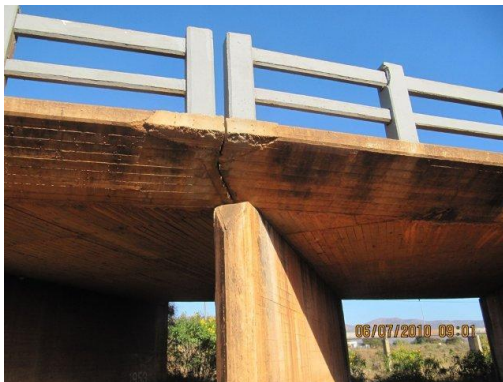
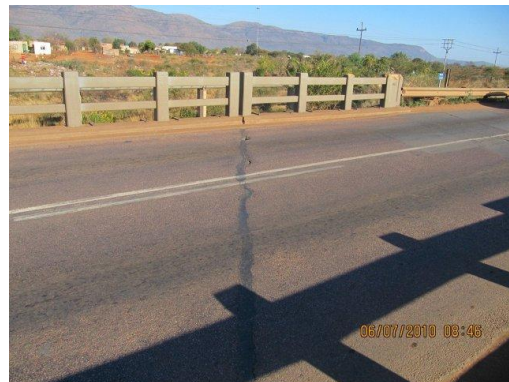
The joints where the various spans come together show signs of damage and consequent repairs.

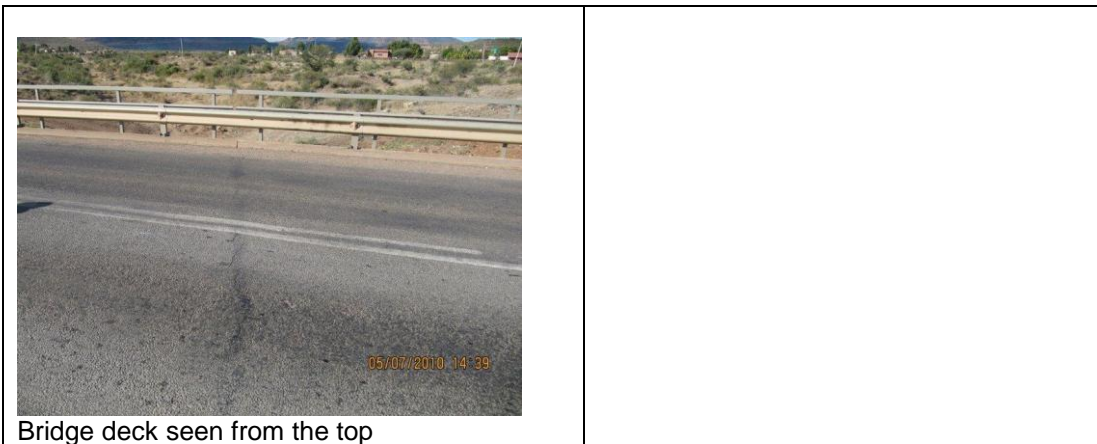
The bridge deck consists of three concrete slabs reinforced by girders. The top layer of the bridge deck consists of concrete, which is also part of the construction of the bridge and is then covered with a layer of tarmac. The total length of the bridge deck is approximately 16 m.

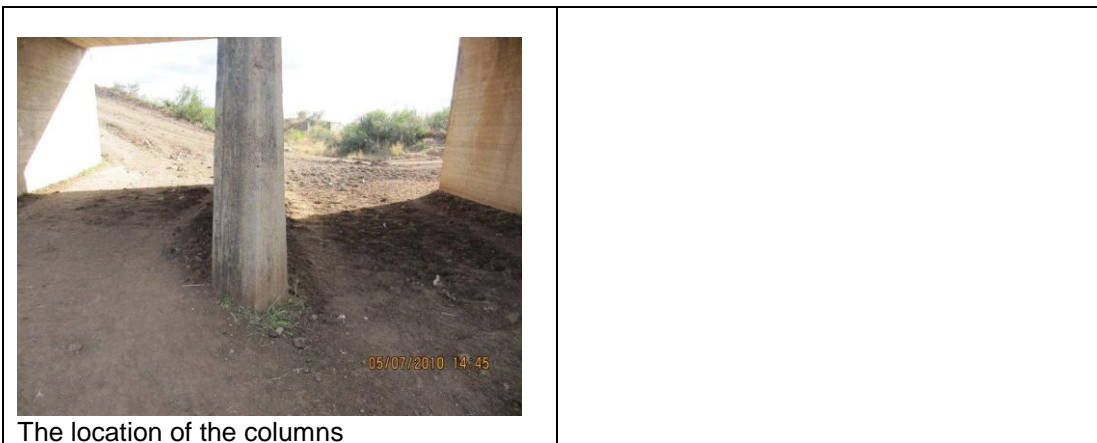
Three columns support the bridge deck. It is from cast concrete and is set at a slight angle to the bridge deck in order to be parallel to the stream bed.

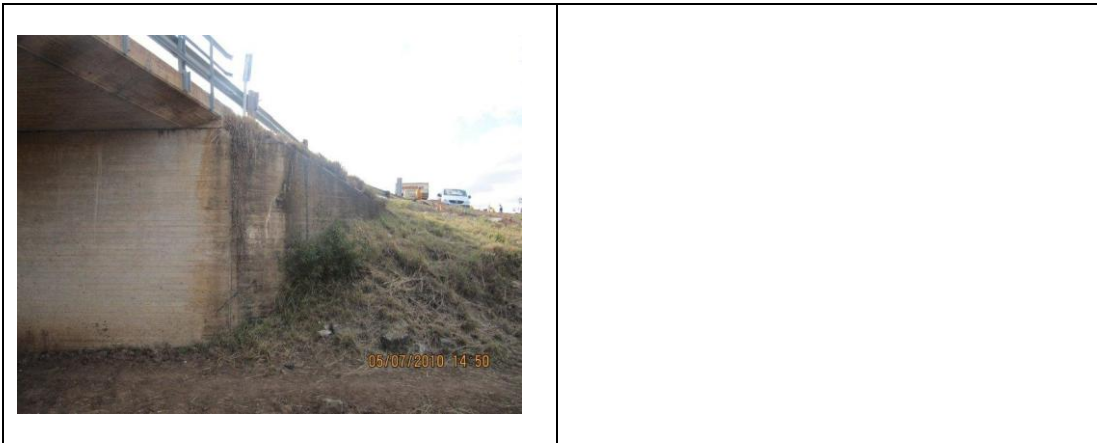
Formed by packing down soil to achieve the necessary height and then sloping down gradually the further away one moves from the river.

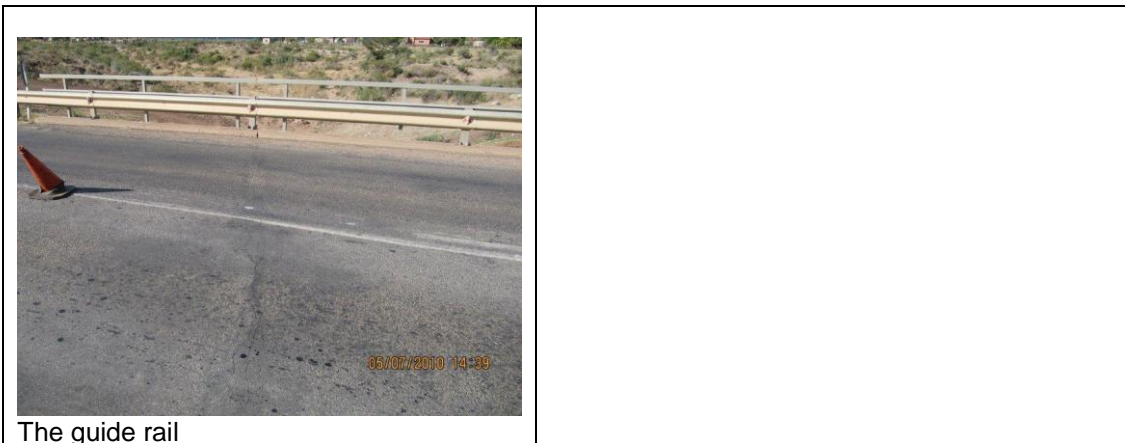
The guide rail is a raised platform of concrete, edged with angle iron that runs the length of the bridge. It is about 10cm high and about 30cm wide.

The guide rail

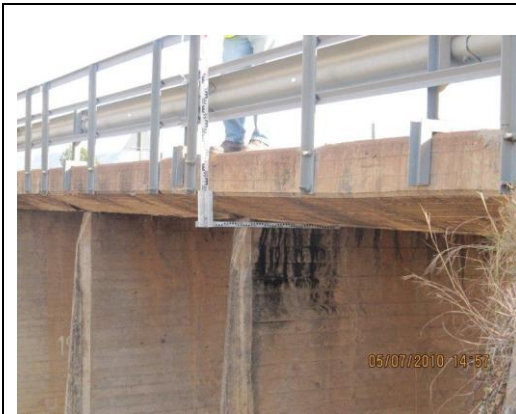
The original railings are made of ten upright sections of steel which supports two horizontal bars running the length of the bridge. The railings are now supported by Armco barriers.

Railing on eastern side of bridge

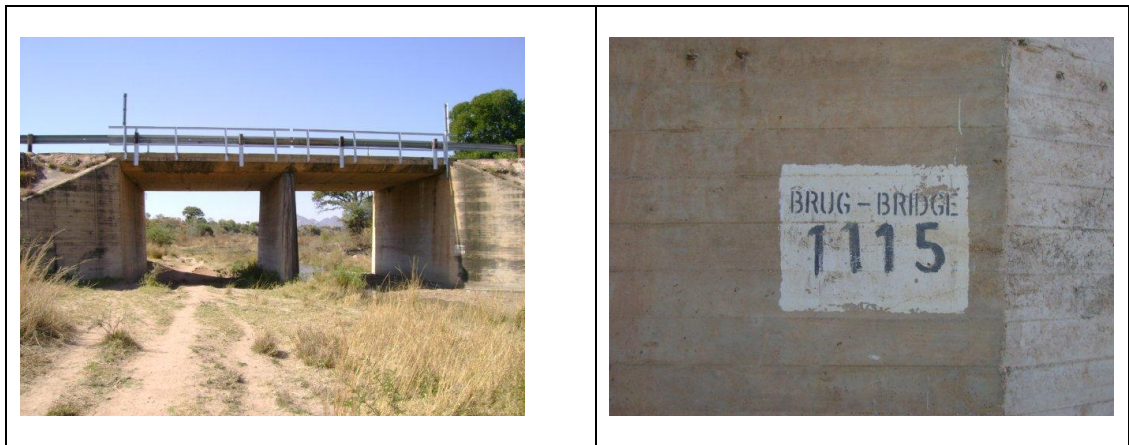
Fig. 14. Side view and identification number of the bridge.

This is a two span bridge of cast concrete. The bridge deck is supported by a single concrete column. The abutment and wing walls are all of concrete. The original railings are still in place and are now supported by Armco barriers. No date could be found on this bridge, but it is assumed to be in the same time-frame (1950s) as that of the other bridges.

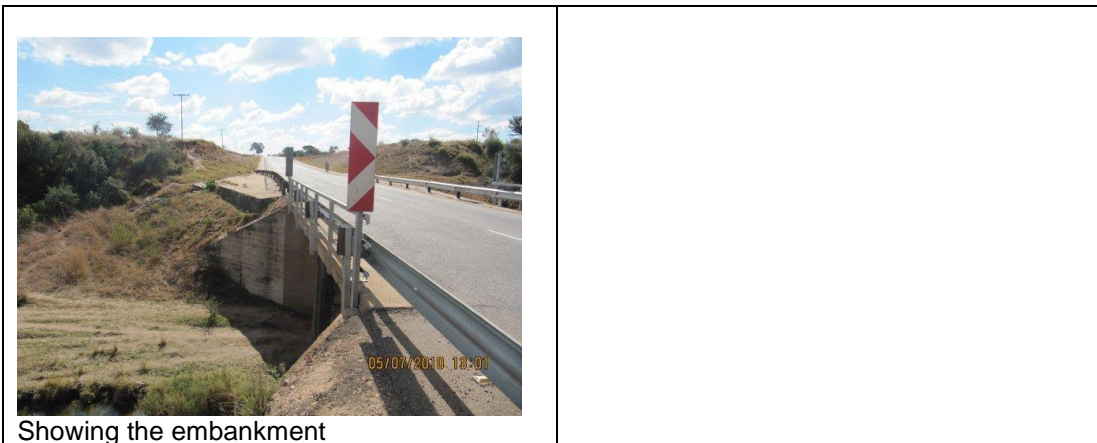
Formed by packing down soil to achieve the necessary height and then sloping down gradually the further away one moves from the river.

Showing the embankment

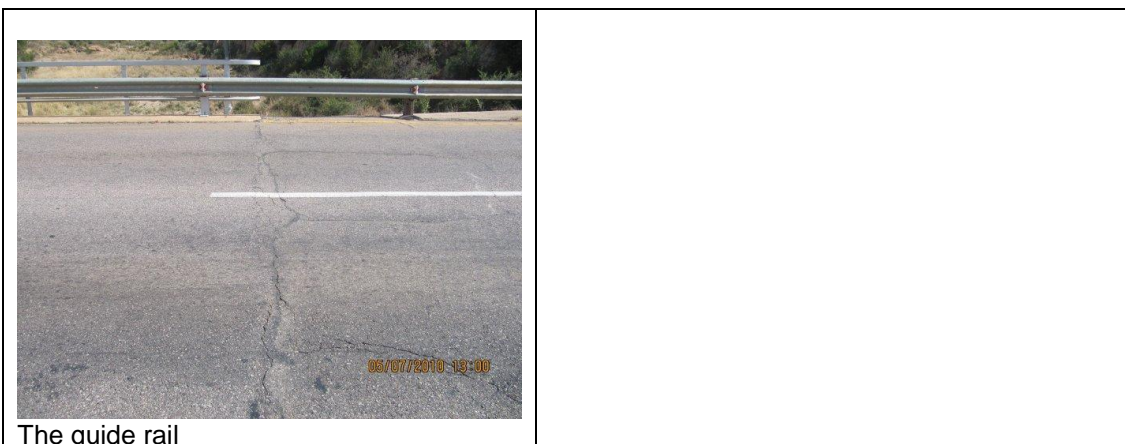
The guide rail is a raised platform of concrete, edged with angle iron that runs the length of the bridge. It is about 10cm high and about 30cm wide.

The guide rail

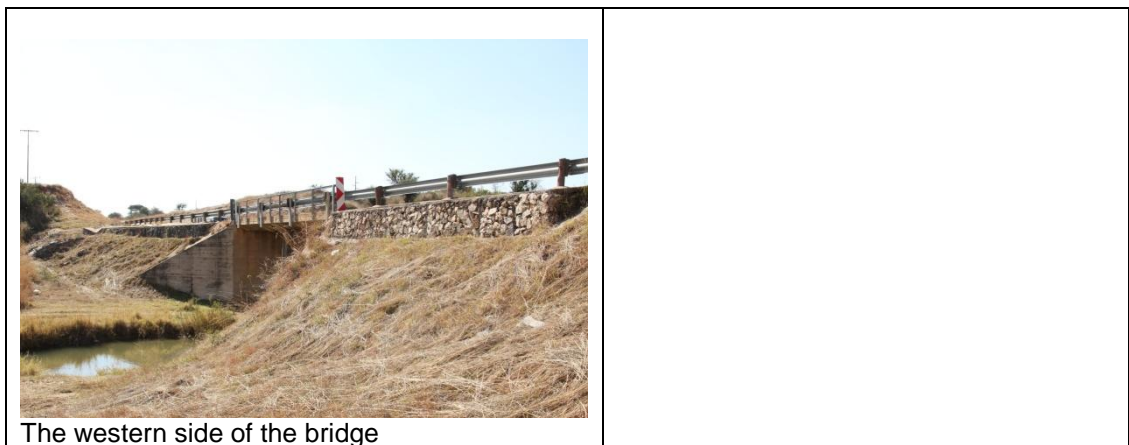
The revetments on this bridge have recently been strengthened by the installation of gabions.

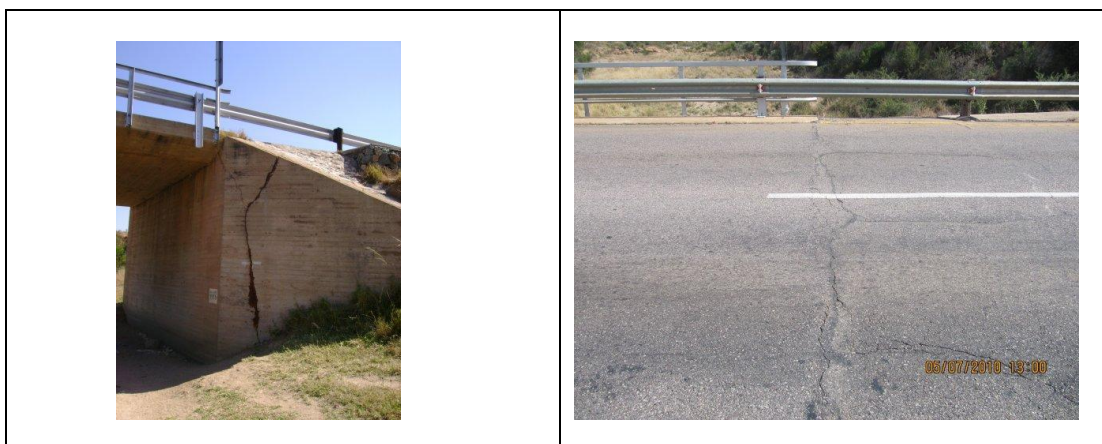
The bridge show large cracks in the abutment walls as well on the bridge deck.
