# MARKS BUILDING : PARLIAMENTARY PRECINCT : CAPE TOWN

## HERITAGE STATEMENT

AUGUST 2013

# **MARKS BUILDING : PARLIAMENTARY PRECINCT : CAPE TOWN**

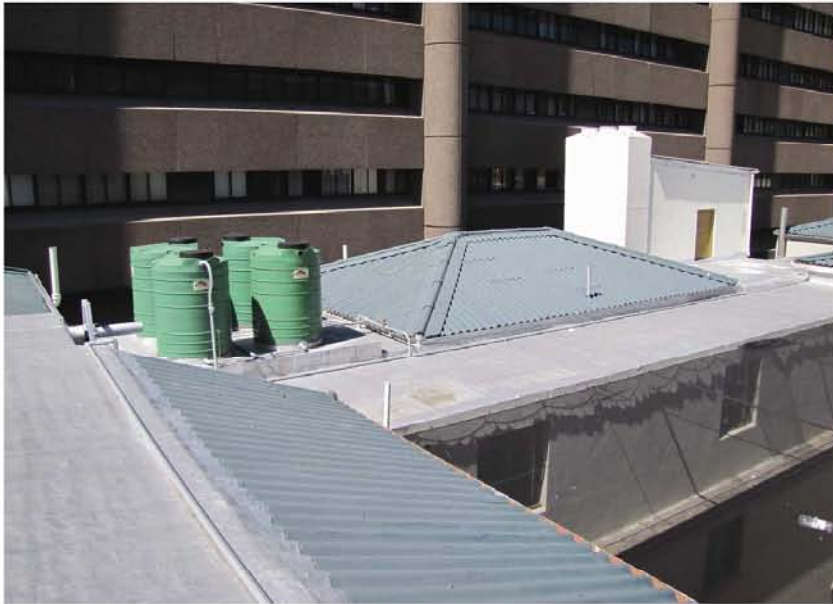
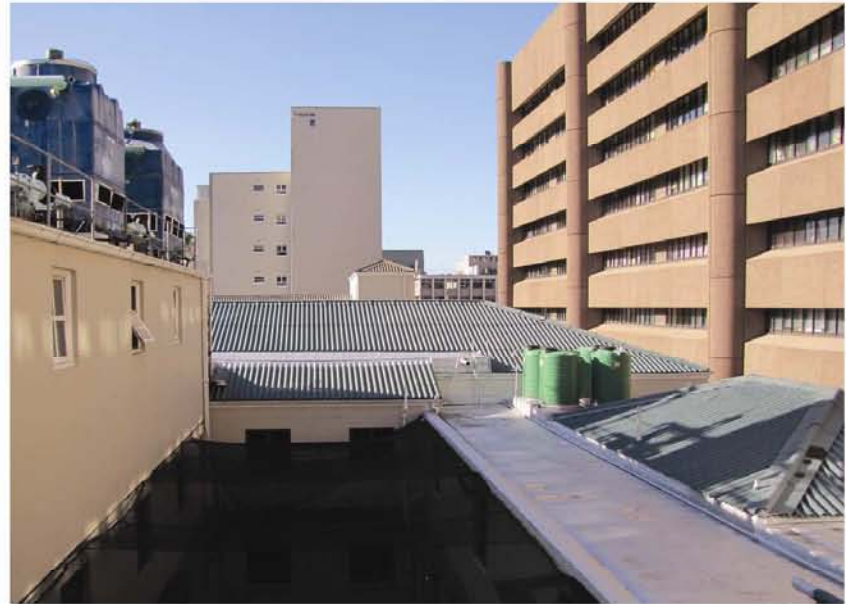
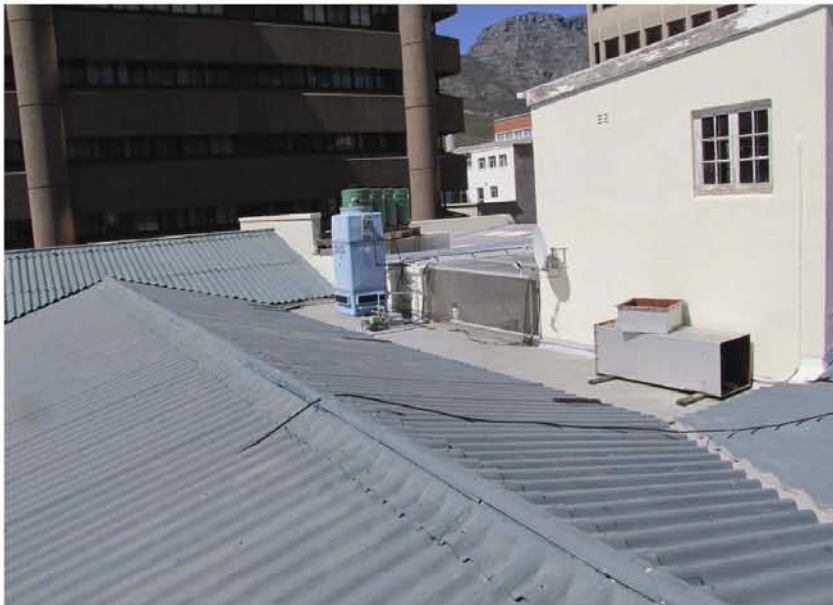
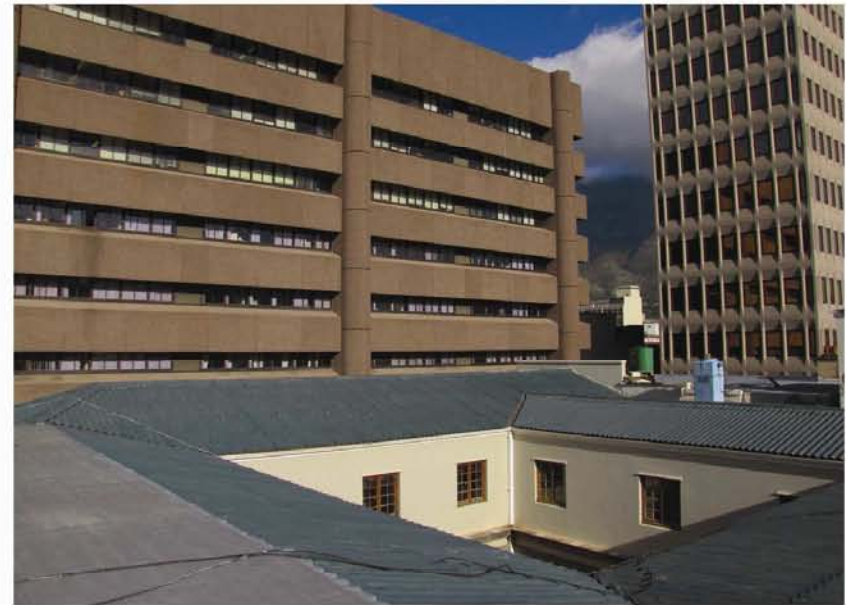
ROOF ELEMENTS : CORRUGATED IRON PITCHED ROOFS  
marks building : parliamentary precinct : cape town

Above the steep sloping outer face of the Mansard roof is a series of flat, waterproofed timber roofs and corrugated steel and asbestos low-pitched roofs.

- Top level roofs: [pitched asbestos-cement and corrugated iron sheeting, and waterproofed flat timber roofs]: replace with long-span, secret-fixed pre-coated galvanised steel roof sheeting, all ridge cappings to be aligned and consistent;
- Facade [front] pitch of Mansard roof: Replace asbestos-cement slates with dark slate-coloured fibre cement shingle-type tiles;
- Dormers [roof and sides]: currently lead sheeting - restore if possible. Use appropriate fixings to prevent electrolytic reaction between non-ferrous metals;
- Copper roofs at courtyard infills: repair - lift all seams;
- Polycarbonate roof: repair and re-seal.

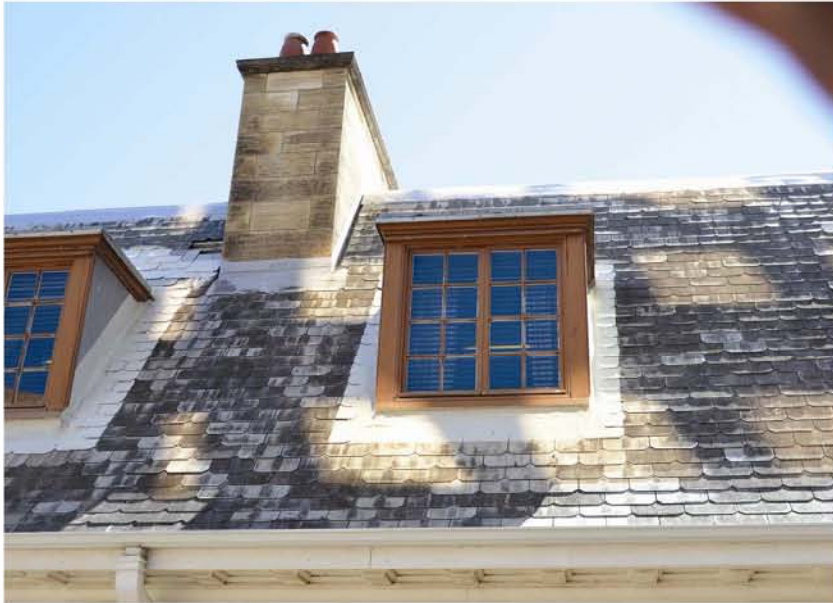
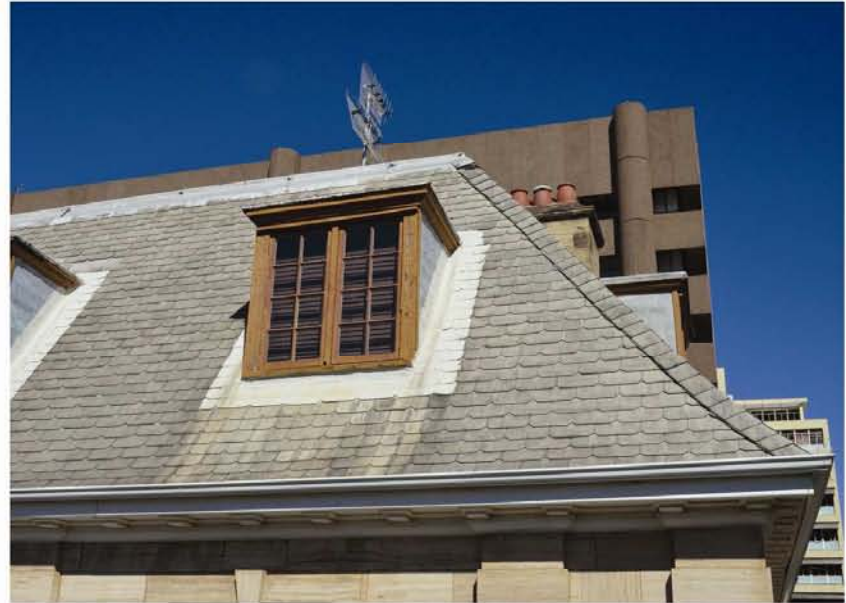
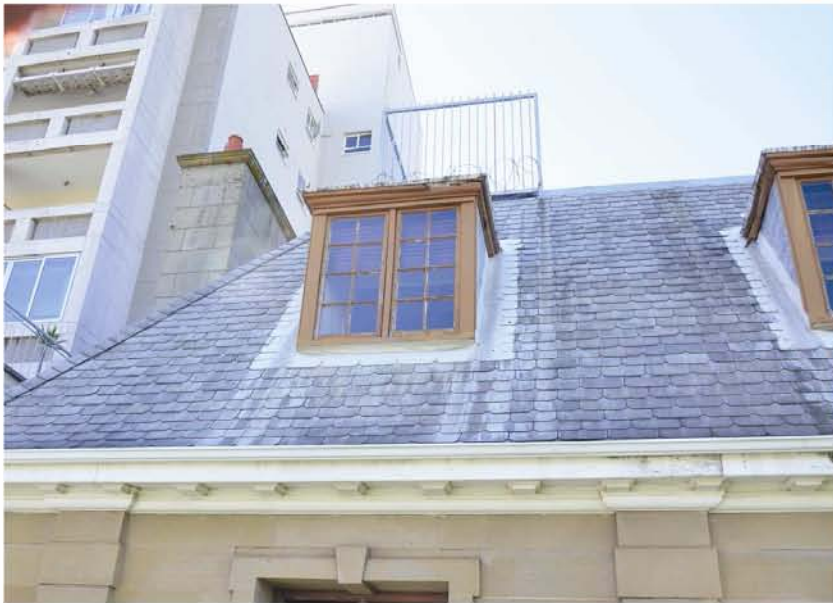
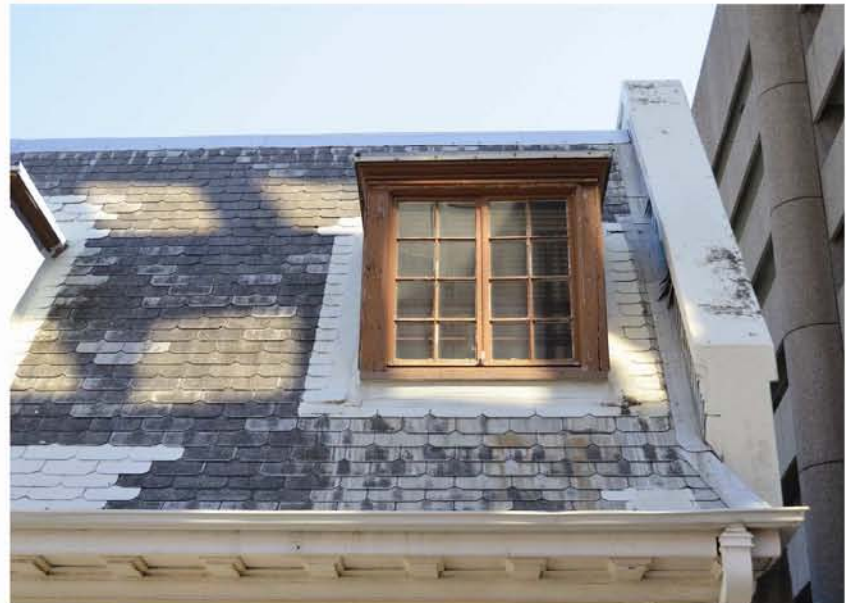
ROOF ELEMENTS : TILED  
marks building : parliamentary precinct : cape town

From street level, the roof appears to be Mansard roof above a storey above a ornate projecting cornice, with dormer windows repeating the bay arrangement below.

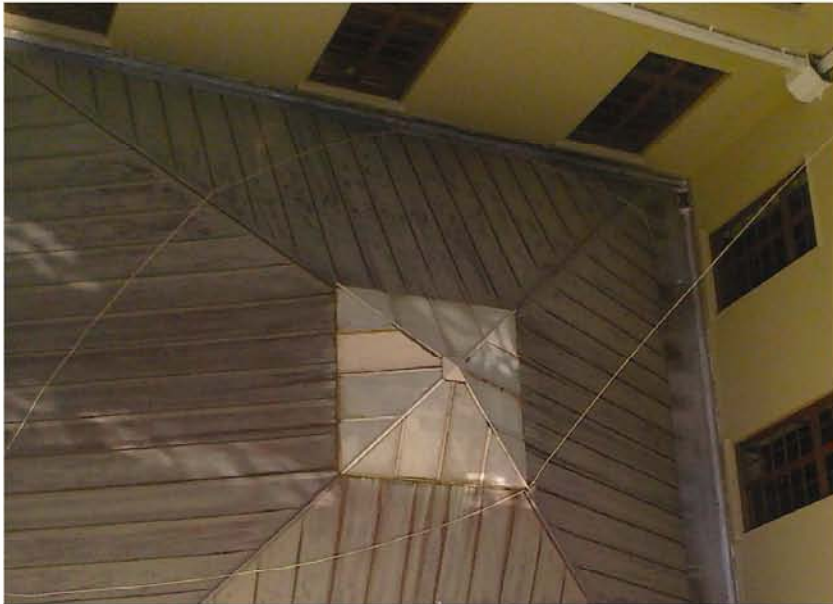
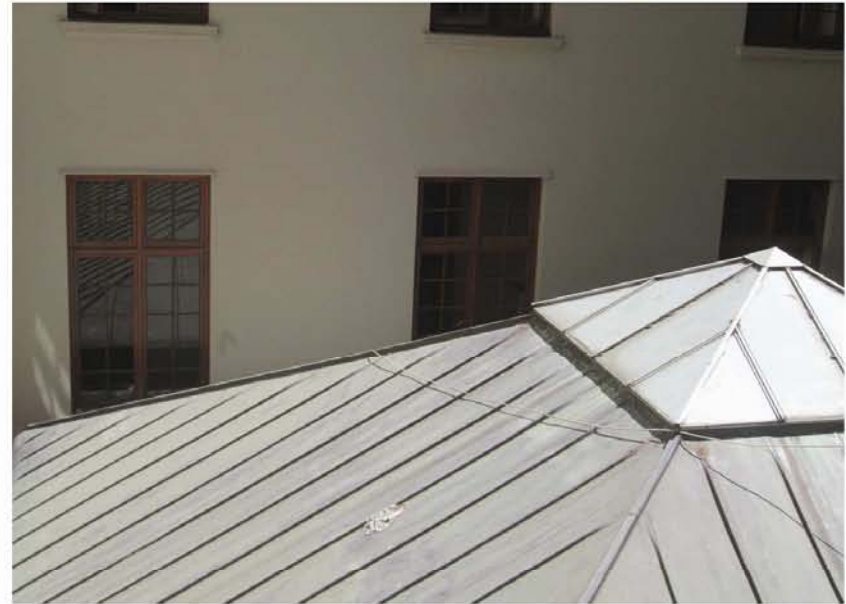
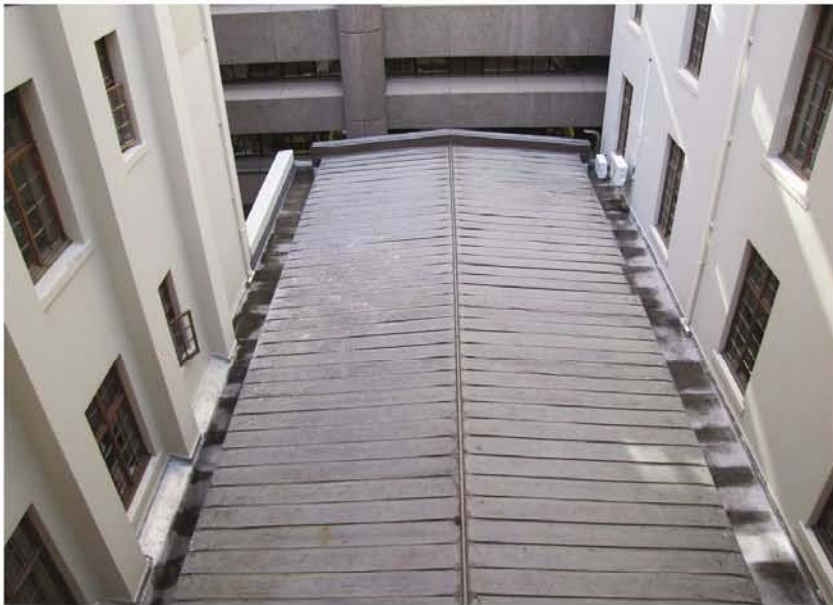
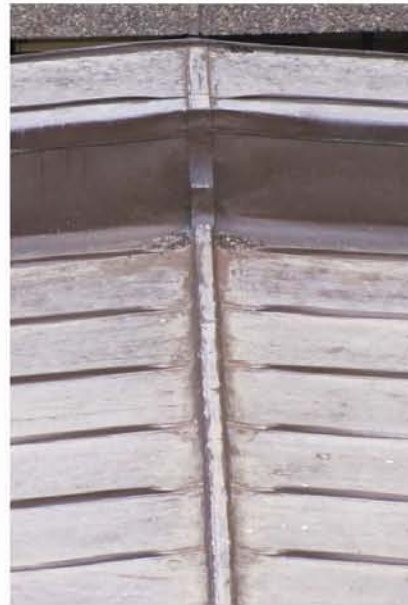
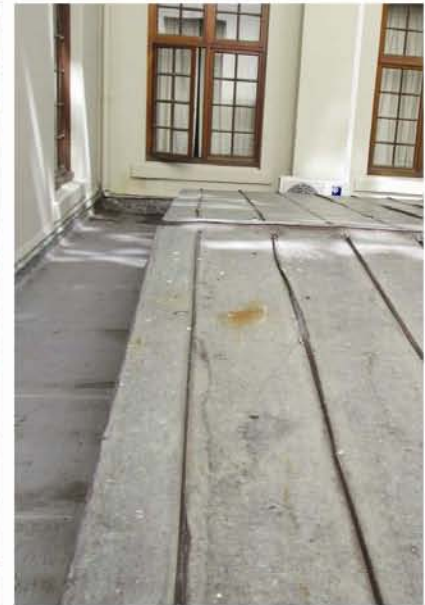
ROOF ELEMENTS : COPPER PITCHED ROOFS  
marks building : parliamentary precinct : cape town

Three courtyards were roofed over, presumably in the 1980's refurbishment, two with copper roofs, and one with a vaulted polycarbonate roof.

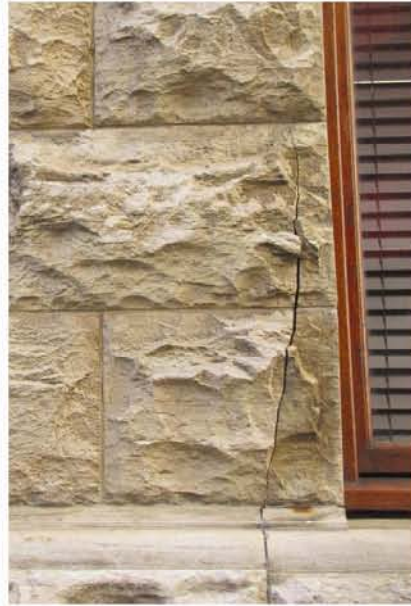
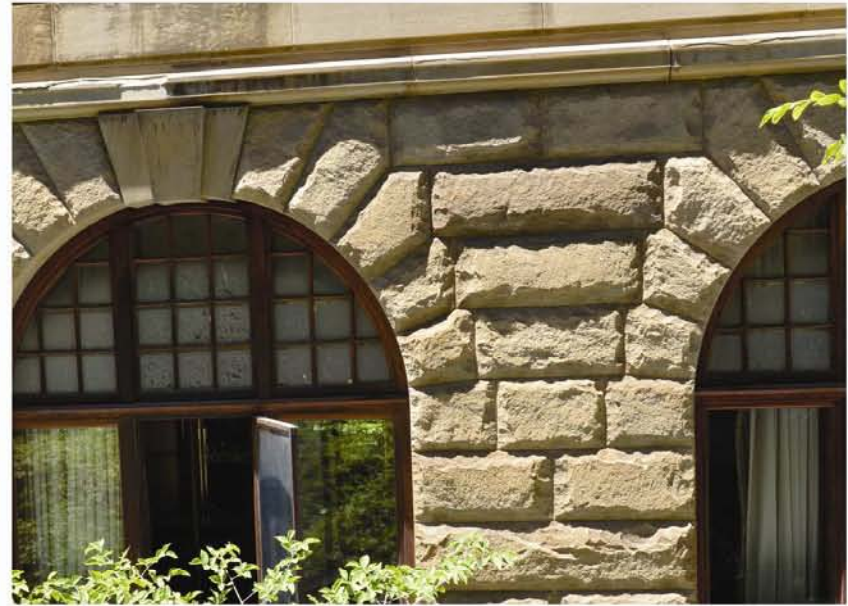
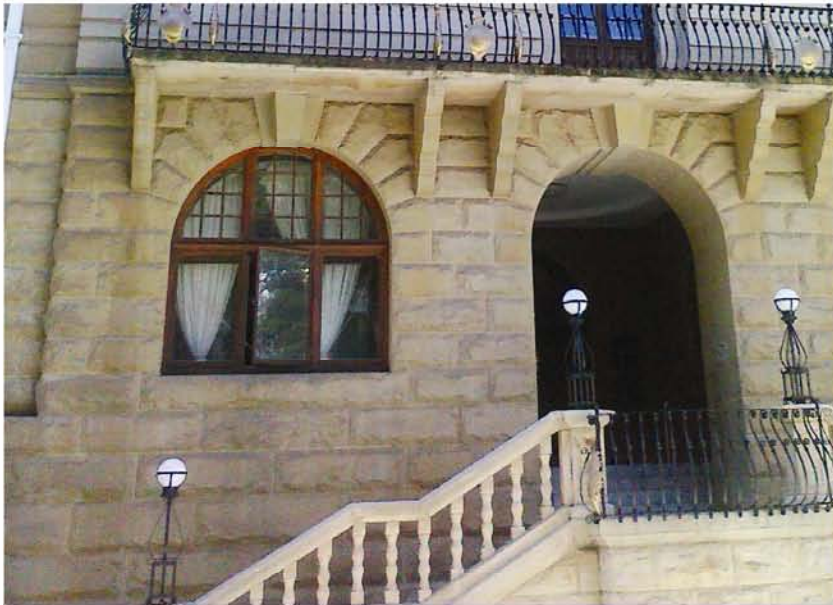
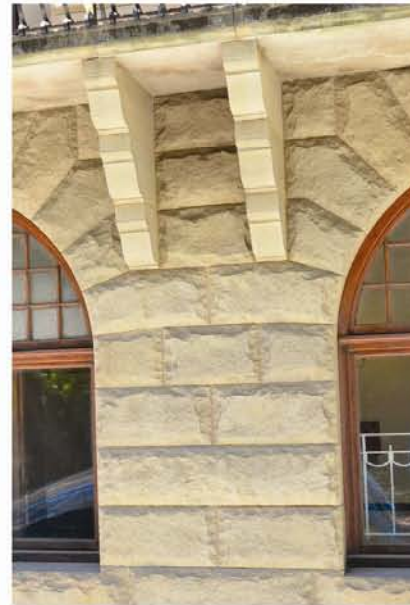
STONEMWORK : ROUGH  
marks building : parliamentary precinct : cape town

As described above, the facade facing Parliament St is clad in two types of local sandstone, with the Lelie St facade being partially clad in stone. The walls to the rear of the building are

- To be undertaken by specialists, using best current practices;
- Principle to be followed: to do as much as necessary but as little as possible;
- Do not repair/reface where naturally weathered - it is part of the patina of age;
- Repair only where dangerously eroded, delaminating [eg sills], or allowing water ingress;
- Re-grouting between stonework is to be considered only where there is water ingress;
- Replace balusters where necessary;
- Lead flashings to be fitted to top surfaces of projecting mouldings [replace current torch-on flashings];
- Stone slabs to entrance porch: leave as is - if damp proof membrane is installed under the stone slabs, damp will migrate to walls, which will create a more difficult problem to solve. [Stone floors can reasonably be a little damp in an entrance foyer open to the elements].

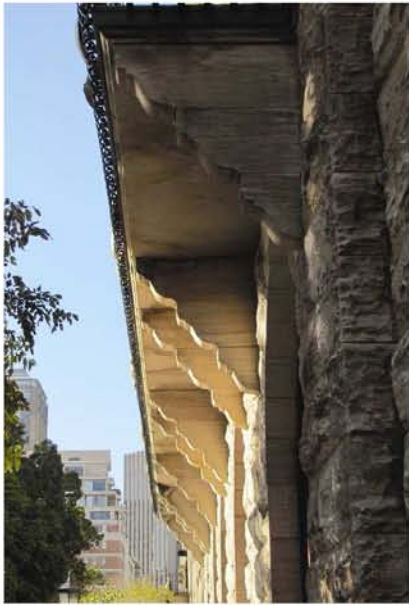
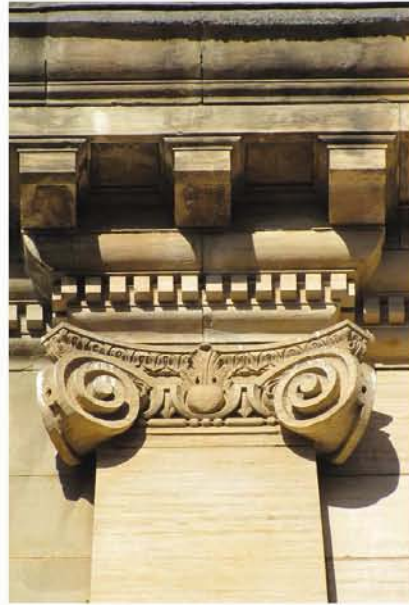
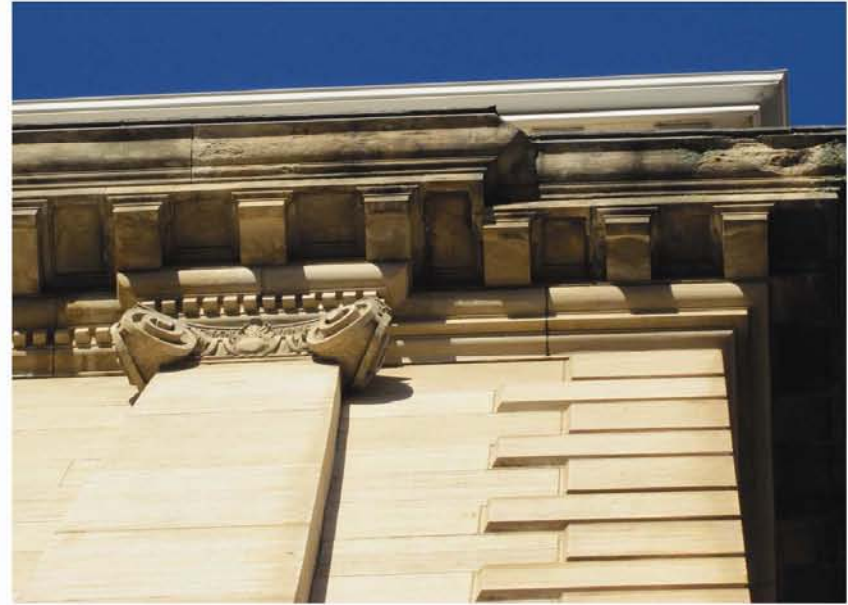
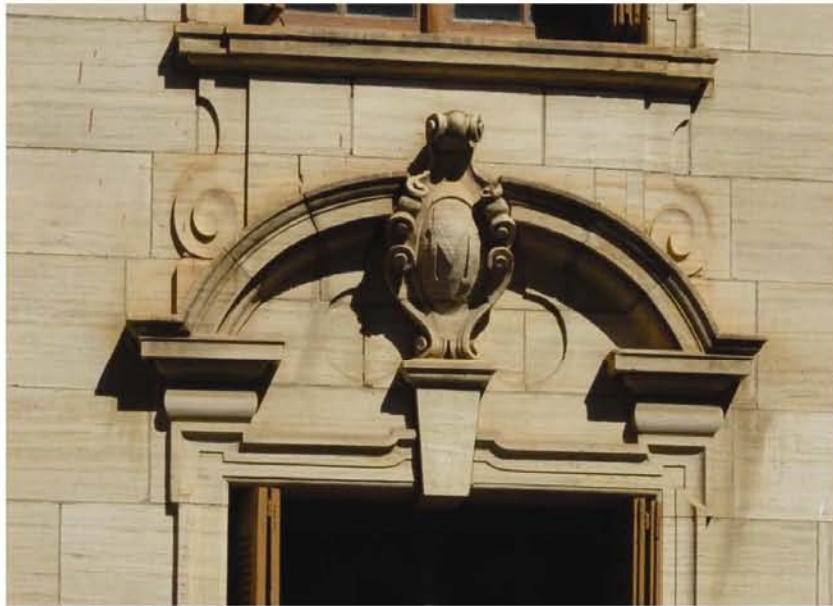
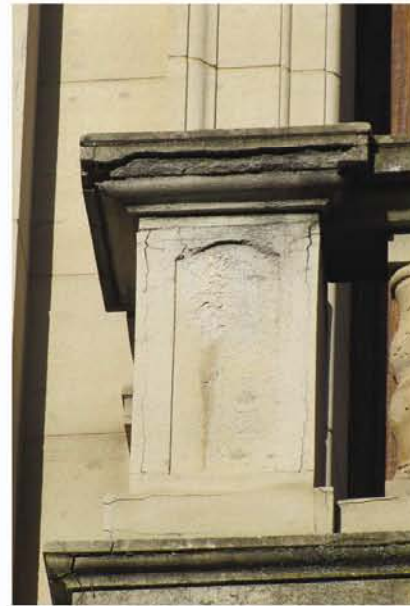
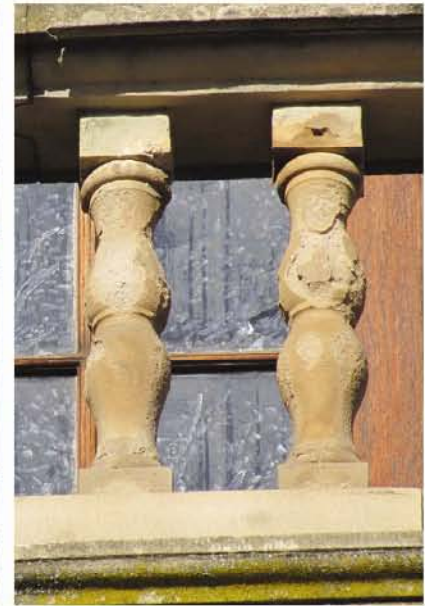
STONWORK : DETAILS  
marks building : parliamentary precinct : cape town

Stone balconies project over Parliament and Lelie St, some with stone balustrades [some balusters are badly eroded and in need of replacement] and some with painted wrought iron balustrades with ornate gilded cartouche decorations.

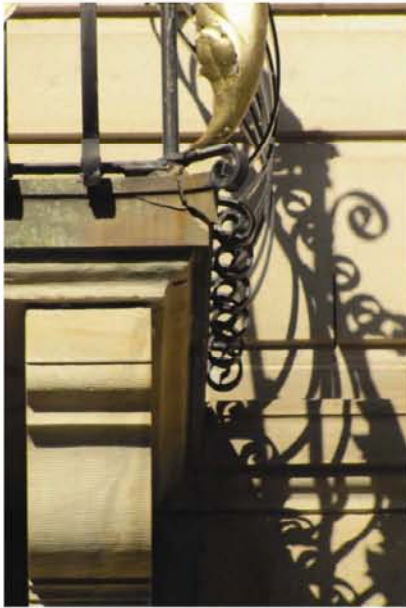
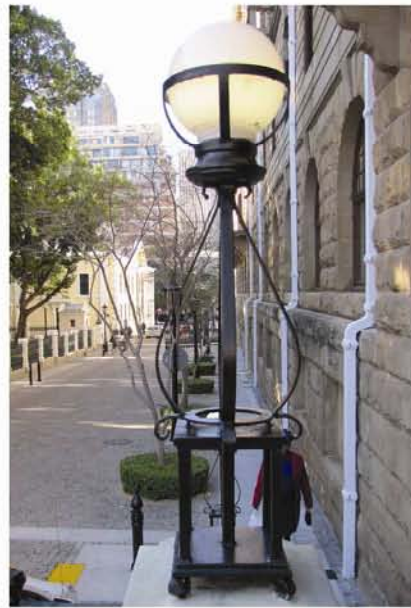
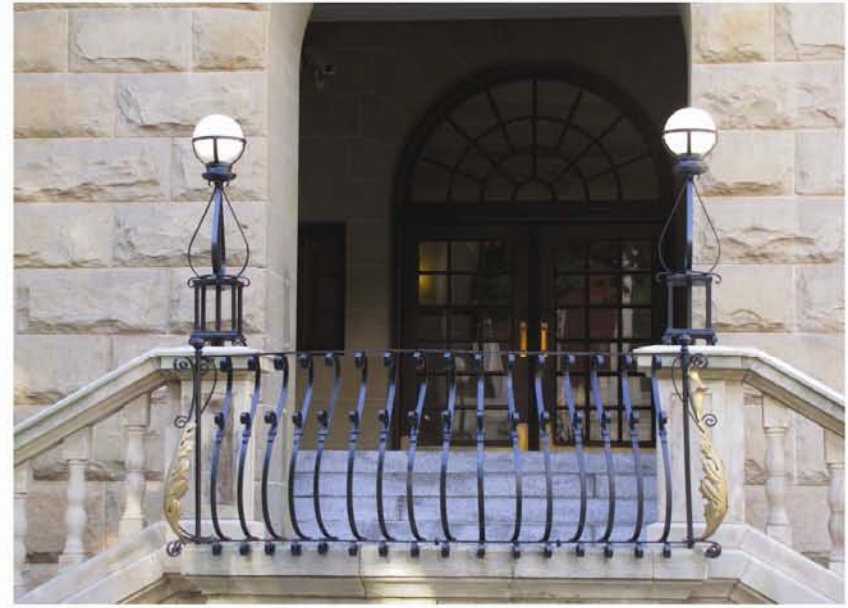
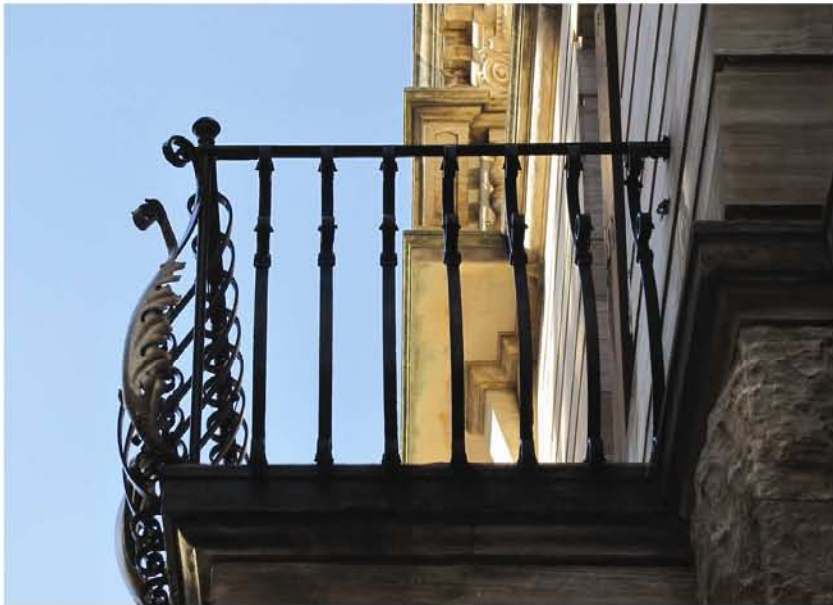
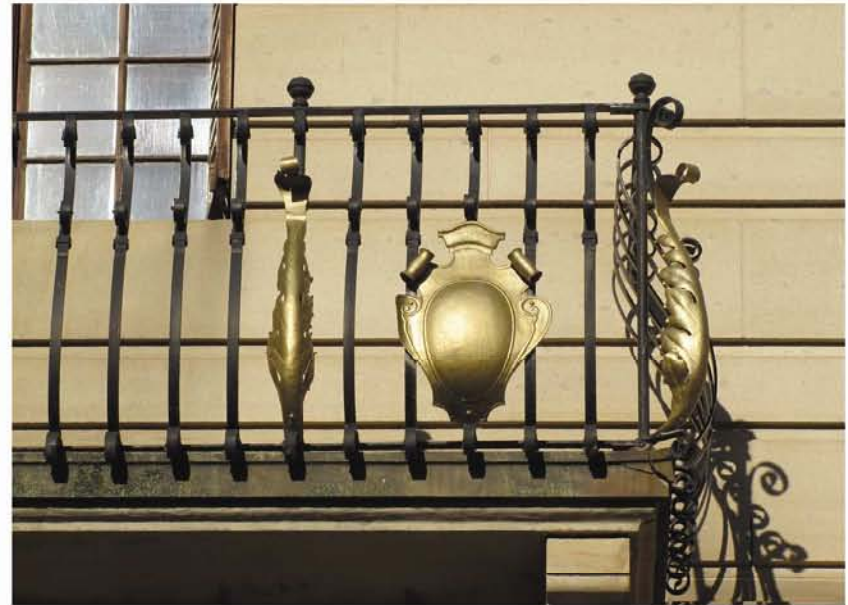
WROUGHT IRON : DETAIL  
marks building : parliamentary precinct : cape town

The wrought iron balustrades and lamp-standards are hand-wrought mild steel, and riveted. There is considerable corrosion of the ironwork, especially where it has been set into stonework with lead. Vigorous remedial work is required to conserve the railings in particular.

- Carefully remove, shot-blast to grey metal, hot-dip galvanise, and epoxy coat. Refit with flexible gasket between wrought ironwork and stonework;
- Replace missing cartouches and decorative elements

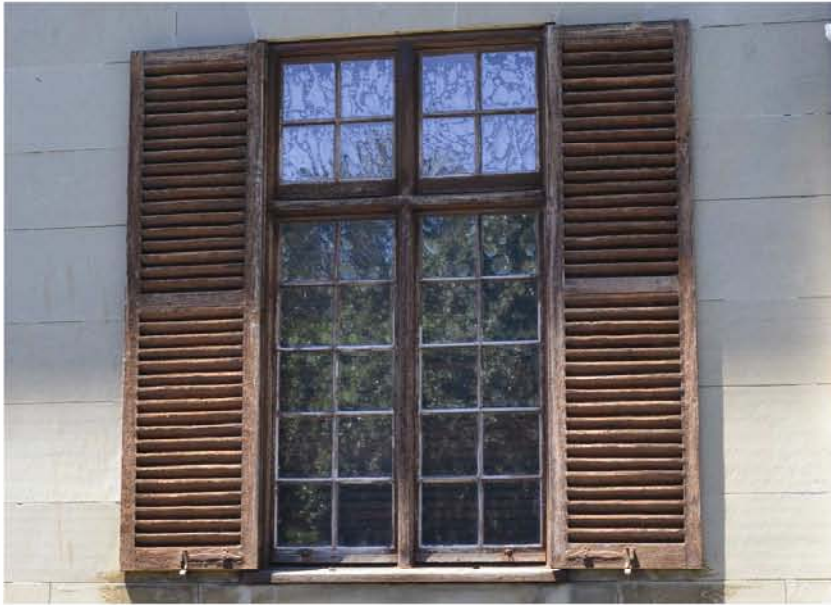
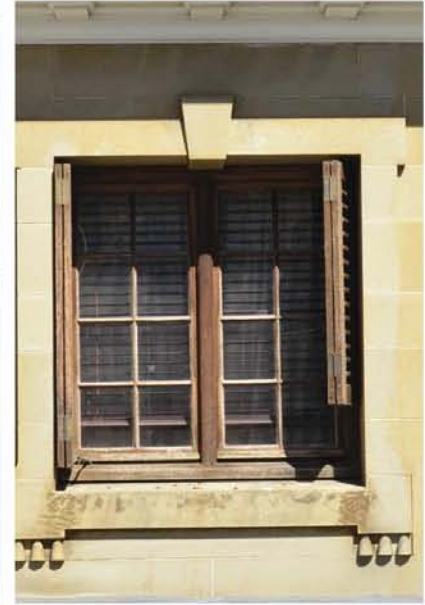
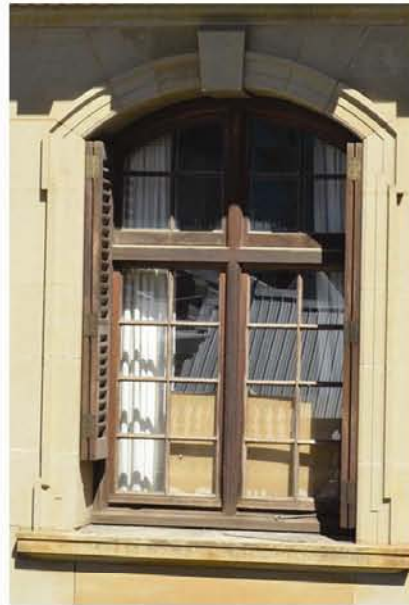
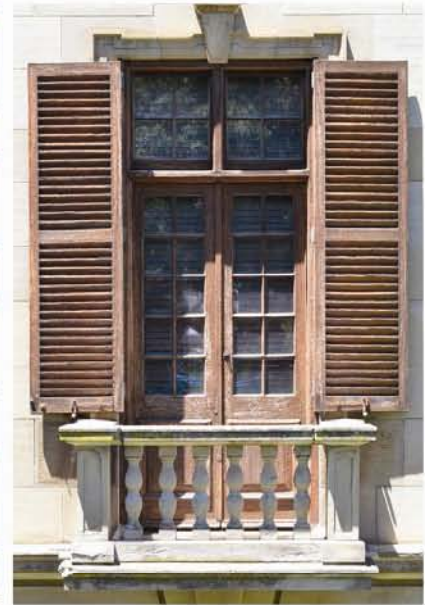
DOORS AND WINDOWS : TEAK  
marks building : parliamentary precinct : cape town

The windows and doors facing Parliament St are Burmese teak, [some painted] generally in good condition, but in need of repair.

- Facades: Burmese teak: repair or replace where necessary. [Use afrormosia if teak is unavailable];
- Steel windows [some in timber subframes] are original: leave as is - in excellent condition [appear to be double-dipped galvanised in hot zinc - almost no signs of rusting]
- Some painted windows [Baltic pine?] may need to be replaced - replace with painted hardwood to match existing exactly.

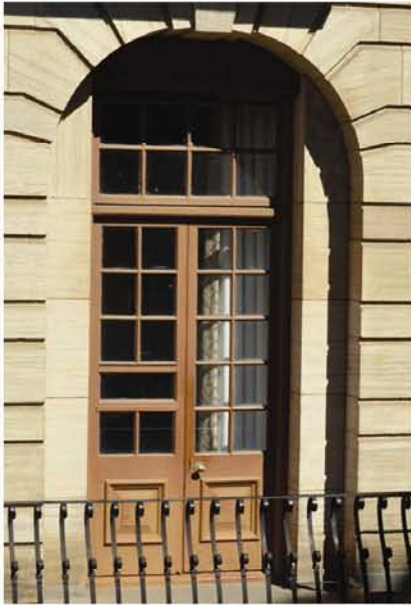
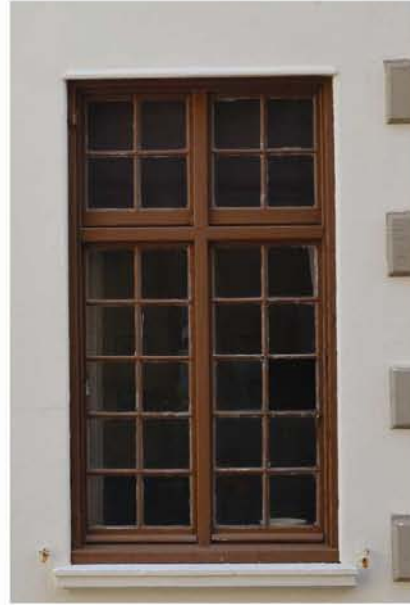
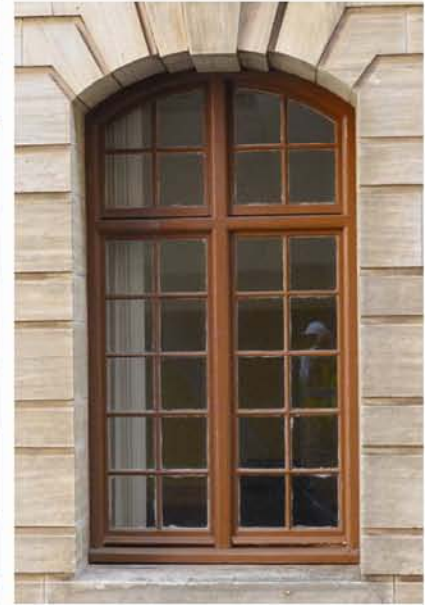
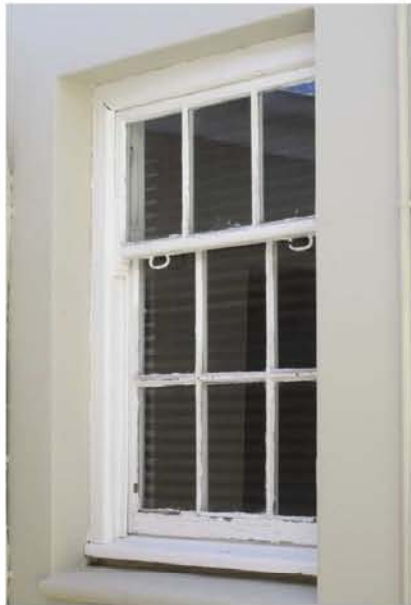
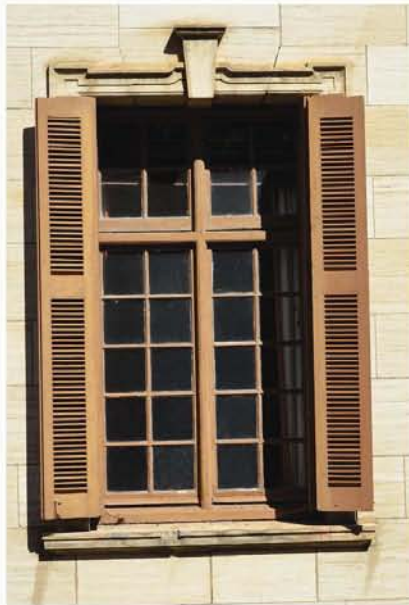
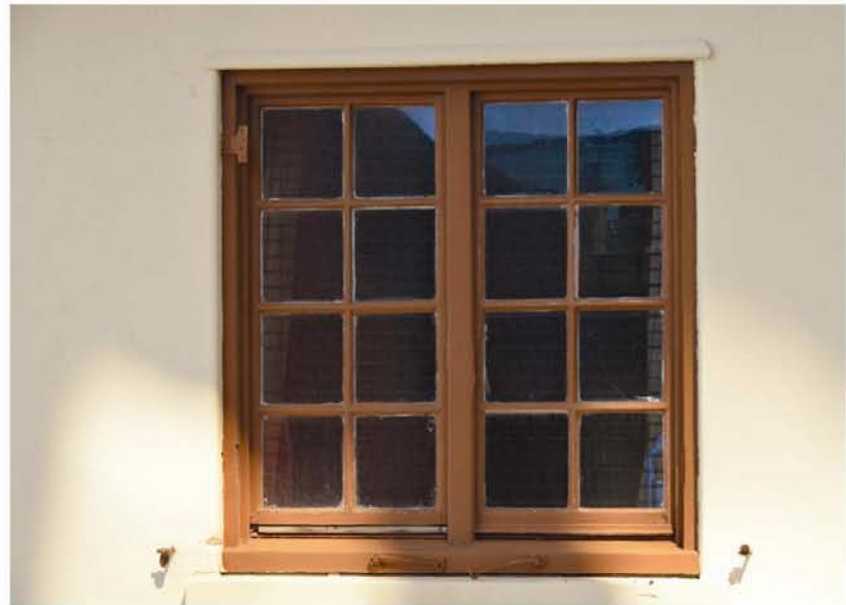
DOORS AND WINDOWS : PAINTED BALTIC PINE  
marks building : parliamentary precinct : cape town

Windows to the service courtyard in the original Baker building are painted Baltic pine, some of which need replacing.

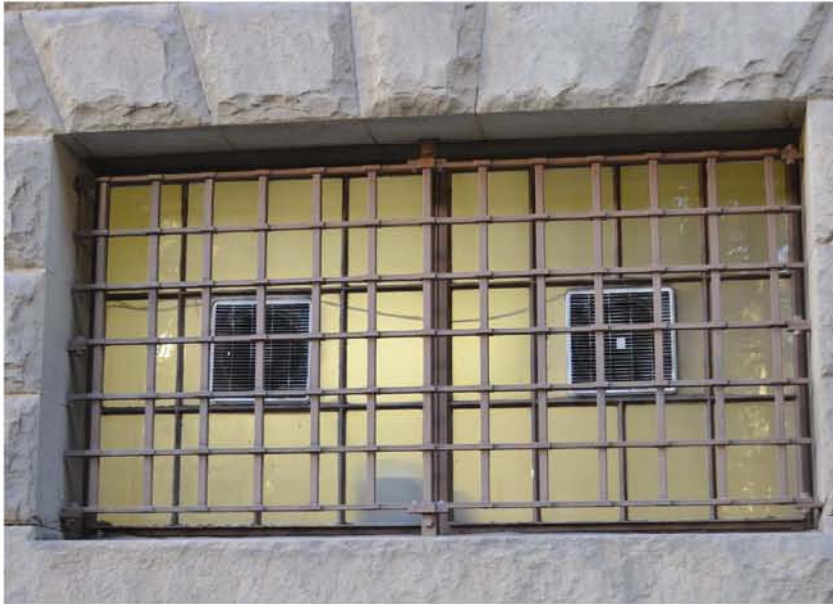
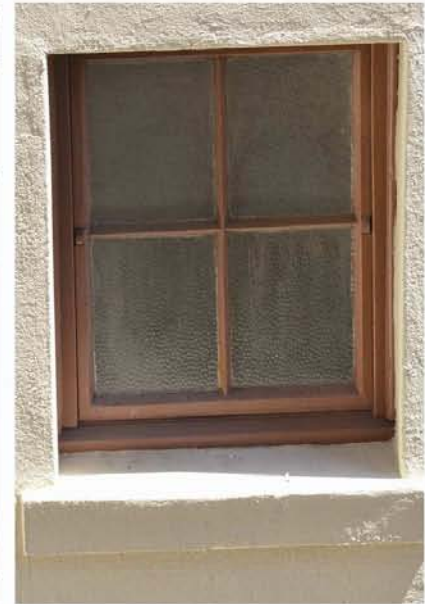
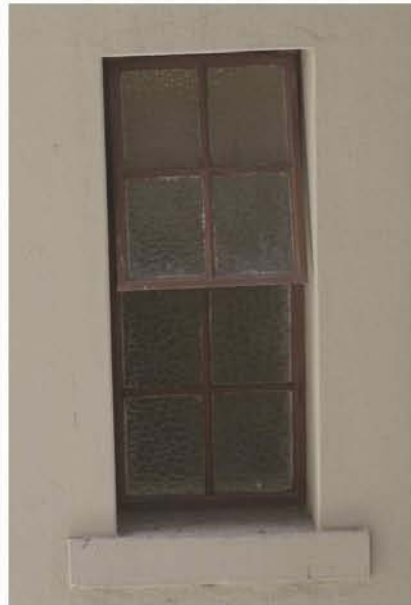
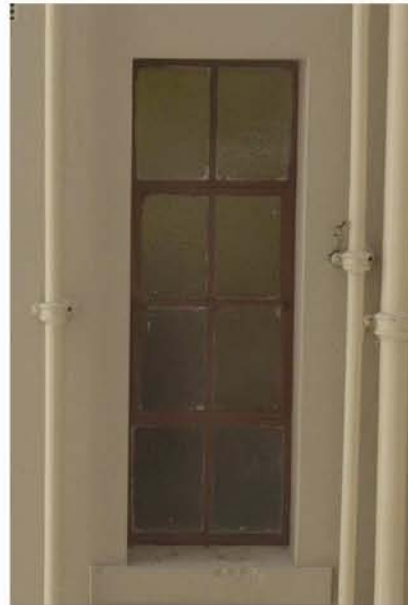
WINDOWS : STEEL WINDOWS  
marks building : parliamentary precinct : cape town

To the rear of the building, and facing the courtyards, are a collection of teak windows, and steel windows, those to the larger offices in a painted teak subframes, all original and in good condition.
